MEMORANDUM

DATE : June 10, 2023

SUBJECT : Weekly Progress Report for Week Ending 06/10/2023
Community Within the Corridor - East Block

COPY TO : Que El-Amin / Scott Crawford, Inc., Robert Reineke, PE, Robert Fedorchak, PE
Project #40441B

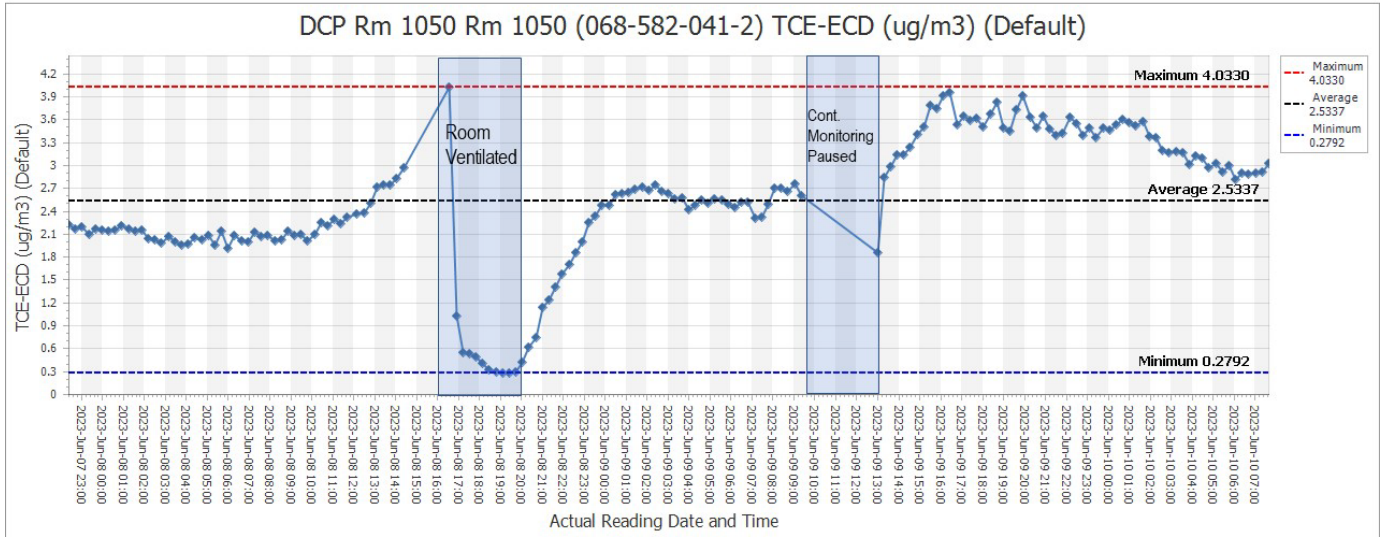
- Continuous monitoring was started in Units 1045 and 1050 which are displayed in Appendix D in Figures 1 and 2, respectively. The continuous monitoring data supports the information gathered from discrete sampling.

Figure 1 – Continuous Monitoring Data for Unit 1050 since June 7, 2023

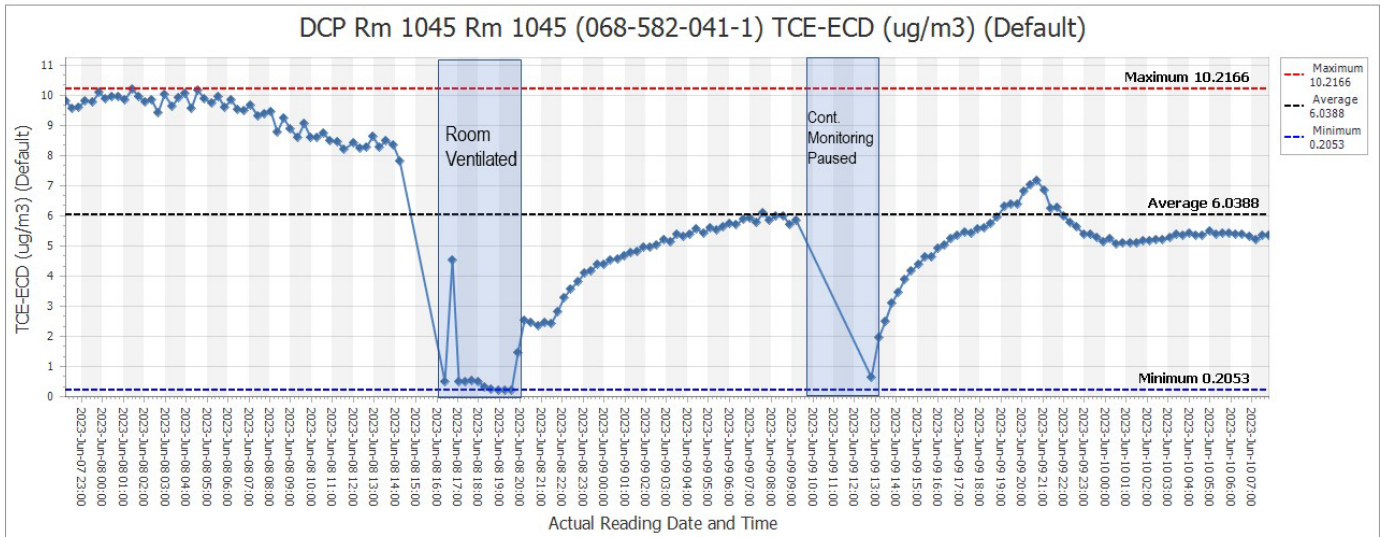
Figure 2 – Continuous Monitoring Data for Unit 1045 since June 7, 2023

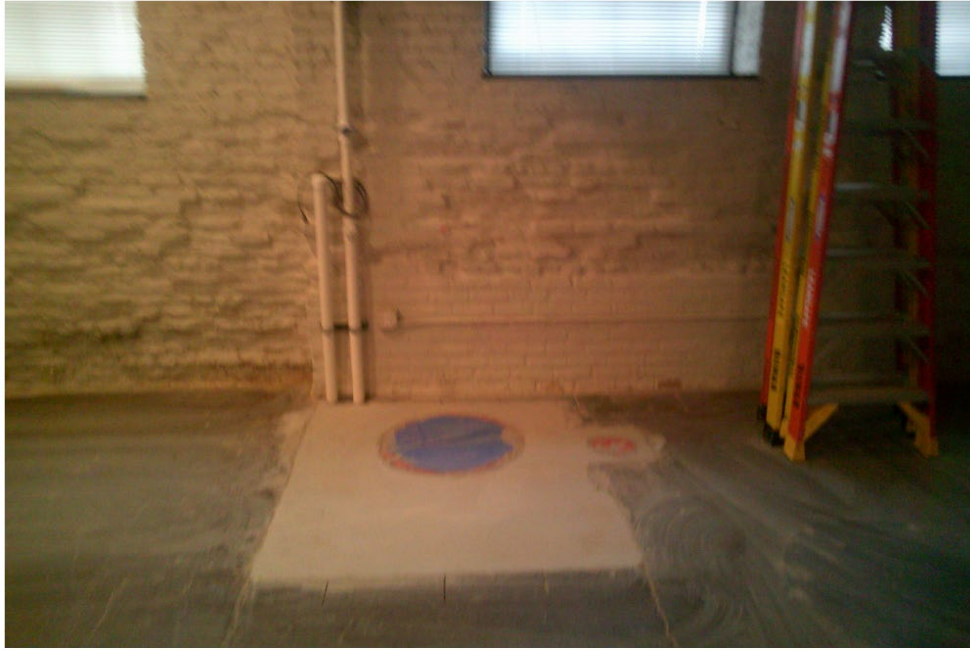
3. Task #3 – Final Connections for Sumps
All sump connections have been made. Arrangements are being made to connect the sump pumps to power.
 4. Task #4 – Sealing of Access Points
9 out of the 13 installed Access Points were sealed with an air-tight plastic layer covered by reinforced concrete. The other 4 points are covered with plastic sealed air-tight with duct tape to provide access for any additional work.

June 5, 2023 - Sump in Unit 1042 - Plumbing Completed

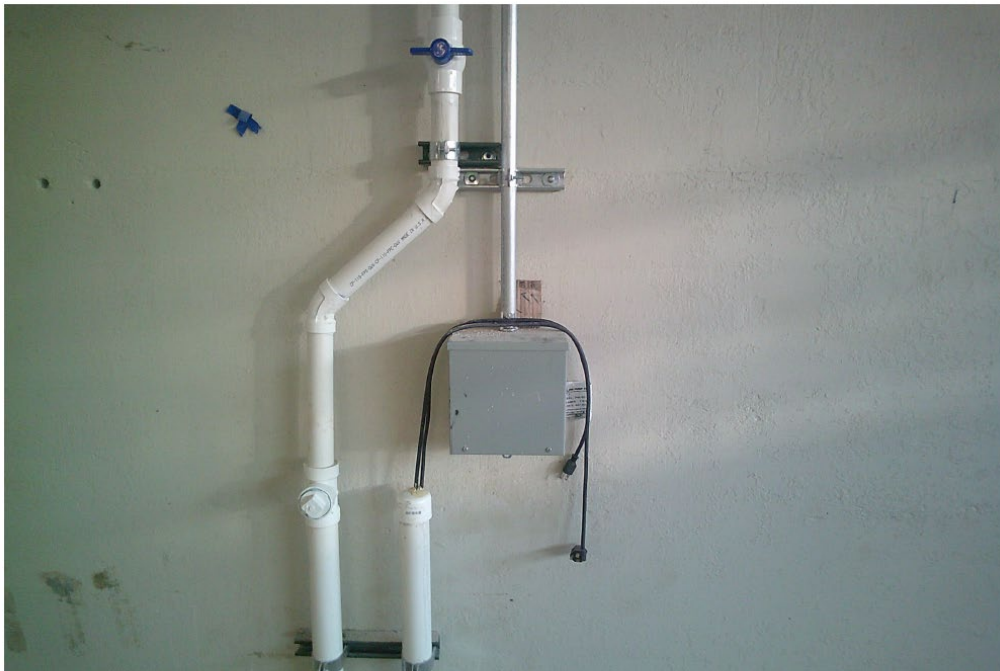
June 5, 2023 - Horner Construction Completed Northern Garage Sump with Plugs

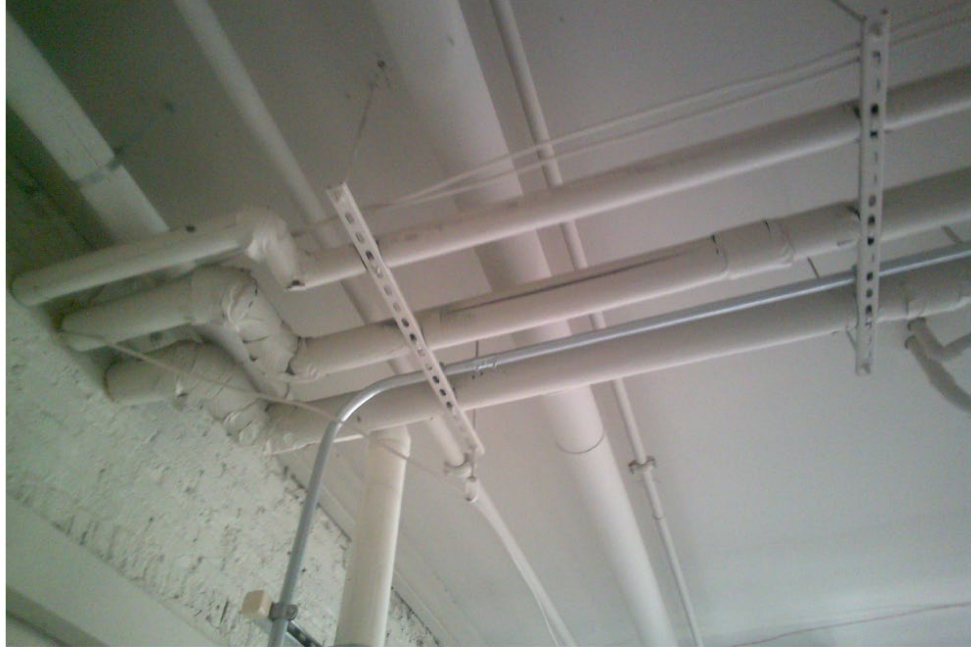
5. Task #5 – Electrical Connection for new Blower
Roman Electric completed the installation of power to the Obar Fan. The fan has been operational since June 6th, 2023.

June 5, 2023 - Installed Ceiling Conduit to Obar Fan by Roman Electric

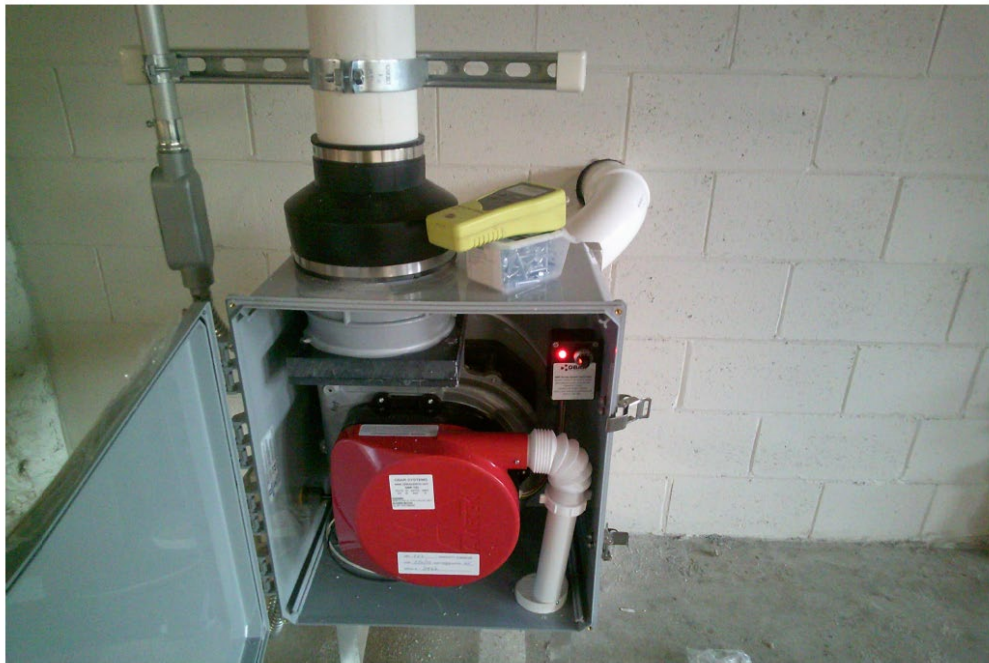
June 6, 2023 - Obar Fan with Active Electrical Connection

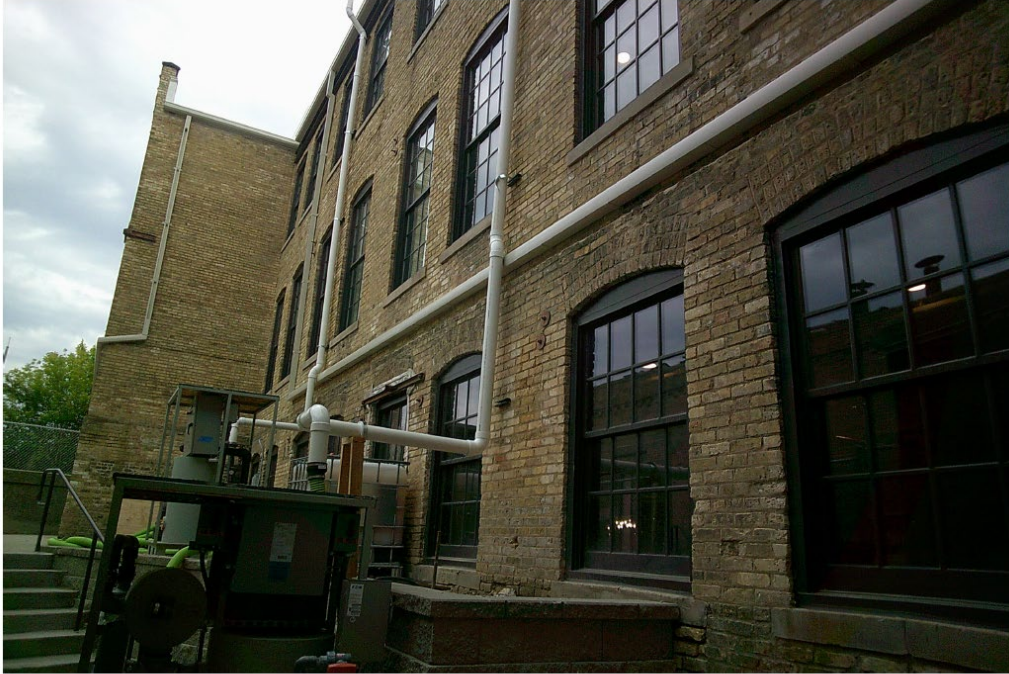
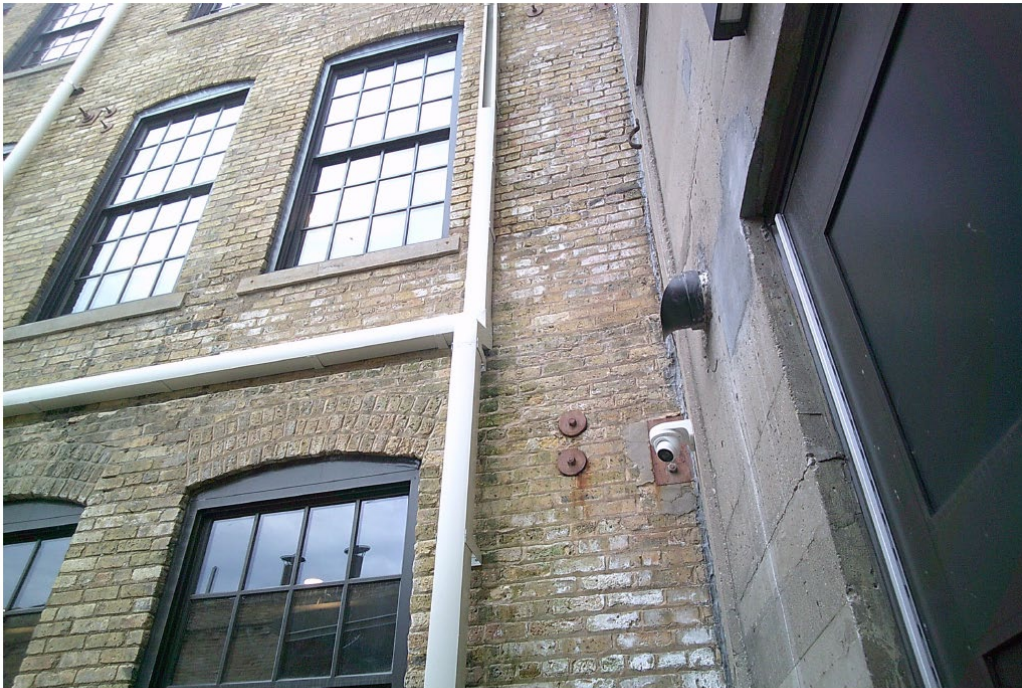
2. Task #2 – Redirection of Downspouts
Wenger Construction was onsite this week working on the downspouts and gutters. Redirection of downspouts from Building 1B-SE were completed. Please see Attachment E for photo documentation.

June 6, 2023 - Rerouted Gutters

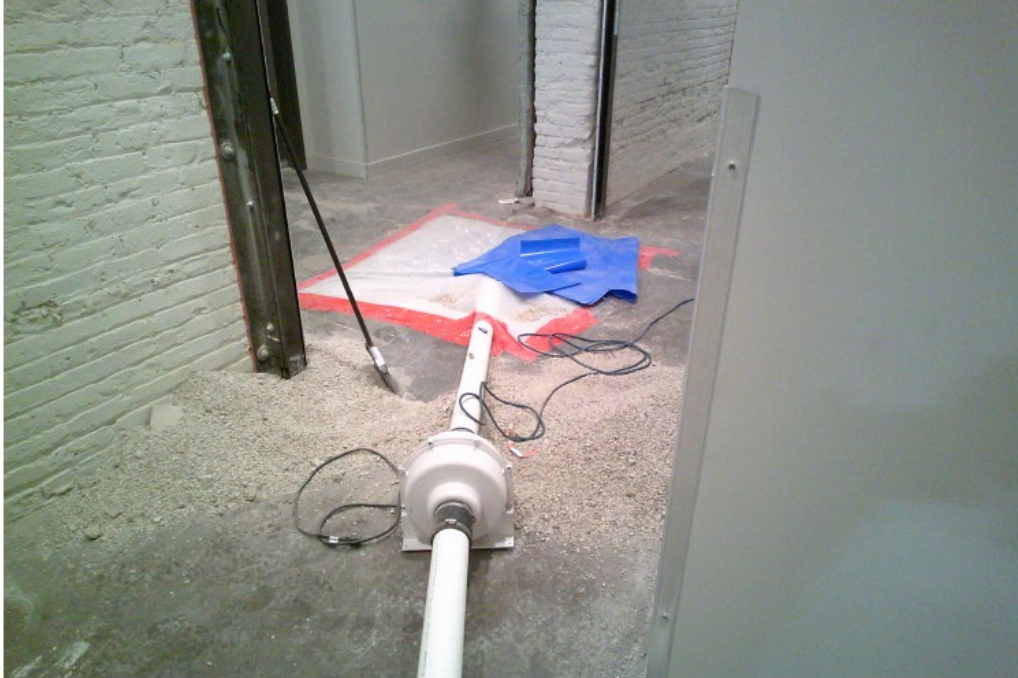
7. Task #7 – Testing of Additional Fan at Access Point 1
A Radonaway GP501C was set up for a Pressure Field Extension Test at Access Point 1 and was plugged in with exhaust vented outdoors. Calculated approximately 68 cfm from GP501C after anemometer measurement. Observed an increase in vacuum and ultimately vacuum under all units greater than -0.004 inches of water except under Unit 1039. A more powerful fan likely to induce vacuum in unit 1039, and arrangements are being made for a permanent fan at Access Point 1.

June 8, 2023 - GP501C Radon Fan Set Up at Access Point 1
