MEMORANDUM

DATE : June 17, 2023

FROM : Pratap Singh, Ph.D., PE / KSingh

SUBJECT : Weekly Progress Report for Week Ending 06/17/2023
Community Within the Corridor - East Block

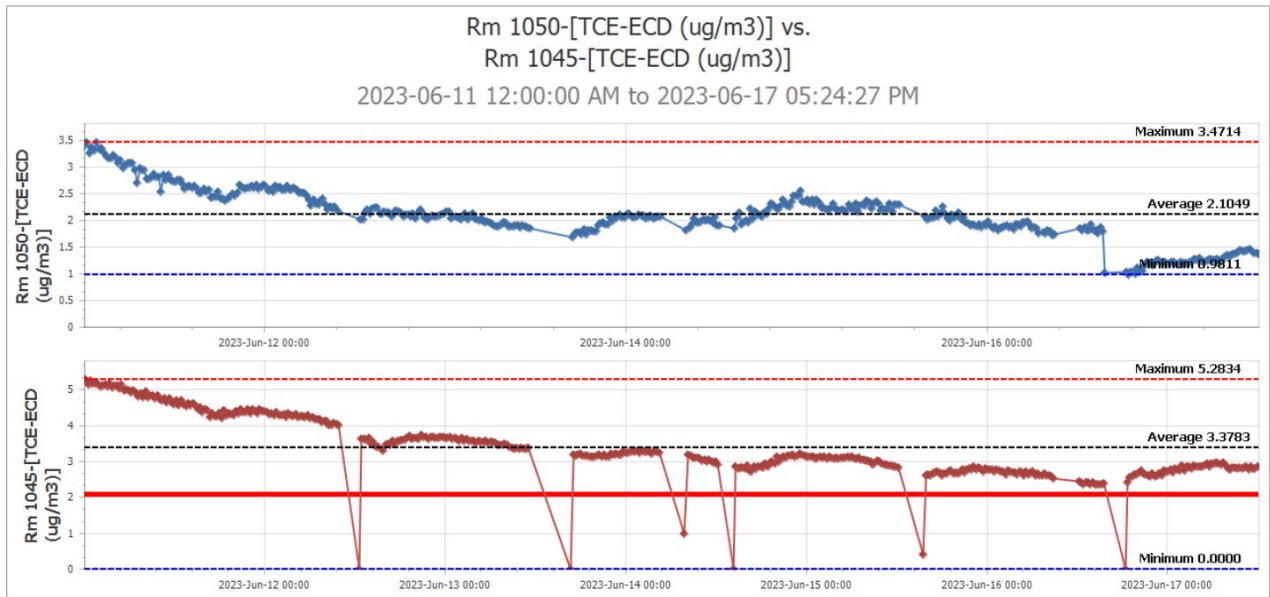
Figure 2 – Continuous Monitoring Data for Units 1045 and 1050 since June 11, 2023

- Continuous monitoring was started in Units 1045 and 1050 which are displayed in Attachment D in Figure 2. The continuous monitoring data supports the information gathered from discrete sampling.

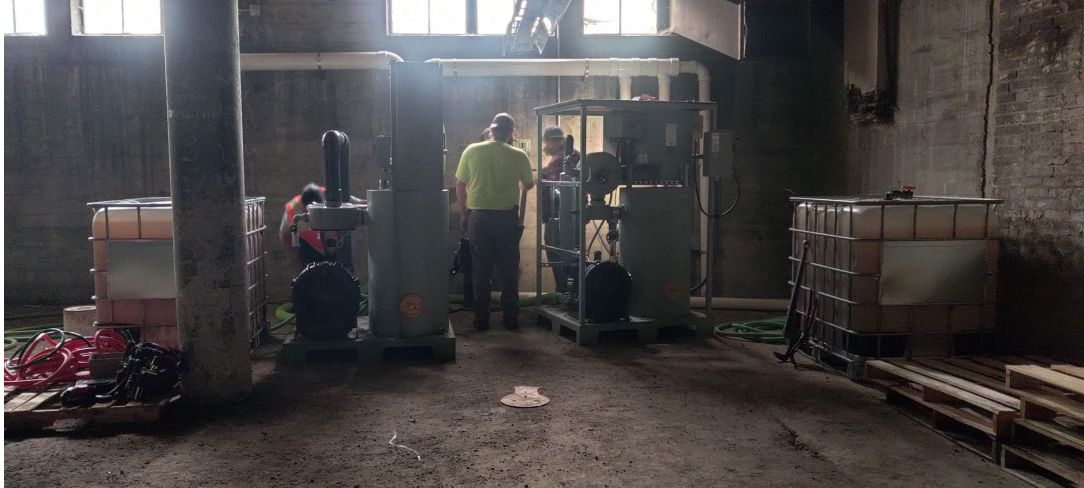
4. Task #4 – Installation of Permanent Blowers #1 and 2
One permanent blower was installed by Fliteway Technology in the northern VMS. The second one is placed on the site and awaiting further electrical connection.

Picture 1 – Installation of 1 Permanent Blower

1. Fliteway will replace the second temporary North Blower #2 with a permanent blower next week. Both blowers are 10-HP and yield about 500 cfm each at 14 inches of water vacuum.
2. Two OBAR Fans (GBR-89) were delivered last week, and electrical and piping connections are in progress. Installation of these blowers (Blower #s 6 and 7) is likely to depressurize the southwest

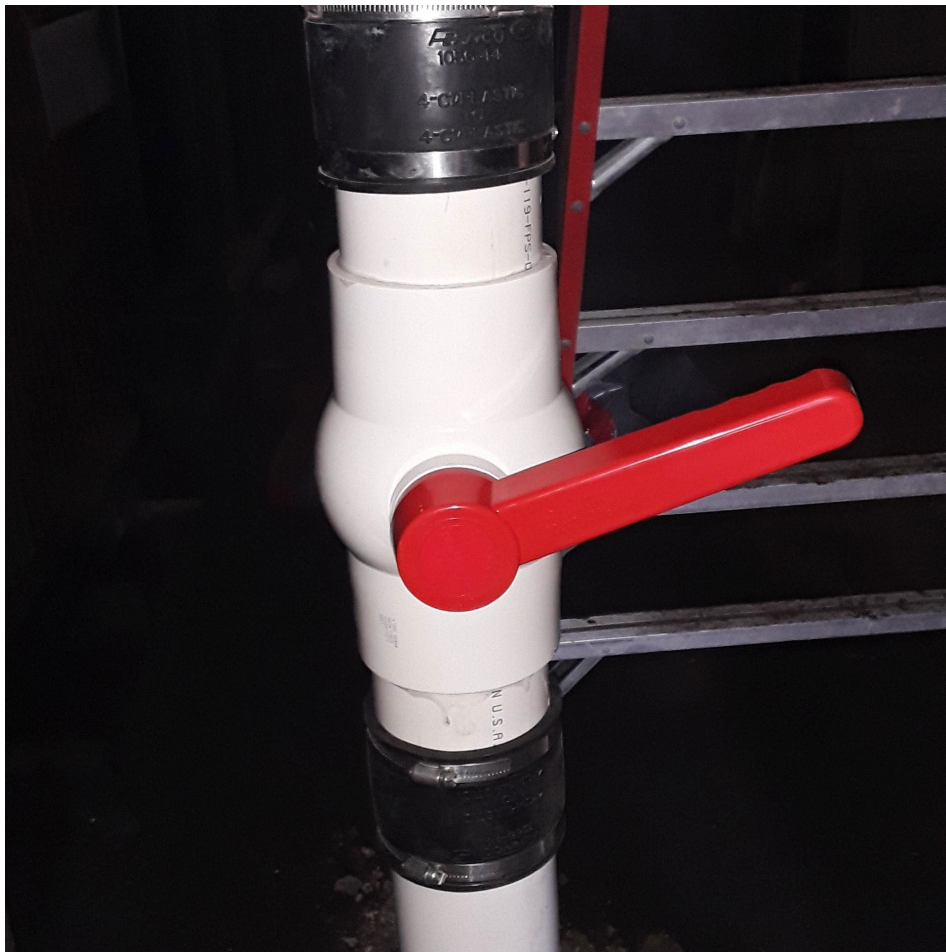
2. Task #2 – Installation of Ball Valve to Power House
Horner Plumbing installed a ball valve in the Powerhouse to address the lack of vacuum under the Northern Mechanical Room.

Picture 2 – Valve Connection in Powerhouse

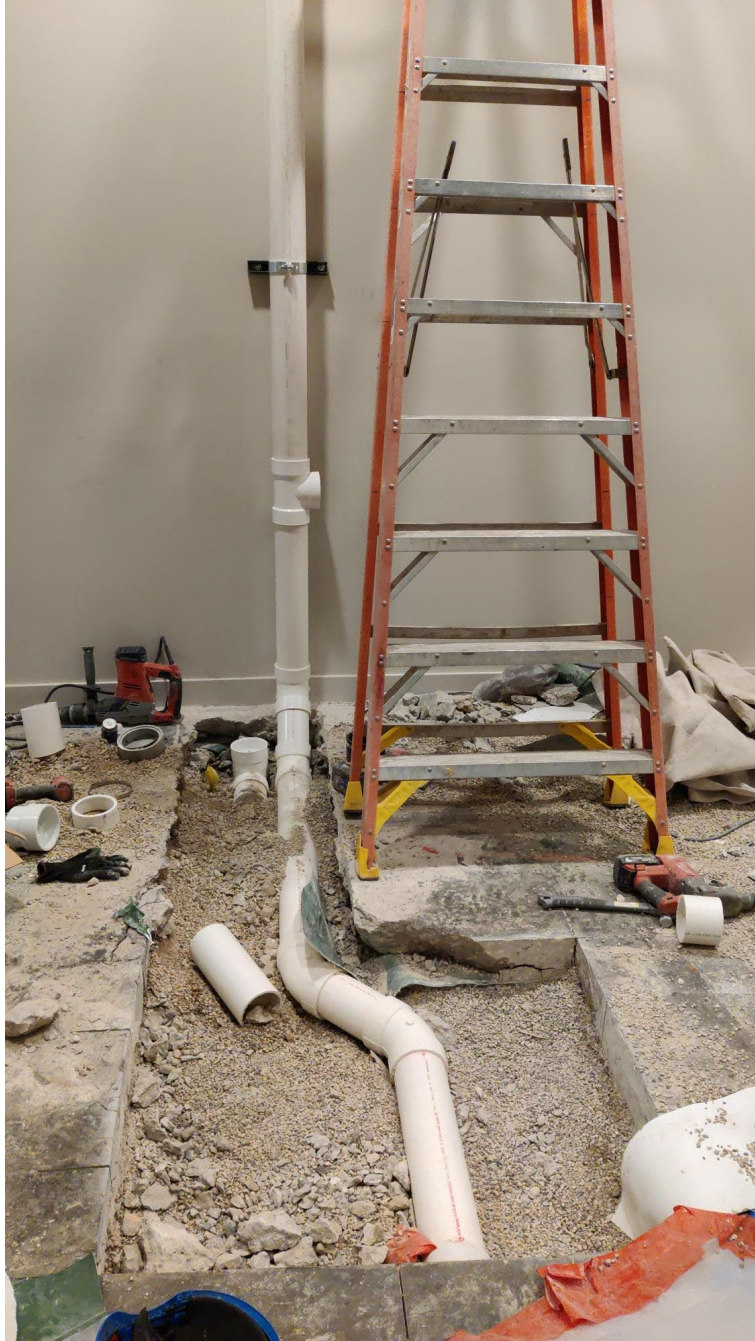
Picture 3 – Preparation for Additional Blower at Access Point 1

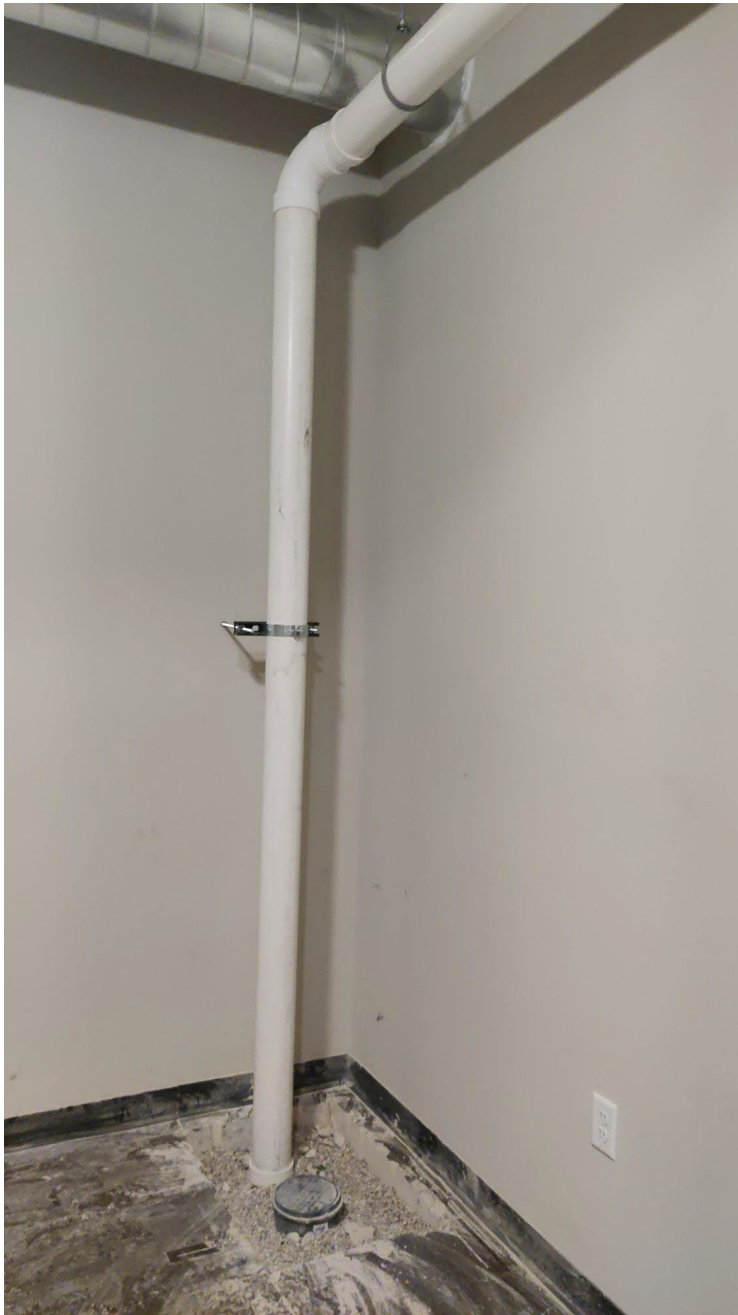
Picture 4 - Preparation for Additional Blower at Access Point 1

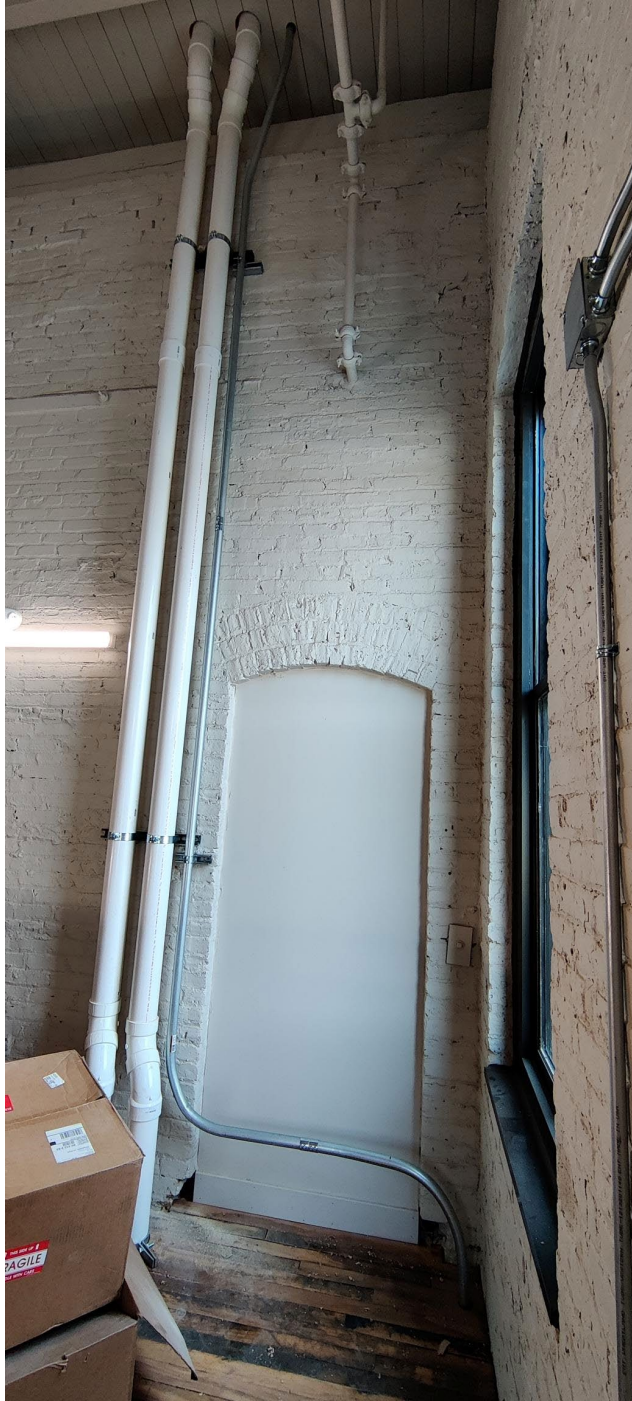
3. Task #3 – Electrical and Plumbing Connection for Blower #s 6 and 7
Horner Plumbing and Roman Electric are working on providing the plumbing and electrical connection to start two Obar Blowers on the roof. This task is nearing completion. The two additional blowers are anticipated to bring depressurization in the area south of the tunnel.

Picture 5 - Plumbing and electrical for Access Points 1 and 4 going up to the roof

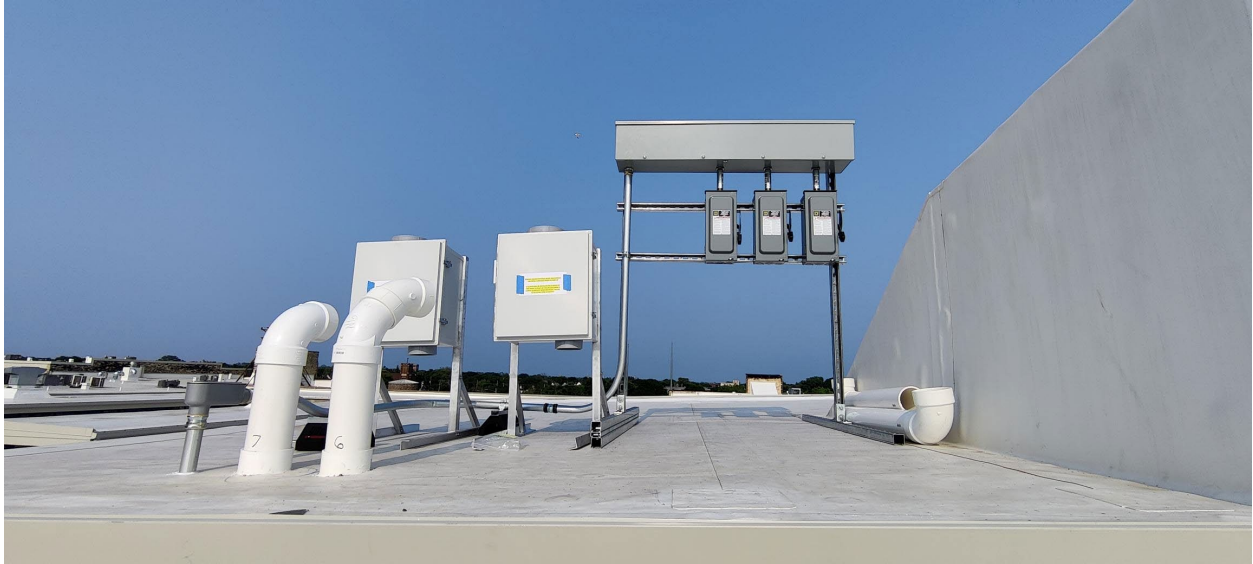
Picture 6 – GBR 89 Blowers on the Roof that are connected to Access Points 1 and 4

portion of the building. With this installation, it is anticipated that we will have a minimum depressurization of 0.004 inch of water throughout the building. Our goal is to depressurize the building at 0.01 inches of water.
