MEMORANDUM

DATE : June 24, 2023

FROM : Pratap Singh, Ph.D., PE / KSingh

SUBJECT : Weekly Progress Report for Week Ending 06/24/2023
Community Within the Corridor - East Block

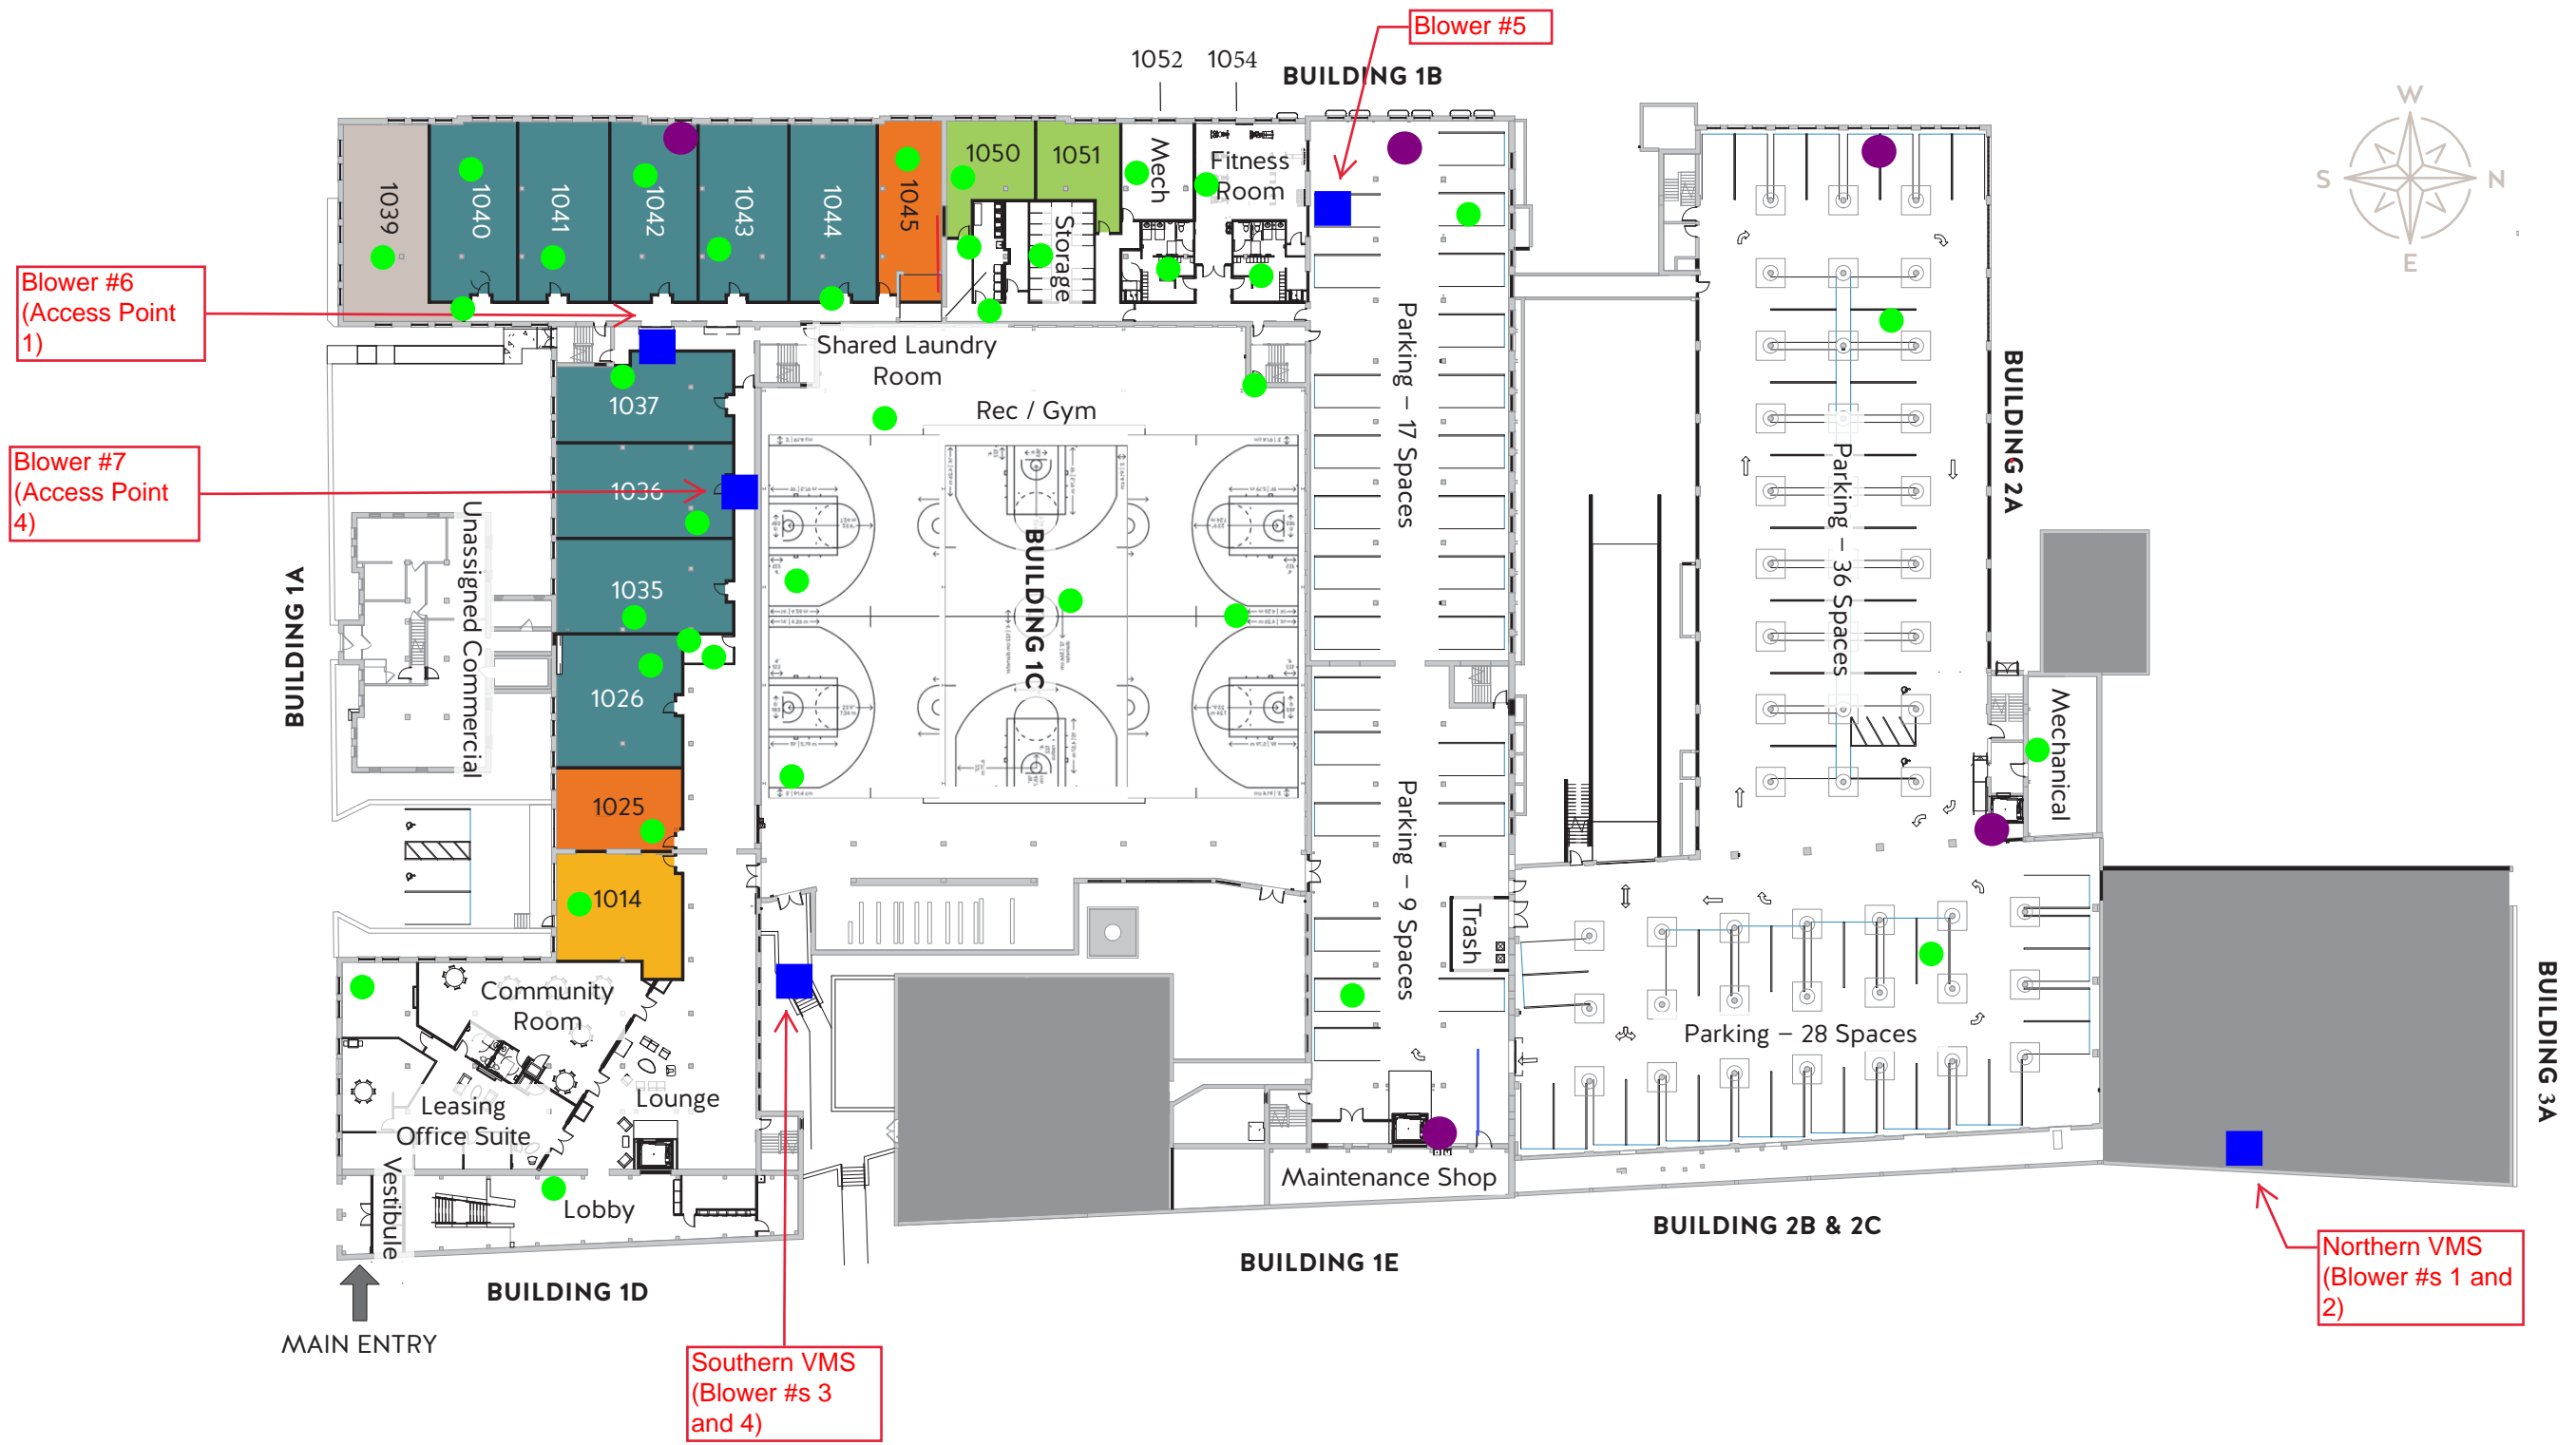
Figure 1 - CWC EB Level 1 Map with Blower, Vapor Pin and Sump Locations

Installation of new vapor pins in the common area of the garage and the gym area resulted in evidence of depressurization along the active VMS. The results of vacuum measurements are shown in Table 6 in Attachment B. The placement of all the vapor pins (new and old) can be seen in Figure 1 in Attachment A. Please note the following:

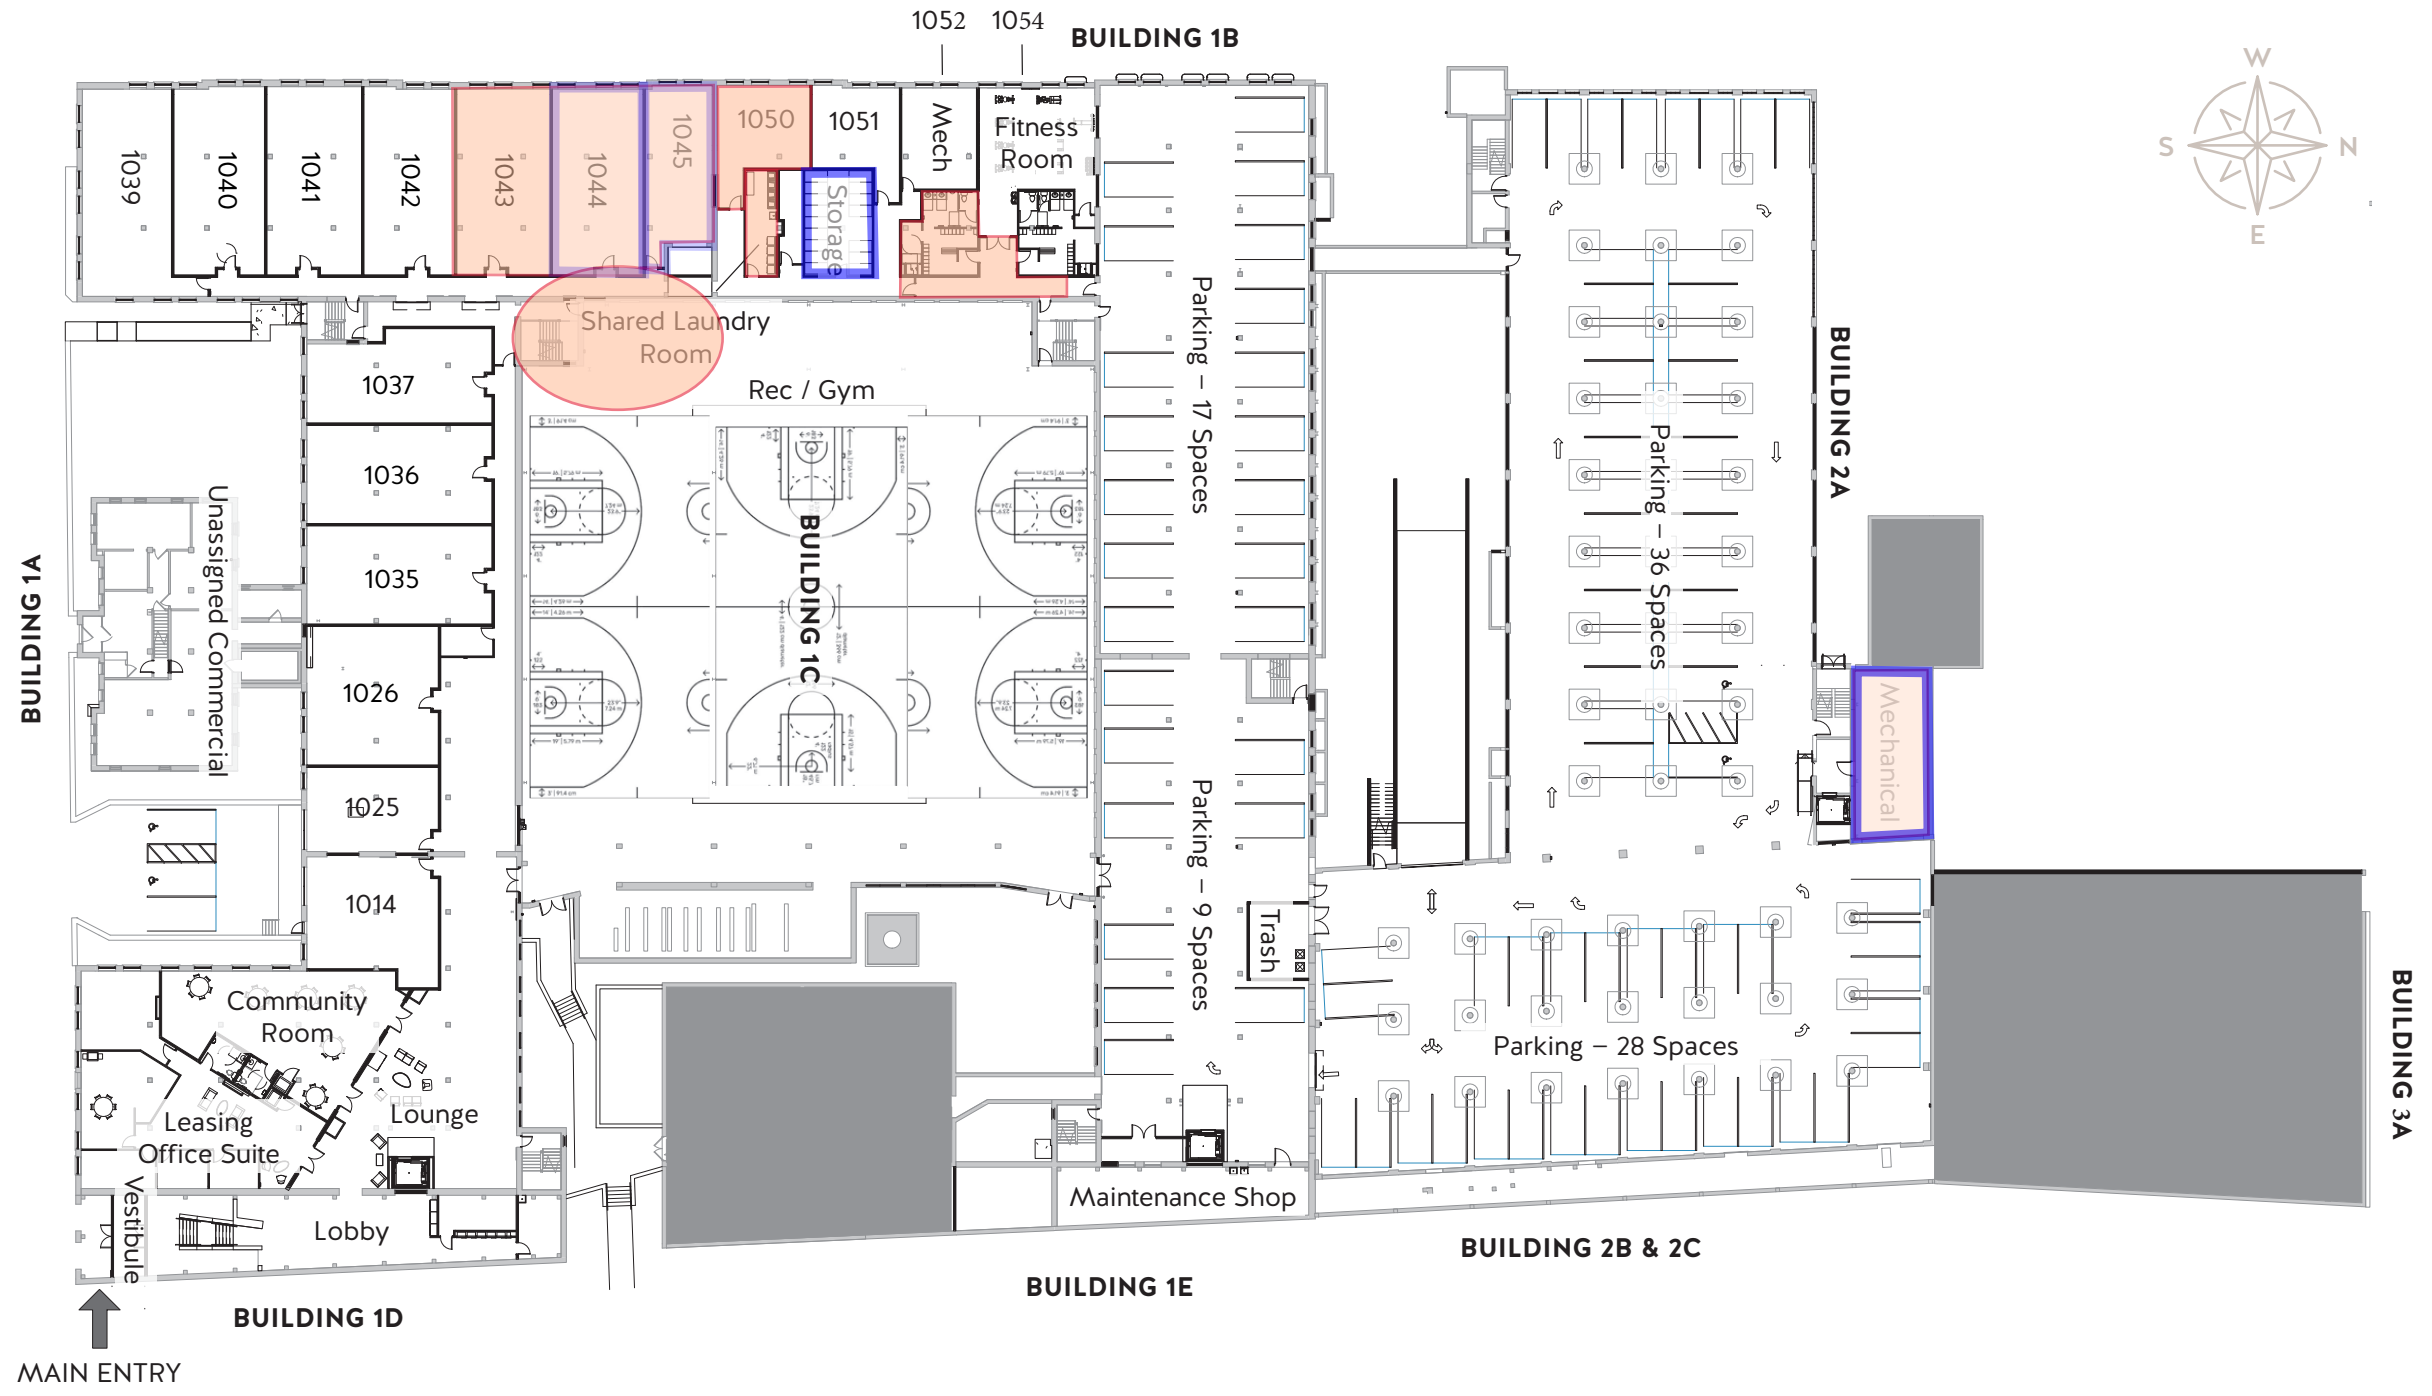
Figure 2 - CWC EB Level 1 Map with VRSL TCE Exceedances

- Sub-slab vapor concentrations taken from various locations saw a decline in the levels after installation of the Obar Fans in the 1B-NW Garage and 1B-S.
- The majority of the areas on the first-floor exhibit lower values than the Vapor Risk Screening Level (VRSL) set forth by WDNR.
- The values of sub-slab TCE can be observed in Appendix D (Table 8). A major hotspot can be observed in the areas between Units 1043 – 1050, extending the Laundry and Storage Room (Figure 2) which will require additional response action.

- VRSL Hotspot Areas based on sub-slab TCE Levels
- Areas with Indoor air TCE levels higher than VAL (2.1 ug/m3)

1. Begin developing a work plan for additional remediation in Units 1043, 1044, 1045, Shared Laundry Room, Storage Room and Mechanical Room in Building 1B, and North Mechanical Room in

Building 2A. The plan will include a combination of source removal, Biochar application, and supplemental radon fan installation.

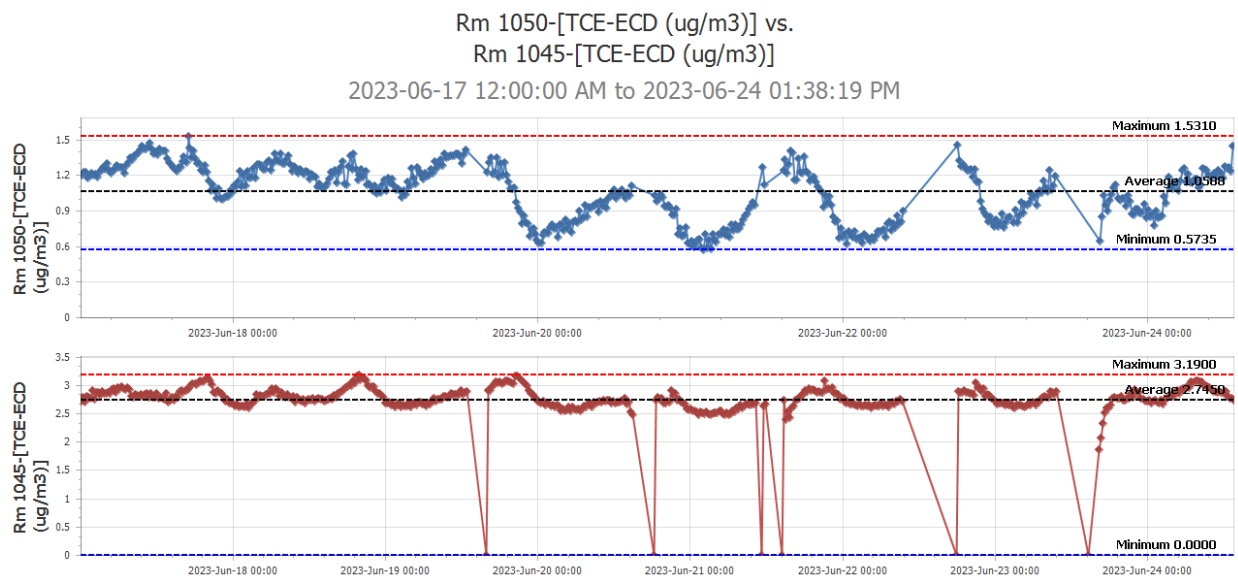
Figure 3 – Continuous Monitoring Data for Units 1045 and 1050 since June 18, 2023

- TCE detections ranged from 1.86 $\mu\text{g}/\text{m}^3$ to 3.19 $\mu\text{g}/\text{m}^3$ in Unit 1045 with an average of 2.74 $\mu\text{g}/\text{m}^3$.
- TCE detections ranged from 0.57 $\mu\text{g}/\text{m}^3$ to 1.53 $\mu\text{g}/\text{m}^3$ in Unit 1050 with an average of 1.06 $\mu\text{g}/\text{m}^3$.
- TCE was **below detection limit** in the Mechanical Room (1052) where the concrete was filled in under the water pipe going out of the wall onto 32nd Street.
- Continuous monitoring continues in Units 1045 and 1050 which are displayed in Attachment D in Figure 3. The continuous monitoring data shows a **steady decline** in the values of TCE.
- TCE detections in Unit 1045 appear to have stabilized at ~2.5 $\mu\text{g}/\text{m}^3$ which requires additional corrective action implementation. See #1 of Action Items on Page 2 for further description of actions to be taken.

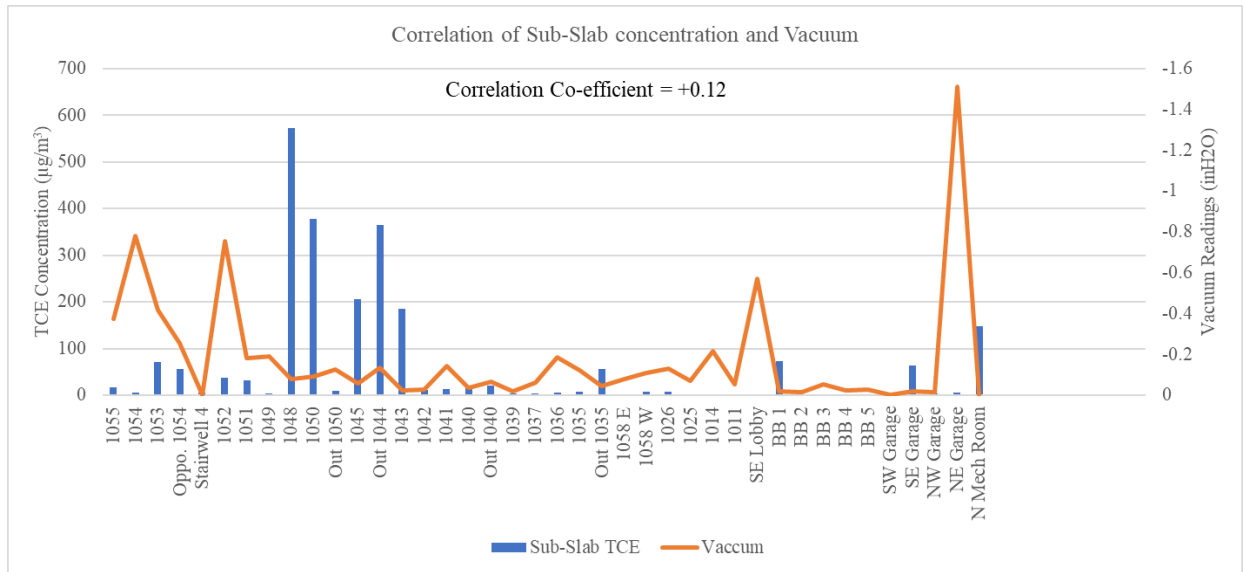
Figure 8 – YTD Data of TCE Concentration in 1st Floor Hallway

- All the units and common areas in the East Block have demonstrated sufficient vacuum (> 0.01) except for Stairwell 4, SW Garage, and the N Mechanical Room as of June 23rd.
- Figure 8 in Attachment E shows the correlation between sub-slab vapor TCE values and the corresponding vacuum levels at all the vapor pin installations. A positive correlation coefficient indicates that presence of higher vacuum would result in lower sub-slab TCE levels giving evidence of the efficient functioning of the VMS system (vacuum readings and sub-slab TCE levels are inversely proportional).

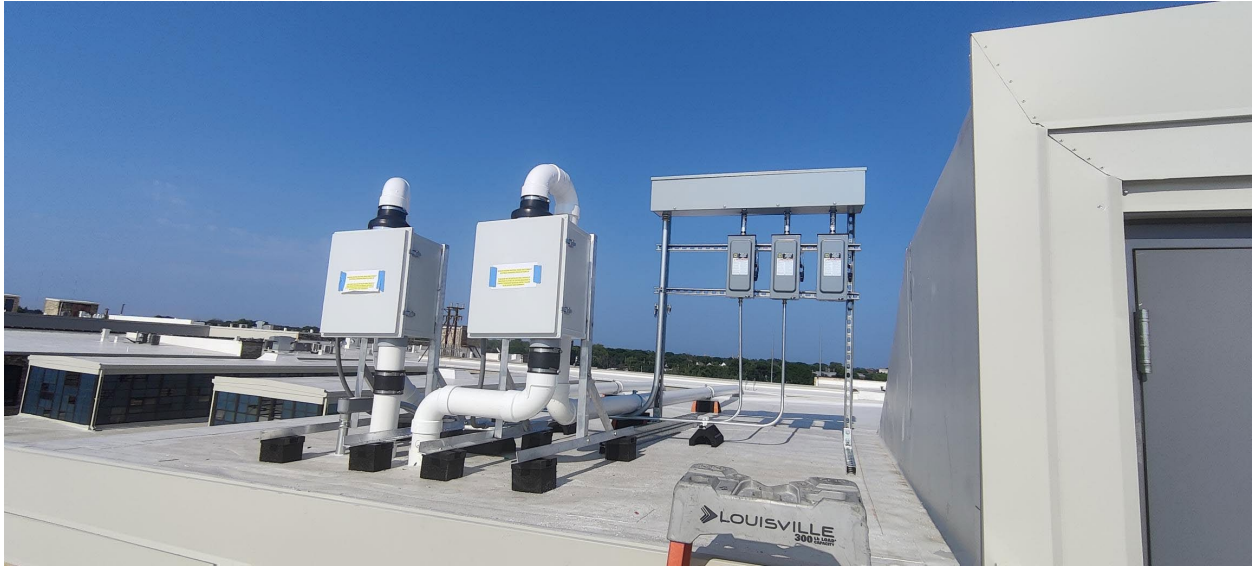
Three blowers continue to function properly. Fliteway Technology replaced the two temporary 7.5-HP and 10-HP blowers with two permanent 10-HP blowers. The replacement of the second temporary blower resulted in additional depressurization across the N Garage.

The presence of Blowers 5, 6, and 7 have been instrumental in overall reduction of sub-slab and indoor air TCE levels in Buildings 1B-W, 1B-SW, and 1B-S.

Picture 1 – Operation of Blowers 6 and 7

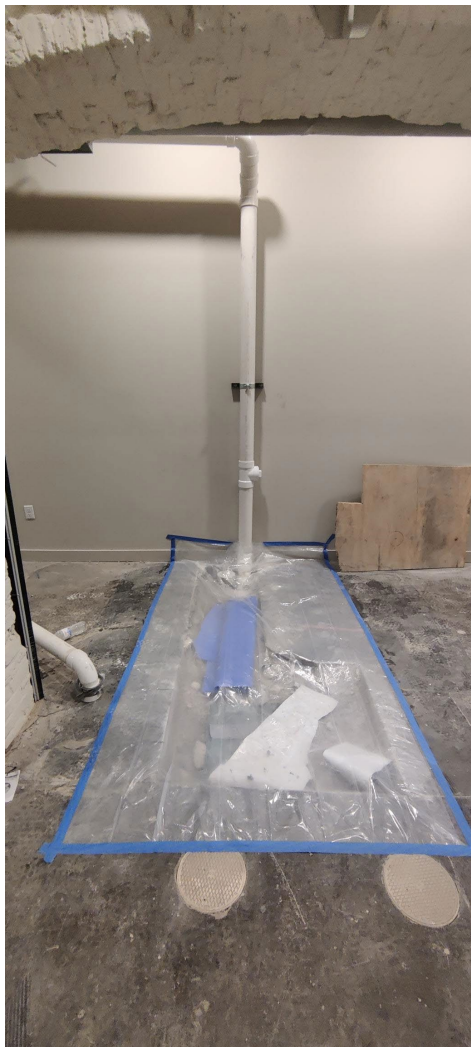
Picture 2 – Sealing of Access Point of Blowers 6

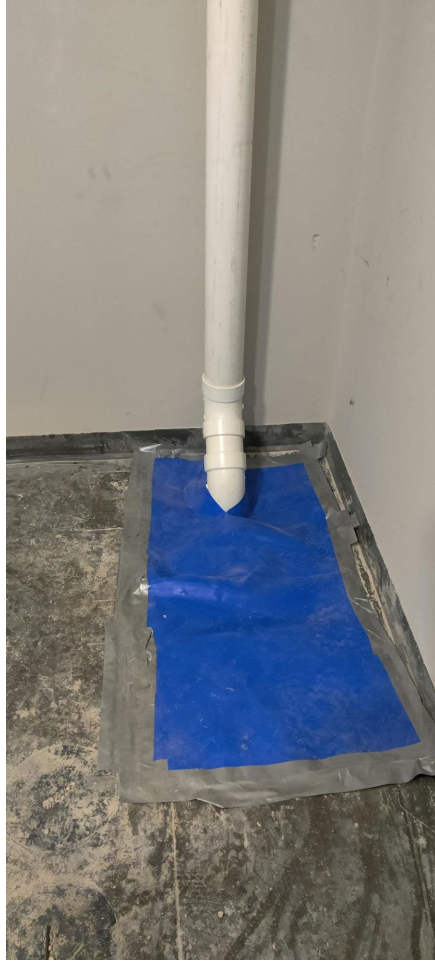
Picture 3 – Sealing of Access Point of Blowers 7

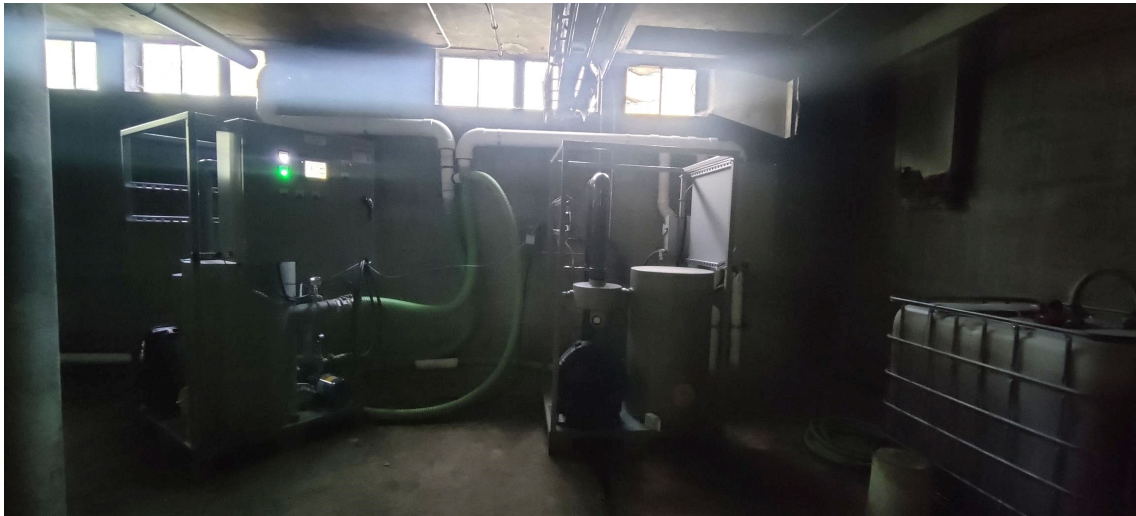
Picture 4 – Operation of Blowers 3 and 4
