MEMORANDUM

DATE : July 8, 2023

SUBJECT : Weekly Progress Report for Week Ending 07/08/2023
Community Within the Corridor - East Block

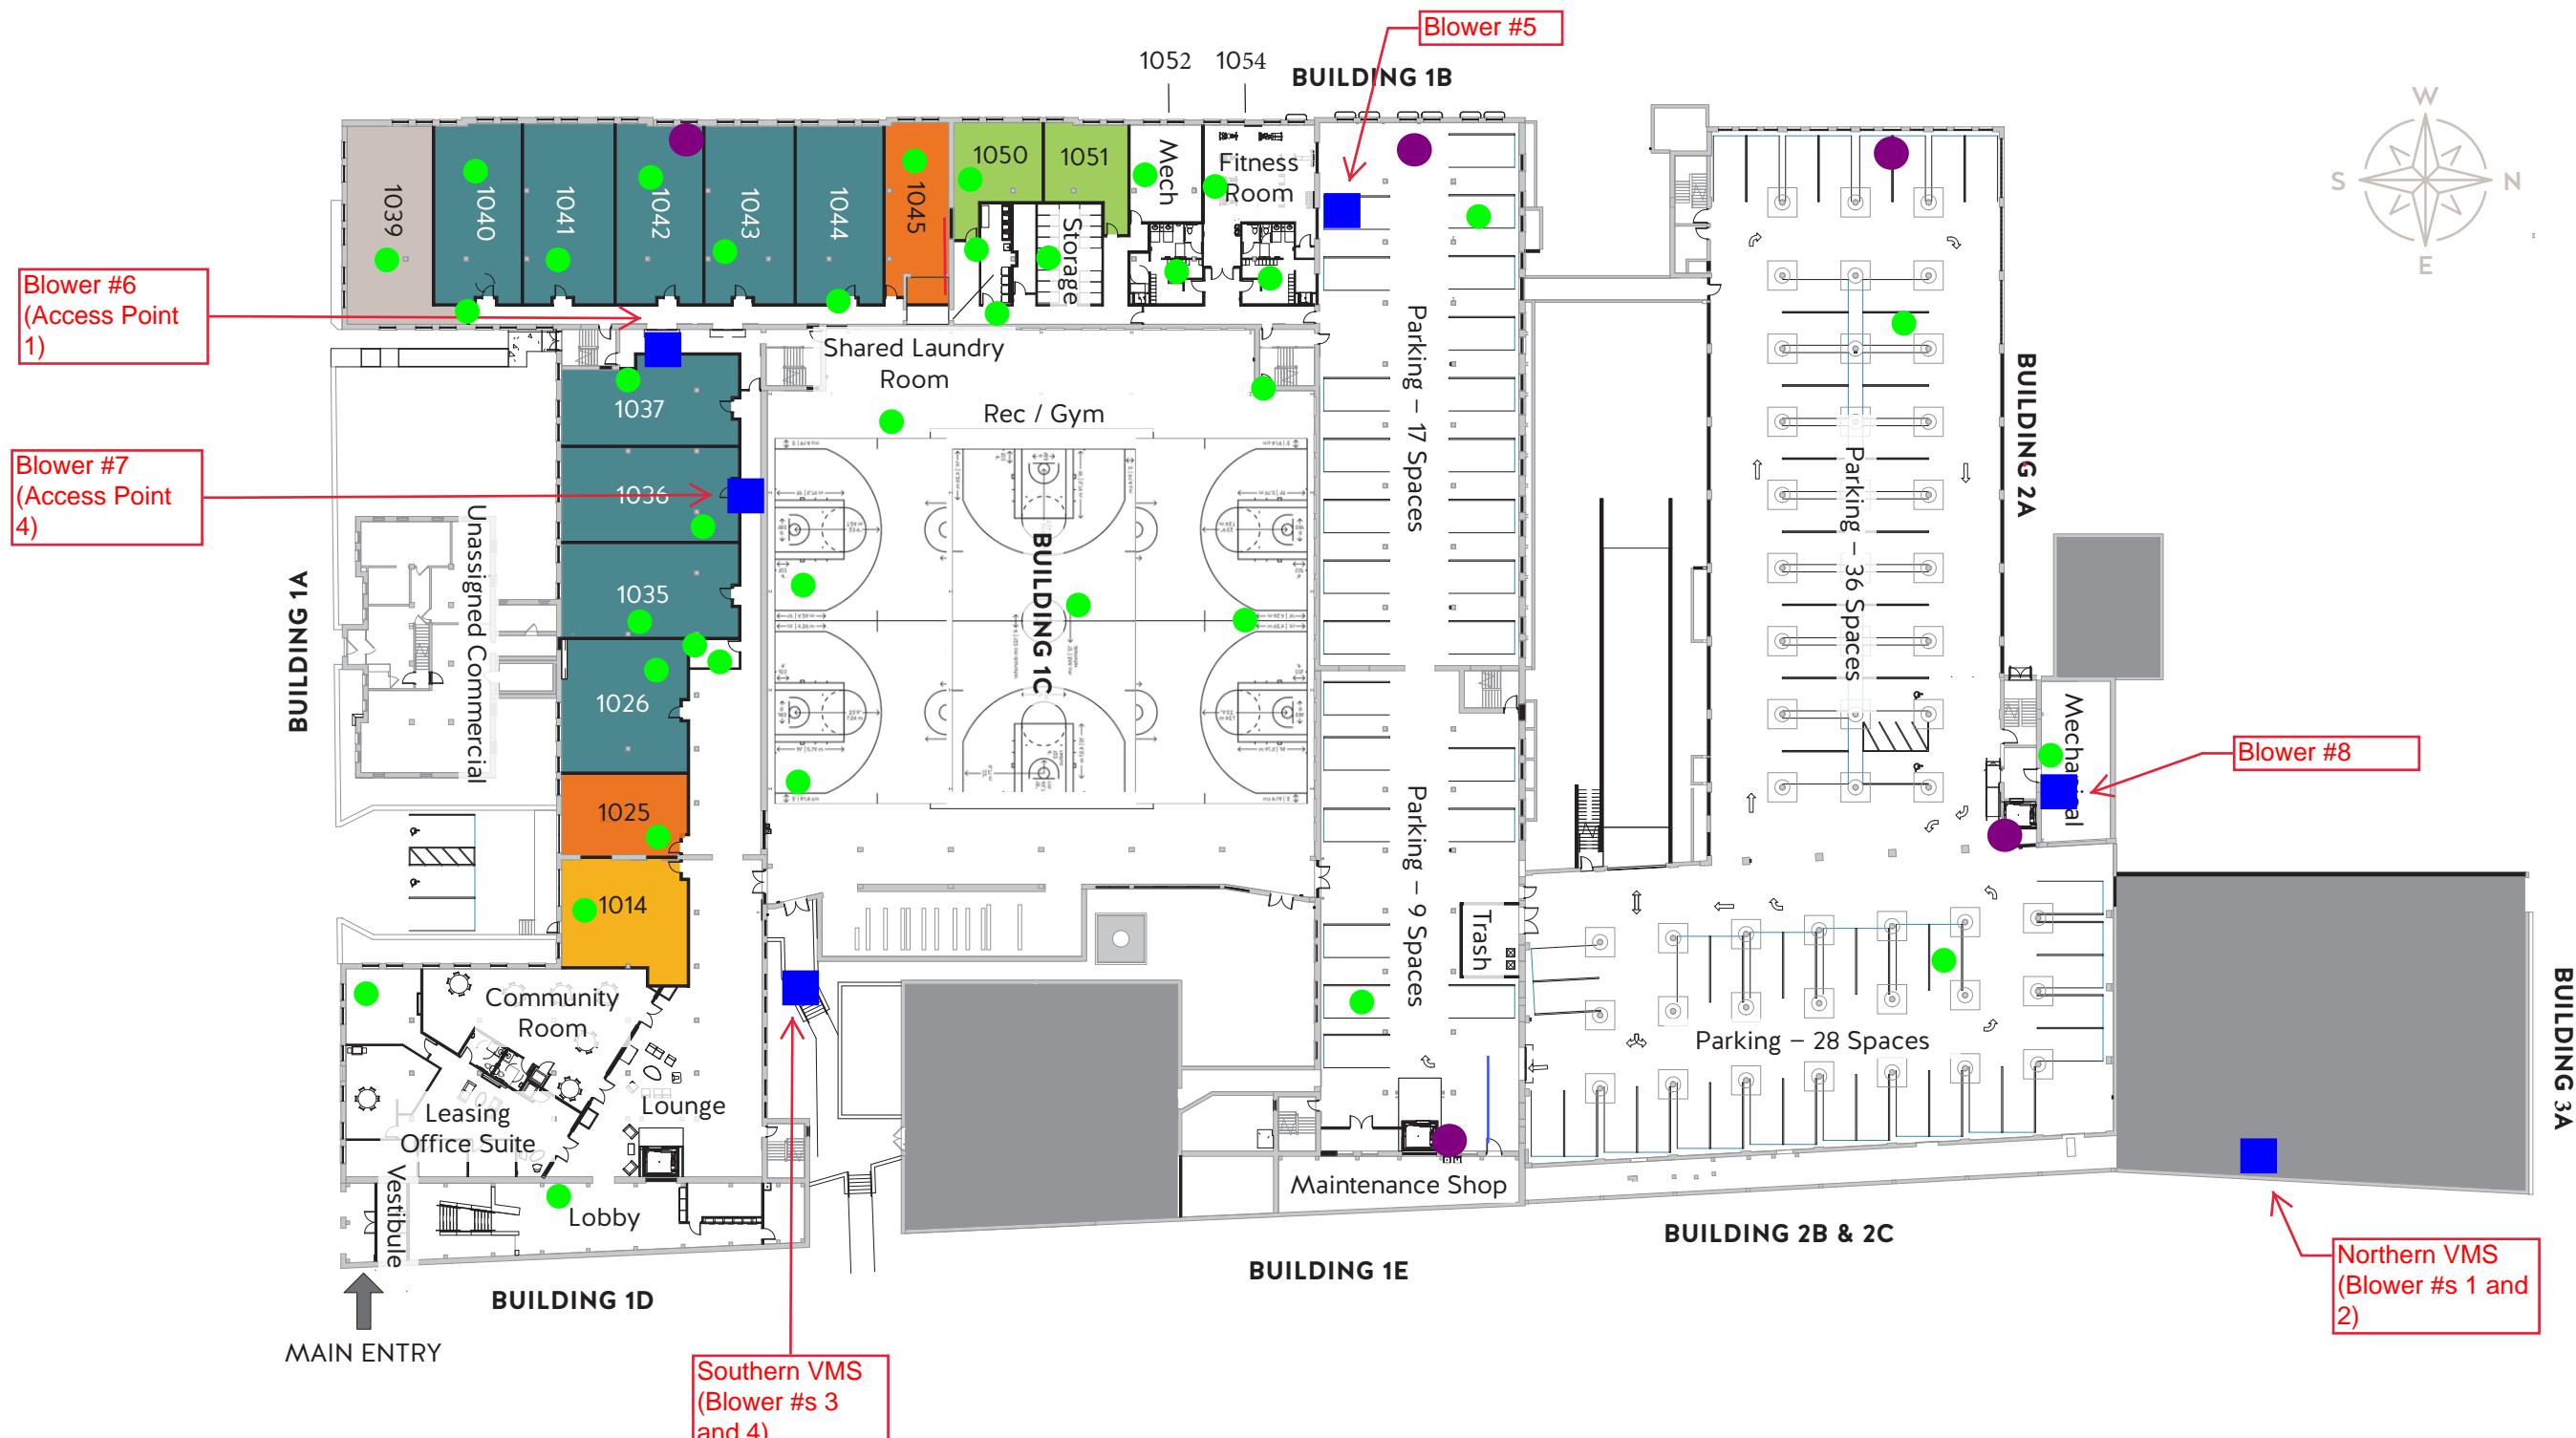
Figure 1 - CWC EB Level 1 Map with Blower, Vapor Pin and Sump Locations

KSingh continues to work on conducting gas chromatograph (GC) testing for measurement of TCE in various units of the East Block focused on the first floor. The focus of testing for TCE is concentrated in units that have detected elevated levels of TCE. Attachment A is comprised of Figure 1, a floor plan for reference of Unit locations, vapor pins, and blowers, with the test results of TCE shown in Tables 1 to 5.

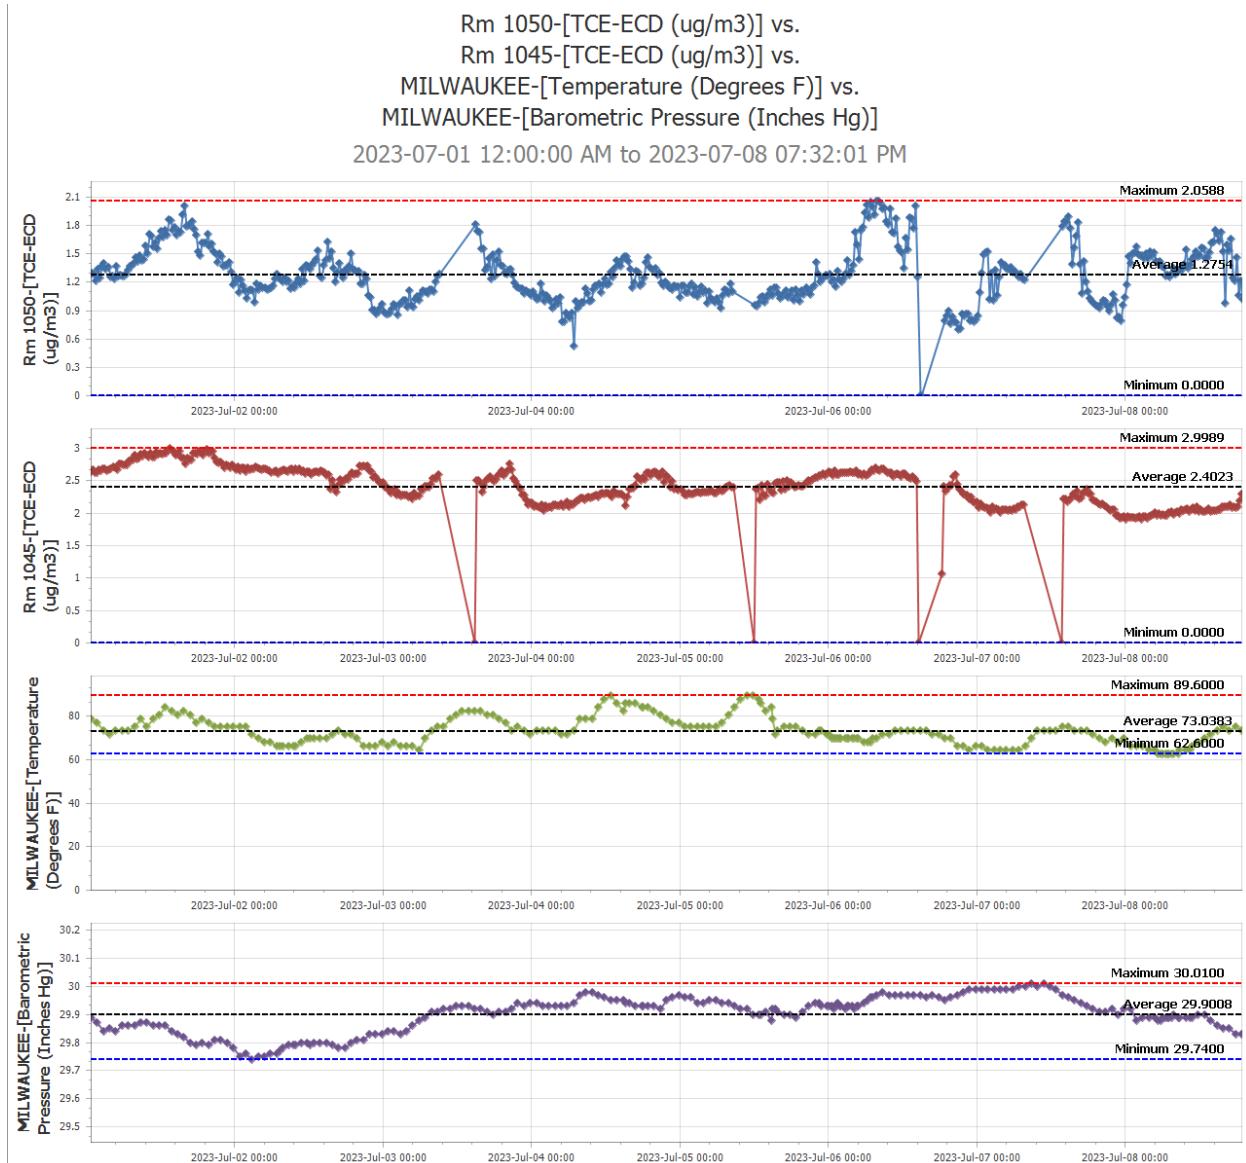
Figure 2 – Continuous Monitoring Data for Units 1045 and 1050 through July 2, 2023

- Continuous monitoring continues in Units 1045 and 1050 which are displayed in Attachment D in Figures 2-4. The continuous monitoring data shows a direct correlation with the barometric pressure and ambient temperature with the values of TCE.

- The increase in temperatures appeared to have aided the volatilization of TCE leading to higher ambient and sub-slab concentrations.
- TCE detections in Unit 1045 appear to have stabilized at ~2.4 $\mu\text{g}/\text{m}^3$ with the most recent data indicating a level of 2.06 $\mu\text{g}/\text{m}^3$.

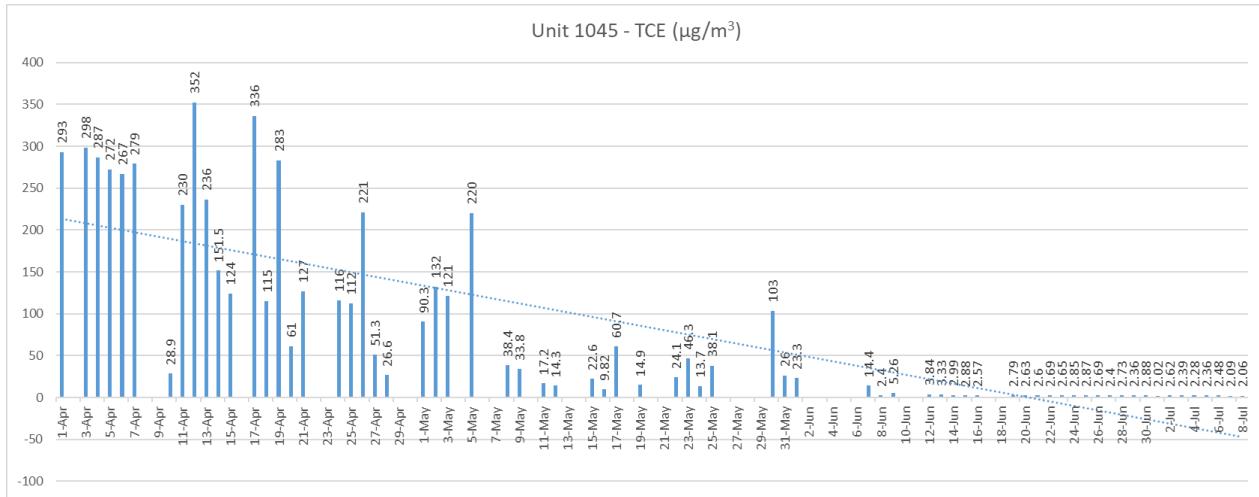
Figure 3 – YTD Data of TCE Concentration in Unit 1045

- TCE detections ranged from 1.9 $\mu\text{g}/\text{m}^3$ to 3 $\mu\text{g}/\text{m}^3$ in Unit 1045 with an average of 2.4 $\mu\text{g}/\text{m}^3$.
- TCE detections ranged from 0.5 $\mu\text{g}/\text{m}^3$ to 2 $\mu\text{g}/\text{m}^3$ in Unit 1050 with an average of 1.37 $\mu\text{g}/\text{m}^3$.

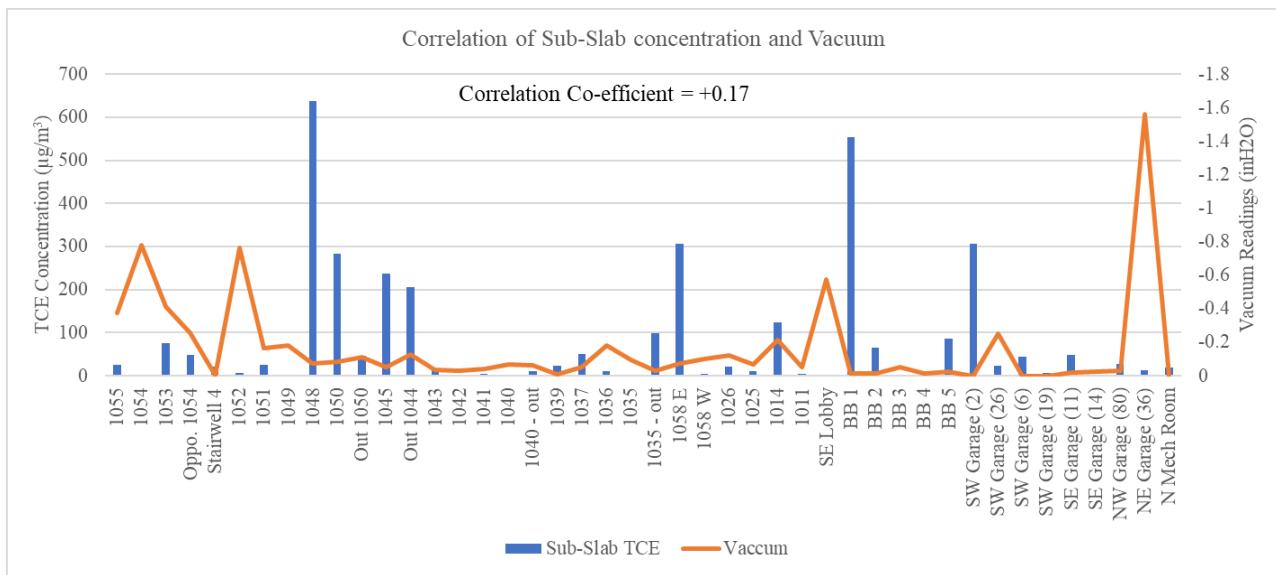
Figure 7 – Correlation of TCE Concentration with Vacuum Measurements

- All the units and common areas in the East Block have demonstrated sufficient vacuum (> 0.01) except for Stairwell 4, SW Garage, and the N Mechanical Room as of July 7th.
- Figure 7 in Attachment E shows the correlation between sub-slab vapor TCE values and the corresponding vacuum levels at all the vapor pin installations. An improved positive correlation coefficient indicates that presence of higher vacuum would result in lower sub-slab TCE levels giving evidence of the efficient functioning of the VMS system (vacuum readings and sub-slab TCE levels are inversely proportional).
- The overall increase in the correlation coefficient indicates improved performance of the VMS.
