MEMORANDUM

SUBJECT : Weekly Progress Report for Week Ending 07/15/2023
Community Within the Corridor - East Block

COPY TO : Que El-Amin / Scott Crawford, Inc., Robert Reineke, PE, Robert Fedorchak, PE
Project #40441B

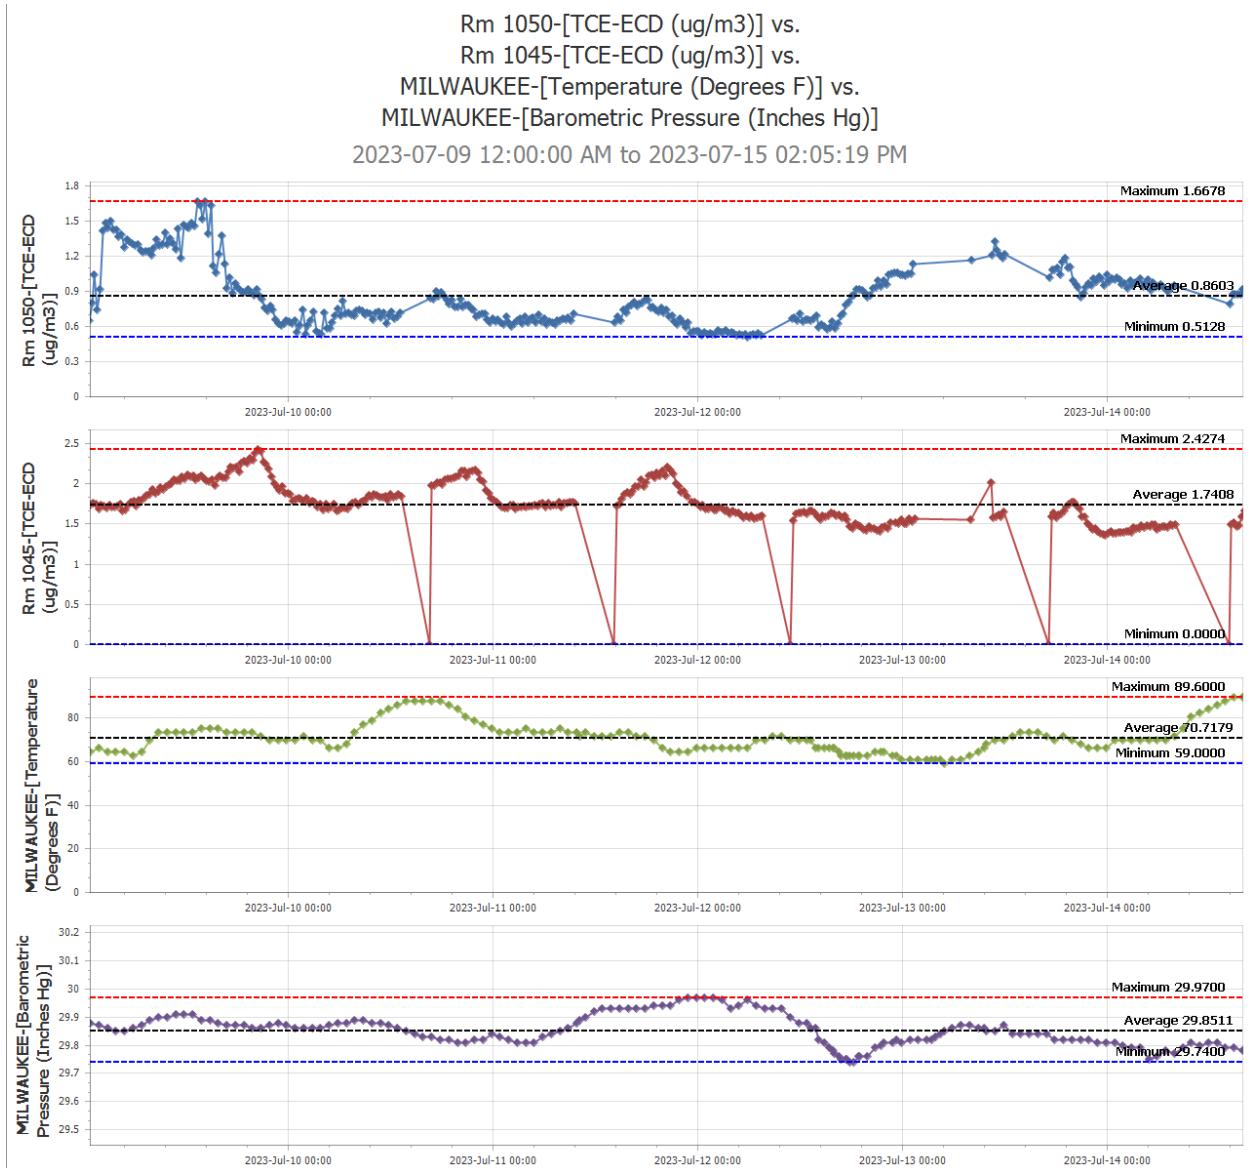
Figure 2 – Continuous Monitoring Data for Units 1045 and 1050

- Continuous monitoring results in Units 1045 and 1050 are displayed in Figure 3. The continuous monitoring data shows a direct correlation with the barometric pressure and ambient temperature with the values of TCE.

- The diurnal variations in temperatures appeared to have aided the volatilization of TCE leading to higher ambient and sub-slab concentrations.
 - TCE detections in Unit 1045 appear to have improved to be at ~1.7 µg/m³ with the most recent data indicating a level of 1.6 µg/m³.

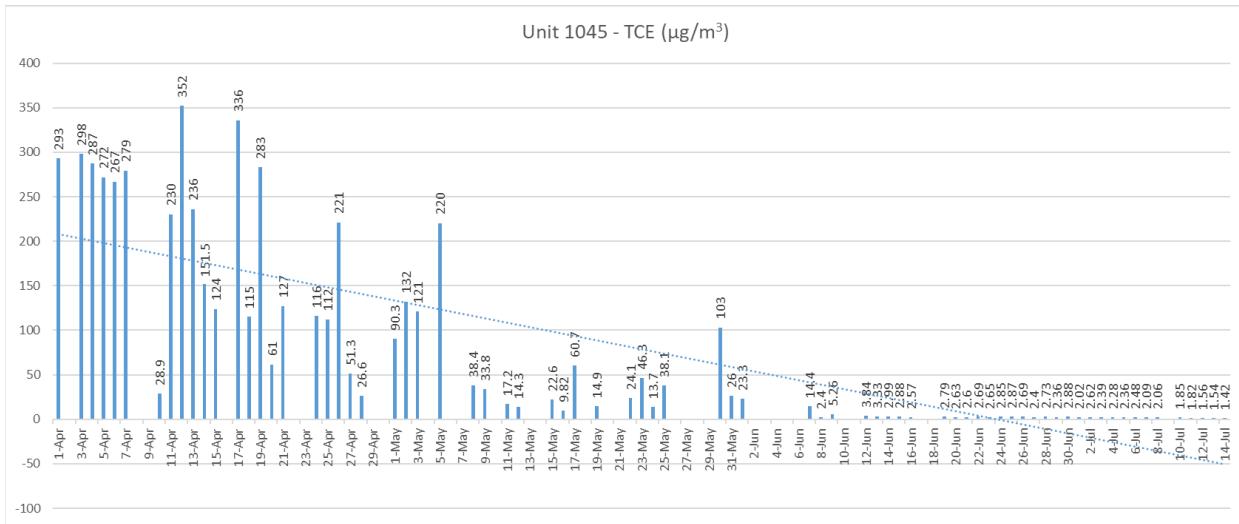
Figure 3 – YTD Data of TCE Concentration in Unit 1045

- TCE detections ranged from 1.5 µg/m³ to 2.4 µg/m³ in Unit 1045 with an average of 1.7 µg/m³.
 - TCE detections ranged from 0.5 µg/m³ to 1.662g/m³ in Unit 1050 with an average of 0.86 µg/m³.

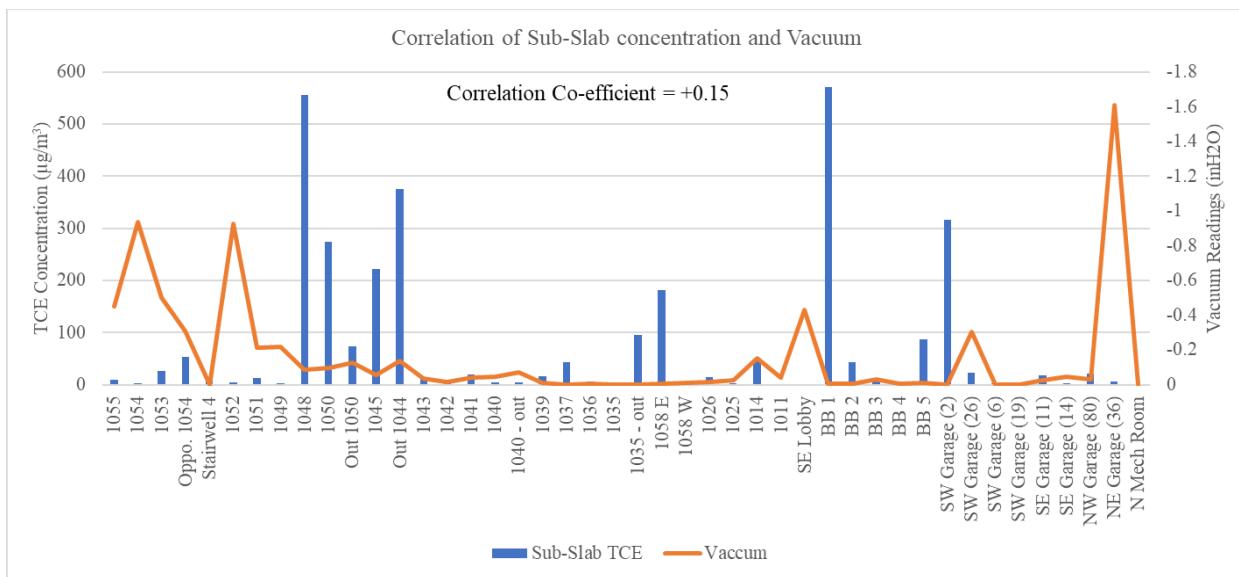
Figure 7 – Correlation of TCE Concentration with Vacuum Measurements

- The vapor pin near the Blower #5 and the pin in the SE Garage demonstrated sufficient vacuum while the other two pins in the SW garage had no vacuum.
- Figure 7 in Attachment E shows the correlation between sub-slab vapor TCE values and the corresponding vacuum levels at all the vapor pin installations. A positive correlation coefficient indicates that presence of higher vacuum would result in lower sub-slab TCE levels giving evidence of the efficient functioning of the VMS system (vacuum readings and sub-slab TCE levels are inversely proportional).
- The decrease in the correlation coefficient can be treated as a temporary skew pending restored functioning of the blowers.
