MEMORANDUM

DATE : August 21, 2023

SUBJECT : Weekly Test Results and Remedial Action Activities for the Week Ending 08/19/2023
Community Within the Corridor - East Block

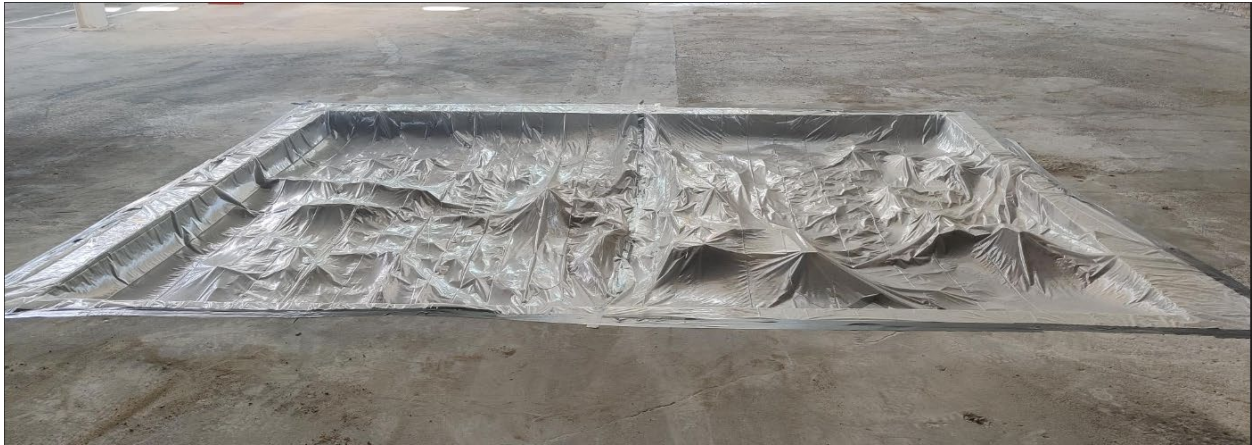
Picture 1: Concrete cut and removed from BB1 Pin Area in the Gym

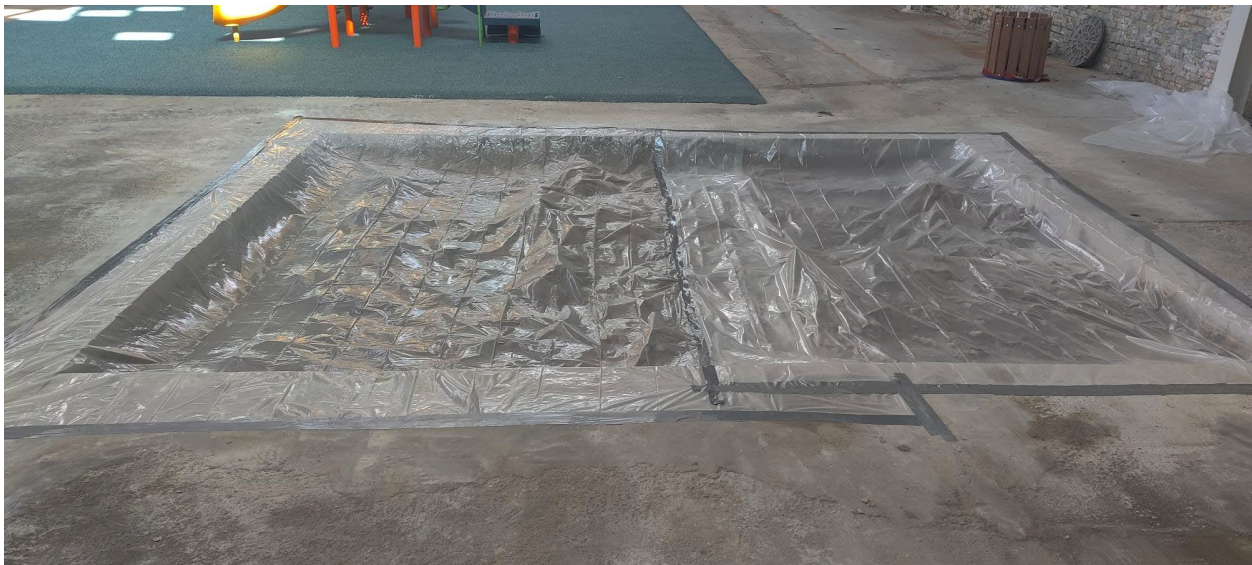
Picture 2: Concrete cut and removed from BB2 Pin Area in the Gym

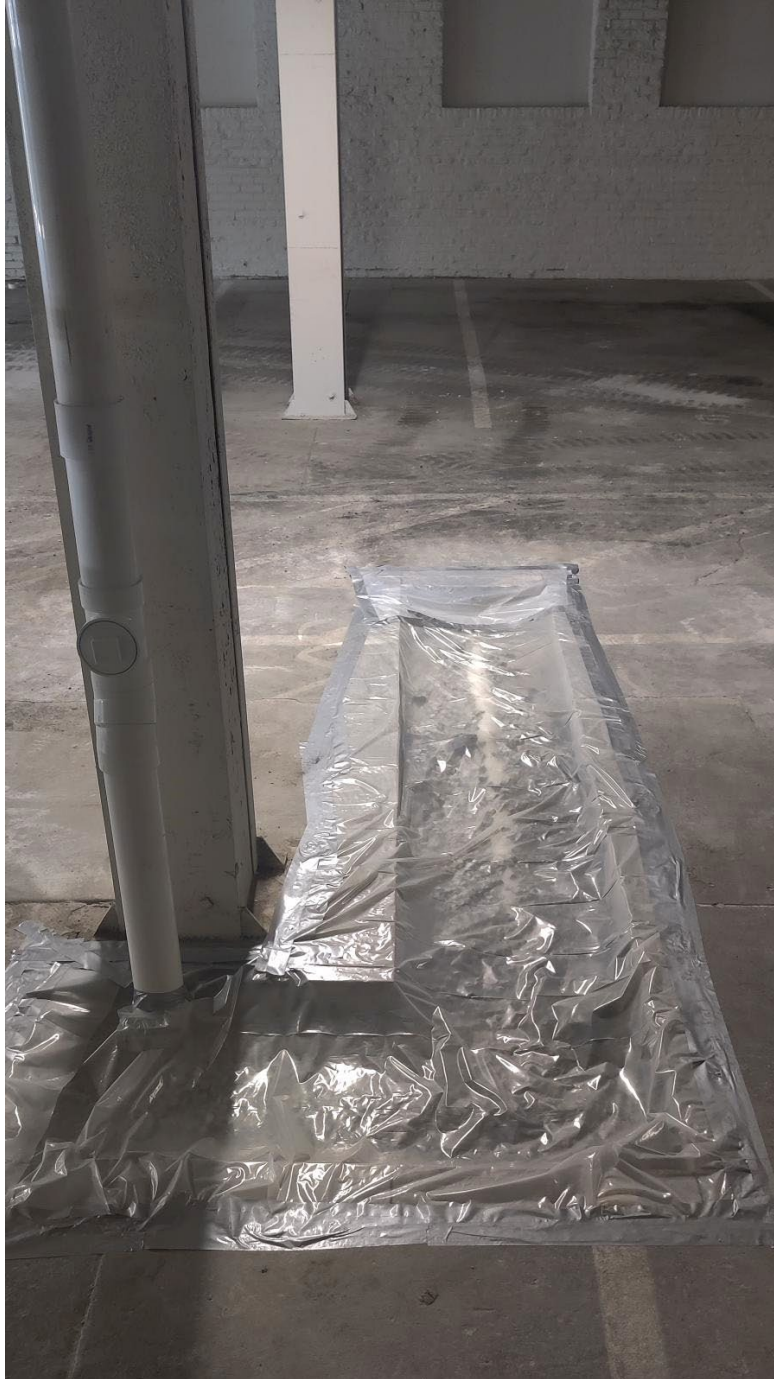
Picture 3: Concrete cut and removed from SW Garage area for the addition of access point for the Blower 11

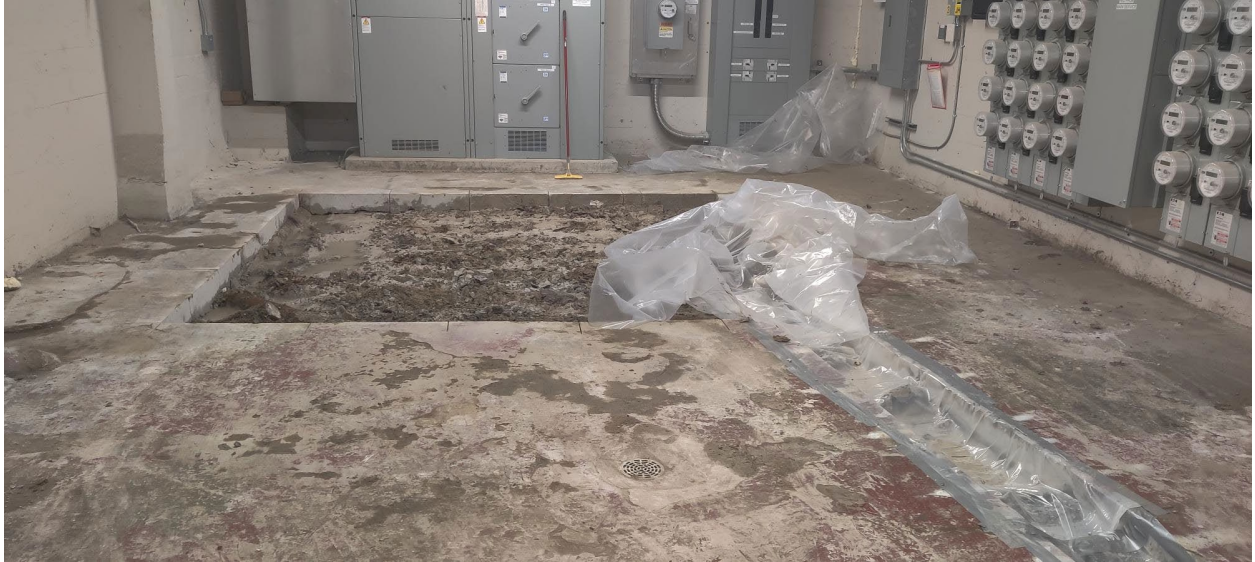
Picture 4: Concrete cut and removed from N Mechanical Room

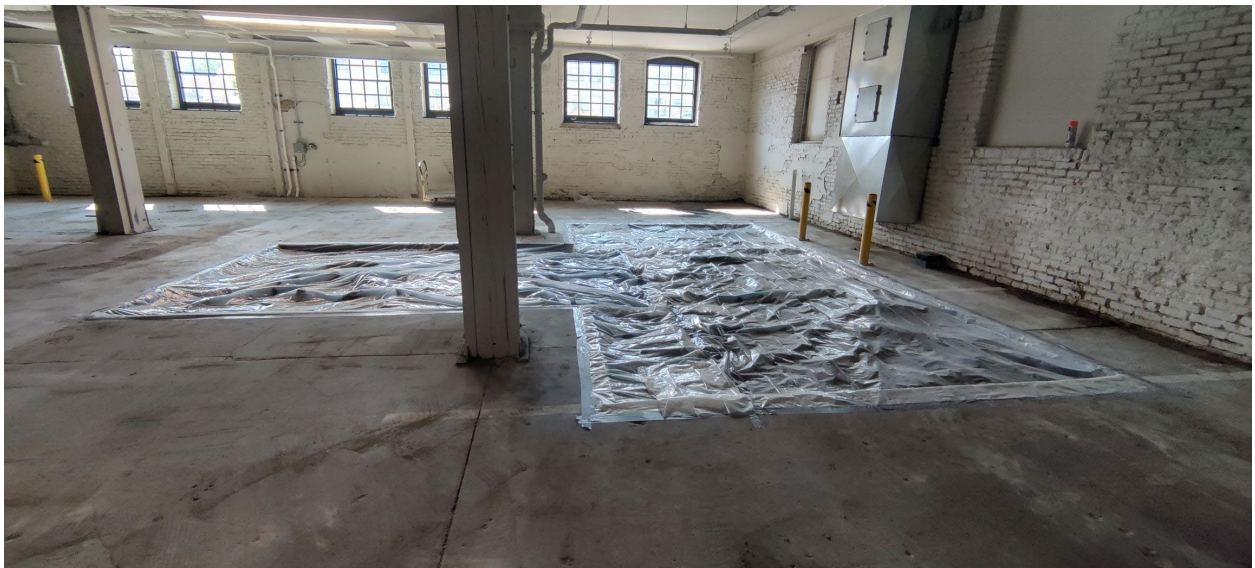
Picture 5: Concrete cut and removed from SW Garage

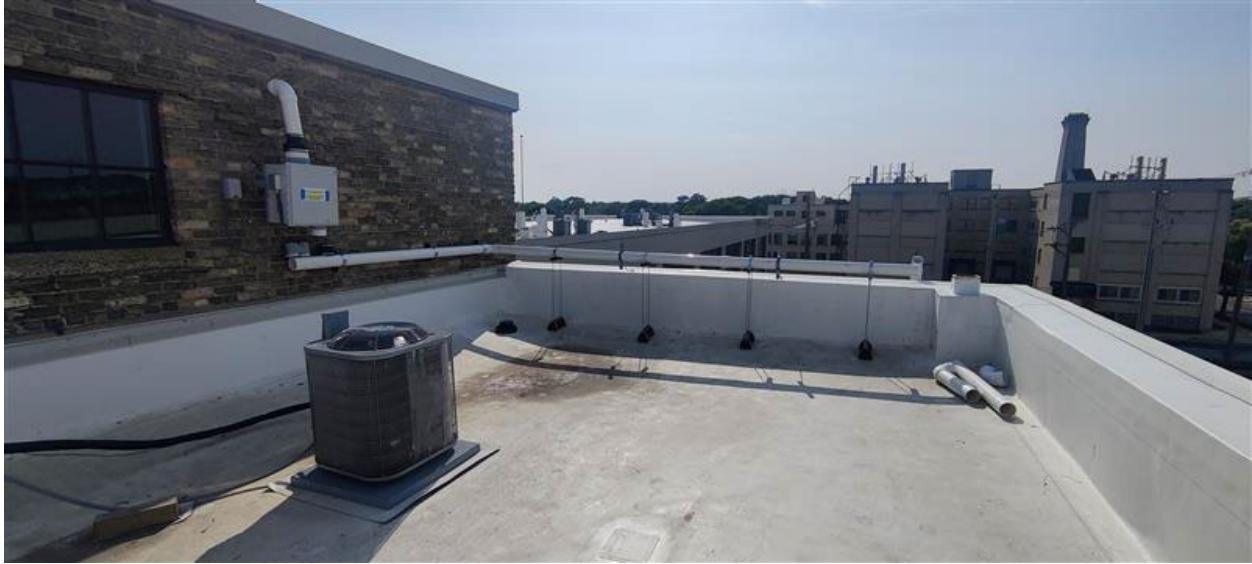
Picture 6: Ongoing installation of Blower 8 on the roof above N Mechanical room

Three new GBR 89 fans were ordered to be installed on the roof. These fans are designed to improve the exhaust of the residual contamination after the remedial action is performed in Building 1B-W and the SW Garage area. The radon fan in the powerhouse next to the N Mechanical Room (Blower 8) will also be replaced by a GBR 89 leading to an improvement in the removal from the area. Pictures of the prospective blower locations are also attached.

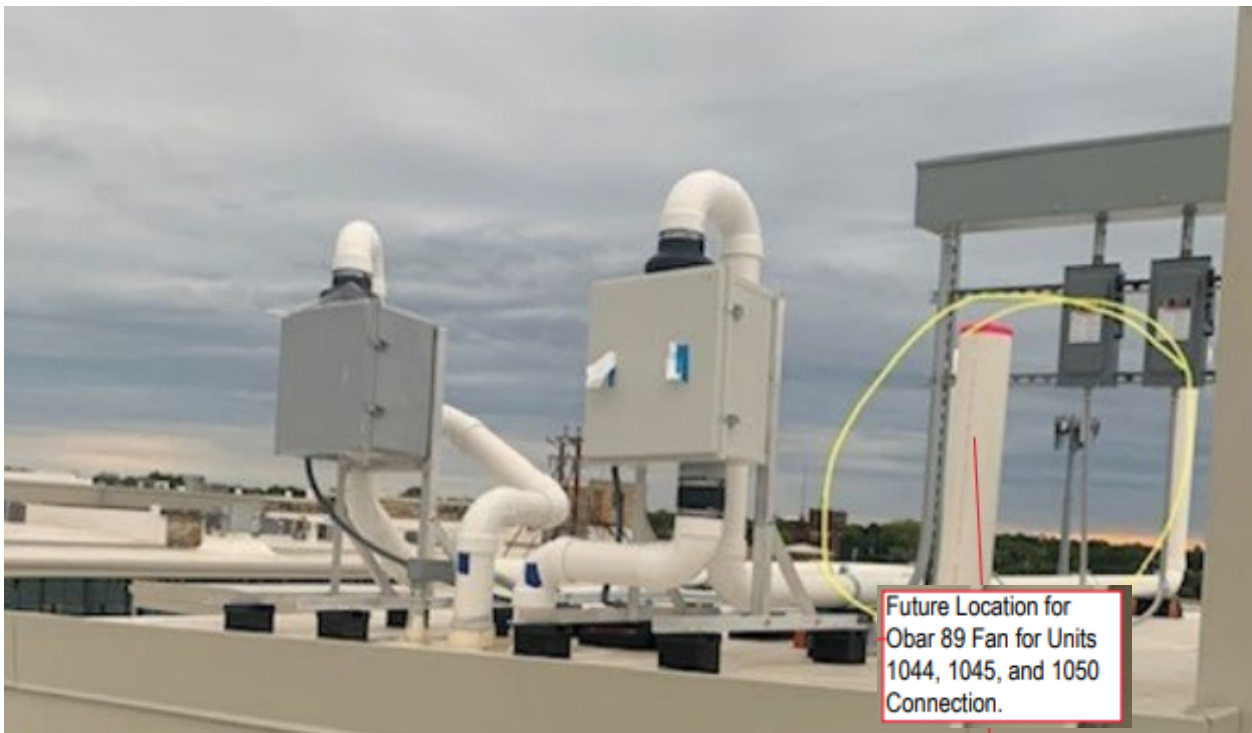
Picture 7: Ongoing installation of Blower 9 on the roof next to Blowers 6 and 7

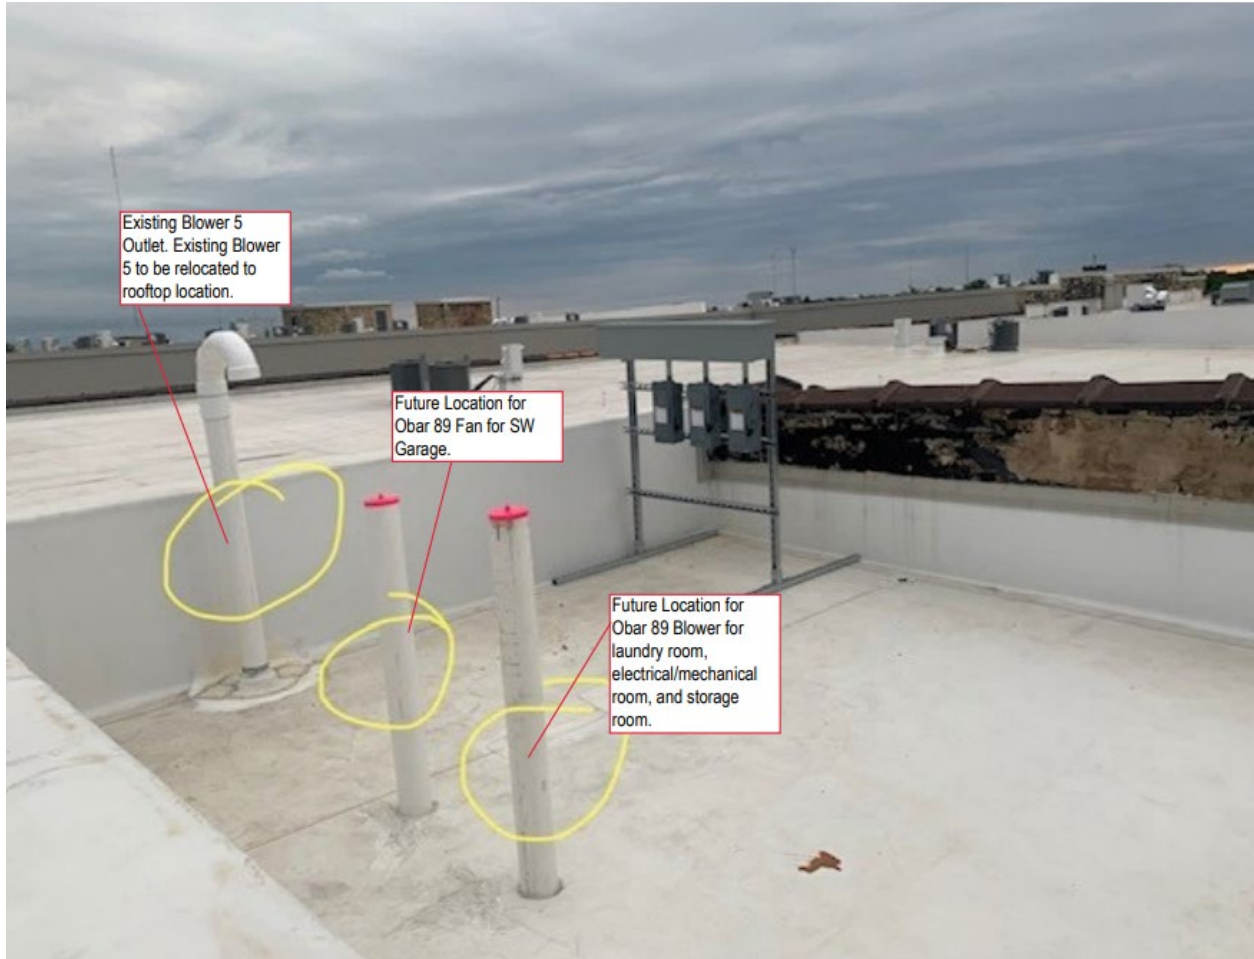
Picture 8: Ongoing installation of Blowers 10 and 11 on the roof above SW Garage
