SUBJECT : Column Sealing Options Report for CWC-East Block

Column Sealing Option Report
Community Within the Corridor – East Block
2748 N. 32nd Street, Milwaukee, WI 53210
BRRTS #: 02-41-263675, FID #: 241025400

**Subject: Column Sealing Option Report
Community Within the Corridor – East Block
2748 N. 32nd Street, Milwaukee, WI 53210
BRRTS #: 02-41-263675, FID #: 241025400**

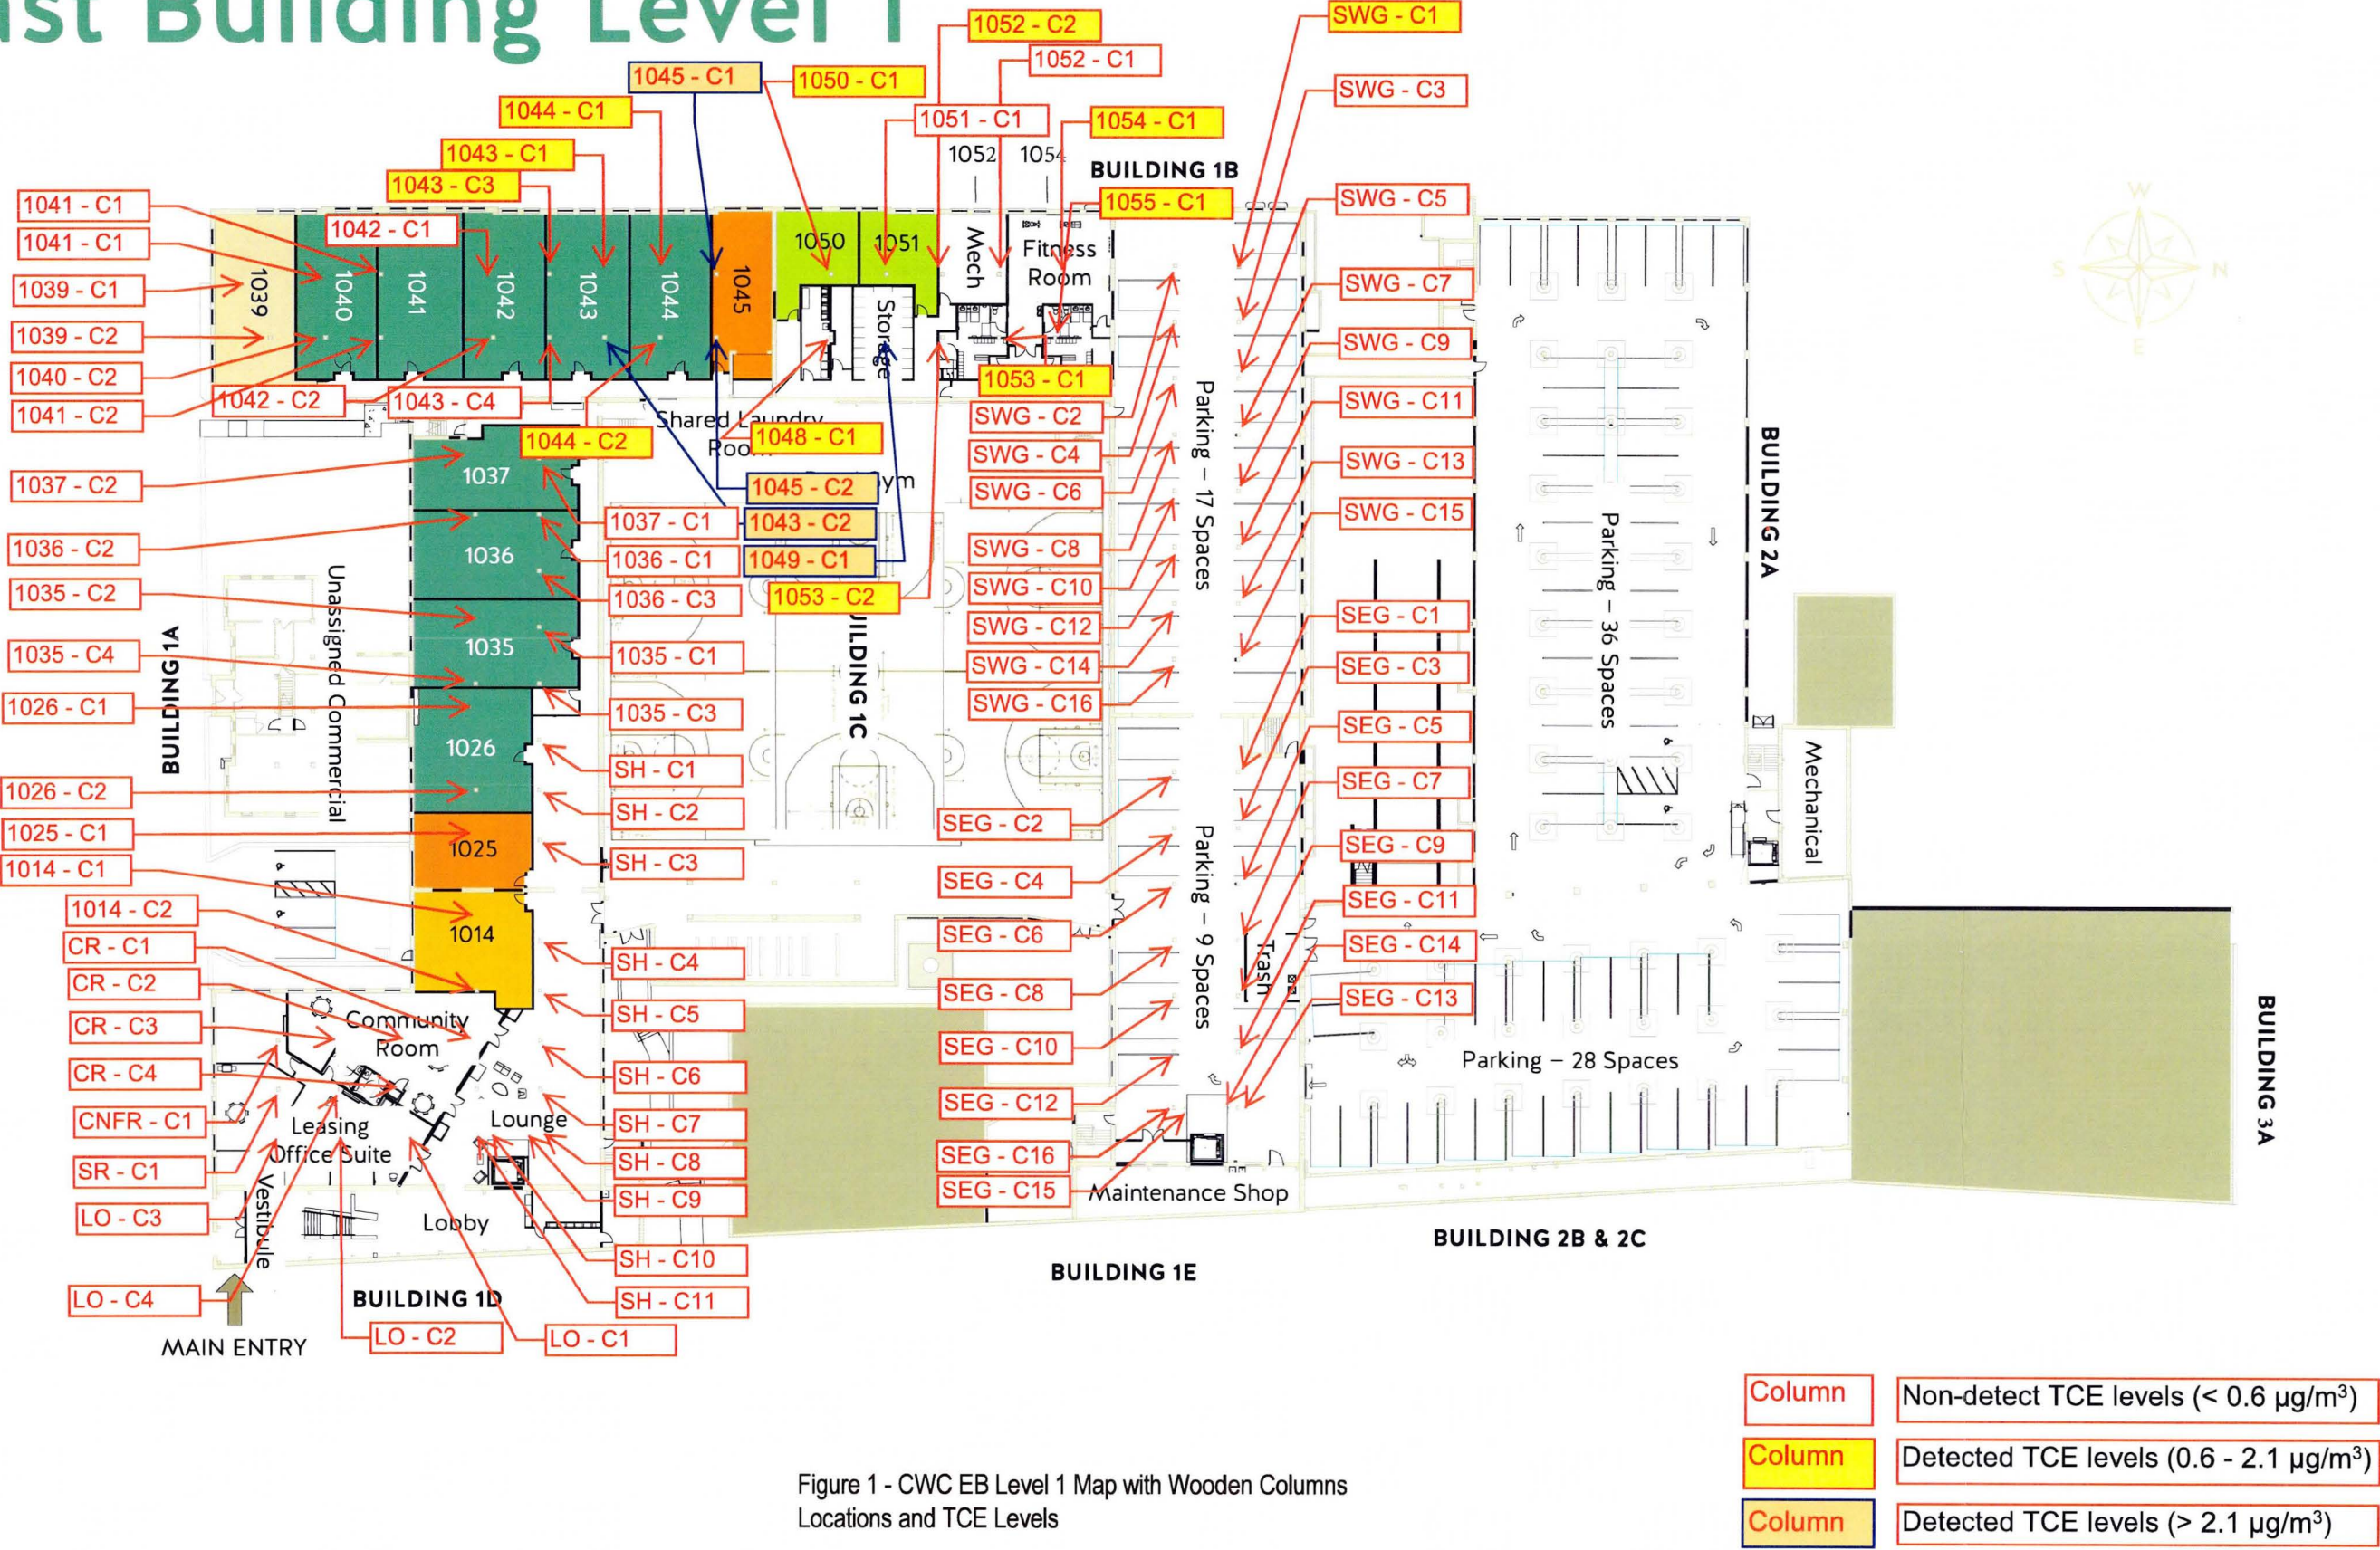
Figure 1 - CWC EB Level 1 Map with Wooden Columns Locations and TCE Levels

As seen in Figure 1, all the 16 columns with detections were found in the area that was reported to be a hotspot due to high sub-slab vapor TCE readings or residual contamination. Only 4 out of 94 columns had a TCE concentration exceeding 2.1 µg/m³. The sealing of these columns would prove to be supplemental to all the other remedial action tasks being conducted. As an additional safeguard, we are also proposing the sealing of 12 columns that had some detection of TCE. This comprehensive approach underscores our commitment to mitigating any potential risks associated with TCE exposure in living spaces. It is proposed that the column sealing operation be conducted in three stages:

- Stage 1: Seal the 4 columns with the values above VALs which are in Units 1049 (1 Column), 1045 (2 Columns), and 1043 (1 Column).
- Stage 2: Seal the 7 columns with the values between 1 and 2.1 µg/m³ which are in Units 1055 (1 Column), 1053 (2 Columns), 1052 (1 Column), 1050 (1 Column), and 1044 (2 Columns).
- Stage 3: Seal the 5 columns with the values between 0.6 and 1 µg/m³ which are in Units 1054 (1 Column), 1048 (1 Column), 1043 (2 Column), and the Southwest Garage (1 Column).

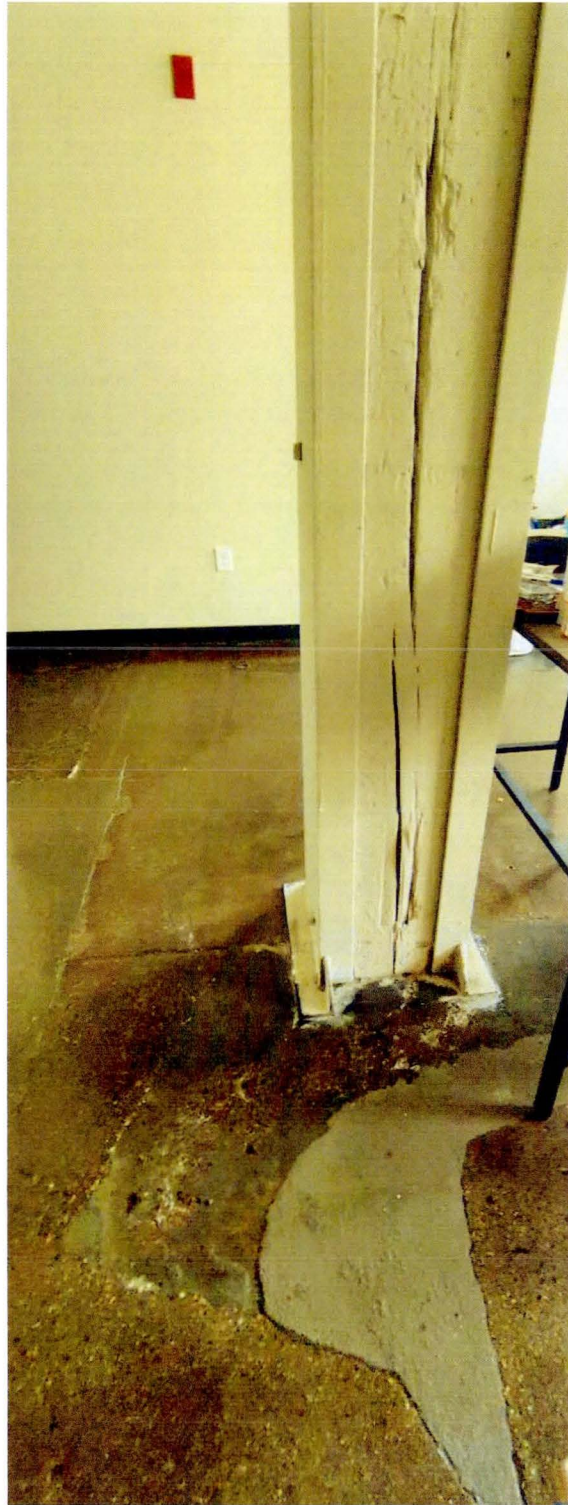
Picture 1: Unit 1040 – Cracks in wooden pillar and floor in living room

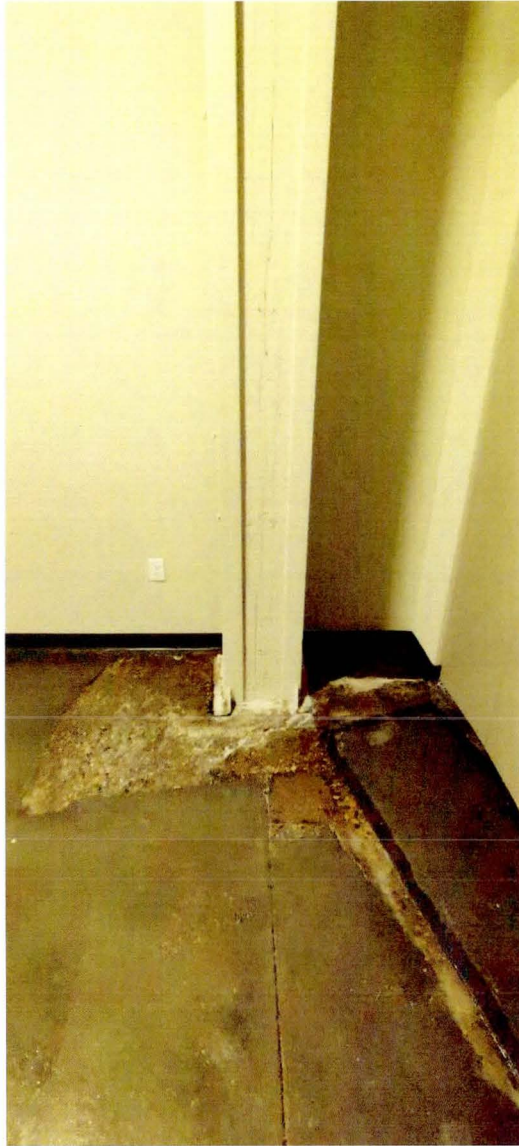
Picture 2: Unit 1036 - Wooden Pillar and cracks in bedroom 1

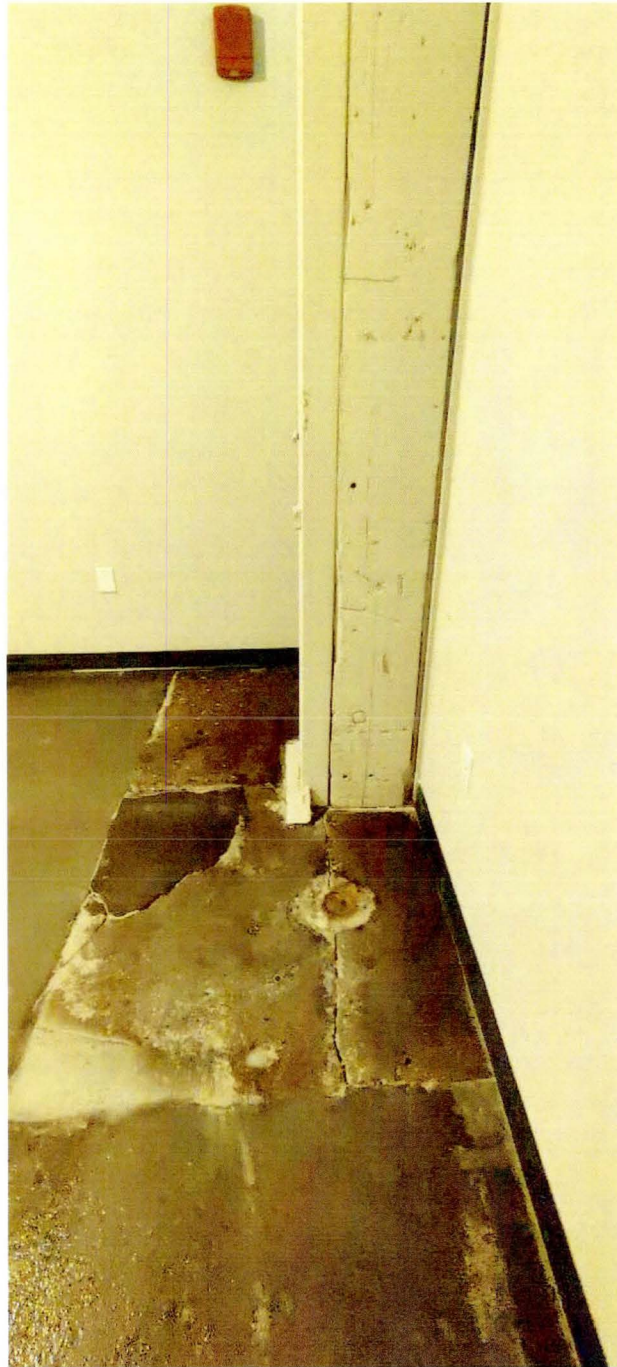
Picture 3: Unit 1025 - Wooden Pillar and cracks in the bedroom

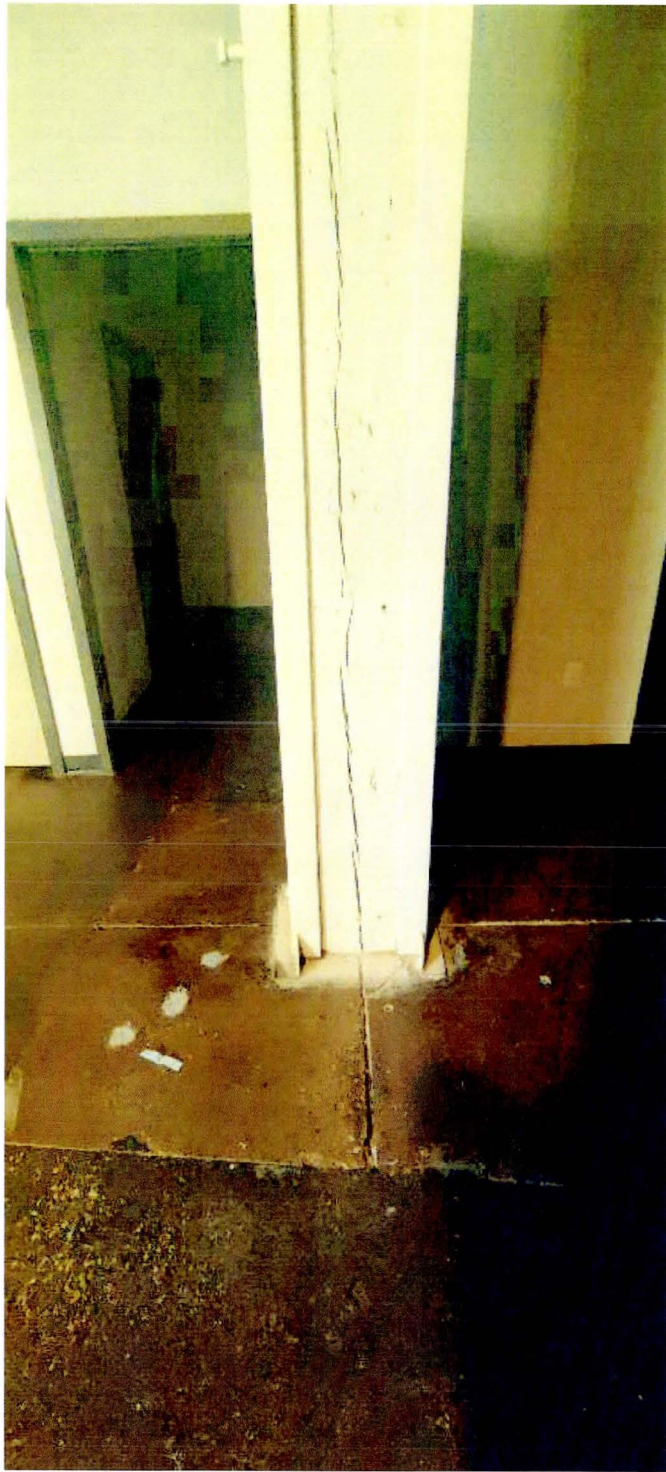
Picture 7: Unit 1026 - Wooden Pillar and cracks in the living room

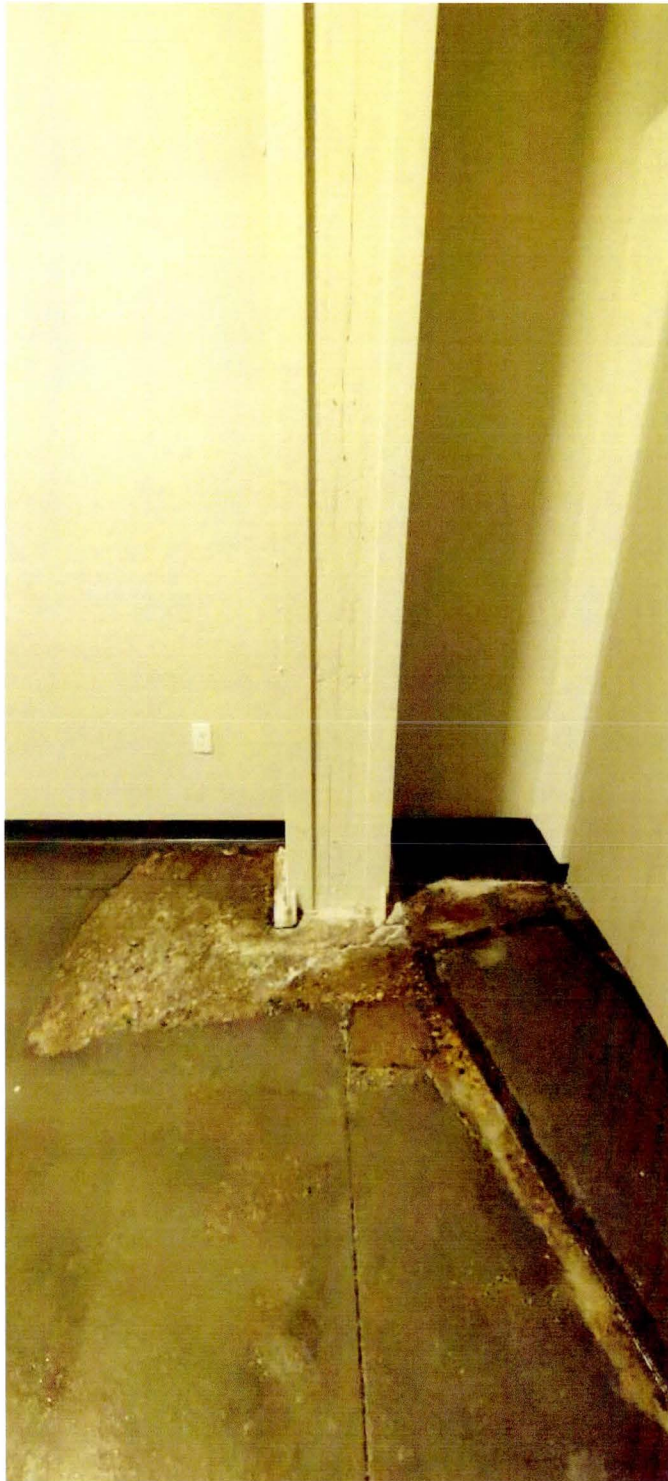
Picture 8: Unit 1036 - Wooden Pillar and cracks in bedroom 1

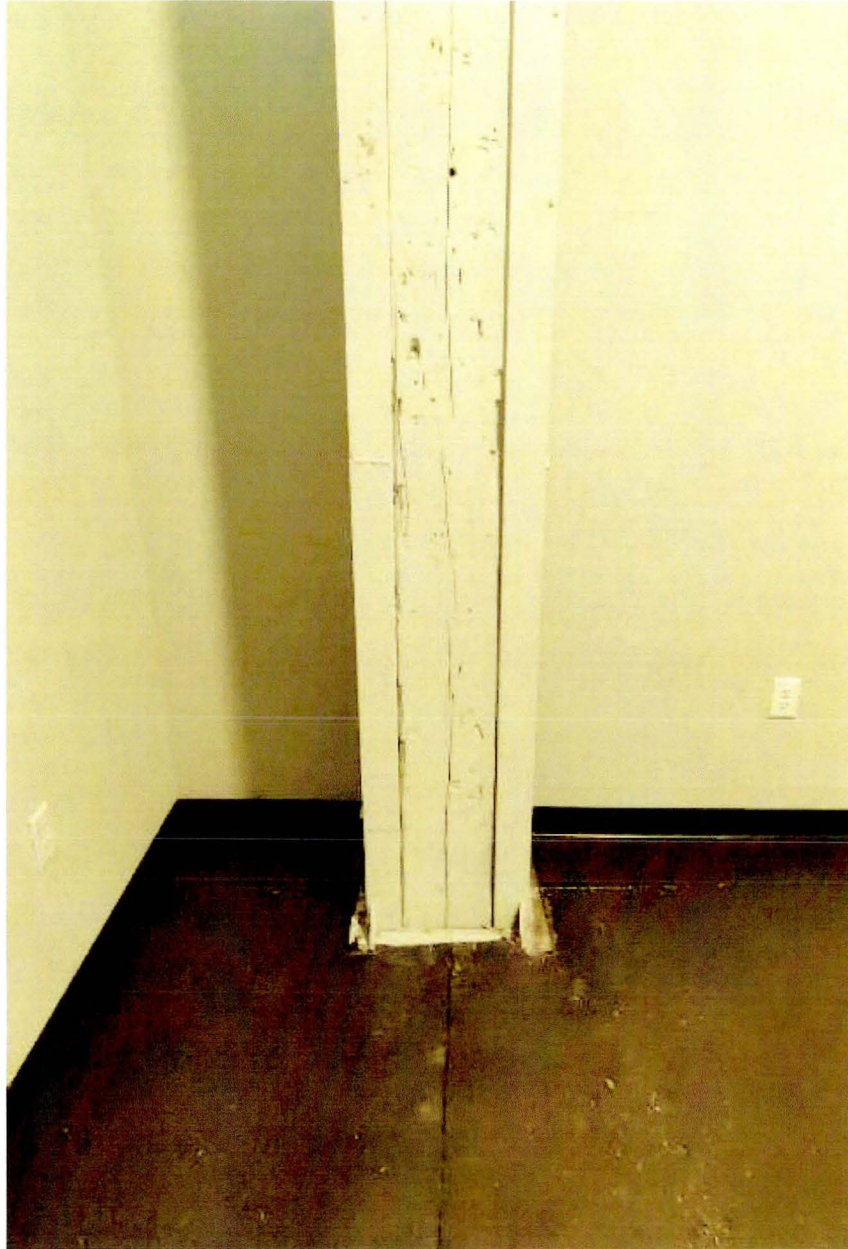
Picture 9: Unit 1036 - Wooden Pillar and cracks in bedroom 2

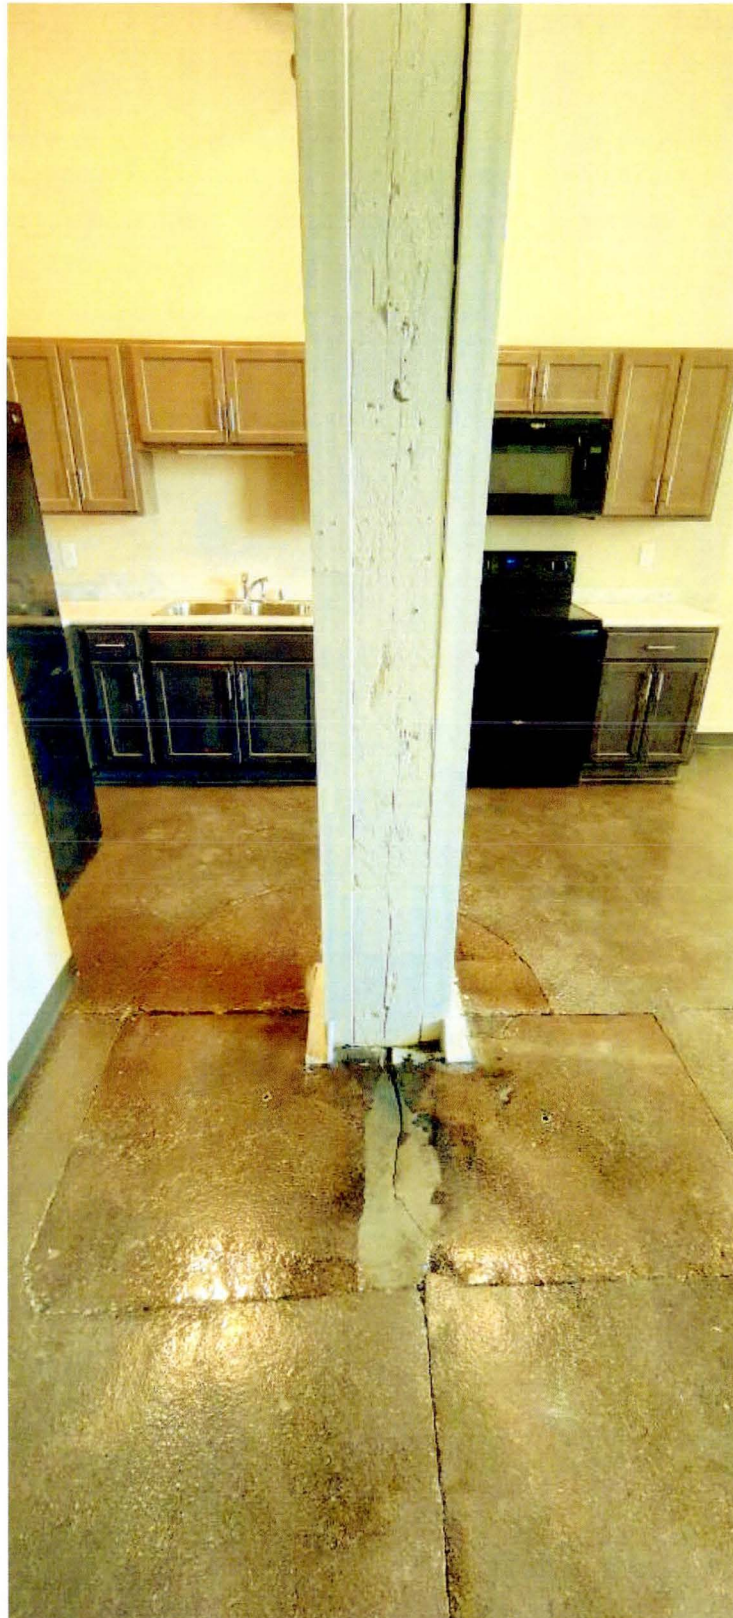
Picture 10: Unit 1036 - Wooden Pillar and cracks in the living room

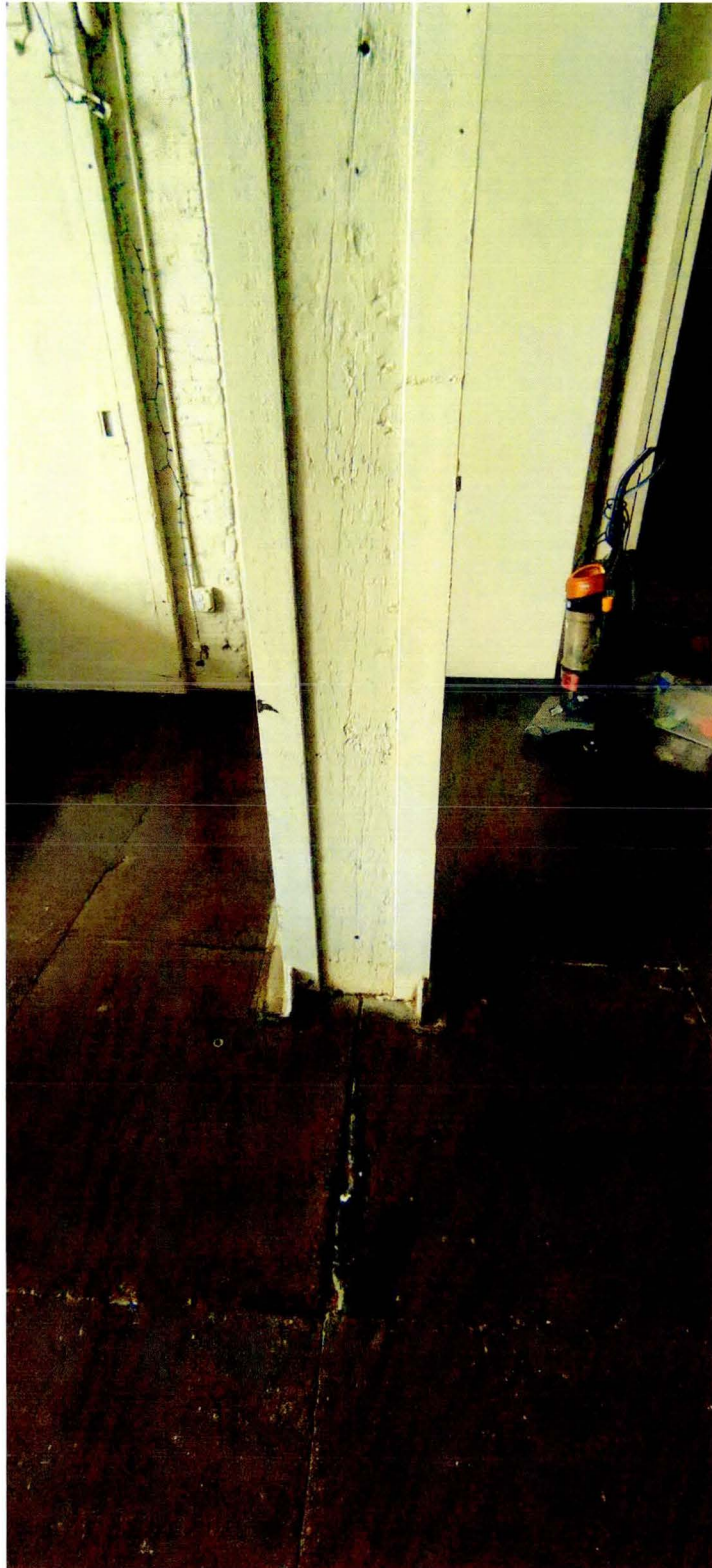
Picture 11: Unit 1037 - Wooden Pillar and cracks in the living room

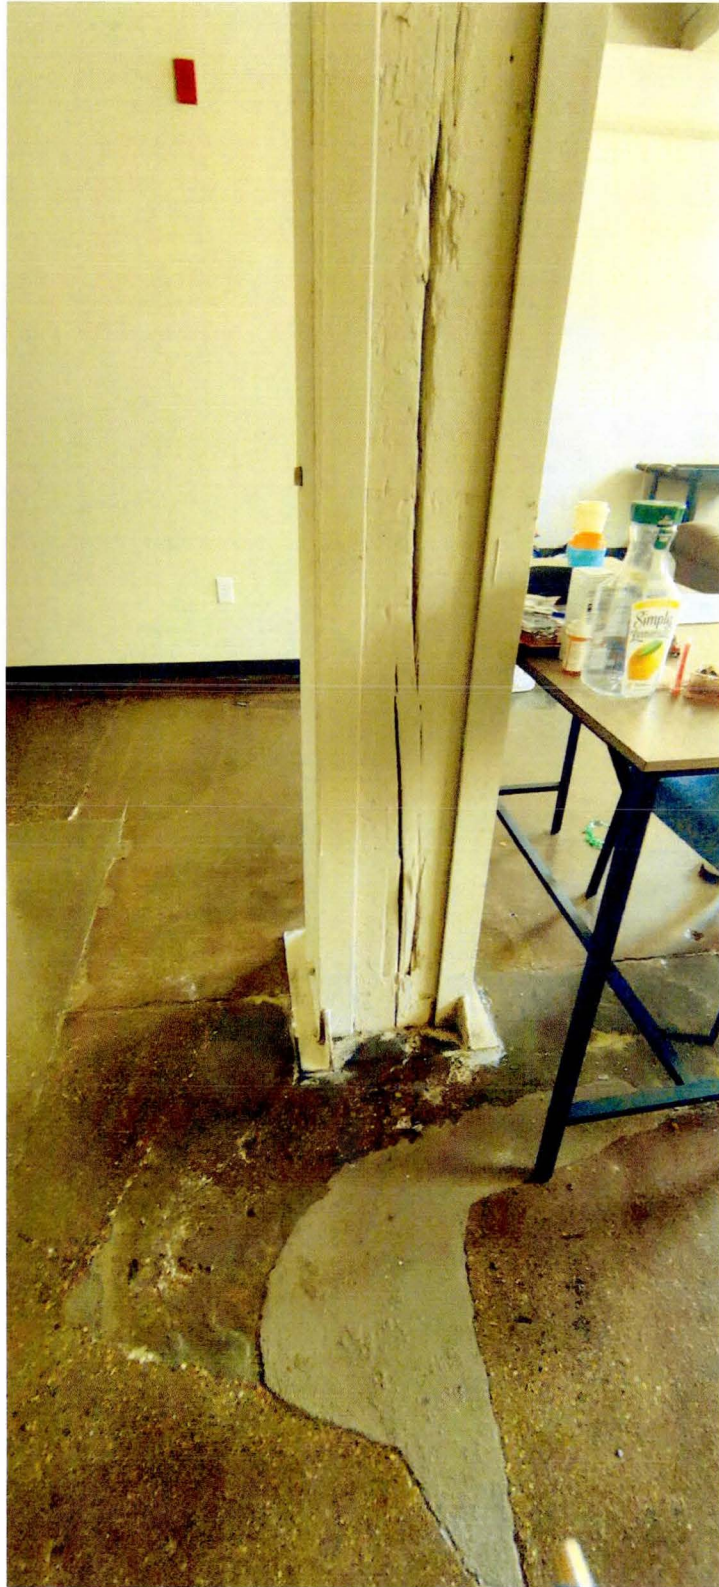
Picture 12: Unit 1040 – Cracks in wooden pillar and floor in living room

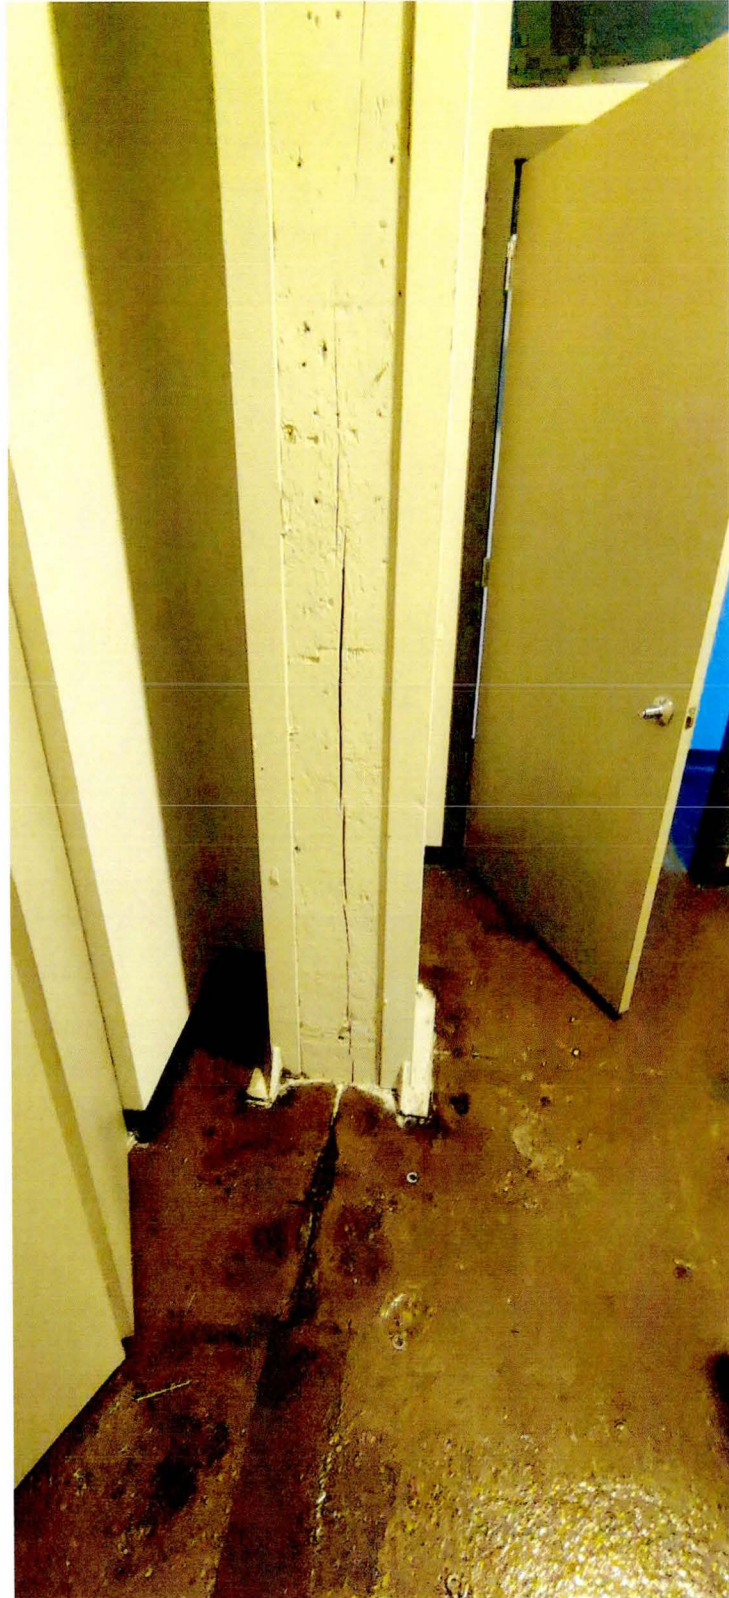
Picture 13: Unit 1040 – Cracks in wooden pillar and floor in bedroom

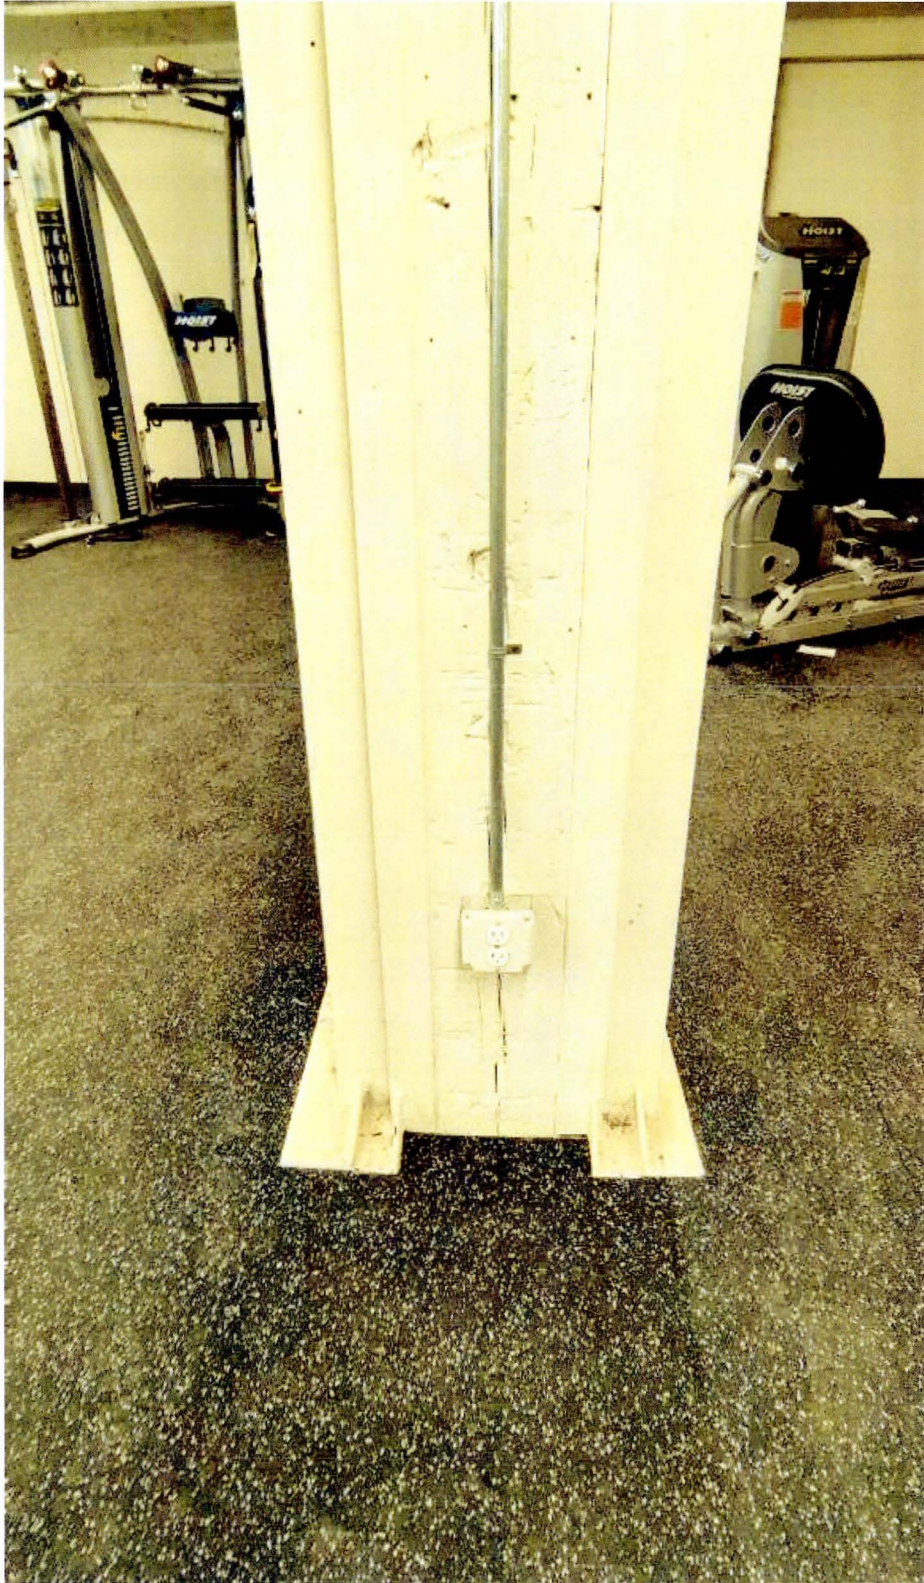
Picture 14: Fitness center – Cracks in the wooden pillar
