March 1, 2024

Subject: [02-13-587341] RockGen Energy Center 2023 Annual Cover System Maintenance  
Inspection Report

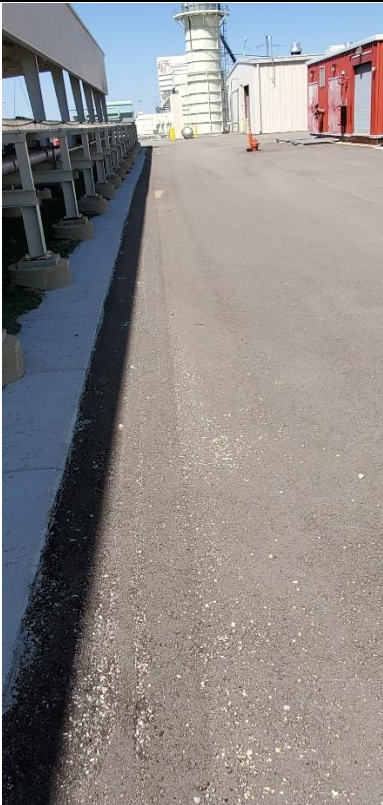
<b>Description</b> Asphalt cover from the southern edge facing north.

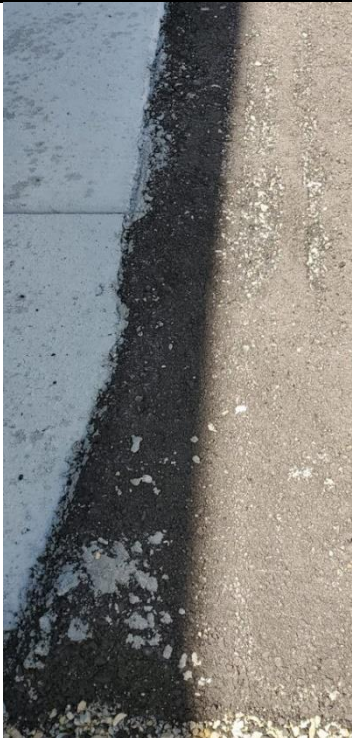
<b>Description</b> Asphalt cover to cement transition area.

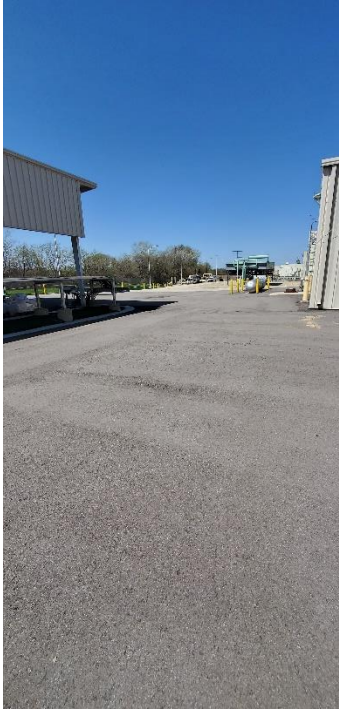
<b>Description</b> Asphalt cover facing north.

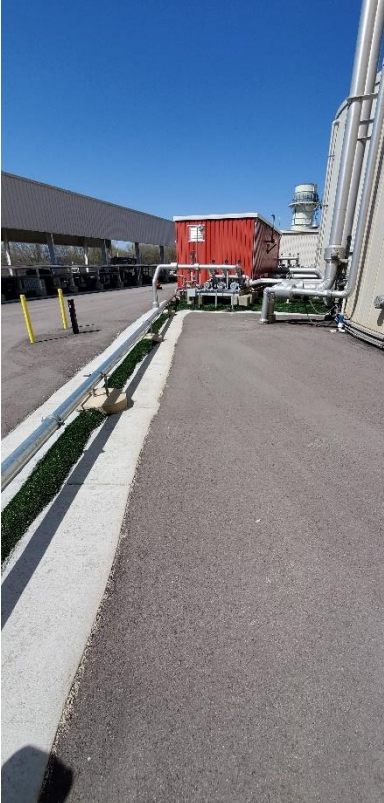
<b>Description</b> Asphalt cover in the piping infrastructure area facing north.

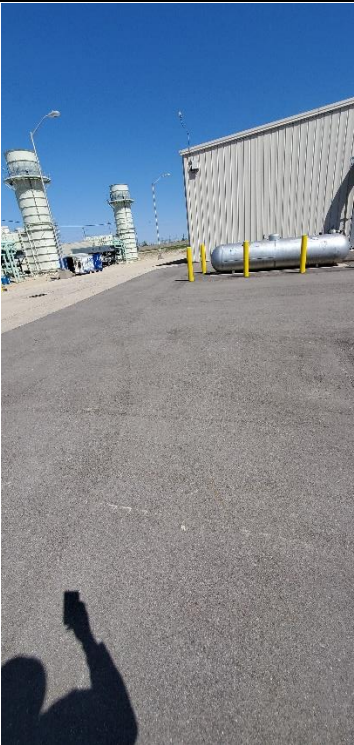
<b>Description</b> Northeastern edge of the asphalt cover facing east.

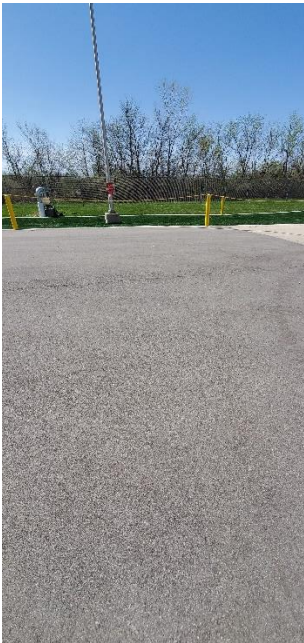
<b>Description</b> Northern edge of the asphalt cover facing west towards the geosynthetic membrane cover system.

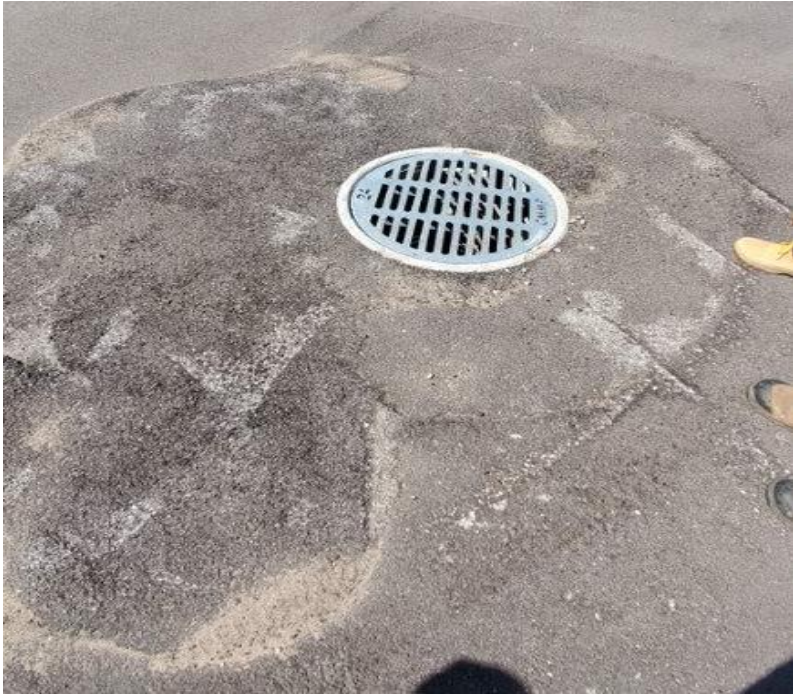
One modification to the asphalt cover made by the site owner and operator was observed during the inspection. A storm drain cover, documented in the accompanying photolog, was installed above the storm sewer inlet in the asphalt cover. The storm drain cover was installed with the addition of asphalt to the existing asphalt cover and no asphalt or other materials were removed or modified in the installation process. The asphalt cover continues to function as originally designed with stormwater flowing to the inlet and not pooling or ponding in this area. The purpose of this modification was to improve traffic flow in this area allowing vehicles to drive directly over the storm drain cover as the original design included a deep recess to the storm sewer inlet that did not allow for direct vehicle traffic.

<b>Description</b> Newly installed drain cover and asphalt fill at the stormwater inlet facing north.

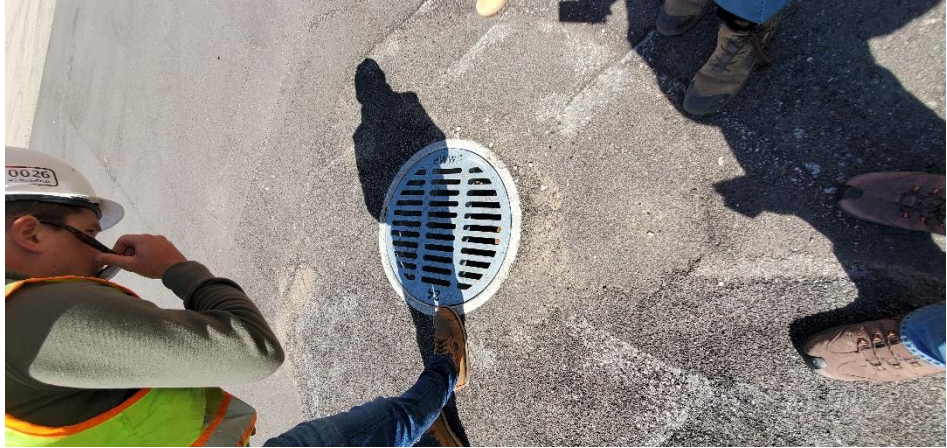
<b>Description</b> Newly installed drain cover and asphalt fill at the stormwater inlet facing east.

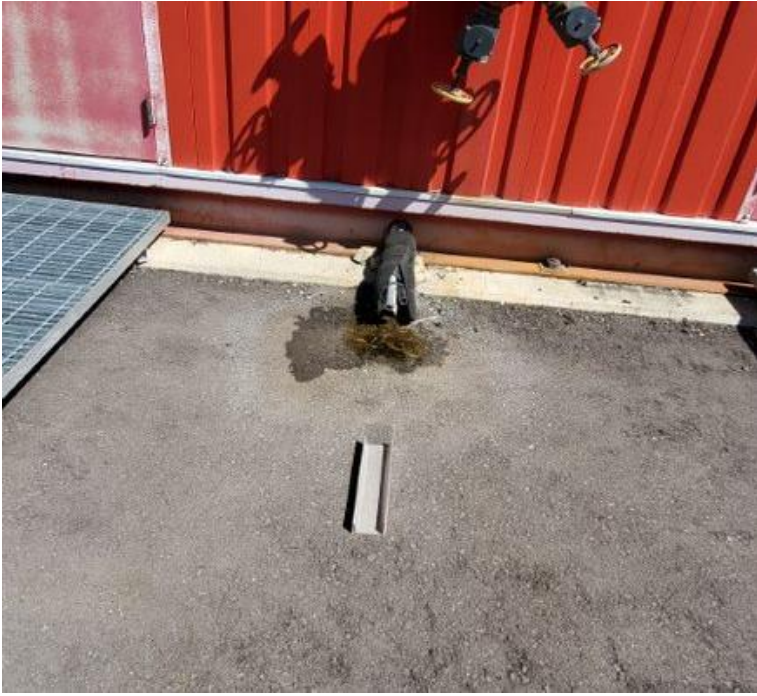
<b>Description</b> Staining on the asphalt cover around the fire suppression building facing east.

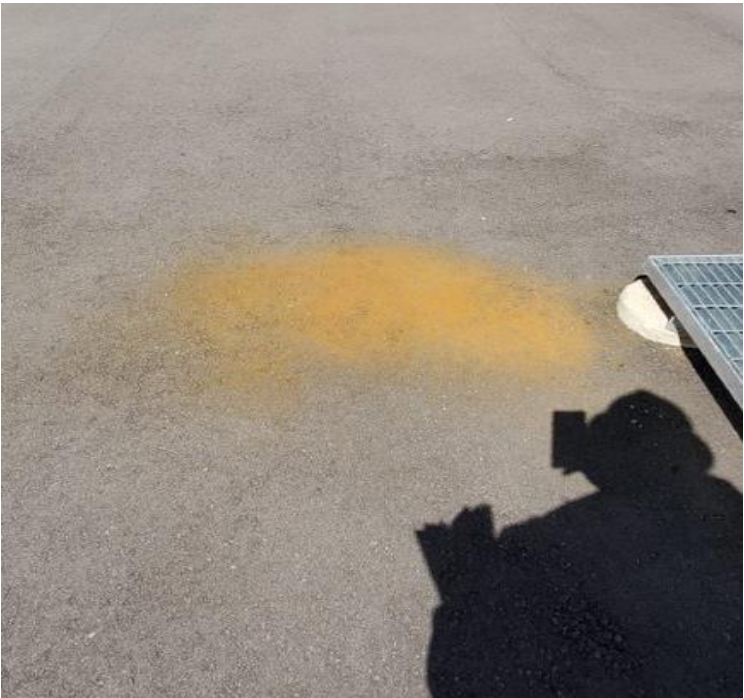
<b>Description</b> Staining near the northern edge of the fire suppression building facing north.

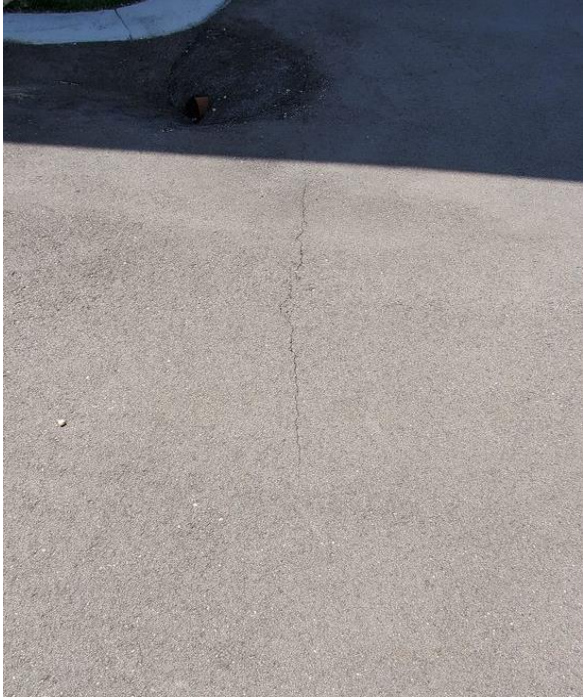
<b>Description</b> Hairline (<1/16 <sup>th</sup> inch) crack of approximately five feet in asphalt cover near the northeastern corner of the fuel unloading building facing west.

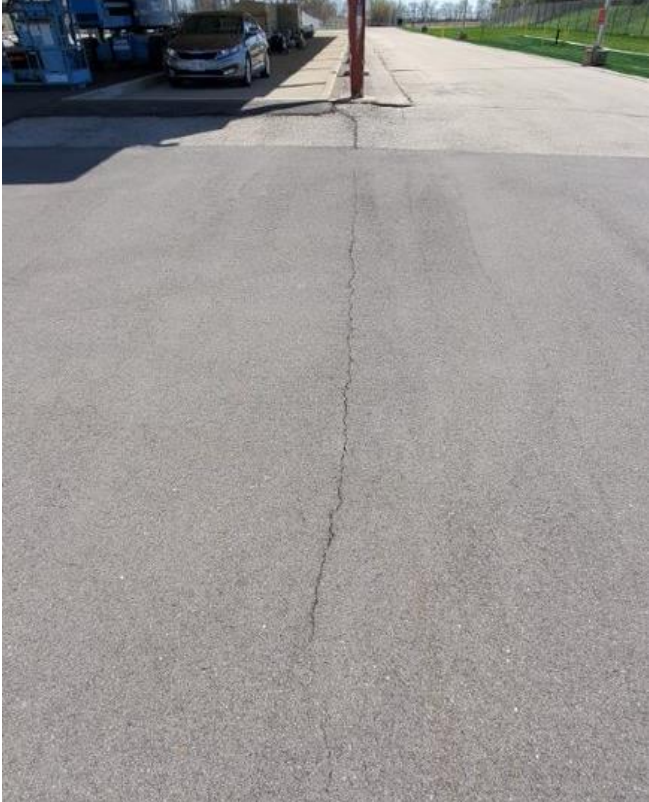
<b>Description</b> Hairline (<1/16 <sup>th</sup> inch) crack of approximately 12 feet in asphalt cover near the northwestern corner of the fuel unloading building facing south.

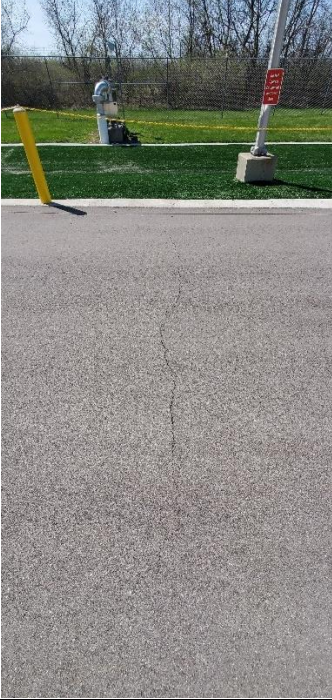
<b>Description</b> Hairline (<1/16 <sup>th</sup> inch) crack of approximately eight feet in asphalt cover near the industrial well and geosynthetic membrane cover system facing west.

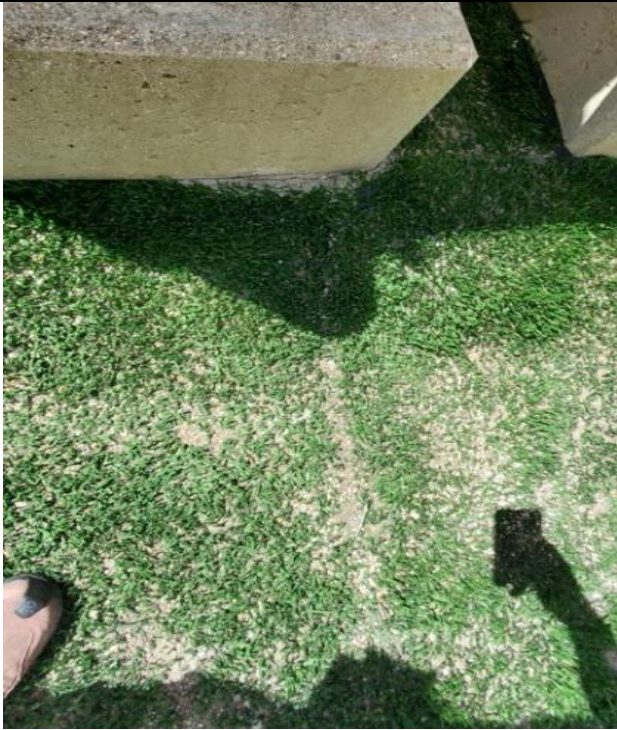
<b>Description</b> Geosynthetic membrane cover system in the piping infrastructure area near the fire suppression system facing east.

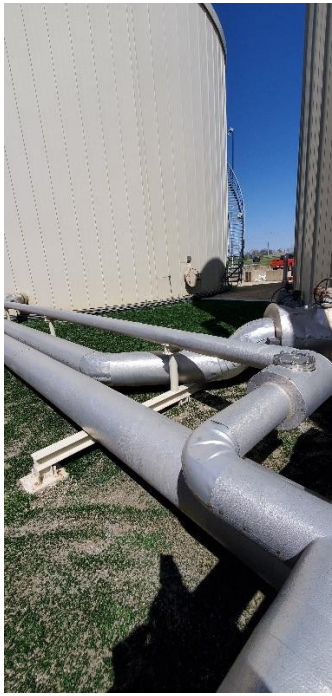
<b>Description</b> Geosynthetic membrane cover system in the piping infrastructure area near the fire suppression system facing east.

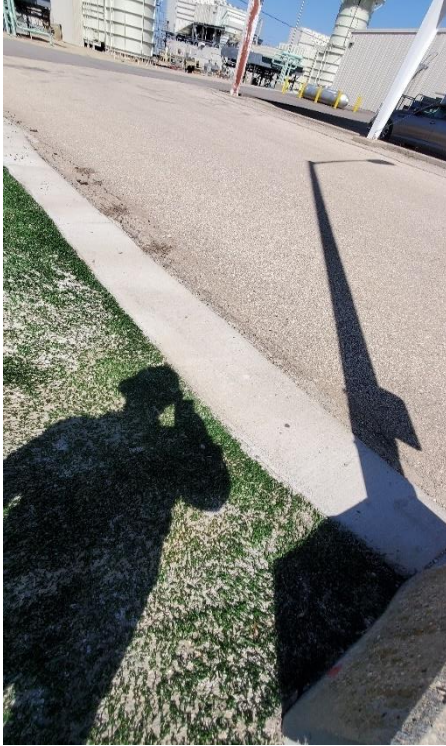
<b>Description</b> Cement transition to geosynthetic membrane cover system in the western swale. Hairline (<1/16 <sup>th</sup> inch) cracks in the existing cement access road facing northeast.

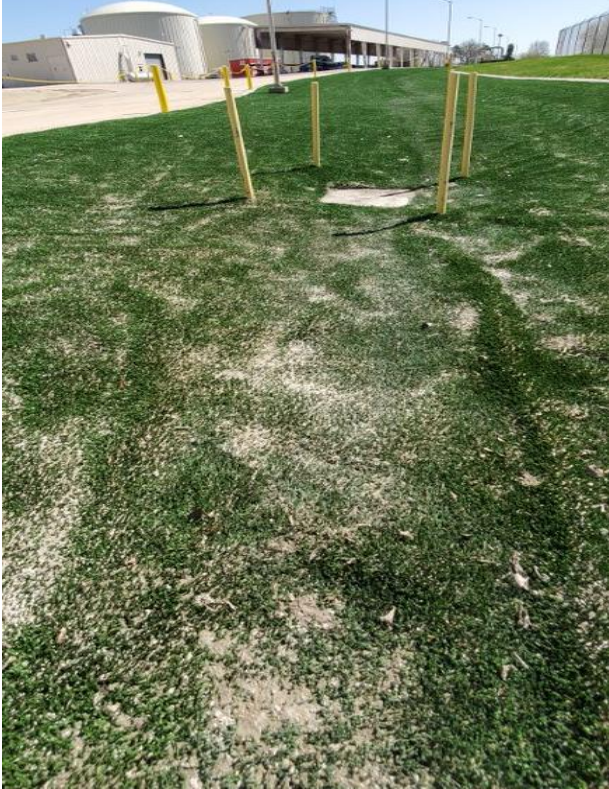
<b>Description</b> Geosynthetic membrane cover system in the western swale northern edge facing south.
