Cumberland Outfall Maintenance Program

April 25, 2013

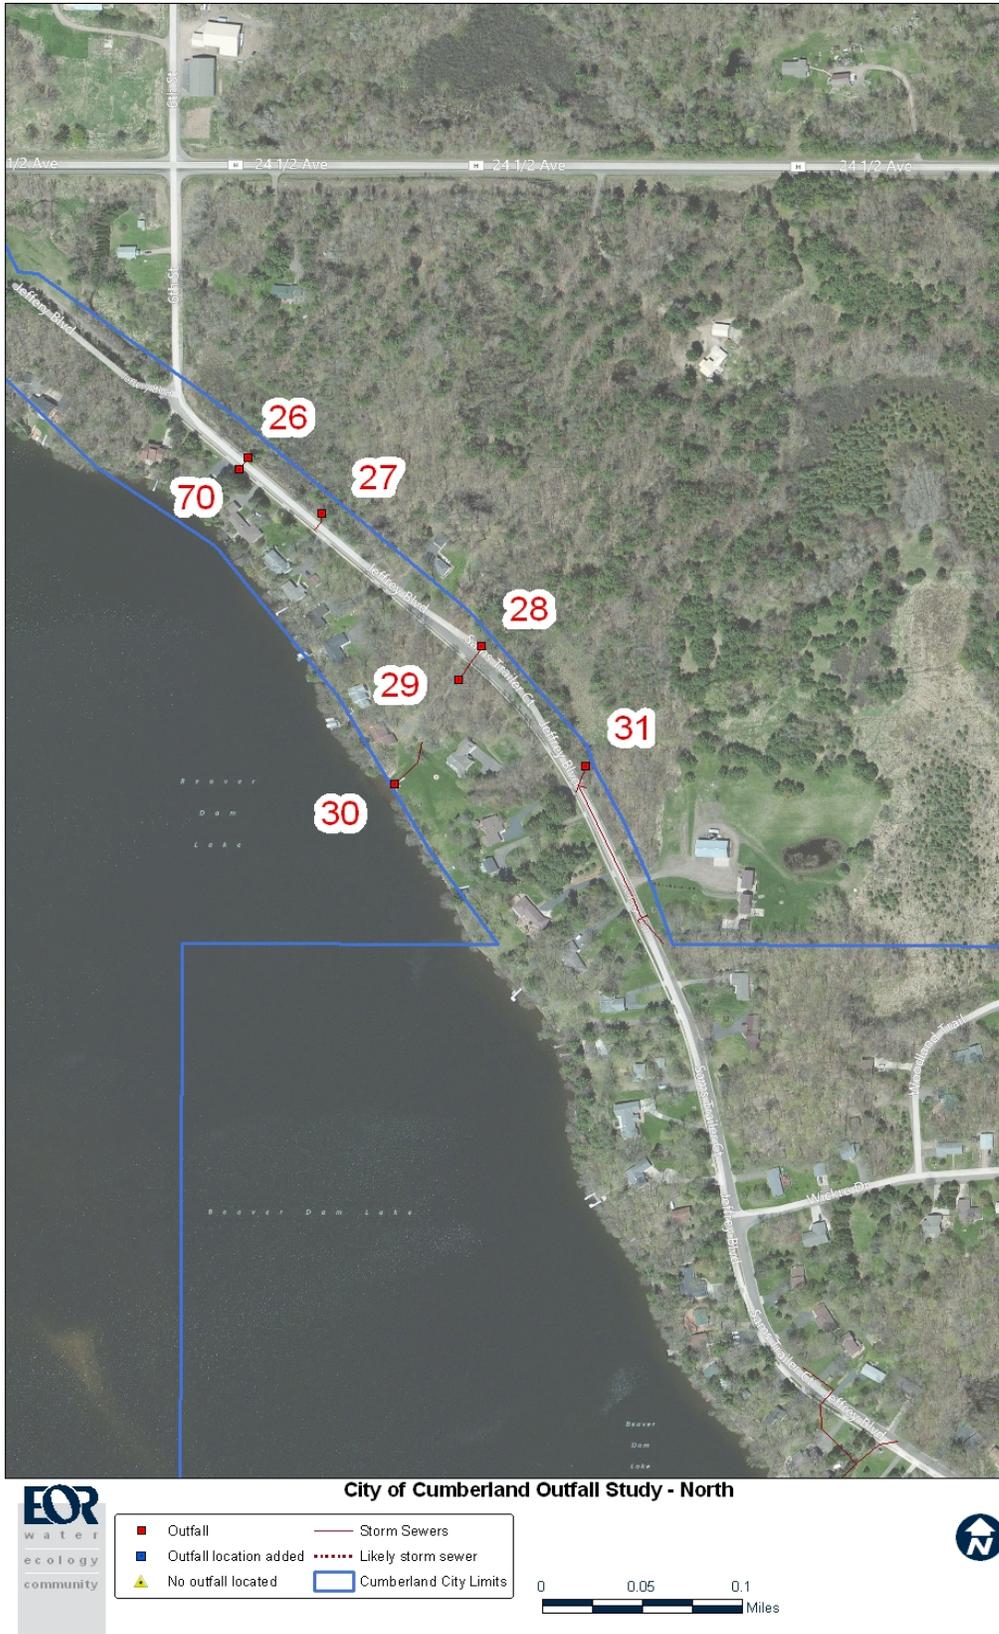
Figure 2. Outfall Locations, North.

Outfall #	Description
26	Two 18" RCP's, no discernible sediment plumes found below the outfalls but some sediment is present in the pipes.
27	15" RCP 100% plugged with sand and leaf debris. The grate needs to be removed to clean out the pipe, not able to survey with GPS, no discernible sediment plume.
28	18" RCP, no sediment plume, outlets to sandy gravel wooded swale, not able to survey with GPS.
29	18" RCP, no sediment plume, outlets to sandy gravel wooded swale, not able to survey with GPS.
30	18" RCP, no sediment plume, riprap occurs below the outfall, not able to survey with GPS.
31	24" RCP, a small sediment plume of approximately 2 cubic yards was found below outfall which is likely the product of the swale cutting through wooded area upstream of the plume. The sediment plume was mostly vegetated with sedges and reed canary grass, not able to survey with GPS.
70	18" RCP, not able to survey with GPS, no discernible sediment plume found.

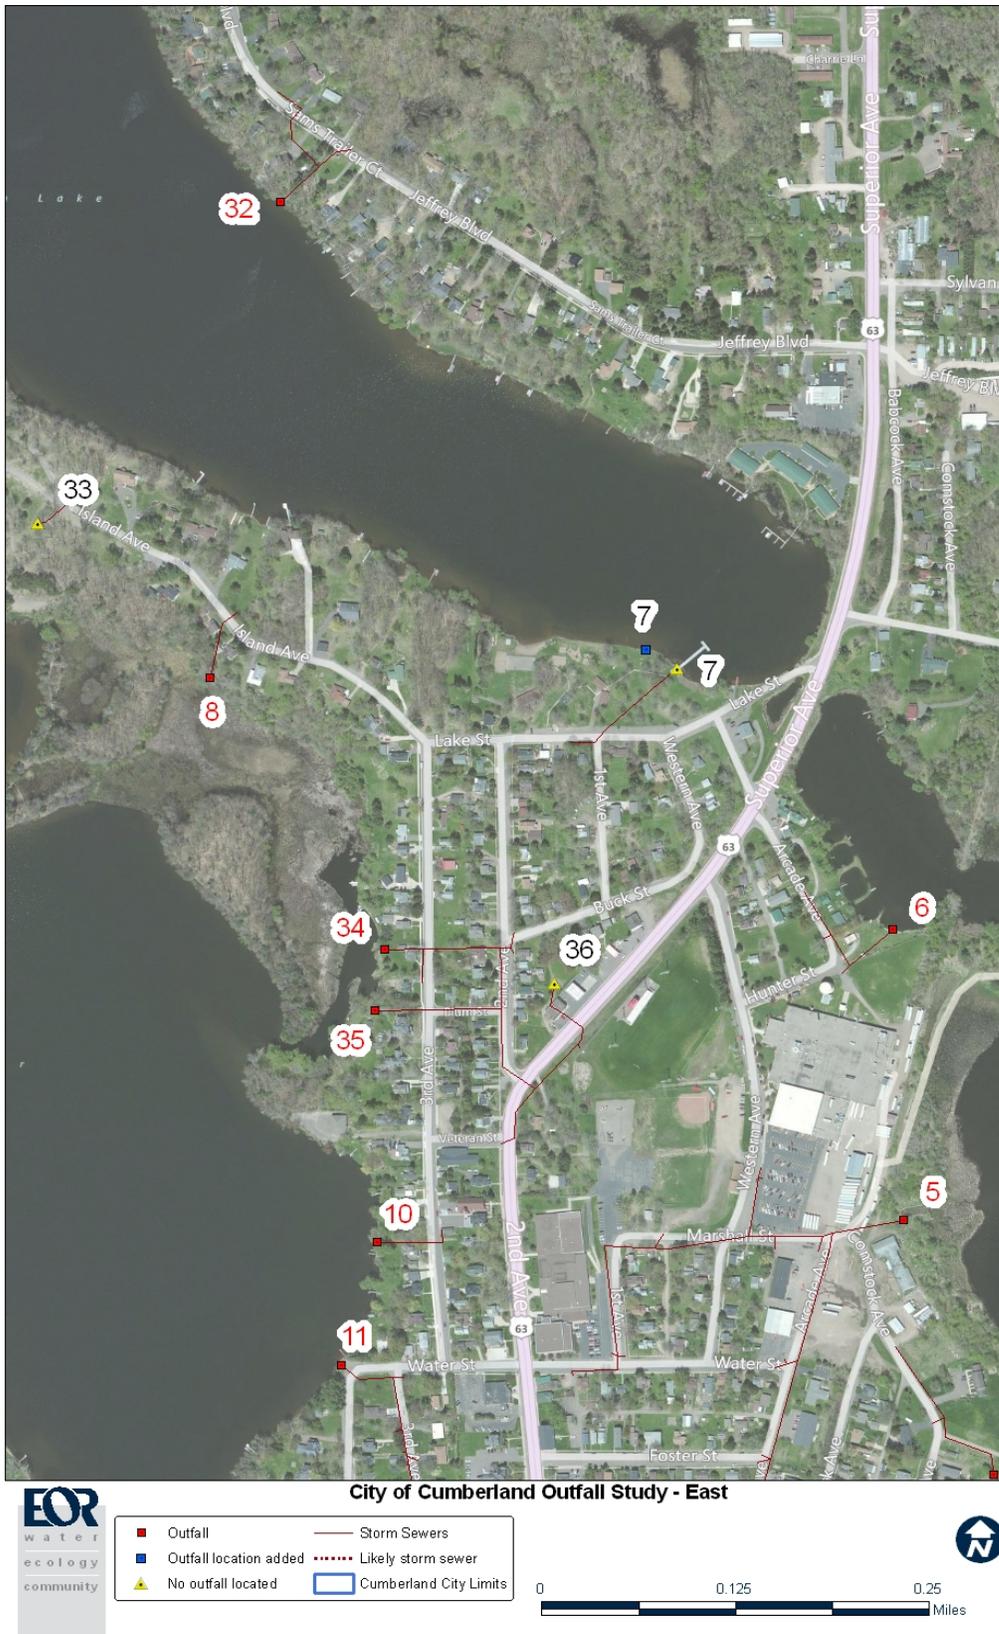
Figure 3. Outfall Locations, East.

Outfall #	Description
5	Two outfalls occur at this site: 21"x27" arch CMP, 14"x20" arch CMP. A sediment plume of approximately 15 cubic yards was surveyed beyond the outfall. Plant species present include cattail spp., reed canary grass, and arrowhead.
6	18" HDPE pipe, a small sediment plume of approximately 1.2 cubic yards was surveyed. Plant species present include coontail, Canada waterweed, and white water-lily.
7	No outfall found at the dock, but a 15" HDPE pipe was surveyed approximately 100 ft. northeast of the dock, no sediment plume found. The lakeshore is comprised of sandy gravel.
8	12" CMP, pipe slope close to 45 degrees near outlet resulting in some swale erosion below the pipe but no discernible sediment plume was found at the wetland edge. The pipe could use an energy dissipater to prevent further erosion, not able to survey outfall with GPS.
10	8" clay pipe 100% plugged with sediment, outlet is set low at the lakeshore and was likely plugged from ice heaving, no sediment plume found. The lakeshore is comprised of sandy gravel.

11	18" RCP in poor condition with the pipe joints separated near the outlet. A sediment plume of approximately 5 cubic yards was surveyed beyond the edge of the plunge pool. Plant species present include blue flag iris, reed canary grass, sandbar willow, and pickerelweed just beyond the sediment plume.
32	15" RCP, an approximate 3 ft. drop occurs below the outfall to the rocky lakeshore, no sediment plume found, the outfall could not be surveyed with GPS.
33	No outfall found, but overland flow likely occurs between the depressions in landscape.
34	15" RCP, a sediment plume of approximately 6.5 cubic yards was surveyed, plant species present include cattail spp. and white water-lily.
35	24" RCP, no discernible sediment plume, not able to survey with GPS.
36	No outfall found but a manhole near the BP gas station was located. The direction of stormwater flow at this site is unknown because the outfall could not be located.

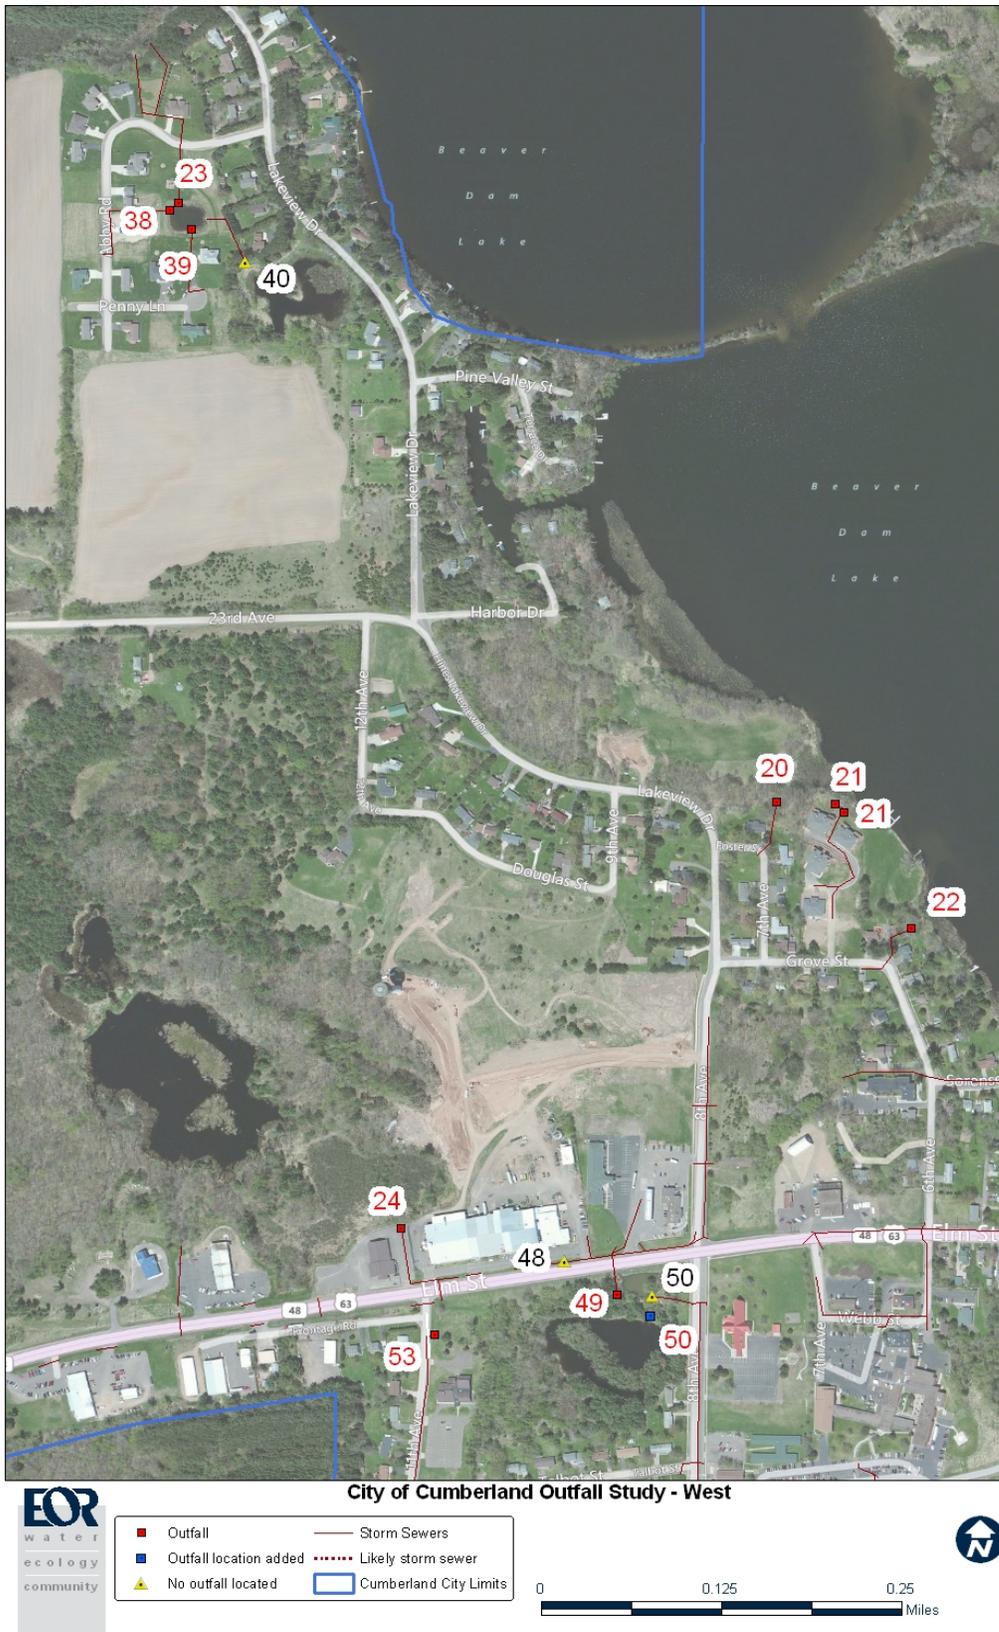
Figure 4. Outfall Locations, West.

Outfall #	Description
20	Detailed assessment completed by Derek Lash of EOR. 12" CMP protruding from bank, gully erosion below, not able to survey with GPS.
21	Two outfalls at this location. Detailed assessment completed by Derek Lash of EOR. 15" HDPE pipe inlet to a pond with 6" PVC outlet, rock swale in good shape, not able to survey with GPS.
22	Detailed assessment completed by Derek Lash of EOR. 15" PVC protruding from bank, gully erosion below, not able to survey with GPS.
23	12" HDPE pipe, no sediment plume, pipe in good condition.
24	30" HDPE pipe, open cut channel below the outfall but no discernible sediment plume identified.
38	15" HDPE pipe, no discernible sediment plume.
39	12" HDPE pipe, no discernible sediment plume.
40	No outfall found, outfall possibly underwater or buried underground.
48	No outfall found.
49	42"W x 72"H box culvert with 1-2" of sediment at the invert. No sediment plume below outfall.

50	No outfall found, but a 24" CMP was located approximately 75 ft. to the south with a 3-4 ft. deep plunge pool below the outfall. A concrete slab overflow occurs at the edge of the plunge pool. The presence of a sediment plume could not be assessed due to water depth beyond the plunge pool.
53	18" HDPE pipe, pipe partially plugged with approximately 6" of sediment, no discernible sediment plume below outfall.

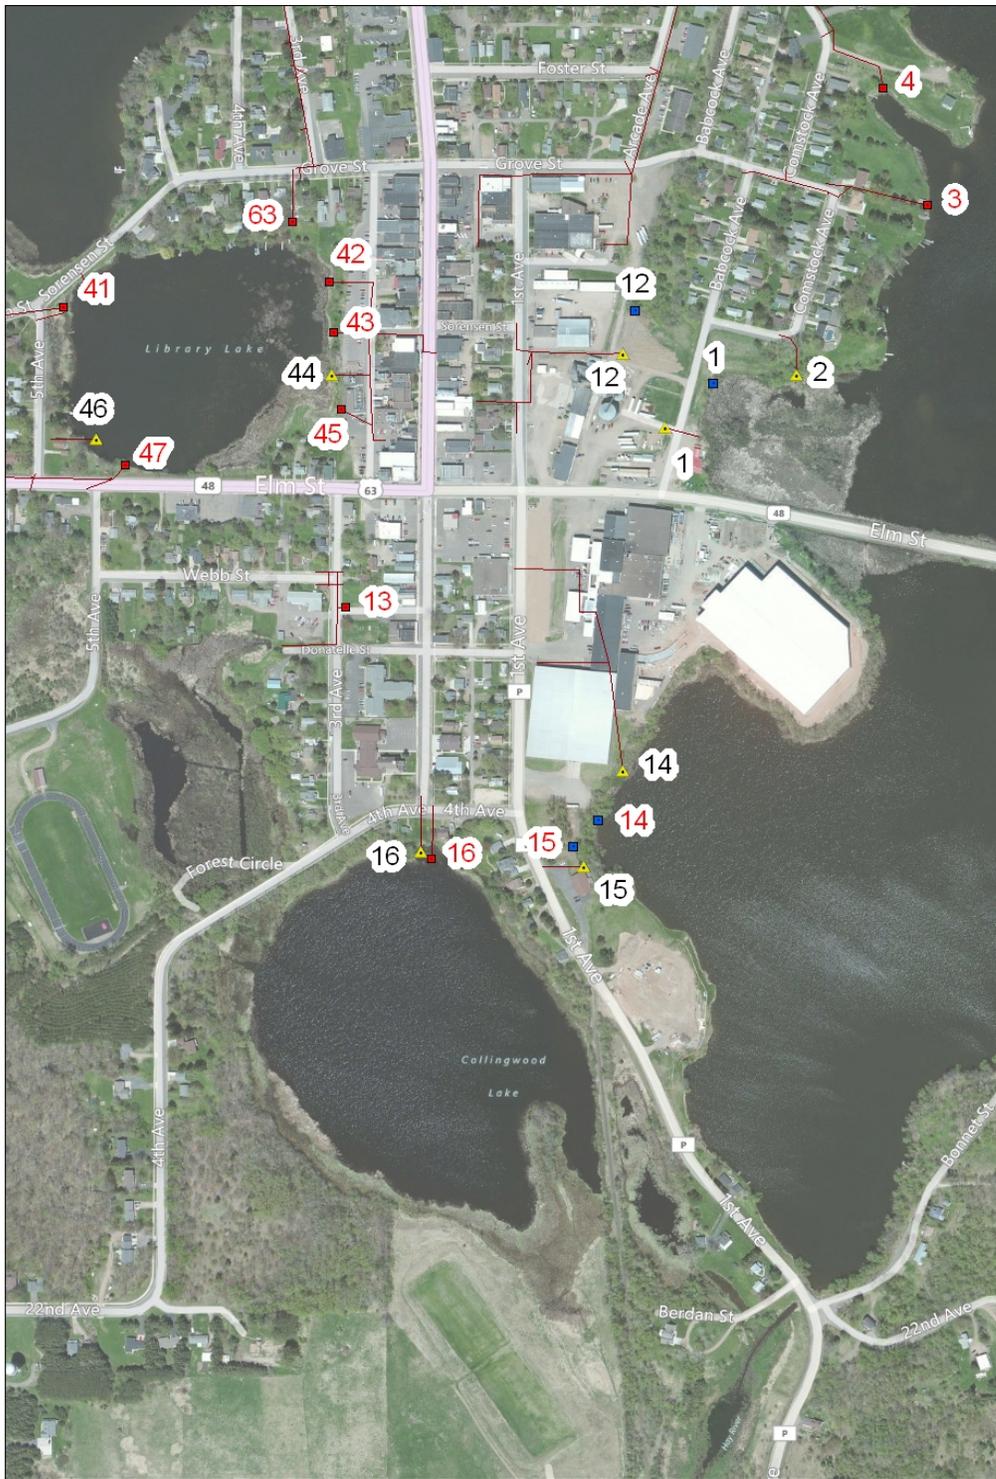
Figure 5. Outfall Locations, Southeast.

Outfall #	Description
1	No outfall found, but a rusted out 18" CMP was located approximately 190 ft. to the north. The outlet pipe is in very poor condition. A sediment plume of approximately 4.3 cubic yards occurred beyond the plunge pool below the pipe outlet. Plant species present include reed canary grass, nightshade spp., and sandbar willow.
2	No outfall found; it is possibly buried in lake sediments. A small sediment plume of approximately 1.2 cubic yards was surveyed near the potential outfall location.
3	12" PVC, no sediment plume, aquatic macrophytes include pondweed spp. and Canada waterweed.
4	12" RCP in poor condition; the pipe joints have separated near the outlet. A sediment plume of approximately 9.5 cubic yards was surveyed, but the pipe elevation could not be surveyed with the GPS due to tree cover.
12	No outfall found, but a 4" clay pipe was located approximately 230 ft. to the northeast. Erosion was noted beneath the pipe and some overland erosion exists but no discernible sediment plume was found beyond the outfall. The outfall could not be surveyed with GPS.

13	12" RCP, no sediment plume, pipe outlets to parking lot grass swale.
14	No outfall found, but an 18" RCP was located approximately 190 ft. to the southwest. The outfall could not be surveyed with GPS due to tree cover. An approximate 12 ft. x 14 ft. x 3 ft. deep plunge pool with a sediment plume at outer edge likely formed beyond the plunge pool. The sediment plume could not be surveyed due to water depth. Plant species present include black willow and box elder. The pipe outlet occurs several feet above the water surface. Flows from the outlet from this elevation have likely scoured out the plunge pool below the outfall.
15	No outfall found, but an 18" RCP was located approximately 75 ft. to the northwest. The outfall could not be surveyed with GPS. The outlet is well above the lake, no discernible sediment plume found.
16	The west outfall was not found, but an 18" HDPE pipe was located to the east and a sediment plume of approximately 8 cubic yards was surveyed. Plant species present include smartweed and reed canary grass. A small swale with an eroding headcut was found below the pipe.

41	Recently modified site- new pipe installed in the summer of 2012 for the Neuer Pond BMP.
42	15" CMP, a sediment plume of approximately 2 cubic yards occurs beyond the outfall. Plant species present include sandbar willow, reed canary grass, and cattail spp.
43	15" RCP, a sediment plume of approximately 2 cubic yards occurs beyond the outfall. Sediment core analysis completed for this site, samples were collected on 11/15/11 (core #4). Plant species present include sandbar willow, and cattail spp.
44	No outfall found, no discernible sediment plume found.
45	15" CMP, a sediment plume of approximately 2 cubic yards occurs beyond the outfall. Sediment core analysis completed for this site, samples were collected on 11/15/11 (core #5). Plant species present include sandbar willow, reed canary grass, and cattail spp.
46	No outfall found.
47	30" RCP, a sediment plume of approximately 96 cubic yards was surveyed beyond the edge of the plunge pool.

63	15" RCP, a sediment plume of approximately 22.4 cubic yards was surveyed. Sediment core analysis completed for this site, samples were collected on 11/15/11 (core #3). Plant species present include reed canary grass, cattail spp., and white water-lily.

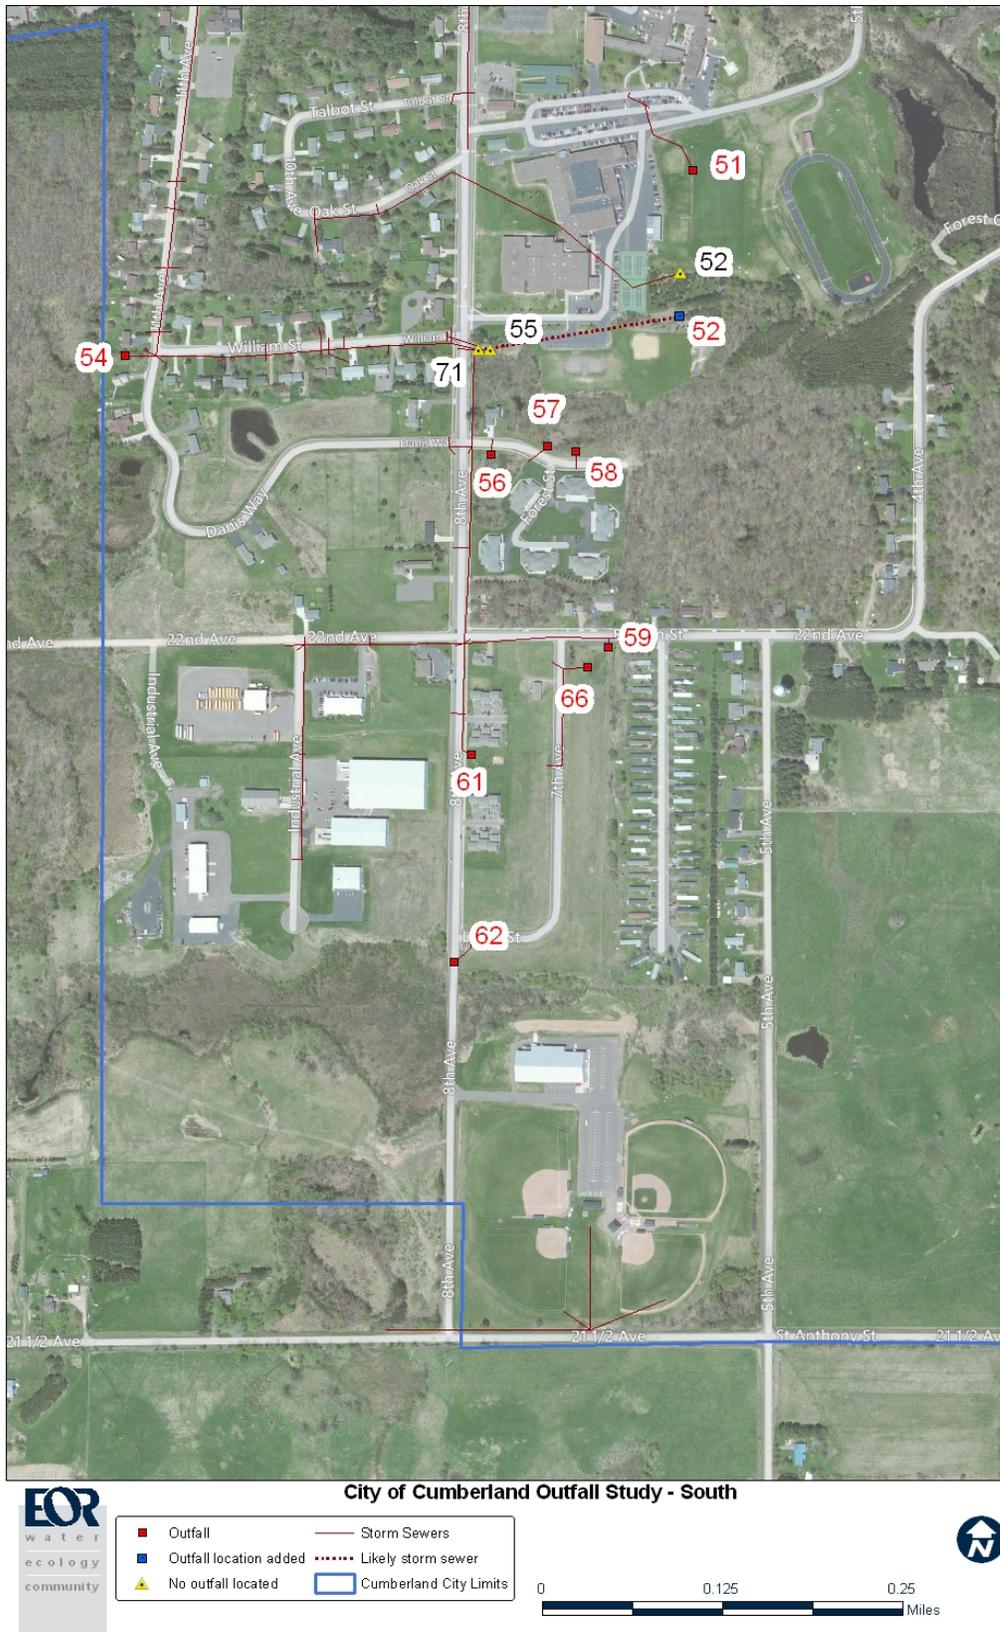
Figure 6. Outfall Locations, South.

Outfall #	Description
51	12" RCP, pipe joint separated on slope, survey elevation taken at the separated joint, no sediment plume found.
52	No outfall found, but a 42" RCP was located approximately 150 ft. to the south. A connection from site #71 occurs at the manhole located just southwest of the tennis court in the parking lot. This site has a riprap swale with no sediment plume.
54	This site is not an outfall. The 18" RCP slopes east toward 11 th Avenue and likely flows east toward outfall #52.
55	No outfall found.
56	12" RCP, no sediment plume found but there is sediment in the pipe with vegetation growing within the flared end section below the pipe grate.
57	8" steel pipe, no sediment plume found. A very small plunge pool occurs below the outfall, not able to survey with GPS.
58	12" RCP, no sediment plume found. An open cut channel occurs below the outfall and leads to the wetland below but no discernible sediment plume could be found.

59	18" RCP drop structure with weir in place, no sediment plume found below the outfall.
61	12" RCP, no sediment plume found below the outfall.
62	15" RCP, no discernible sediment plume found below the outfall.
66	21" RCP, no discernible sediment plume found below the outfall.
71	No outfall found, but a manhole located just east of 8 th Avenue allows access to the underground pipe that continues northeast and ties into the manhole just upstream of outfall #52.
