Site Inspection Documentation Form
Lake Delavan Highlands Association (LDHA) – South Inlet Channel
Town of Delavan, Wisconsin

GEOSYNTEC CONSULTANTS
Photographic Record

Project Number: MOW5540

Site Name: LDHA Inlet Channel

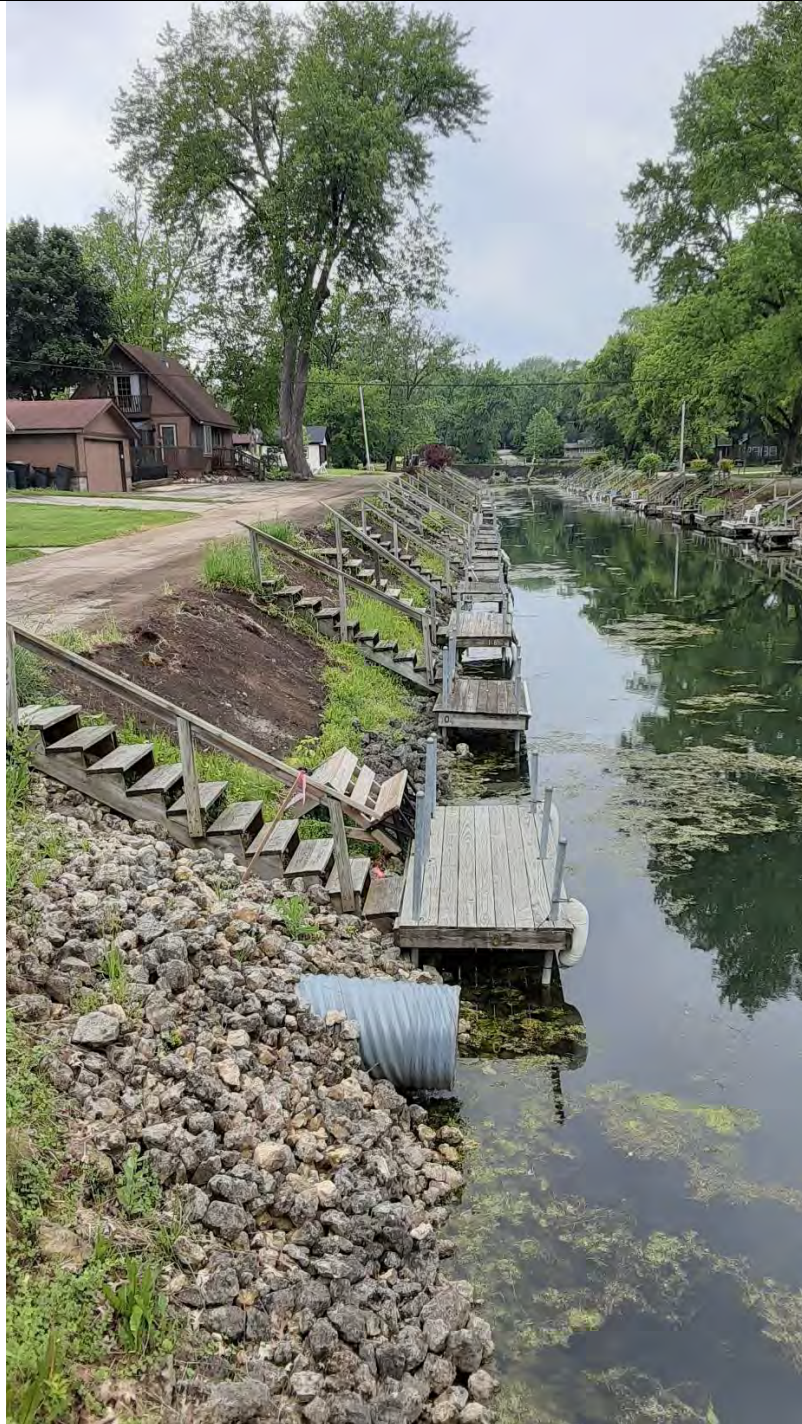
Photograph 1

Perimeter control lacking or nonexistent. All SESC measures are to be installed prior to the commencement of construction per the plans.

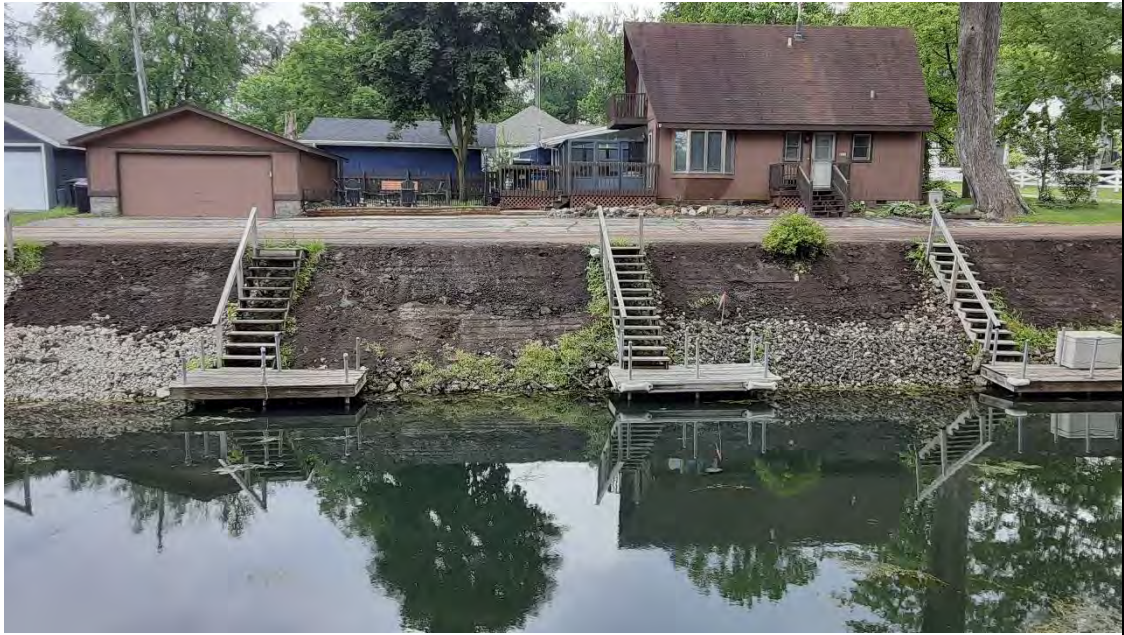
Photograph 2

No perimeter controls

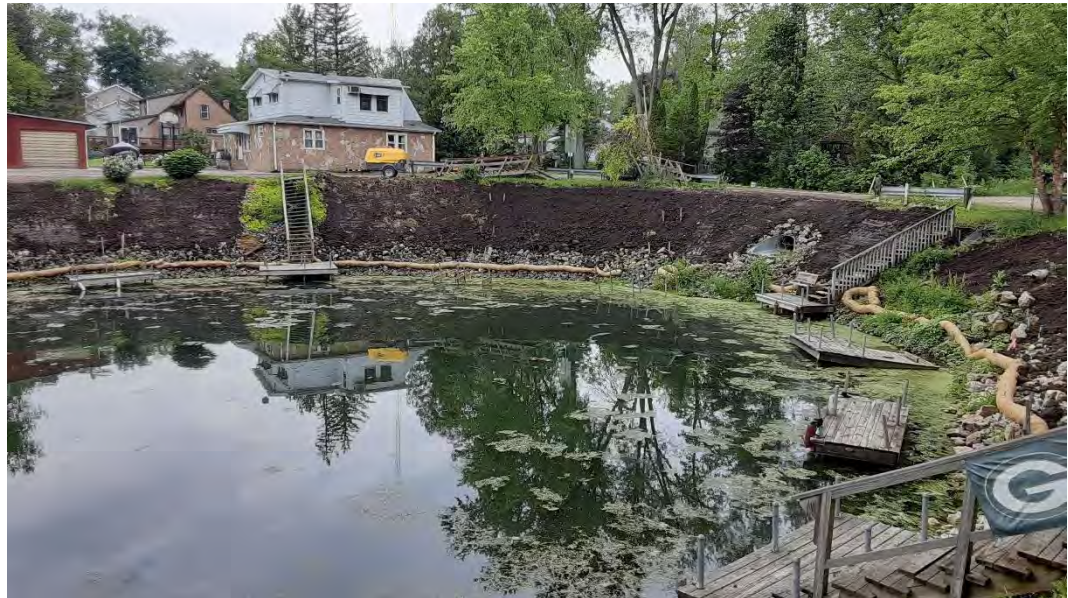
Photograph 3

Perimeter controls not installed atop rock and not in contact with soil or at grade

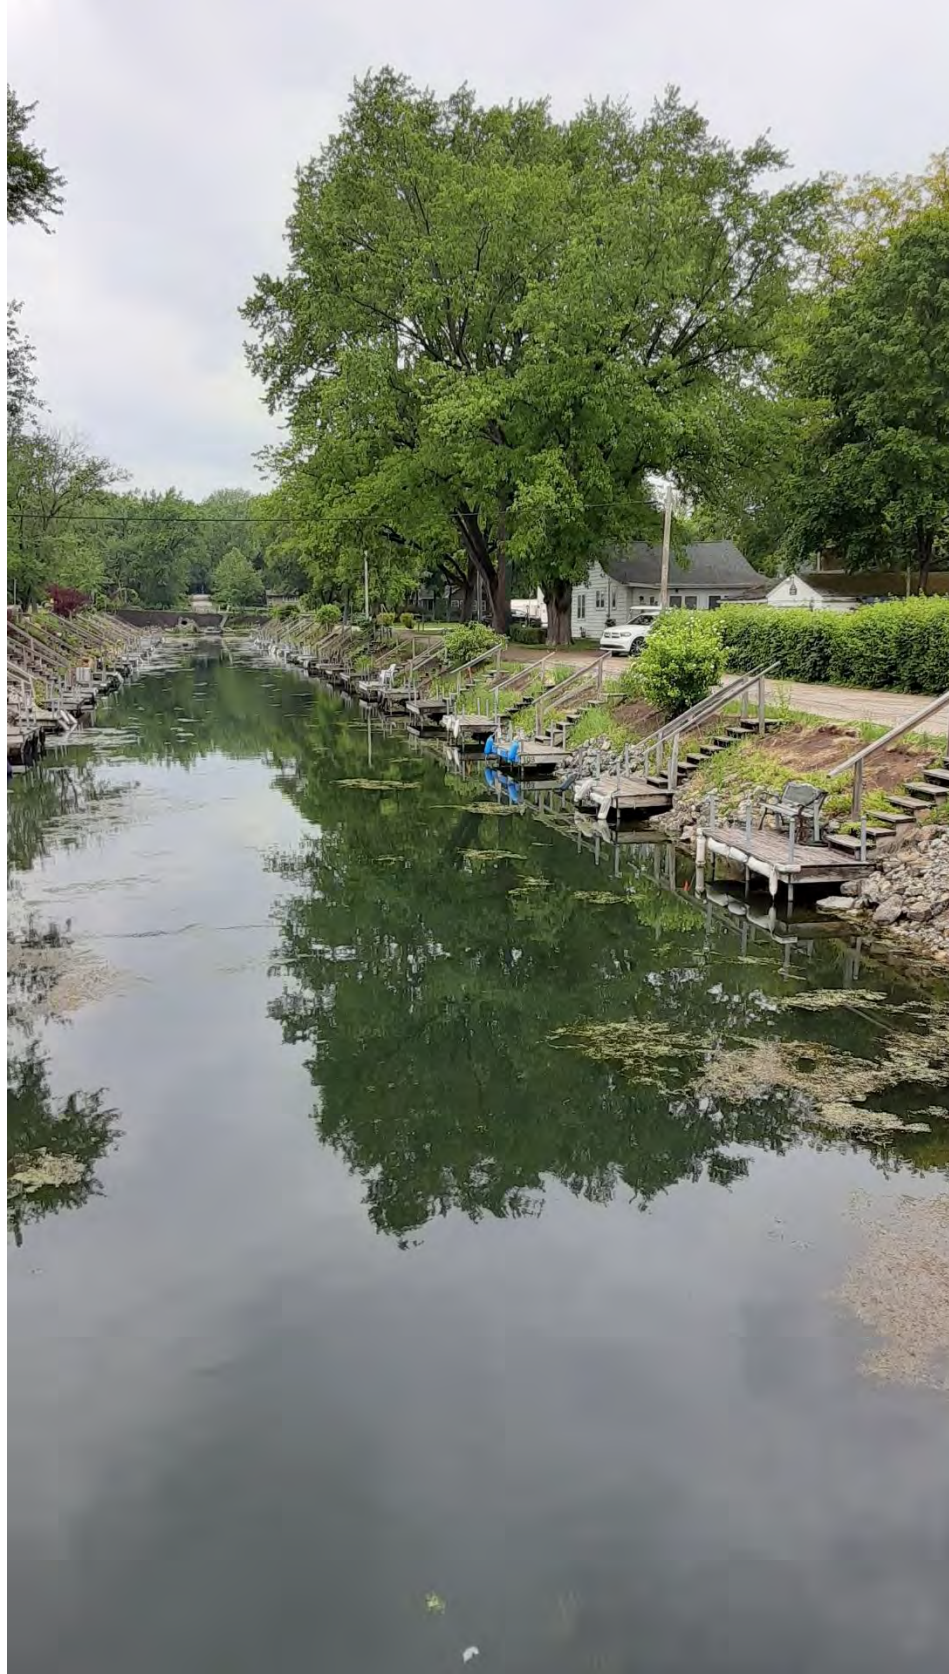
Photograph 4

North embankment – North Channel Drive with no perimeter controls

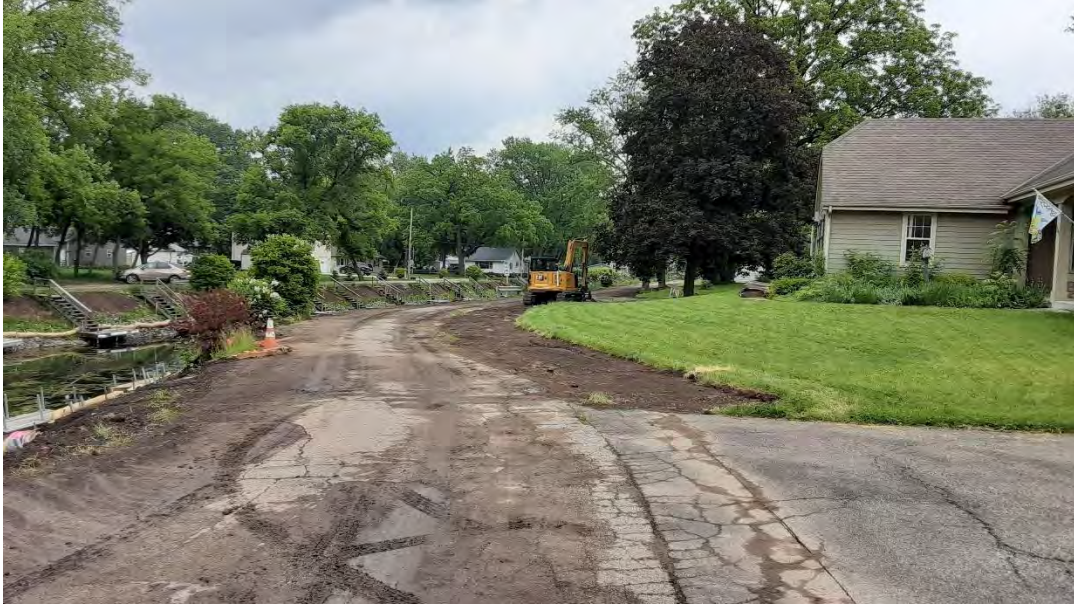
Photograph
5

North Channel Drive – sediment tracking on roads

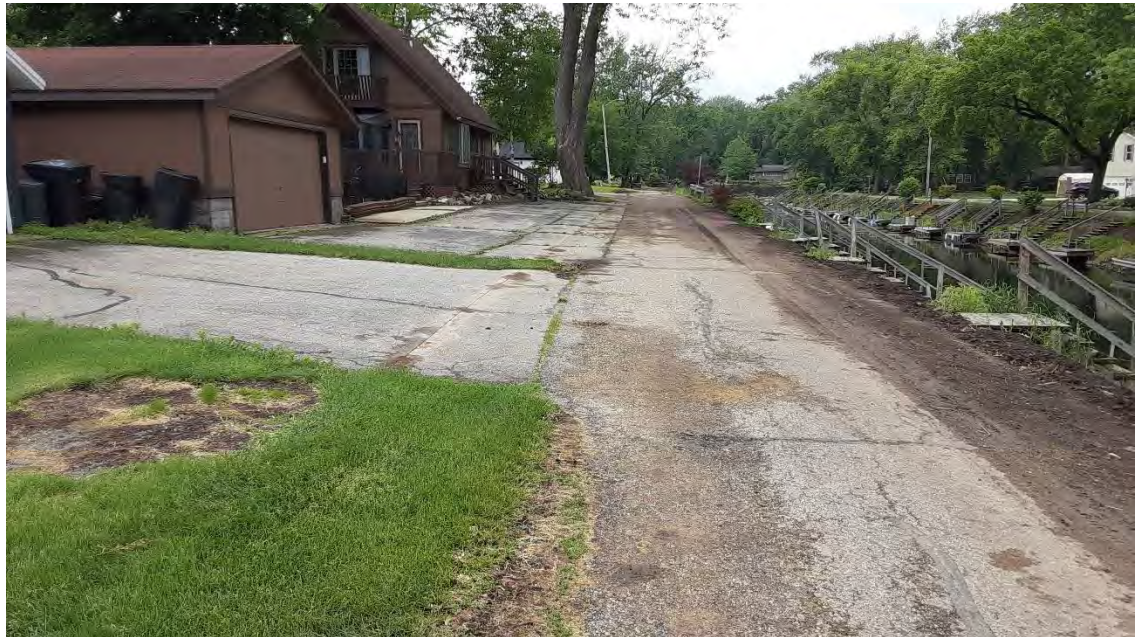
Photograph
6

Sawcut asphalt

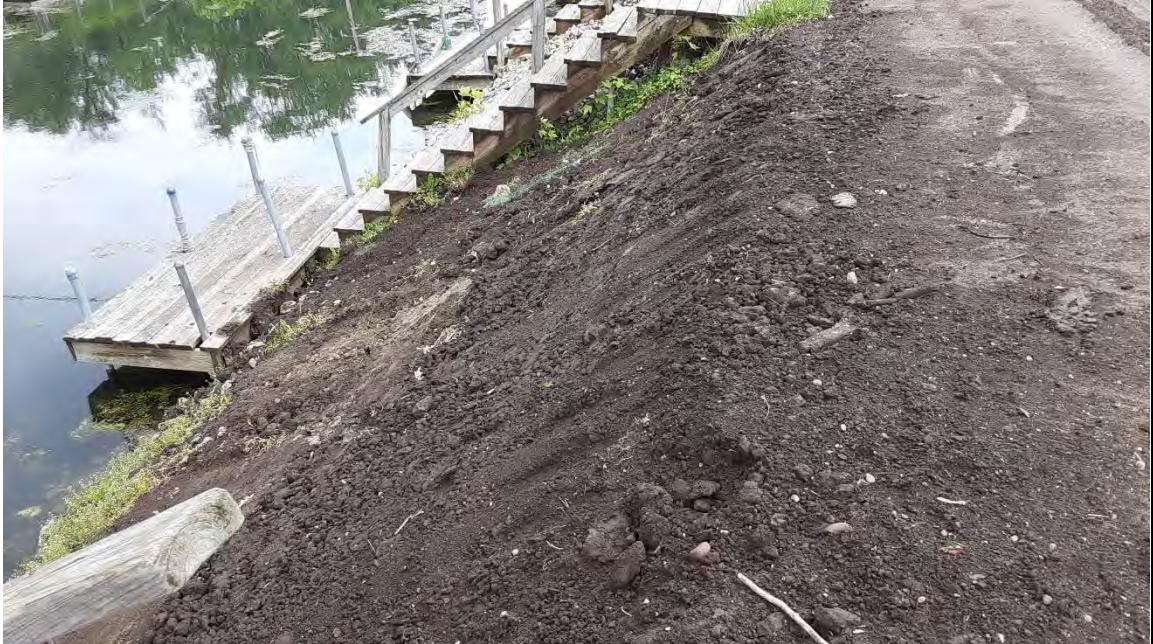
Photograph
7

Apparent topsoil placement with no perimeter control or cover

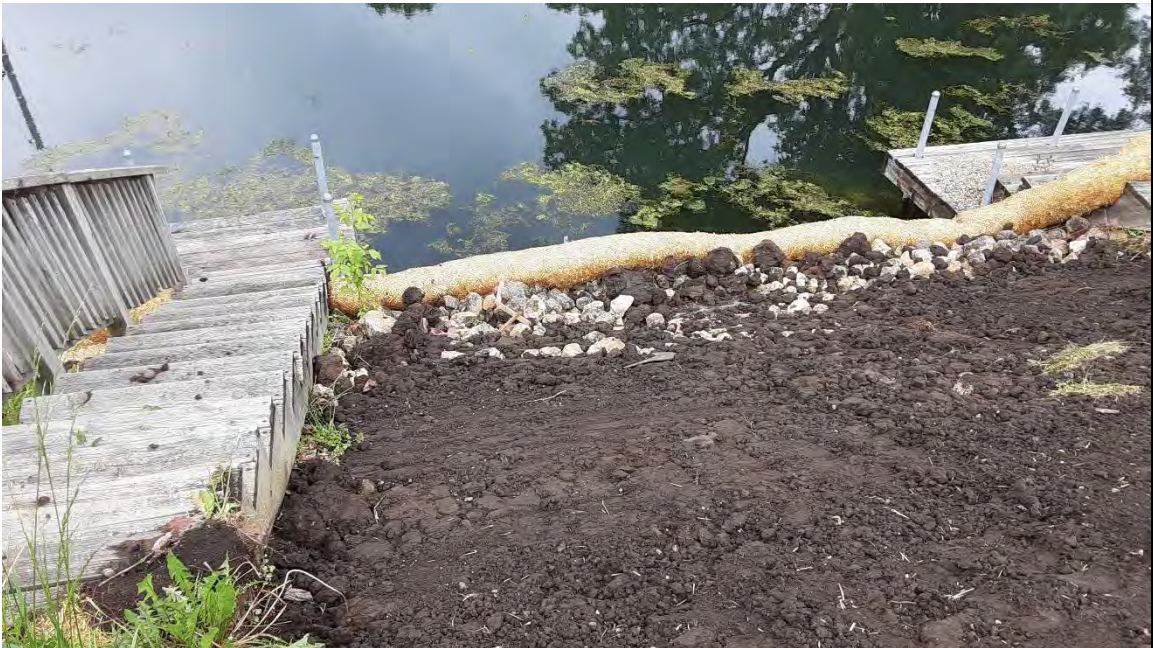
Photograph
8

Placed perimeter control atop stone and improperly staked

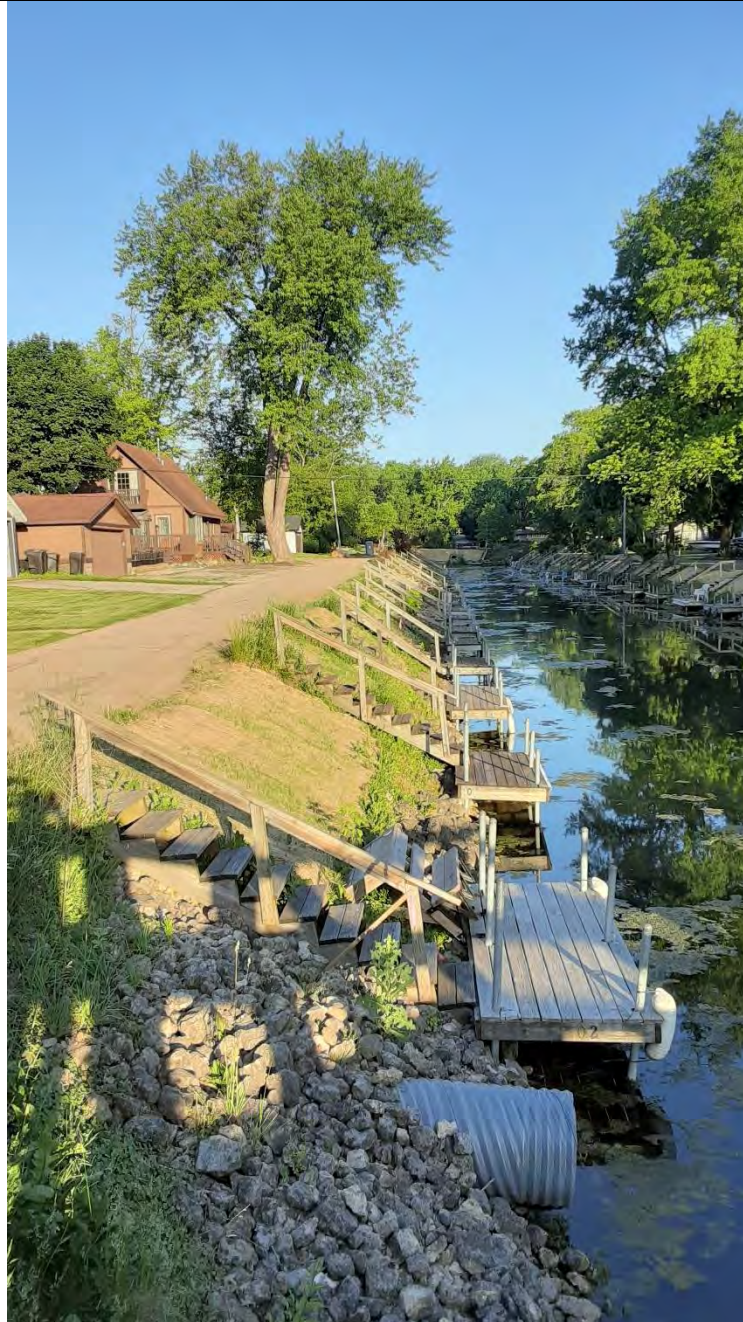
Photograph 1

Slope stabilized with temporary contact blanket and cover crop emerging. Perimeter control still lacking.

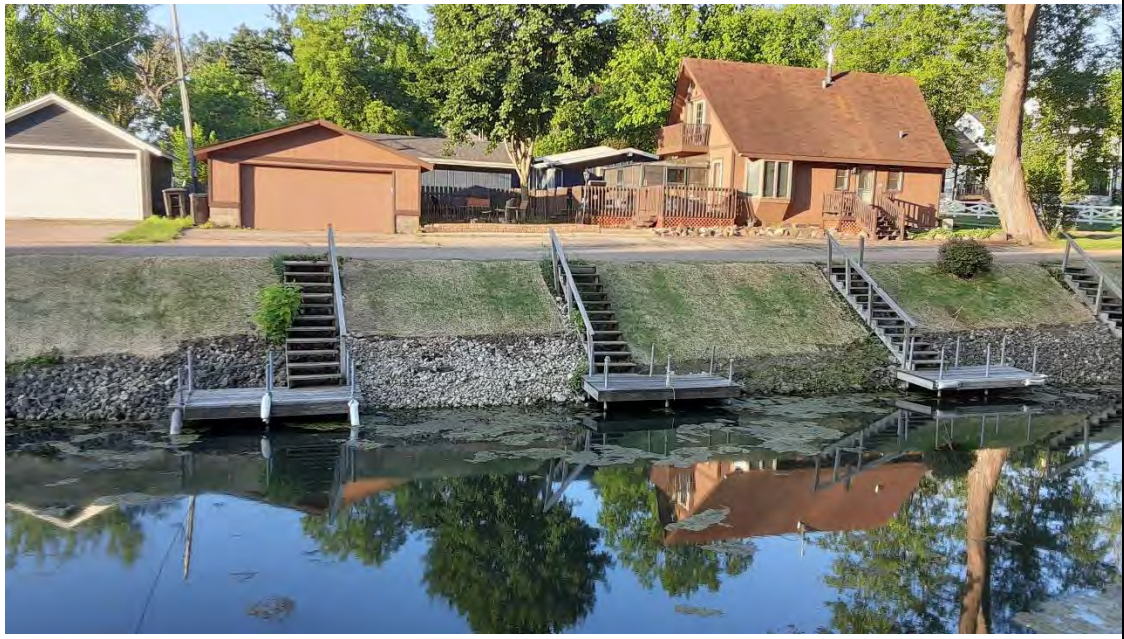
Photograph 2

Variable bank clearing, contact blanket in place.

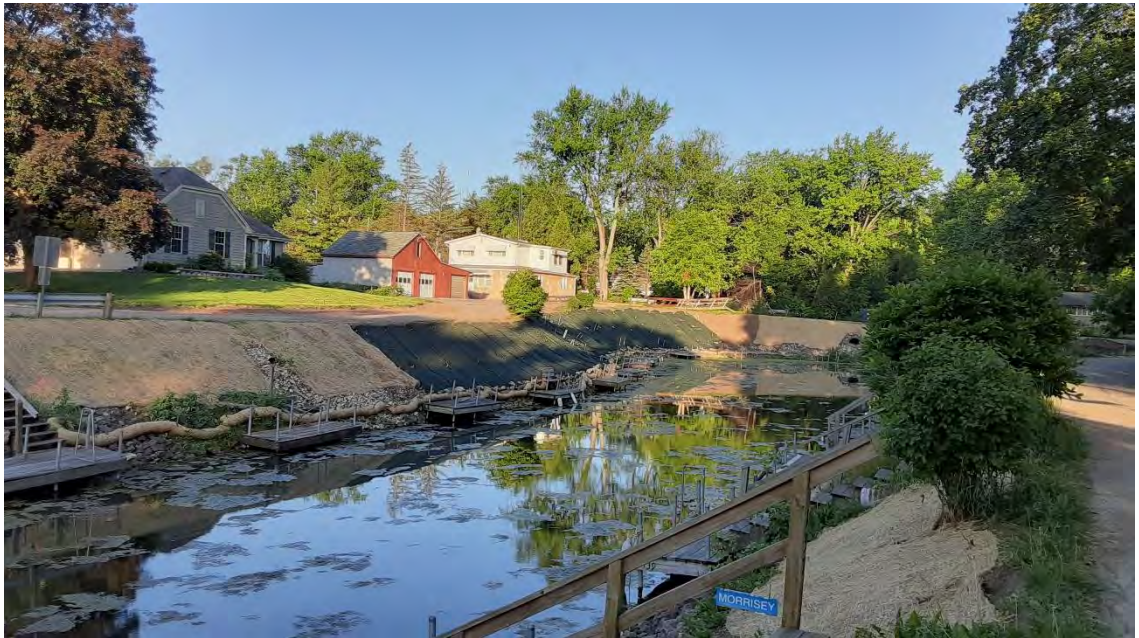
Photograph 3

Transition area from standard slope grade to reinforced mesh and soil nails in southwest corner of inlet channel.

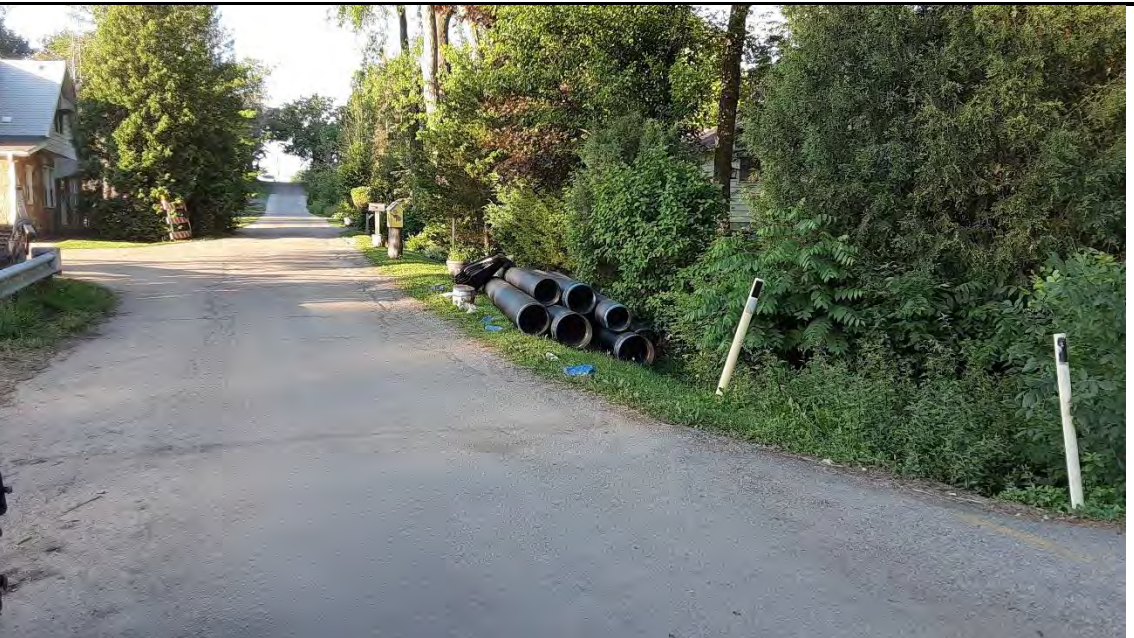
Photograph
5

Replacement pipe and end sections along Poplar Drive

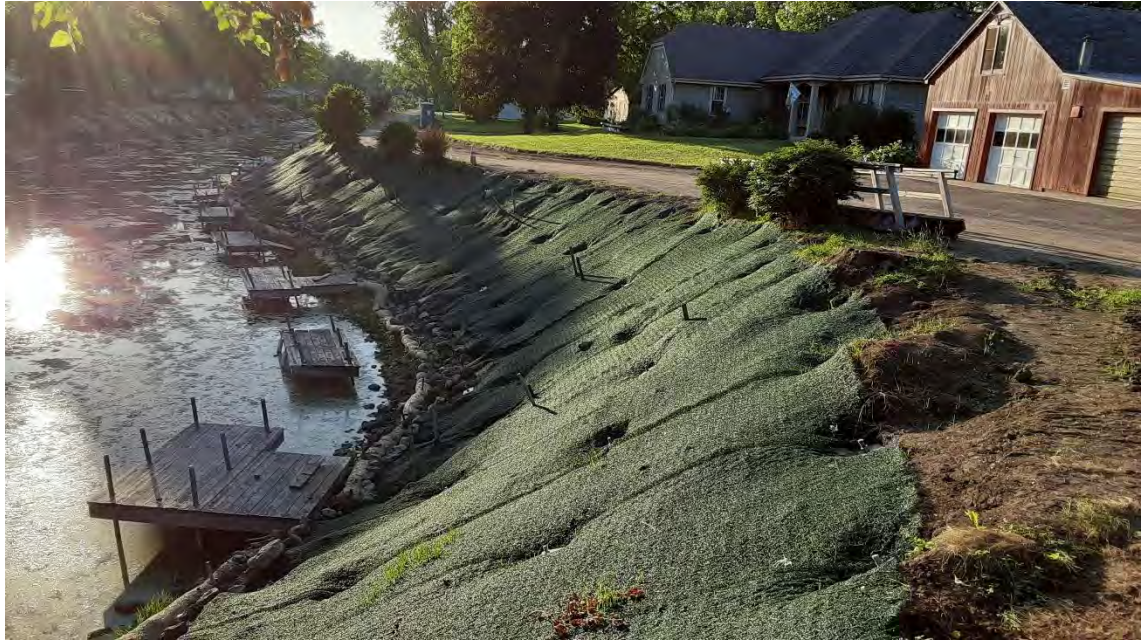
Photograph
6

Close up of reinforced mesh and soil nails

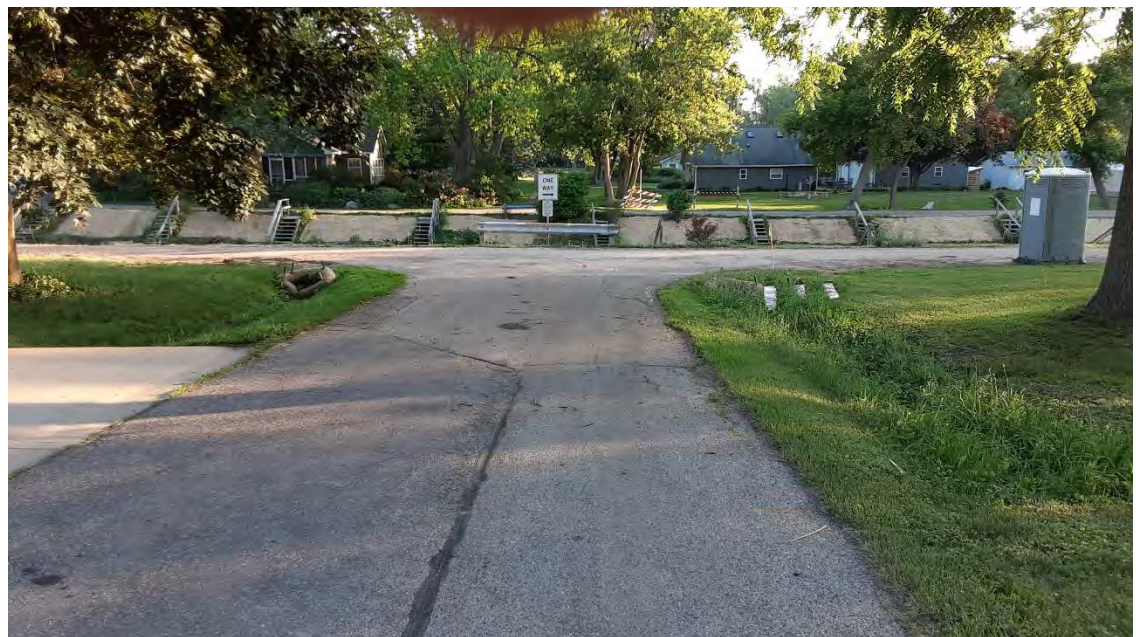
Photograph
7

Stormwater inlet/ditch check SESC controls in place at Mulberry

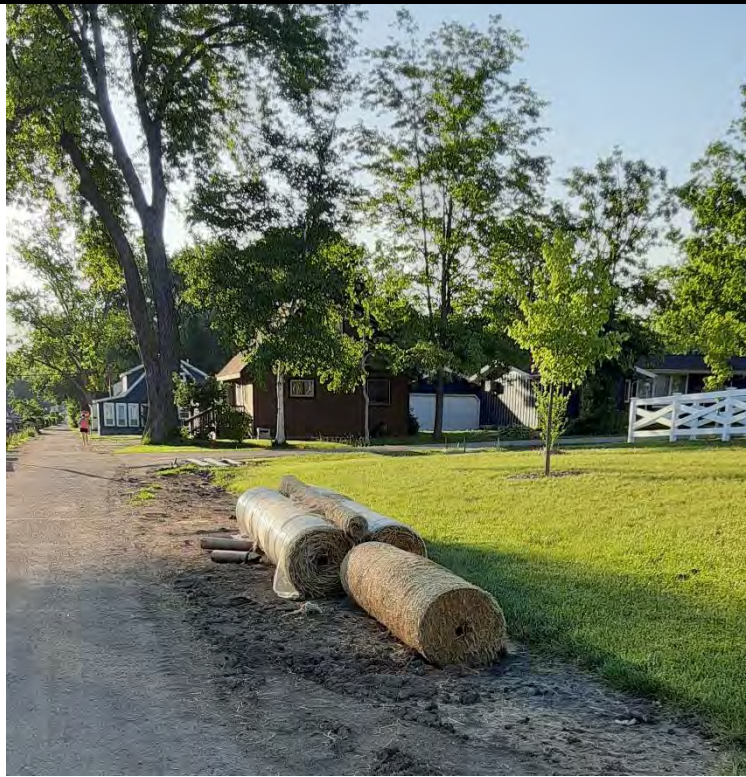
Photograph
8

Temporary Erosion control blanket

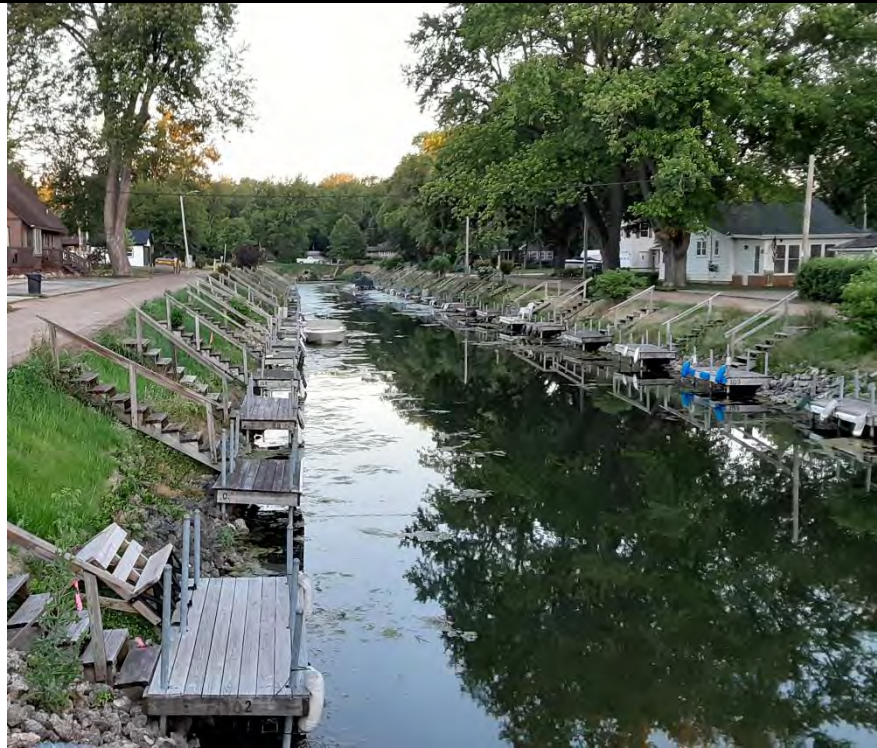
Photograph 1

Cover vegetation taking shape

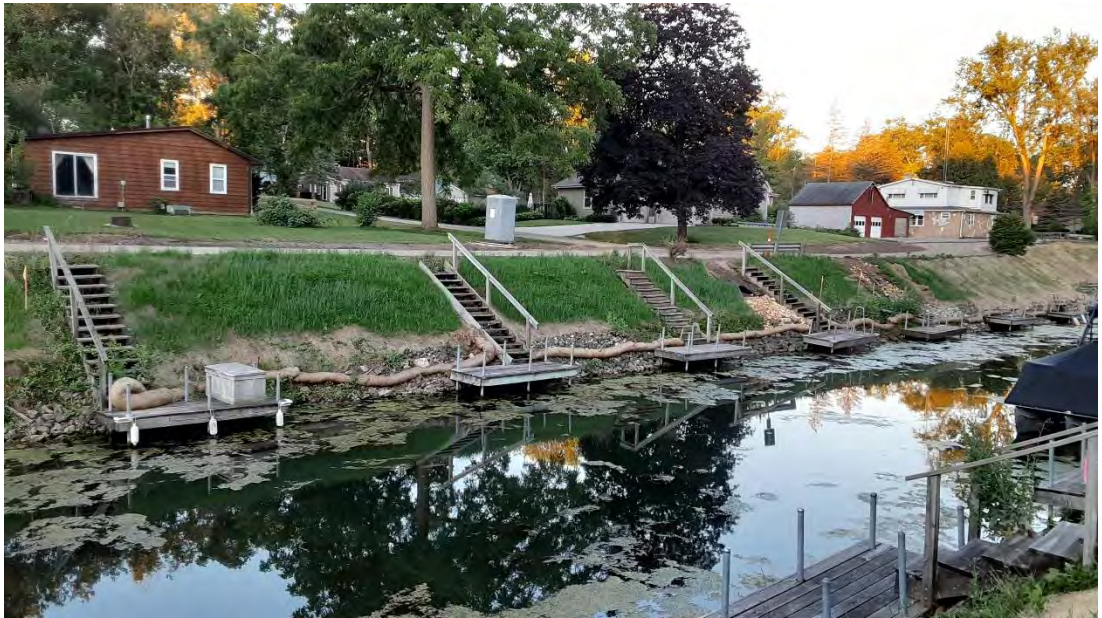
Photograph 2

Cover vegetation along South Channel Drive

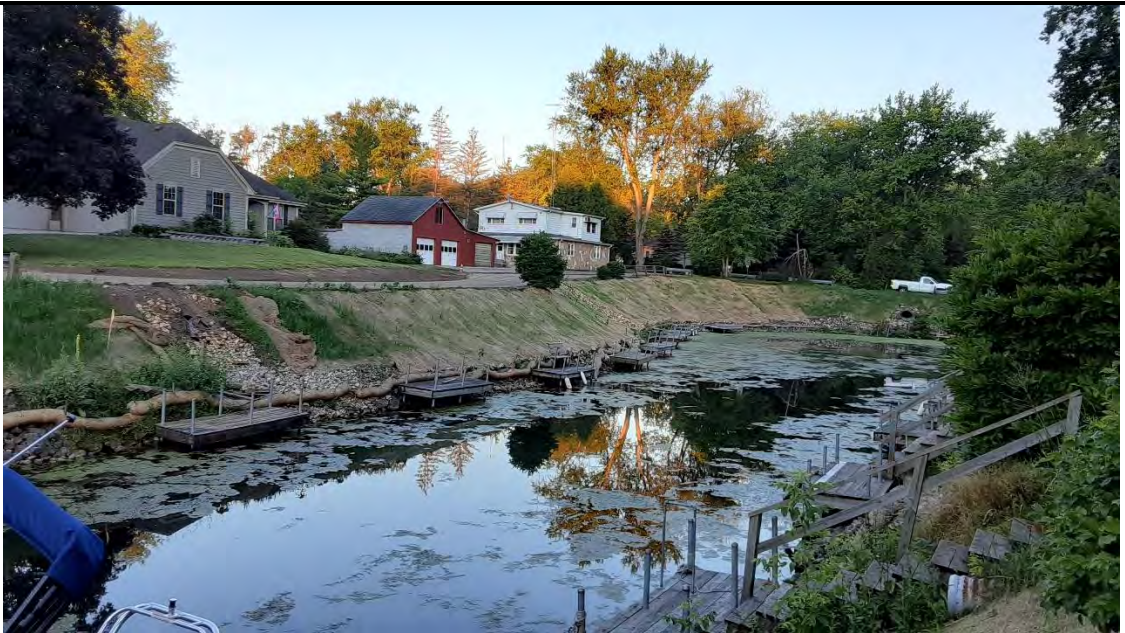
Photograph 3

Blanket and cover over reinforced mesh area. Cover vegetation beginning to establish

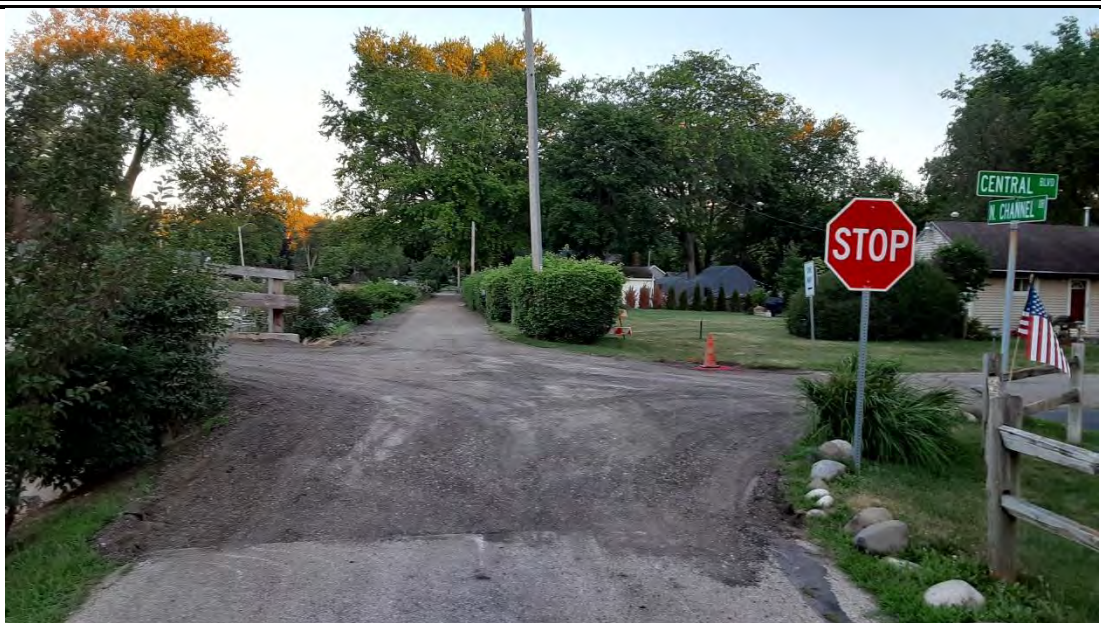
Photograph
5

Typical view of road base foundation prepped for paving

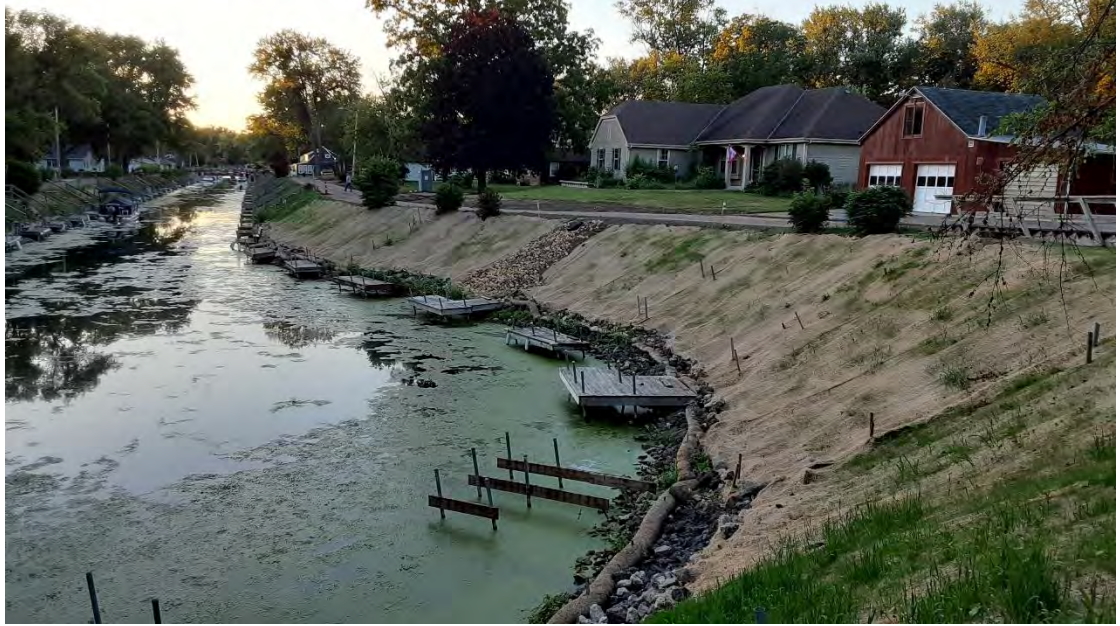
Photograph
6

Closeup of a reinforced section, covered for vegetation establishment

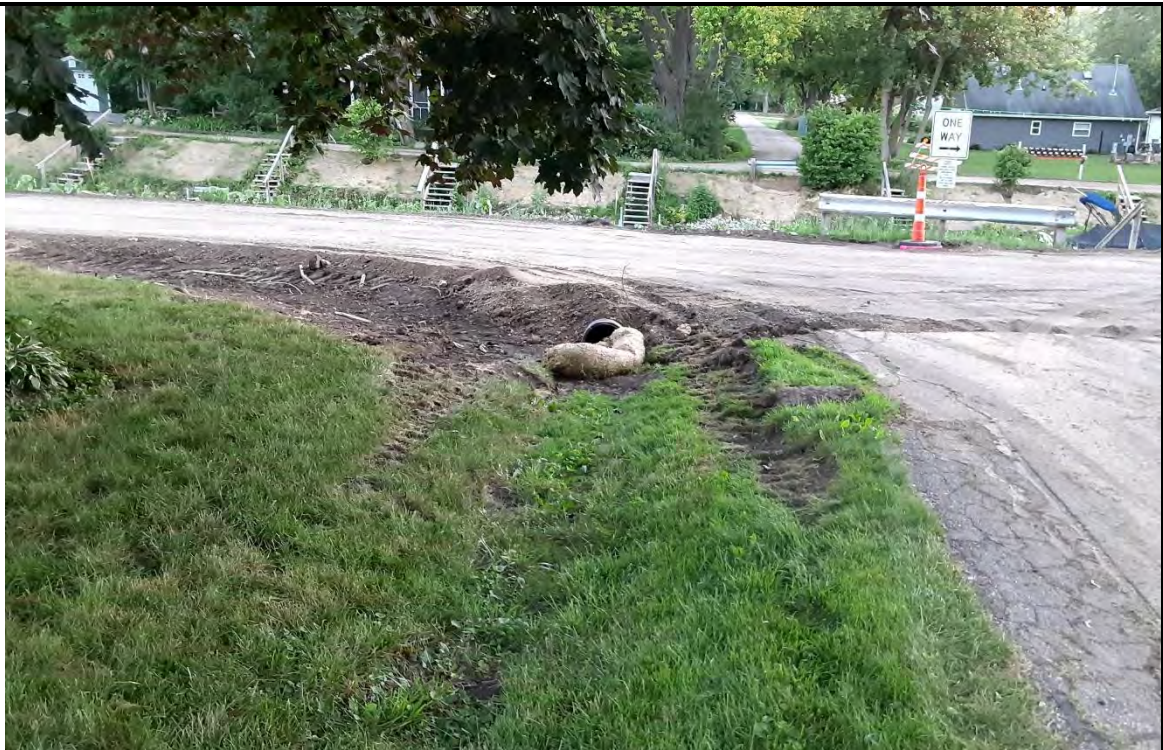
Photograph
7

- C. Both cross culverts located at the intersection of South Channel Drive and Mulberry Ave are considerably blocked by sediment and unmaintained perimeter control. Both cross culverts would be significantly hampered with conveyance limitations during rain events.

Replaced pipe section beneath South Channel Drive. SESC measures need addressing.
See comment C on Site Inspection 7/11, 7/12

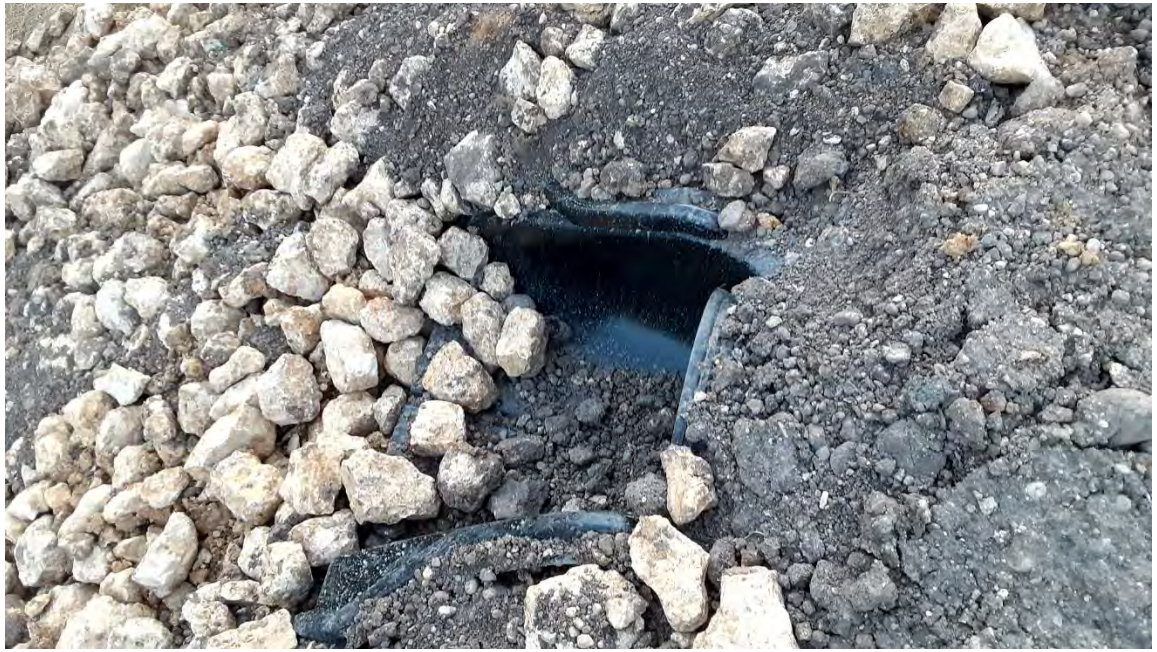
Photograph 8

Newly installed pipe end section, sediment should be cleaned out, see comment G on Site Inspection 7/11, 7/12.

- G. Several of the cross culverts should be cleaned and void of sediment.
- H. New storm structures had already gathered significant sediment and should be cleaned out.

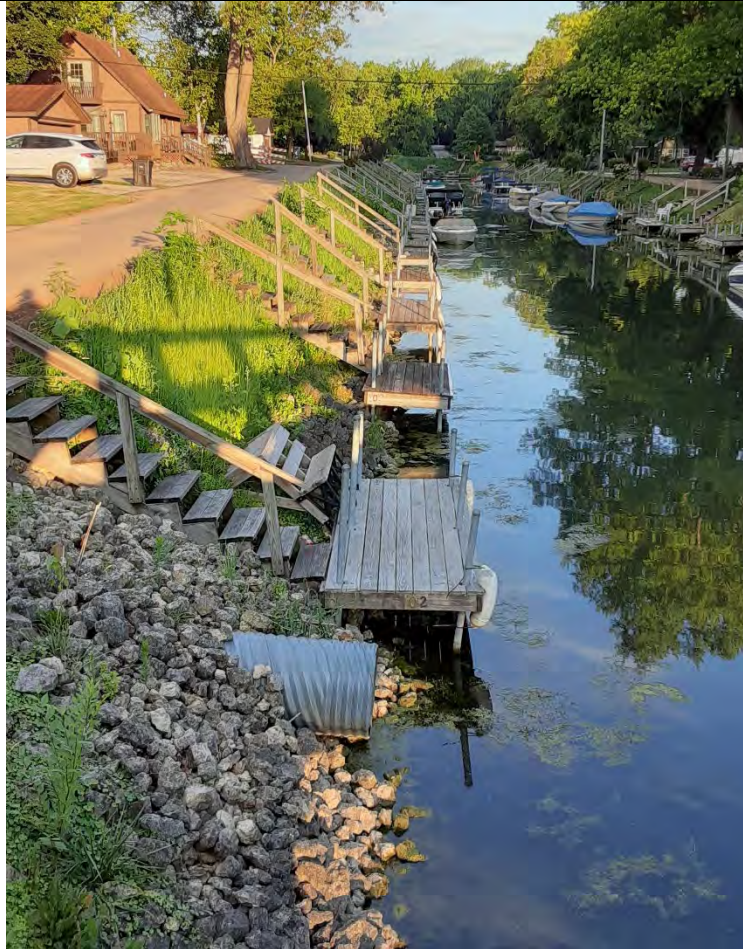
Photograph 1

Cover vegetation in place, section stabilized

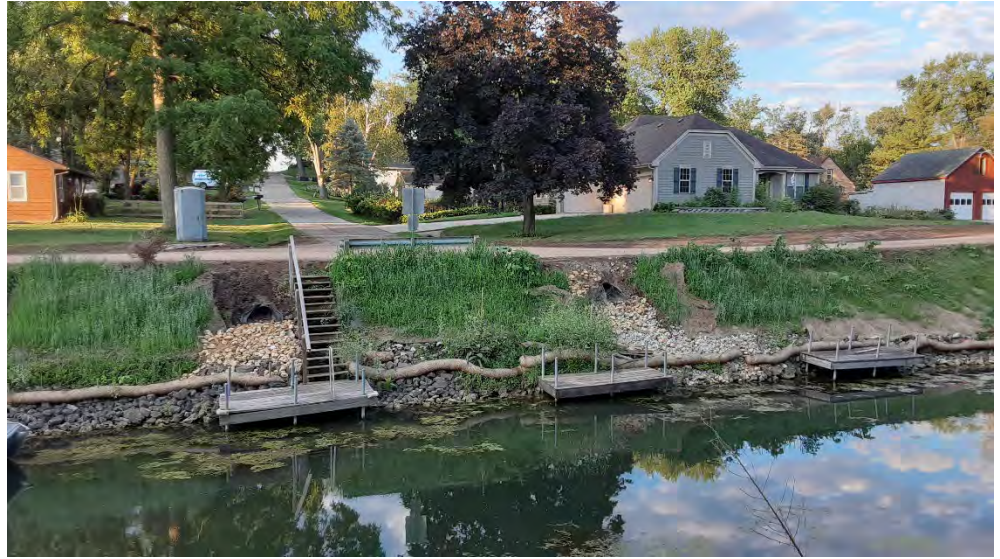
Photograph 2

Cover vegetation along South Channel Drive, installed culverts, cover vegetation sufficient

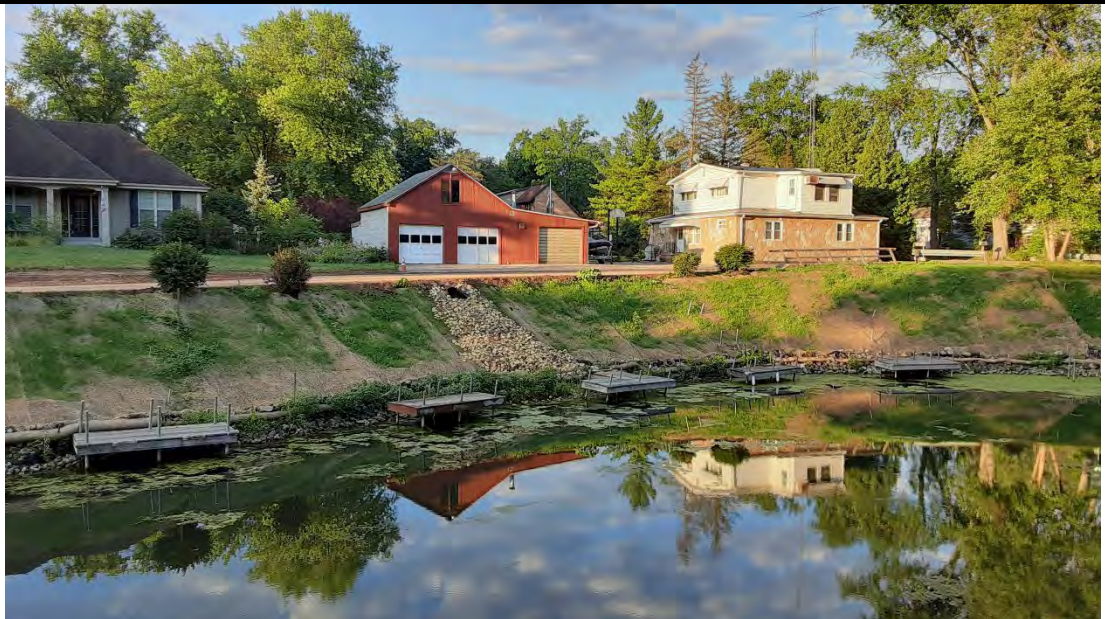
Photograph 3

Blanket and cover over reinforced mesh area. Continue to monitor establishment of vegetation.

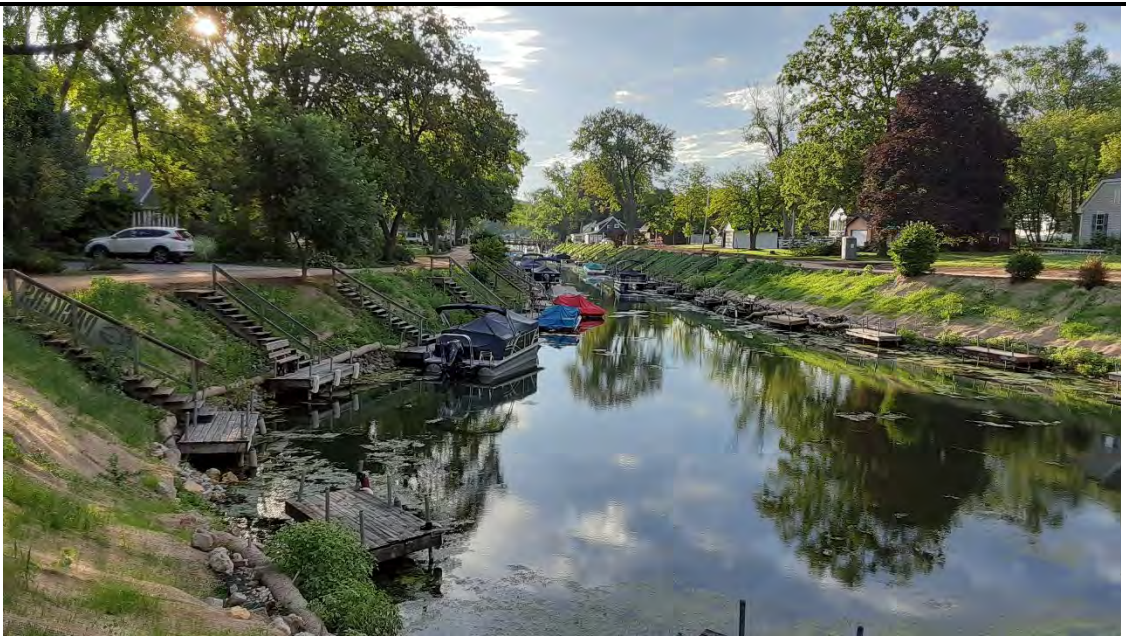
Photograph
4

Inlet channel view east, continue to monitor vegetative growth in shaded zones

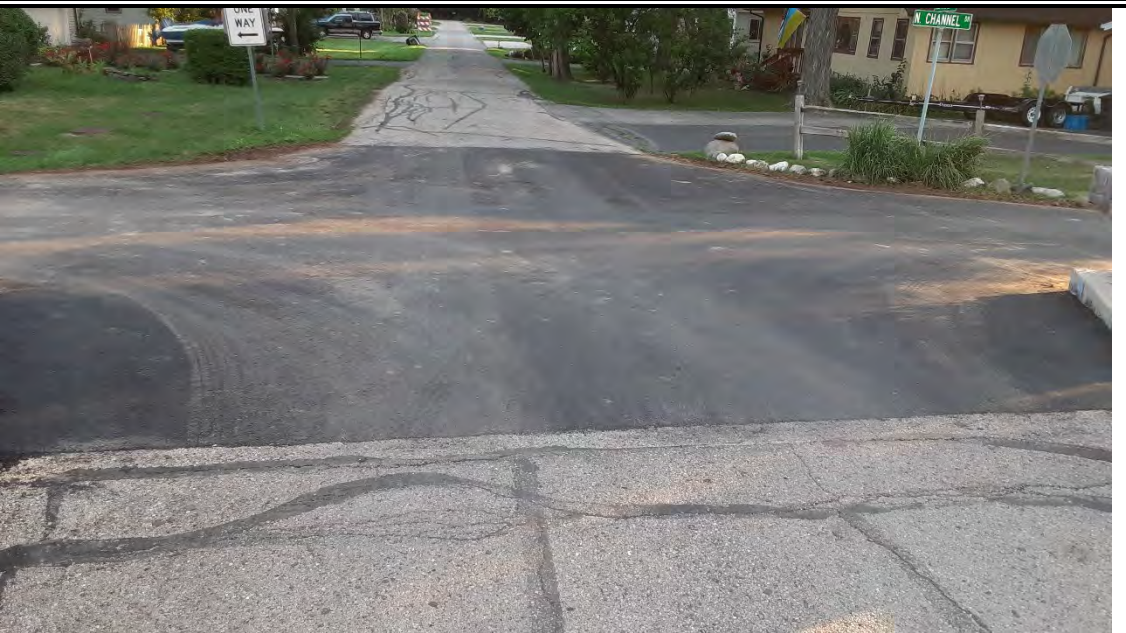
Photograph
5

Road paving completed, typical connection at N Channel Drive and bridge at Central Blvd

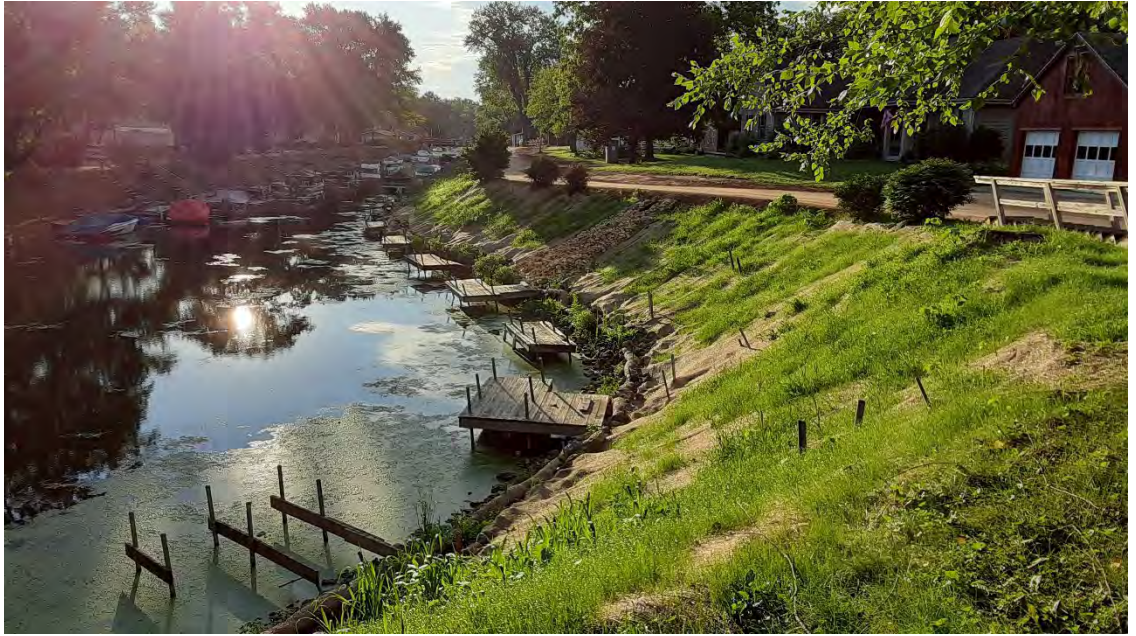
Photograph
6

Closeup of a reinforced section, continue to monitor vegetation

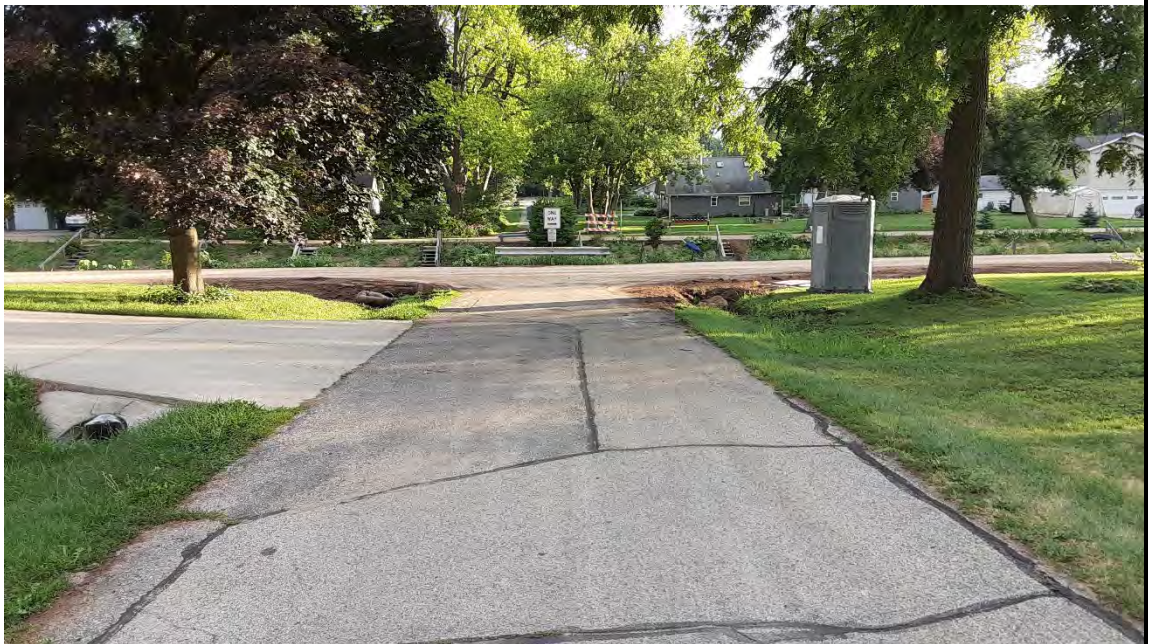
Photograph
7

- C. Both cross culverts located at the intersection of South Channel Drive and Mulberry Ave continue to be an issue. Contractor should address as they are an impediment to flow and have potential to clog.

Culverts at Mulberry and S Channel Drive. SESC measures need to be maintained to ensure culverts do not clog. Current measures are not secured.
