Site Inspection Documentation Form
Lake Delavan Highlands Association (LDHA) – South Inlet Channel
Town of Delavan, Wisconsin

GEOSYNTEC CONSULTANTS
Photographic Record

Project Number: MOW5540

Site Name: LDHA Inlet Channel

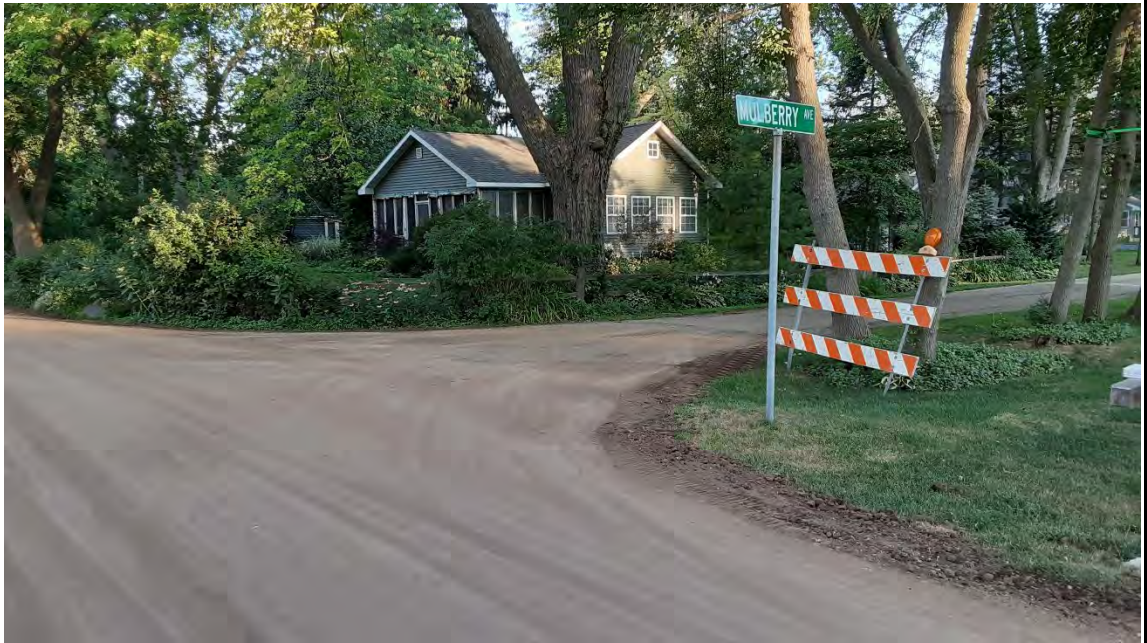
Photograph
8

Roads are laden with dusty sediment. The roads should be cleaned to avoid runoff directly into channel

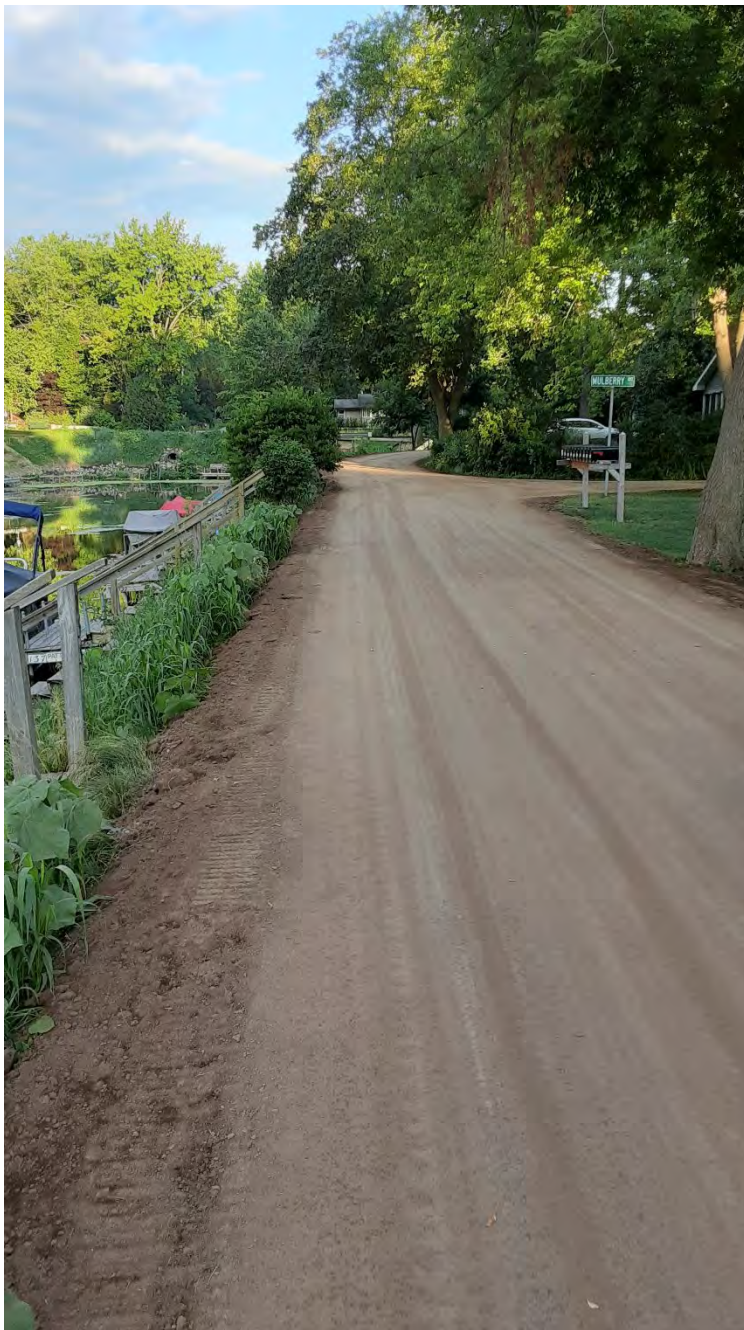
Photograph
9

Apparent grade transition soil should be stabilized with seed and blanket.
