# ANALYSIS OF SITE CONDITIONS AND PROJECT RECOMMENDATION FOR MILJALA TRIBUTARY

October 2022 Revised November 2022

**Rock Lake Improvement Association**

Resource Engineering Associates, Inc. 3510 Parmenter St., Suite 100 Middleton, Wisconsin, 53562

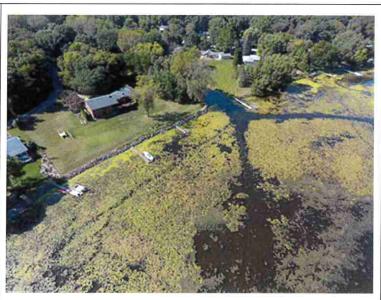
**Photo 11:** Algae bloom in Korth bay at mouth of Miljala channel. Excessive nutrient loading from the Miljala tributary contributes to abundant algae growth in Rock Lake.

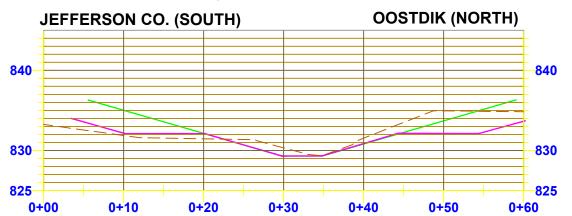
**Cross Section at Alignment - F**

1. Installing a two-stage design that meets with the existing ground where the side slopes of the tributary reach a grade near a 3.5:1 two-stage ditch (cross section F in Appendix B).

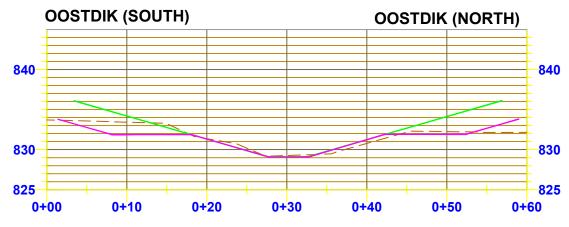
**Cross Section at Alignment G**

Cross section G in Appendix B shows the stable slope viewed on the northeastern side of the Miljala Tributary (Oostdik property) lines up with a 3.5:1 slope – indicating the soils of the Miljala Tributary reach stability at 3.5:1, not 2.5:1. A shallower design (3.5:1 instead of 2.5:1) will provide a more stable slope, and be easier for machinery (e.g., mowers) to work on during vegetation establishment.

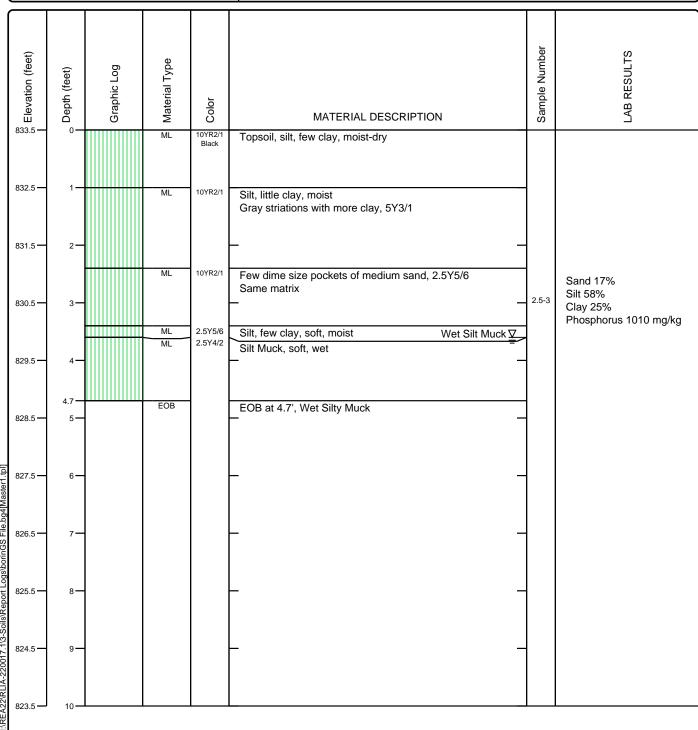
# Log of Boring HB-1 Sheet 1 of 1

- 1. Boring 1 was near the northeast end of the project, within 25 ft. of the tributary to collect data on bank conditions near the low flow area before the water enters the culvert and Miljala Channel.

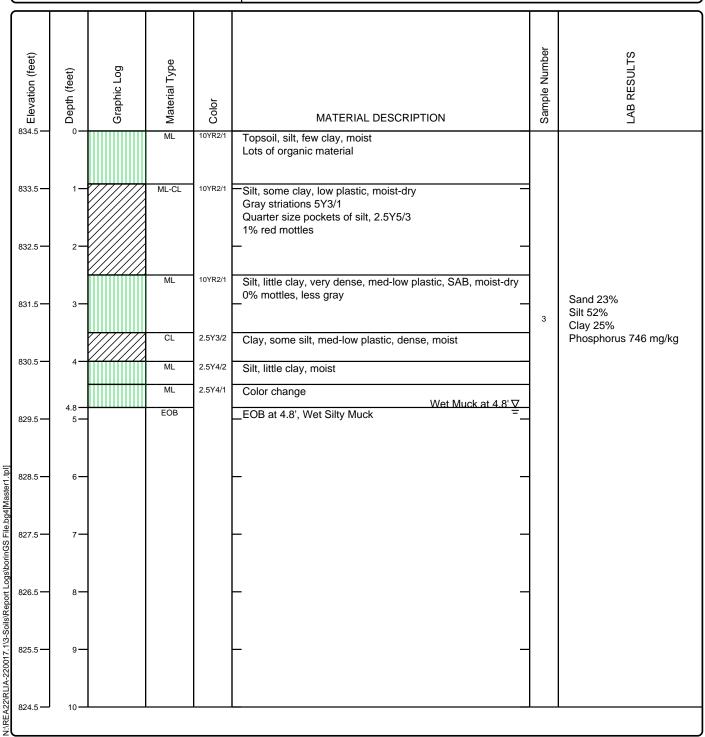
# Log of Boring HB-2 Sheet 1 of 1

- 2. Boring 2 was south of the tributary near the northeast end of the project, around 40 ft. off the bank in a lowland hardwood forest to collect data on conditions further away from the tributary, but still in the floodplain.

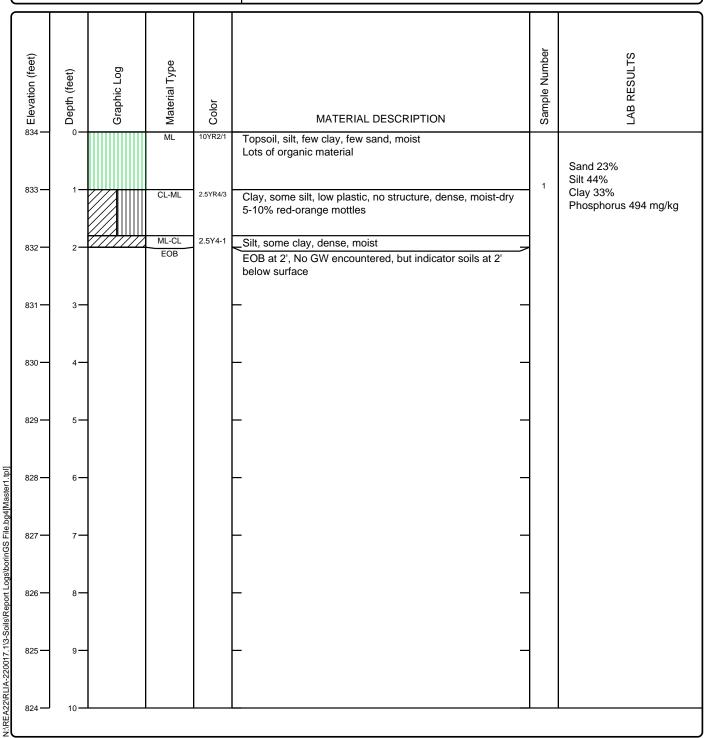
# Log of Boring HB-3 Sheet 1 of 1

- 3. Boring 3 was where the tributary turns from east to northeast, the banks were steeper here than on the northeast portion. The boring was located 2 ft. south of the bank.

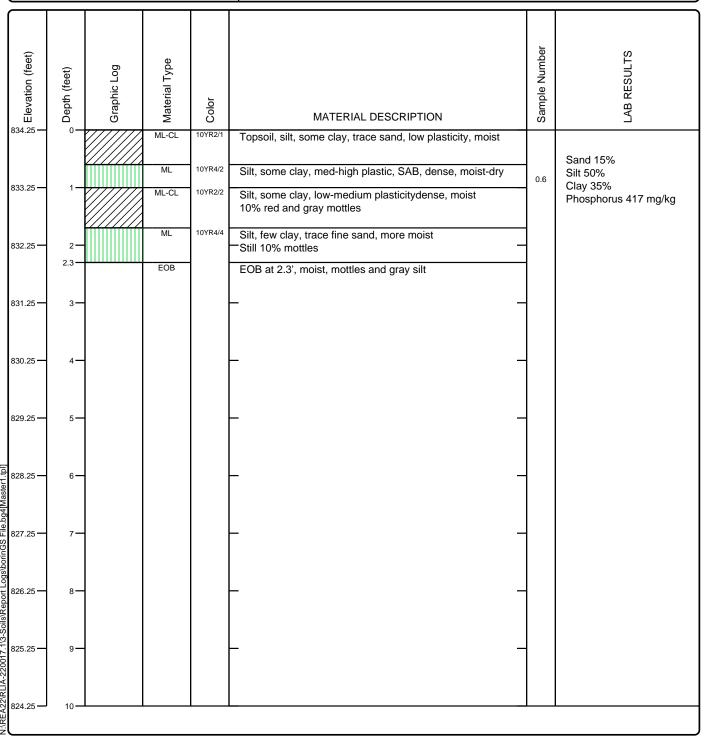
# Log of Boring HB-4 Sheet 1 of 1

- 4. Boring 4 was 20' south of boring 3 in a forested area. This boring was used to capture any change in profile and saturation from right on the bank to 20 ft. away.

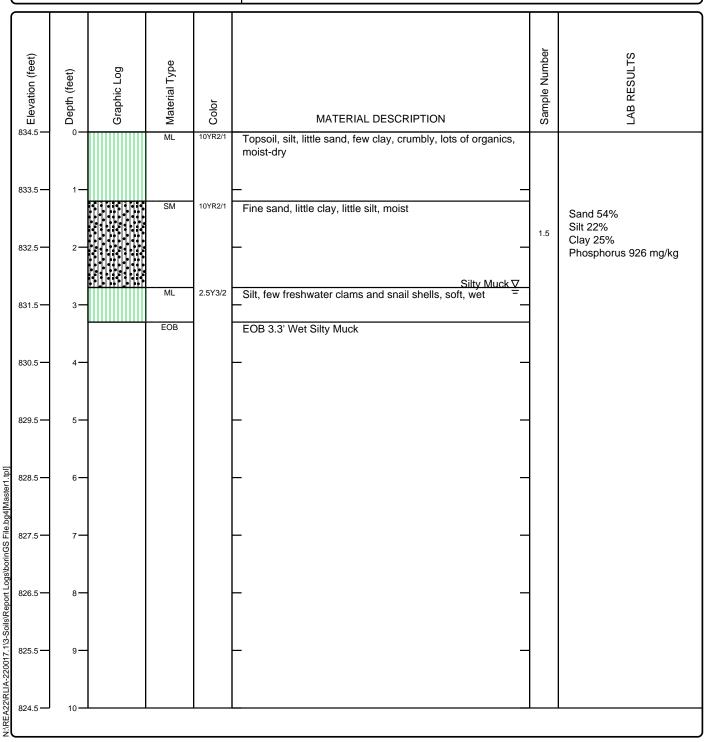
# Log of Boring HB-5 Sheet 1 of 1

- 5. Boring 5 was west of boring 4, around 60 ft. south of the tributary but in an open prairie area. This boring was used to capture any differences in the area corresponding to vegetation. Boring 4 was also in an area not included in the DNR's wetland map, boring 5 is in an area marked as a wetland by the DNR.

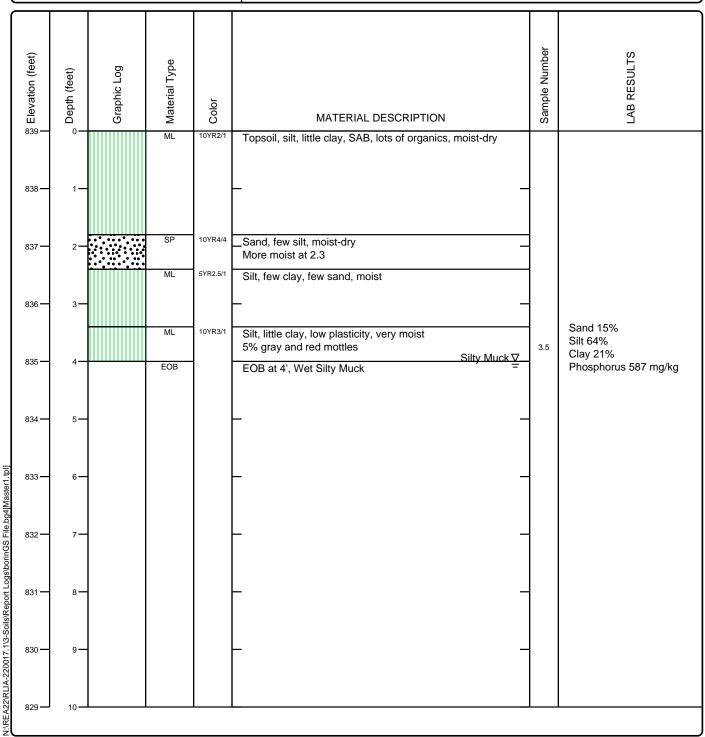
# Log of Boring HB-6 Sheet 1 of 1

- 6. Boring 6 was within 2 ft. south of the bank at the western extent of the project area where the banks are highest and steepest. This boring was taken to collect data on conditions near the beginning of the project area and where the bank erosion is most intense.

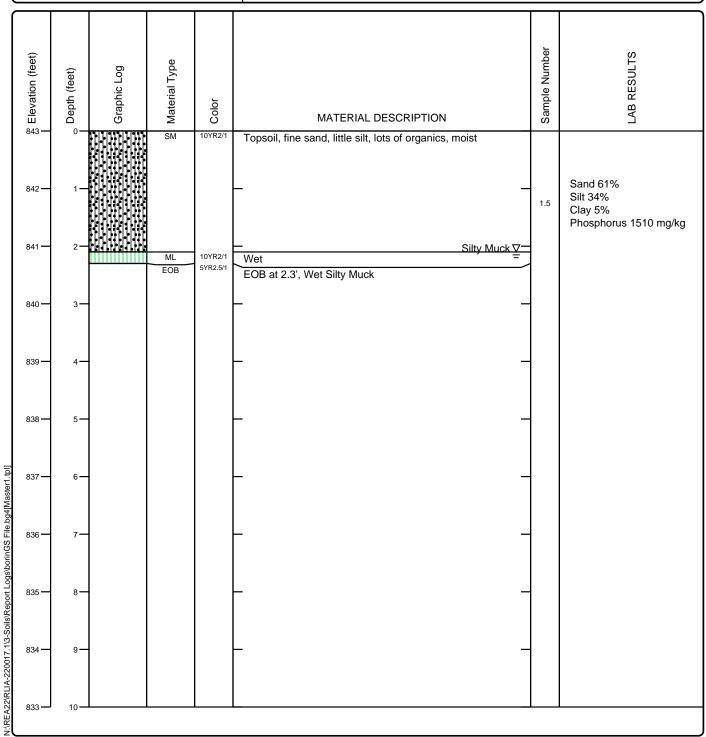
# Log of Boring HB-7 Sheet 1 of 1

- 7. Boring 7 was north of the Miljala Tributary, south of Shorewood Hills Road, where gully erosion leading to the tributary was viewed. This boring was used to collect data on what soil conditions and phosphorus could be entering the tributary from this lateral erosion. We recommend including this area in future projects.
