Seefeldt Manure Storage System, Barnyard Runoff Control System and Manure
Storage Closure

TRC-GB04-38000-14 B; CSA 14-Seefeldt-01

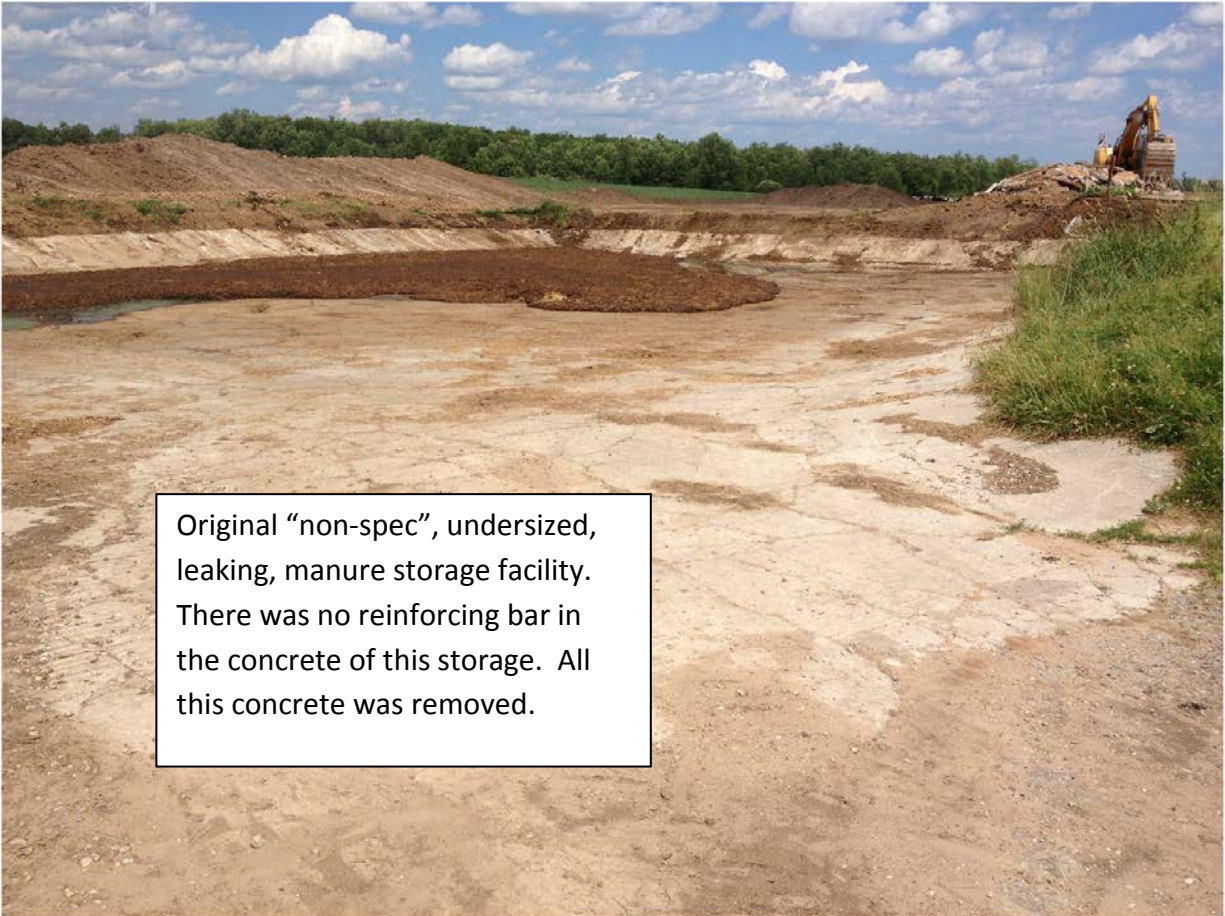
Original "non-spec", undersized,
leaking, manure storage facility.
There was no reinforcing bar in
the concrete of this storage. All
this concrete was removed.

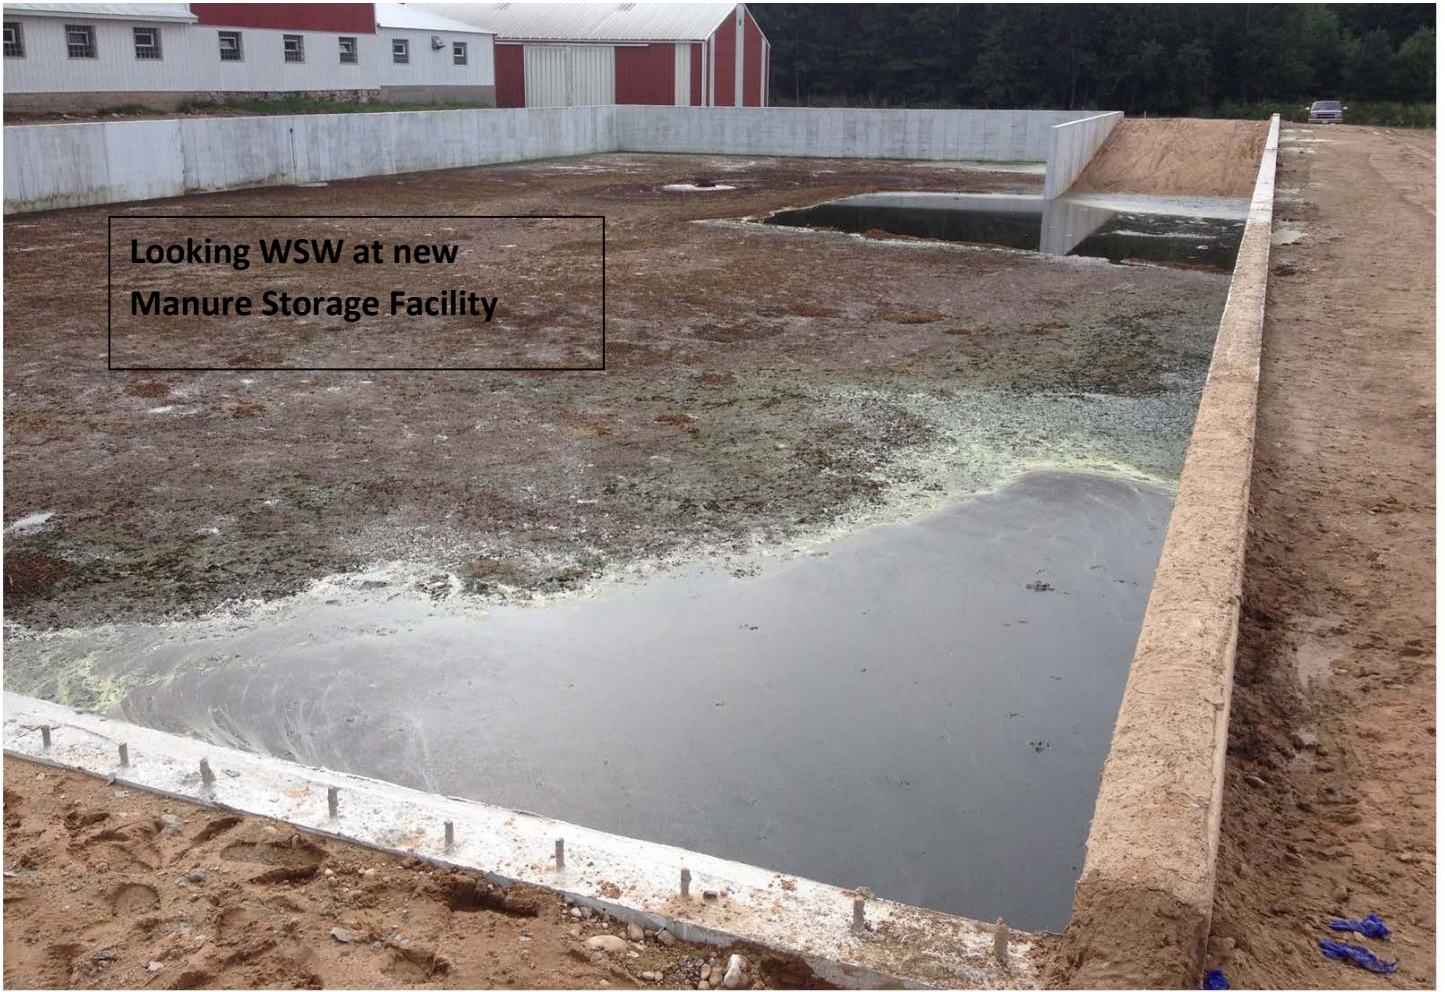
Looking WSW at new
Manure Storage Facility

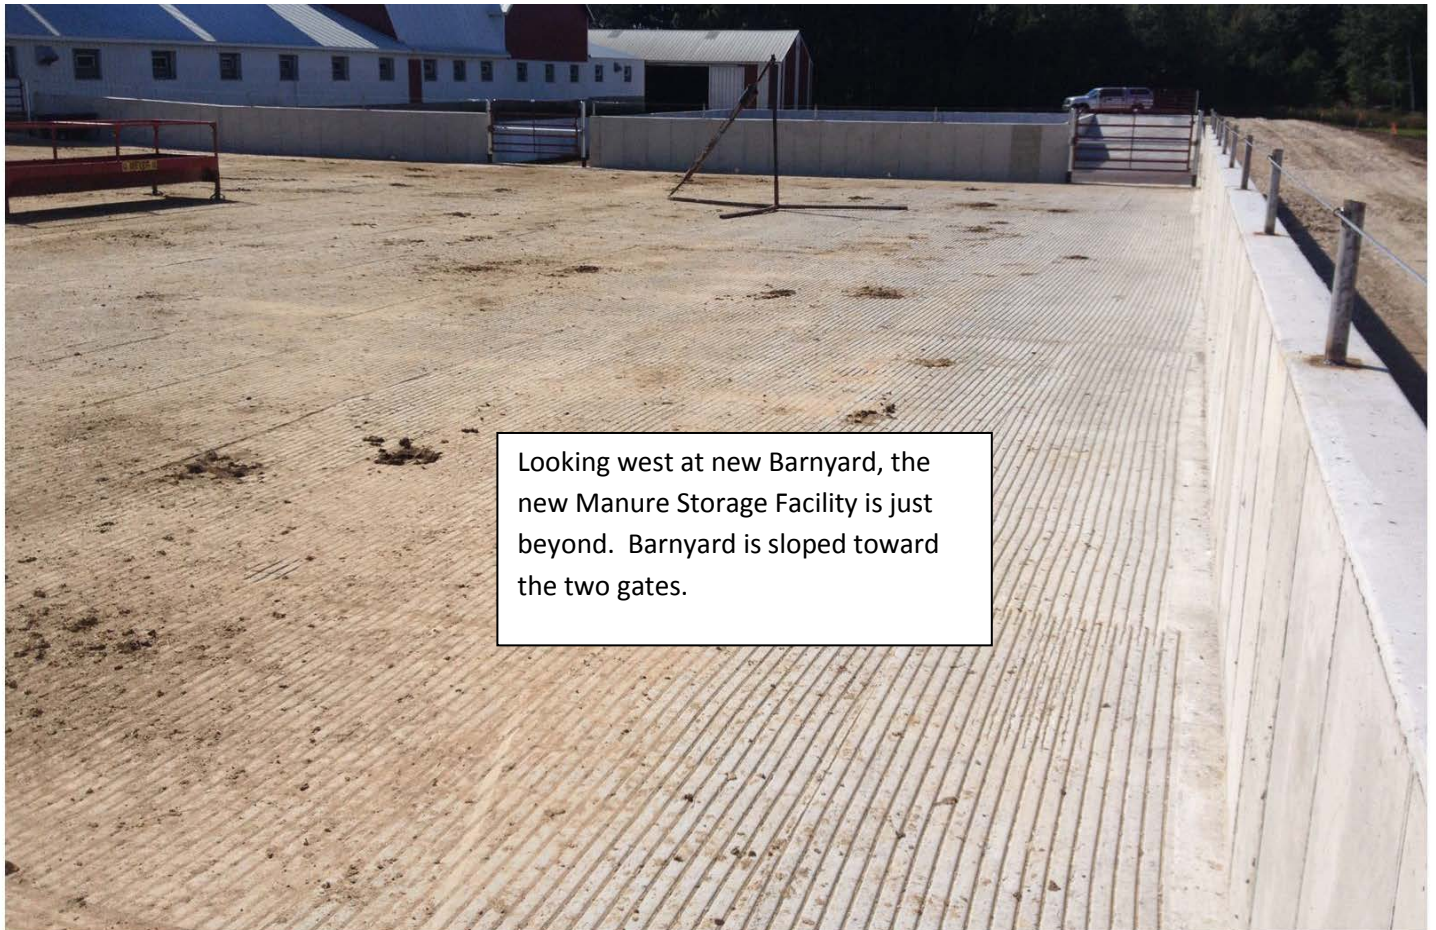
Looking west at new Barnyard, the
new Manure Storage Facility is just
beyond. Barnyard is sloped toward
the two gates.

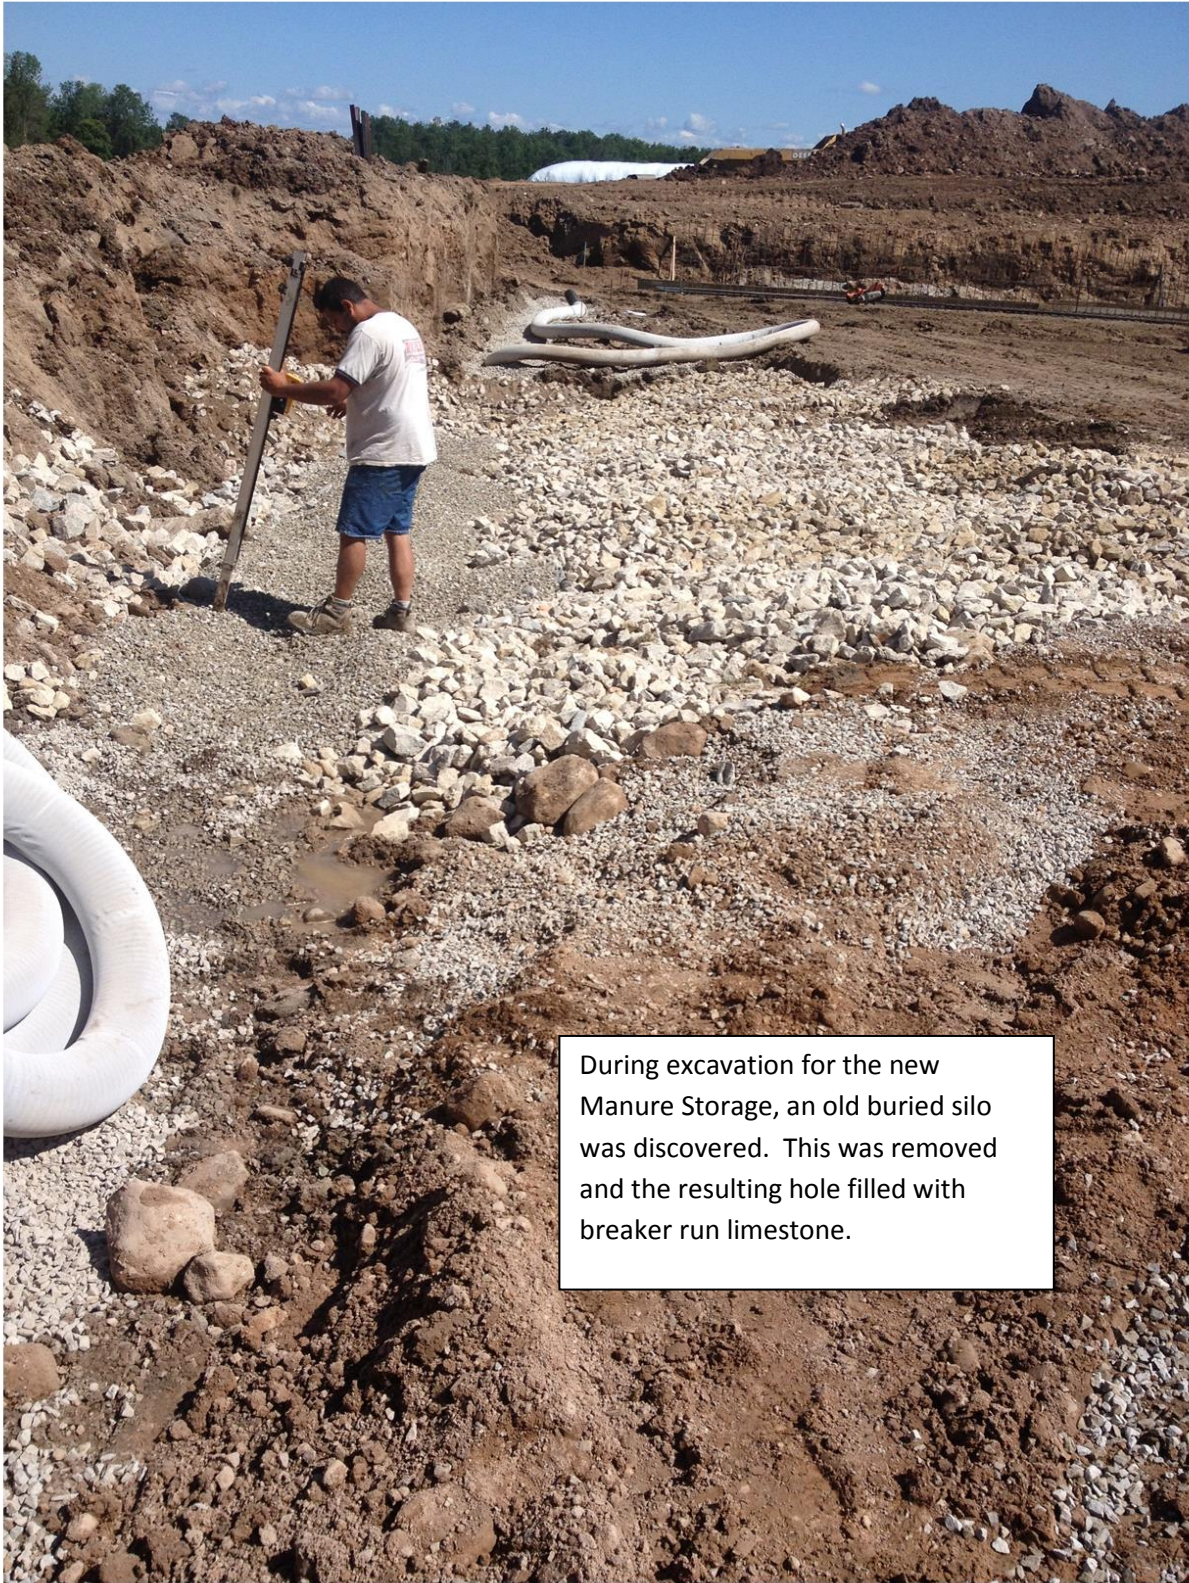
During excavation for the new Manure Storage, an old buried silo was discovered. This was removed and the resulting hole filled with breaker run limestone.

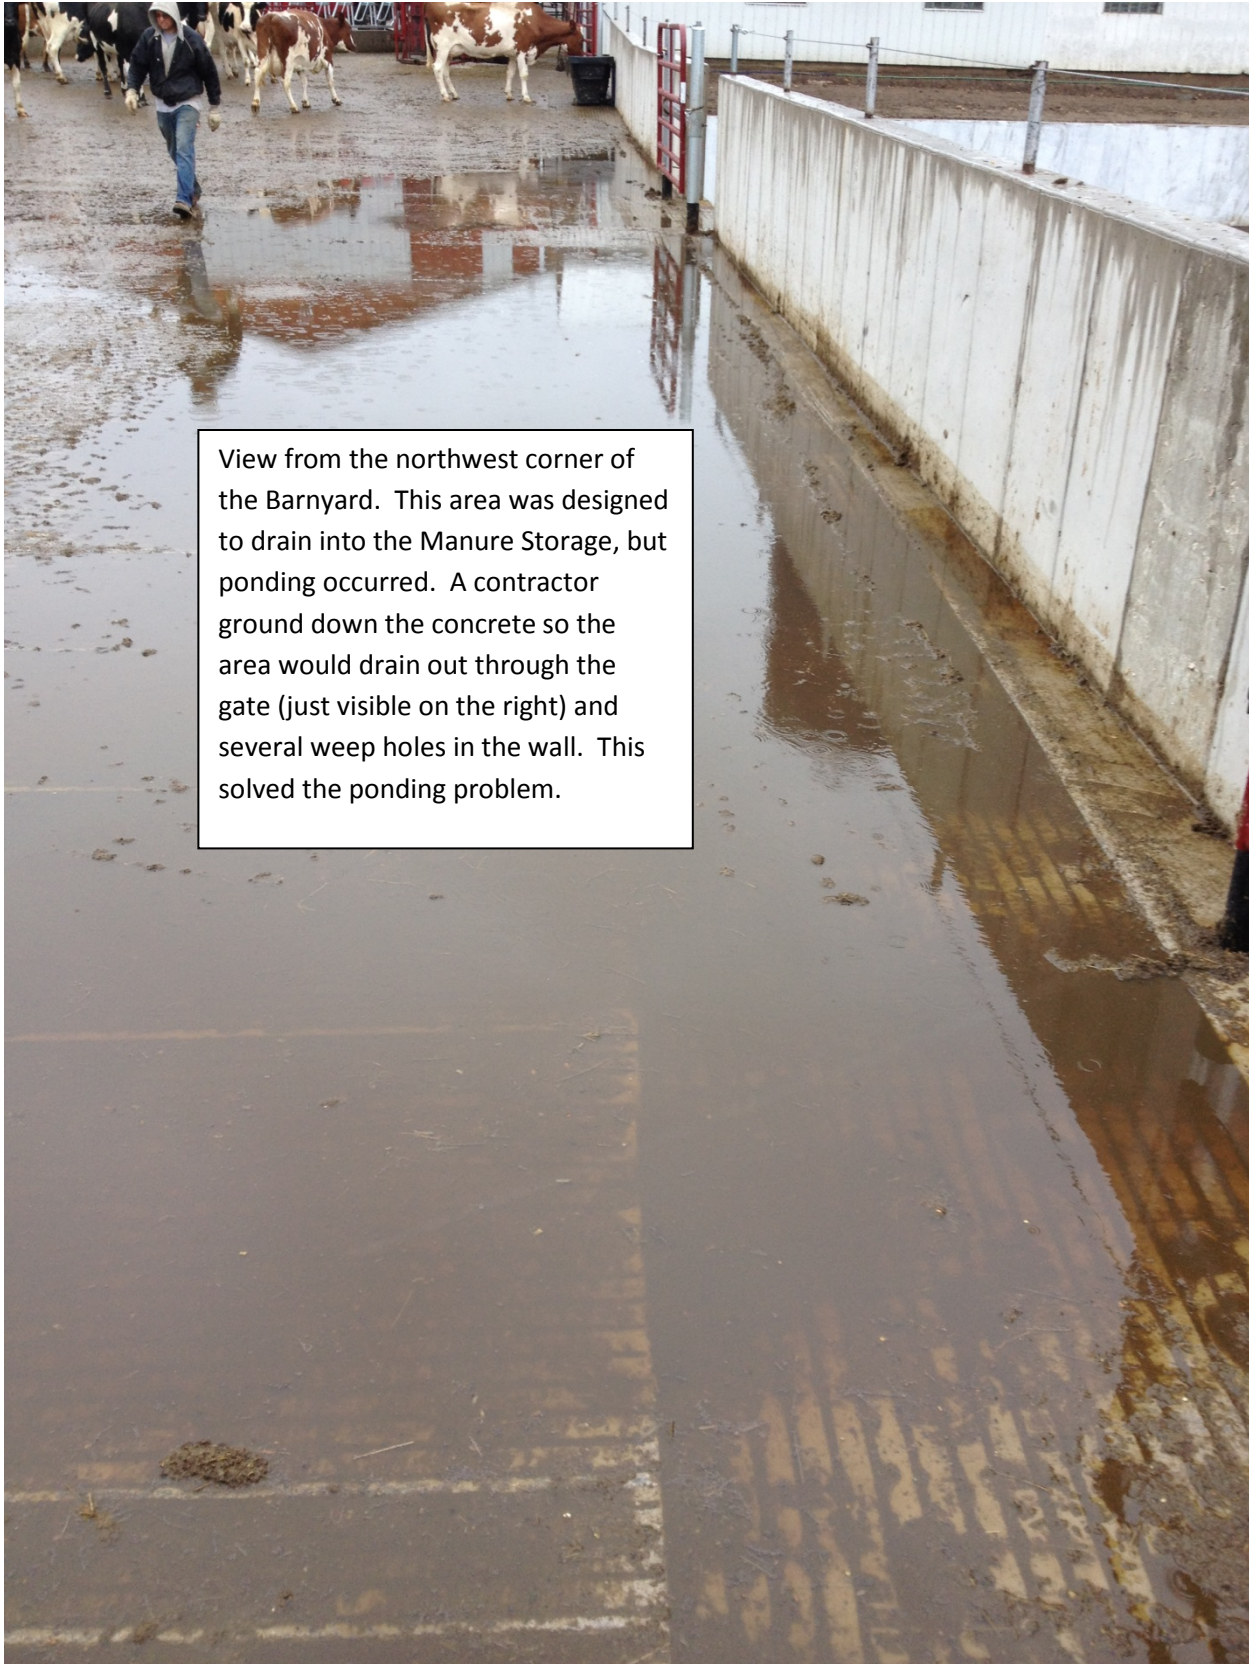
View from the northwest corner of the Barnyard. This area was designed to drain into the Manure Storage, but ponding occurred. A contractor ground down the concrete so the area would drain out through the gate (just visible on the right) and several weep holes in the wall. This solved the ponding problem.

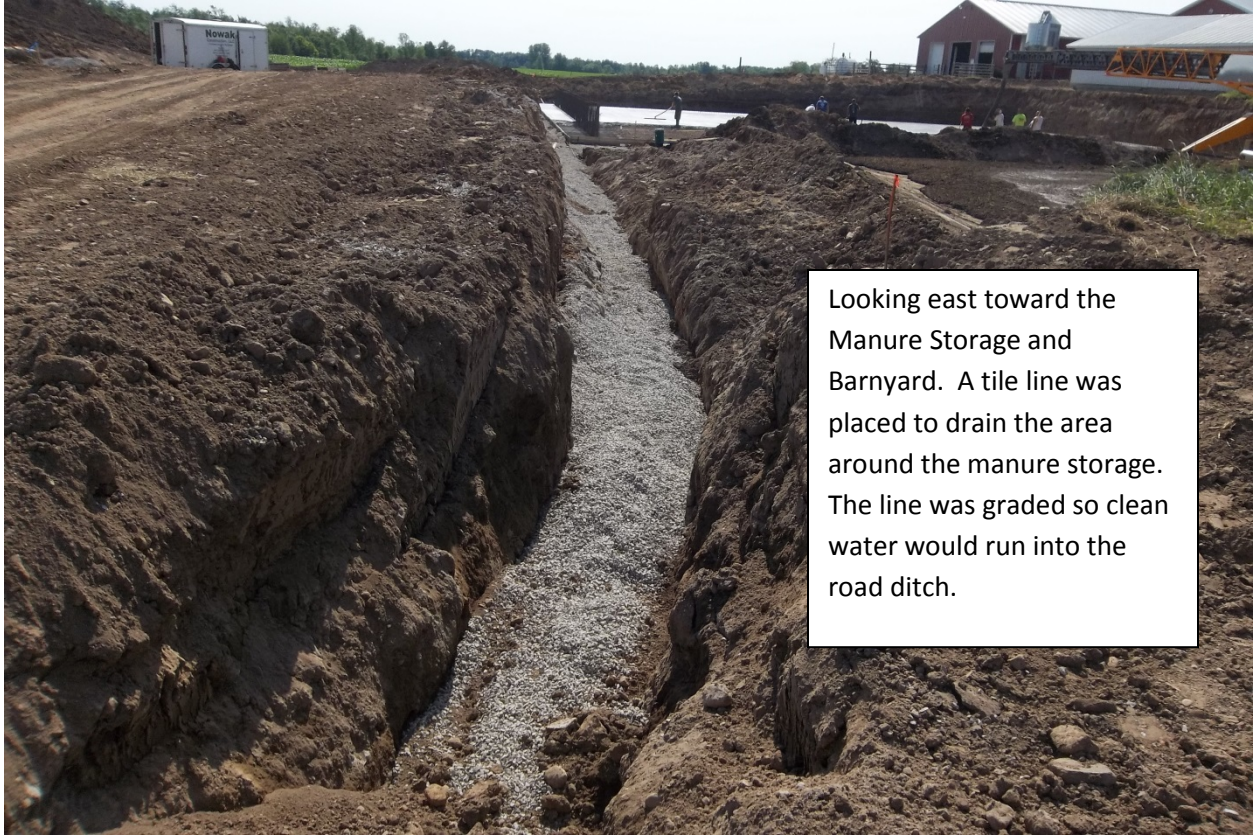
Looking east toward the Manure Storage and Barnyard. A tile line was placed to drain the area around the manure storage. The line was graded so clean water would run into the road ditch.
