DATE: November 19, 2002

SUBJECT: Drummond S. D. - Surface Water Classification & Designated Use Review

Drummond Sanitary District Wastewater Treatment Plant

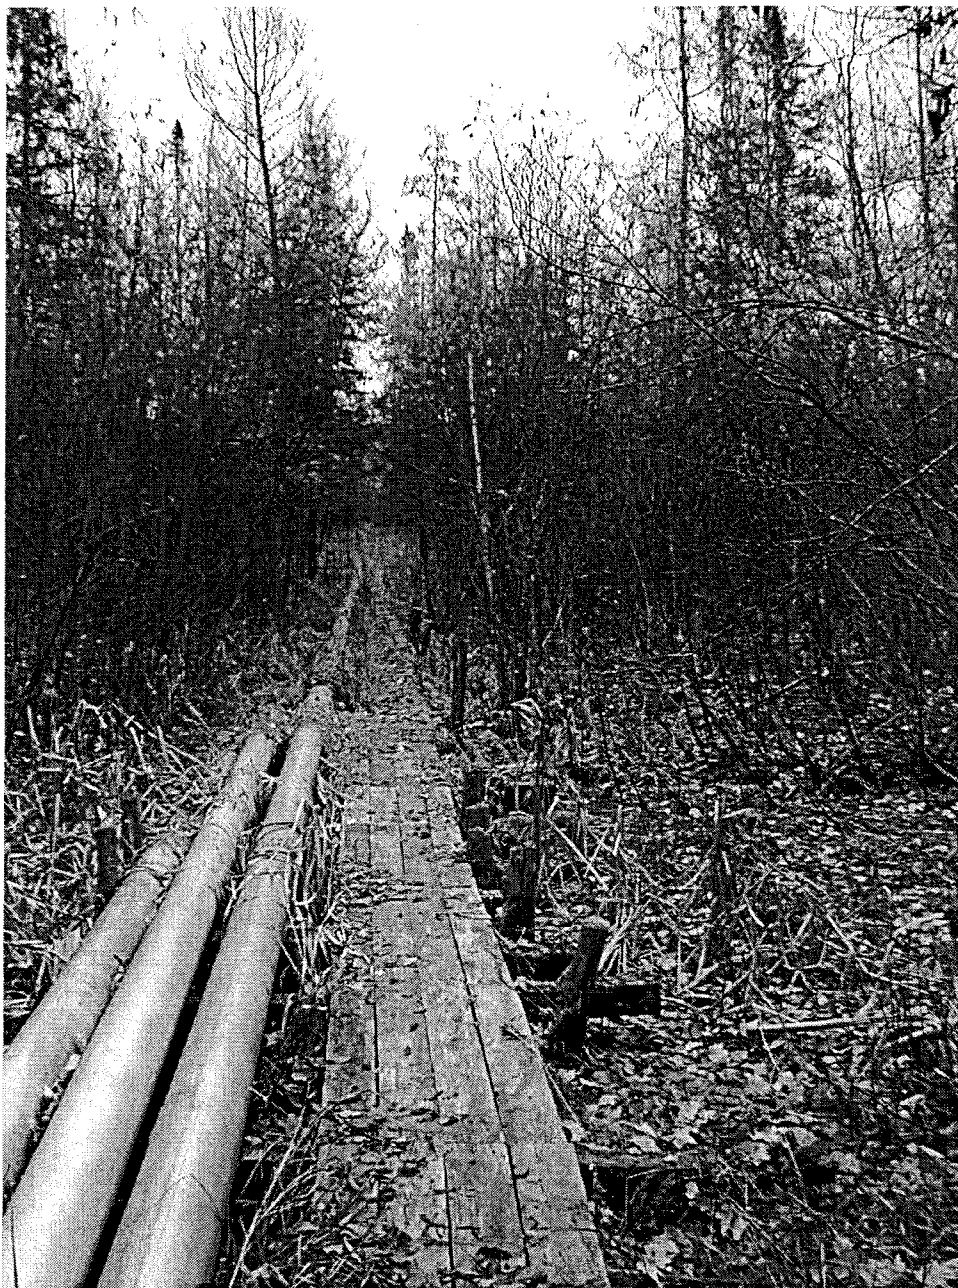
Figure 2. Drummond WWTF outfall pipe into bog.

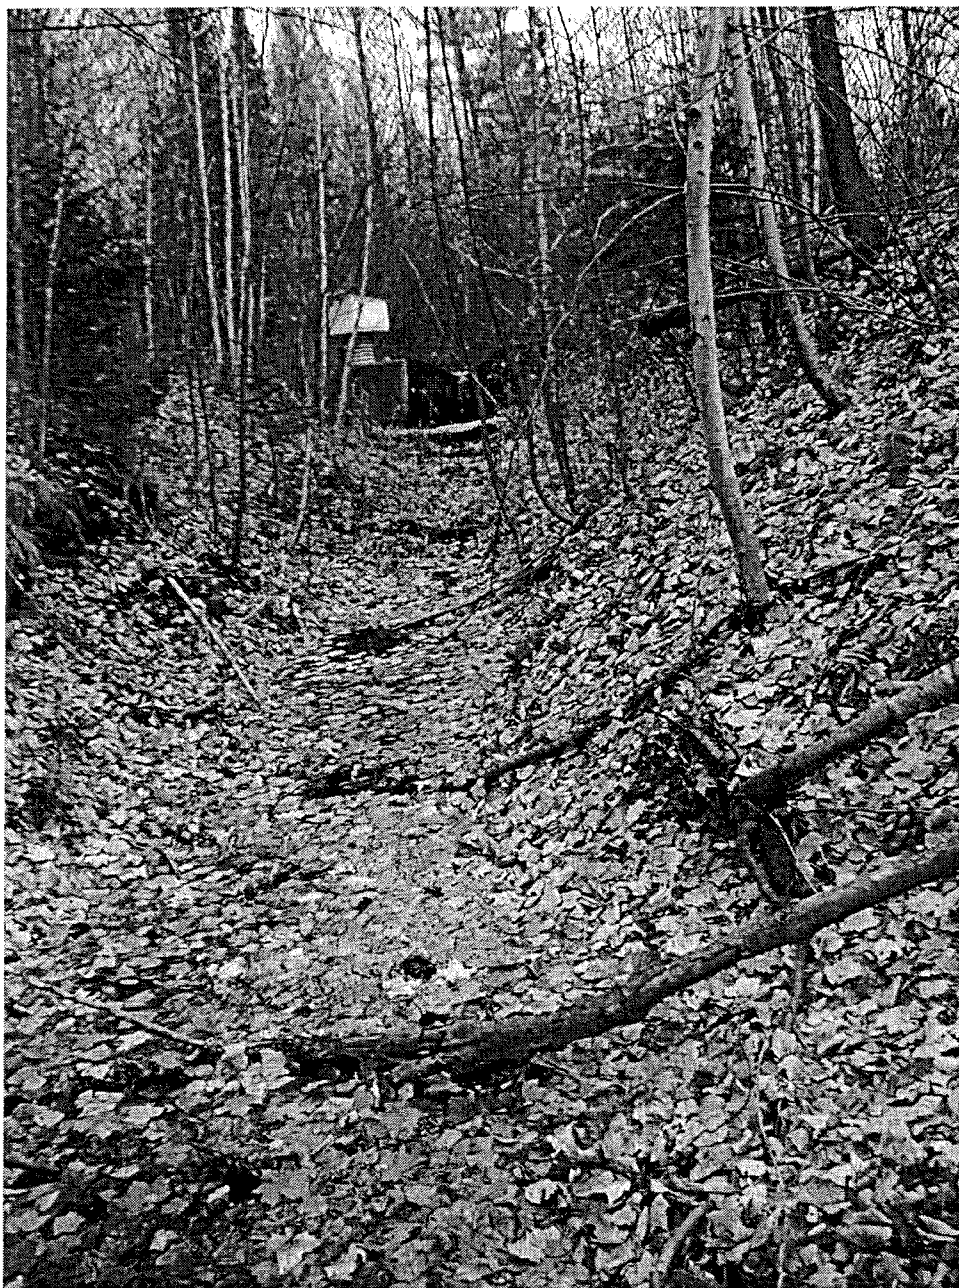
Figure 3. Drummond WWTF weir outlet into noncontinuous tributary stream to the Long Lake Branch of the White River.

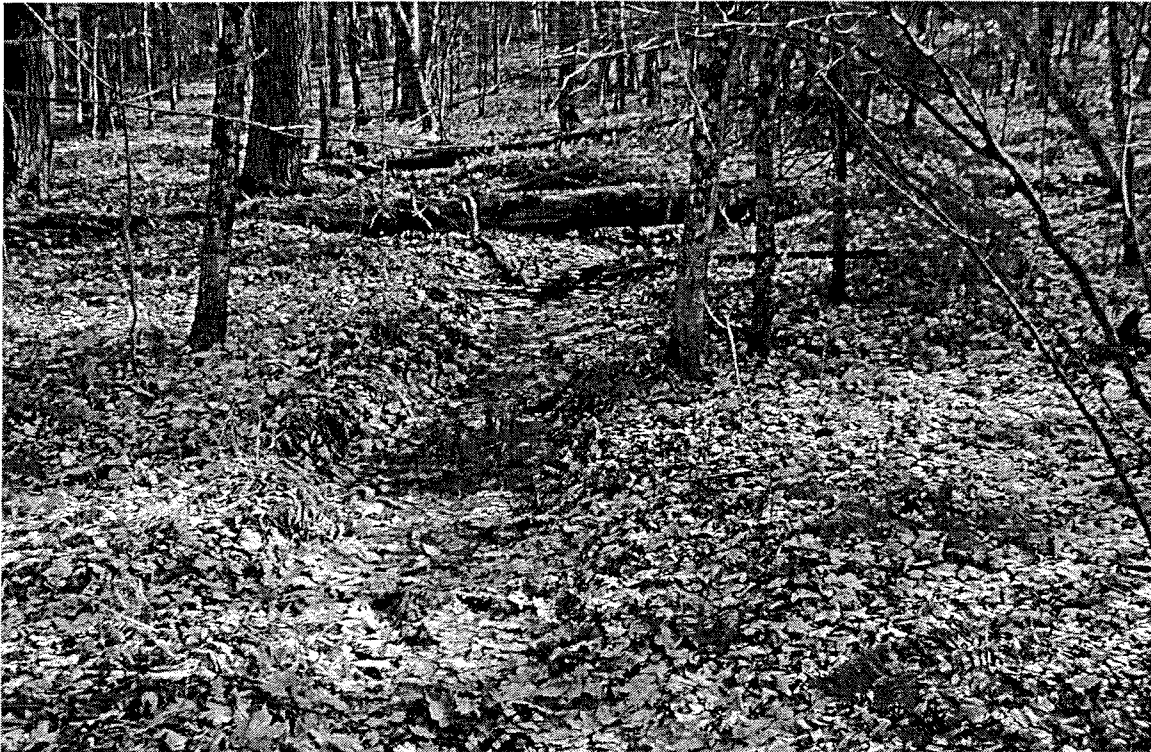
Figure 4. Noncontinuous stream that receives Drummond WWTF effluent and bog discharge. Facing upstream at the end of the tributary segment where the channel loses defined bed and bank.

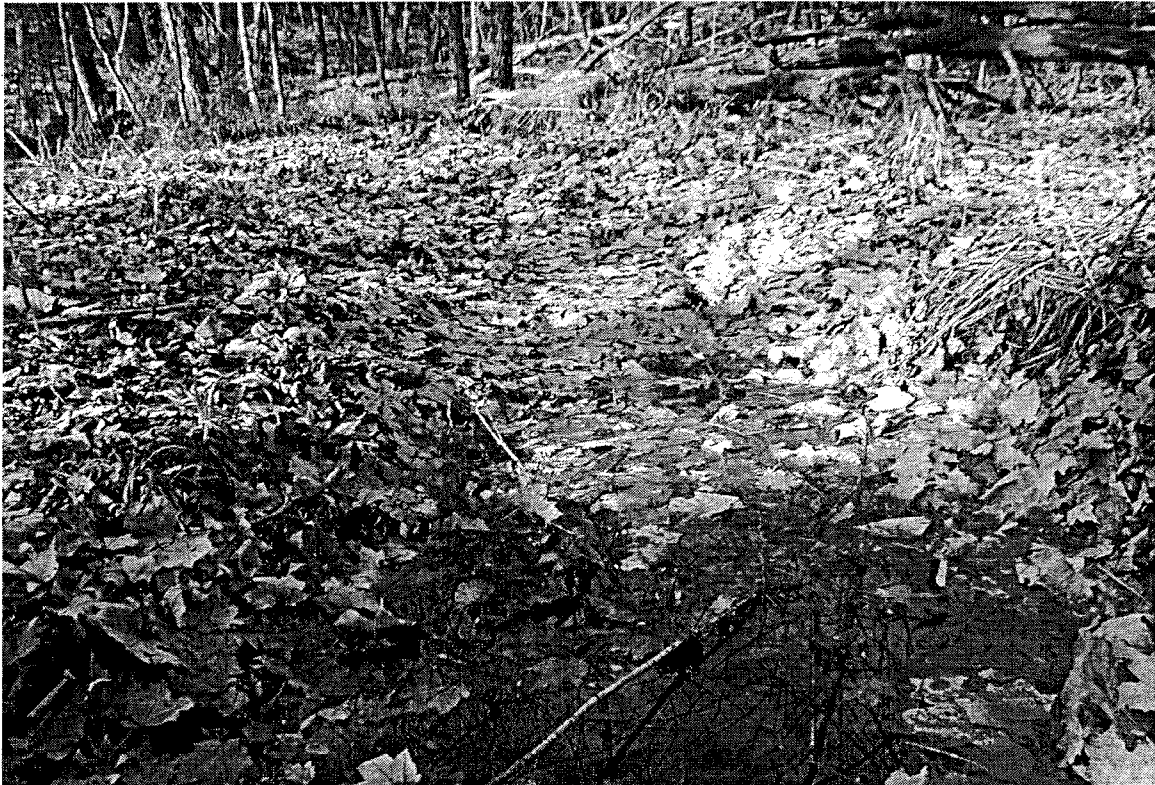
Figure 5. Noncontinuous stream that receives Drummond WWTF effluent and bog discharge. Facing downstream at the end of the tributary segment where the channel diffuses.

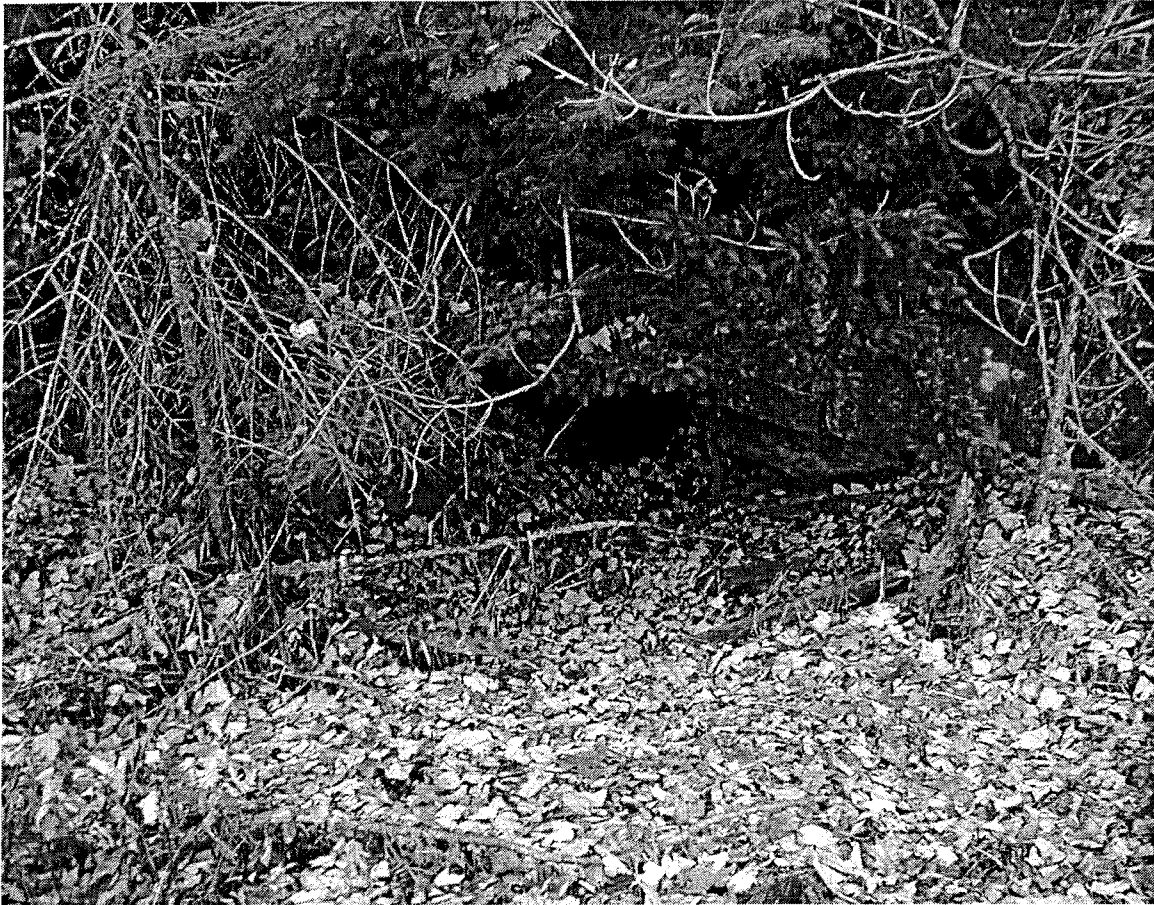
Historically the course of the intermittent stream continued under an abandoned railroad grade, but beaver activity has impounded the watercourse (Figures 6 and 7). Historical data include low dissolved oxygen levels, which are characteristic of wetland drainage streams and limiting for potential fish communities. (05/16/91 L. Prens Site Review)

Figure 6. Historical beaver activity has prevented watercourse from continuing under the railroad grade.

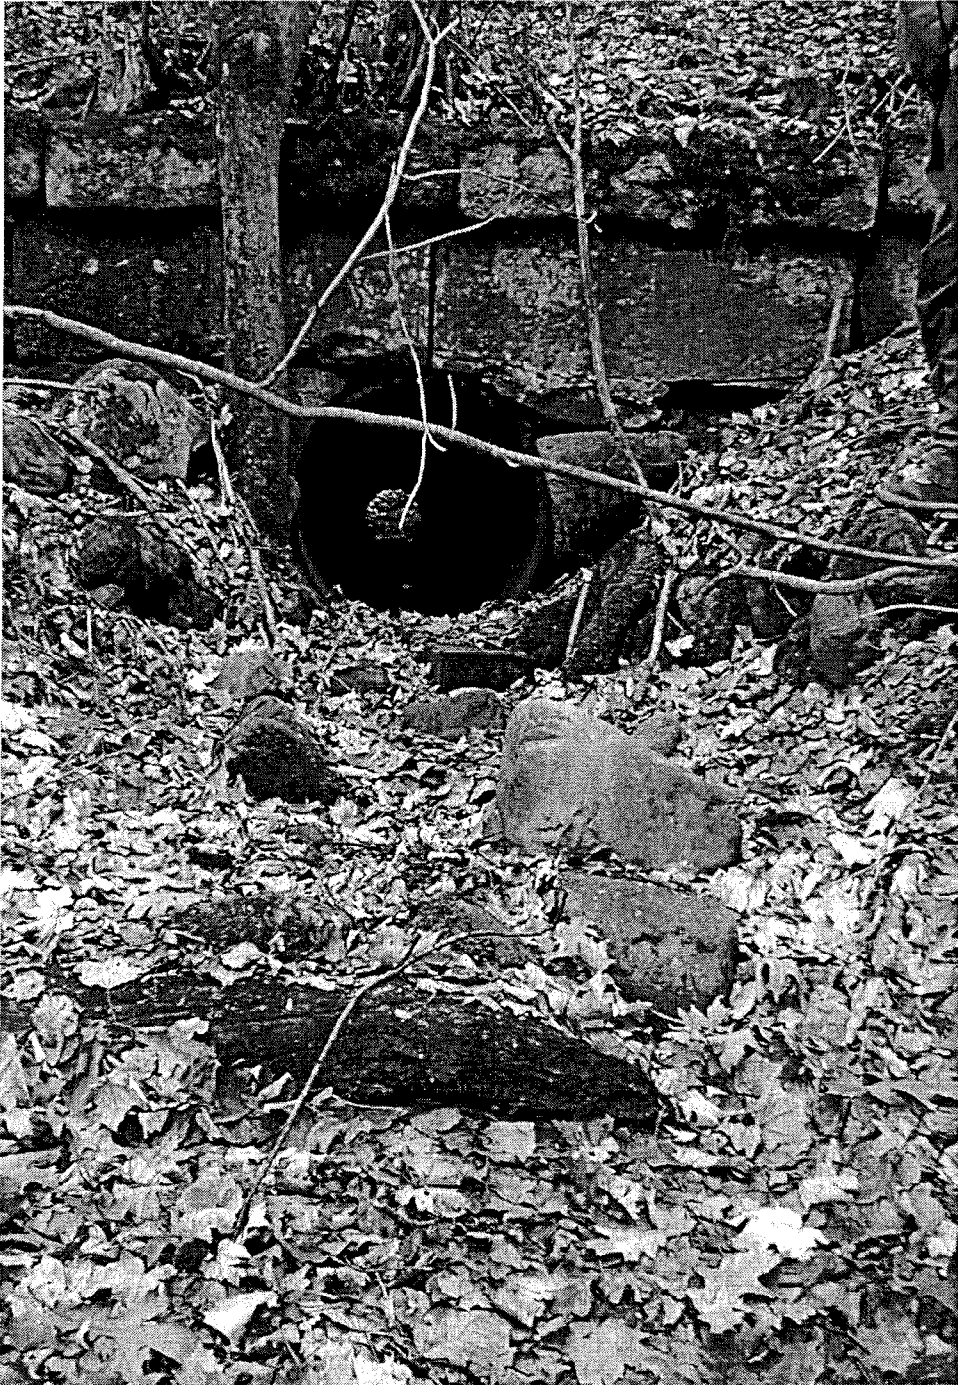
Figure 7. Culvert through which tributary stream to the Long Lake Branch of the White River historically traveled.

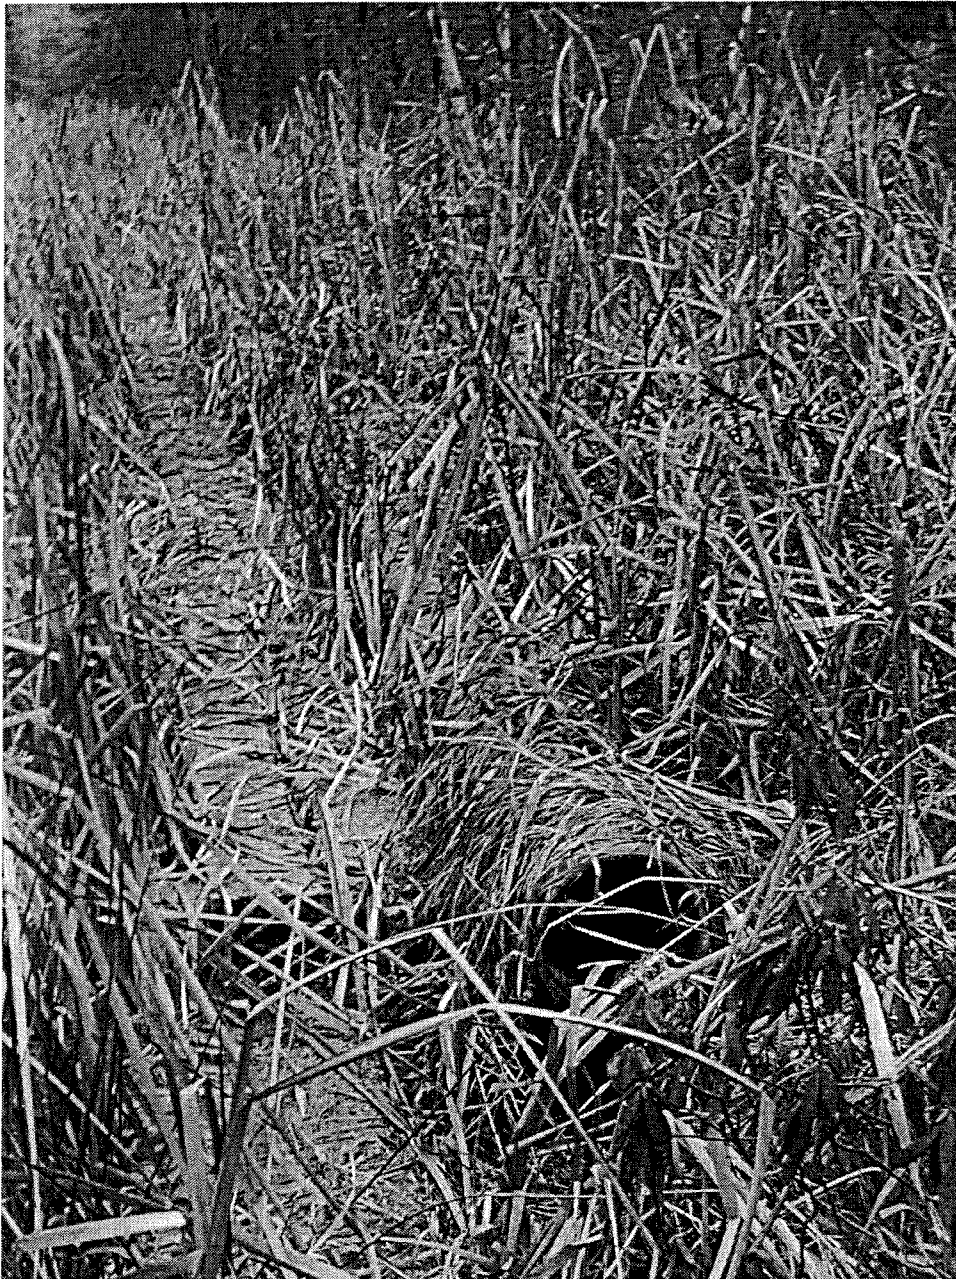
On 4 November 2002 Water Resources Management Specialist Bill Jaeger, Wastewater Engineer Chuck Olson, Watershed Specialist Susan Watson, and I evaluated the site. There was no visible discharge from the dispersal pipe into the bog wetland (Figure 8). Flow from the weir into the tributary channel was negligible. The stream was less than 0.1 m deep and full of allochthonous material (Figure 9). The substrate consisted of silt and decaying organic material. We sampled for fish and aquatic macroinvertebrates immediately downstream of the weir and found nothing. Approximately 200 m downstream of the weir we found a few aquatic macroinvertebrates, including one physid snail and one caddisfly larvae, in an isolated area (<1 m²) that contained gravel and rock substrate.

Figure 8. Drummond WWTF dispersal pipe in bog wetland – no visible discharge.

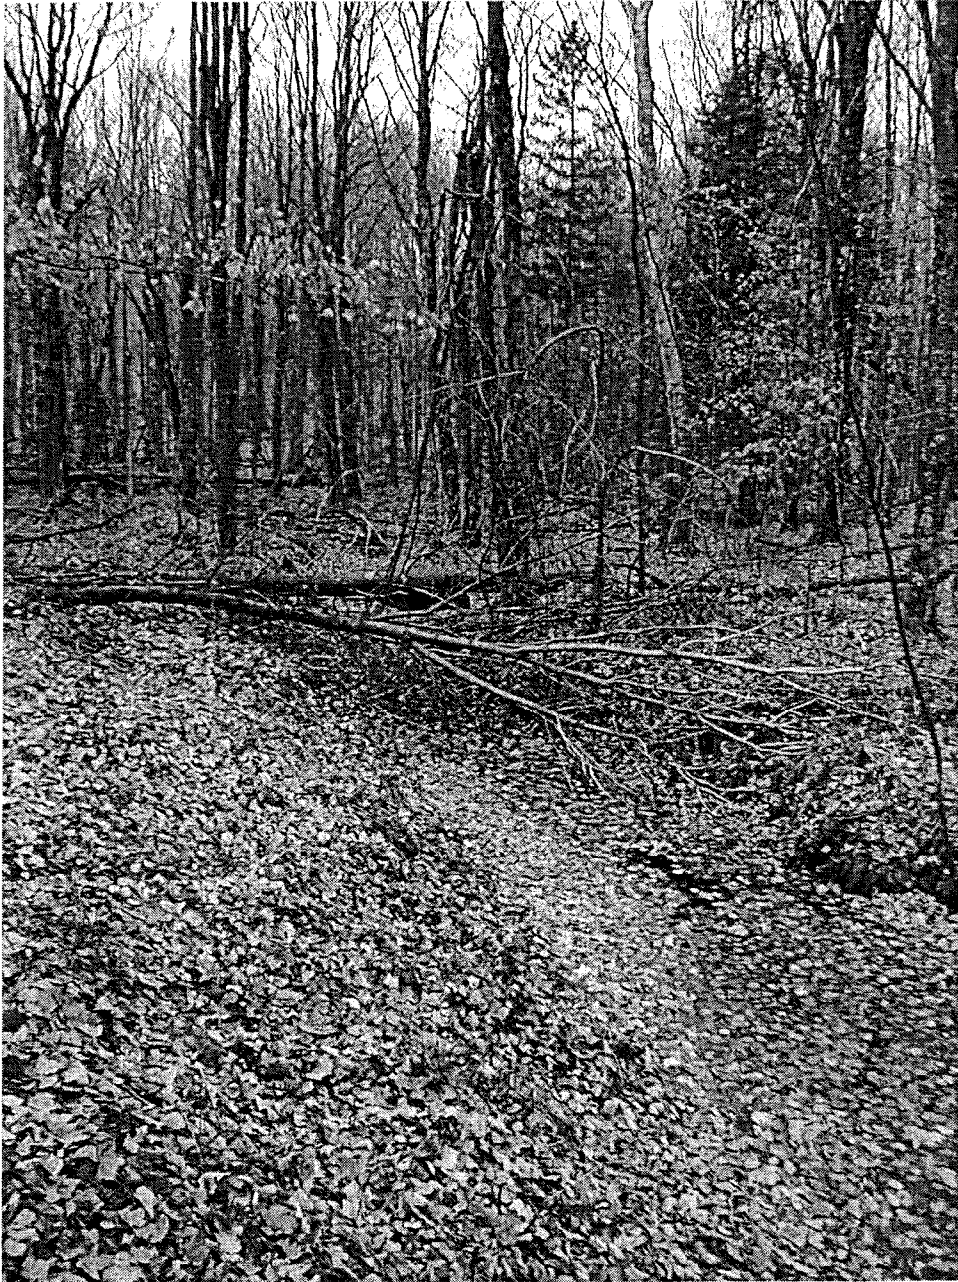
Figure 9. Noncontinuous stream receiving Drummond WWTF and bog discharge.
