Water Quality Monitoring Study: Temperature and Dissolved Oxygen

For the Period
May 1 - Oct 1, 2010

Sturgeon Falls Hydro Project

Conducted for the City of Norway to fulfill
the requirements of their FERC License

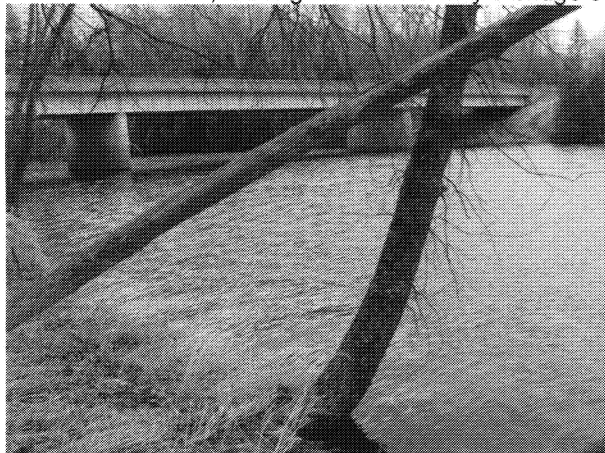
Photo taken at site, looking toward the Hwy 8 bridge over the Menominee River.

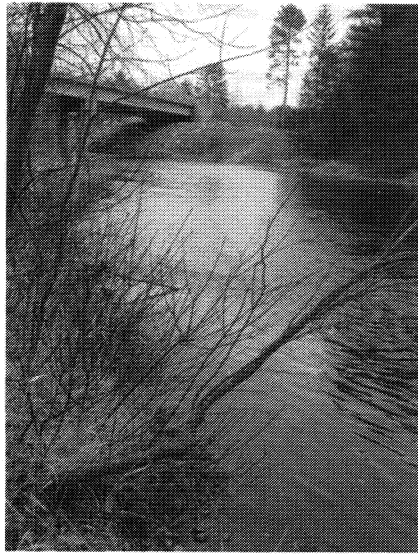
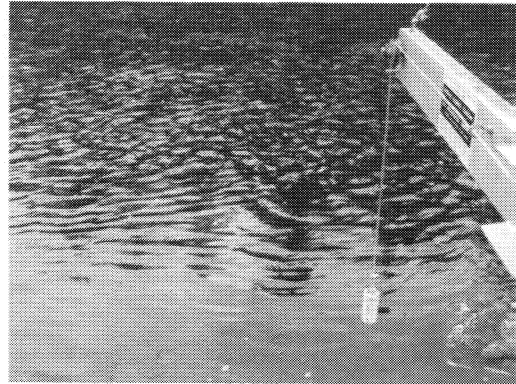
Photo taken at site, looking upstream to the US 2 Bridge (L) and from the gauging station.

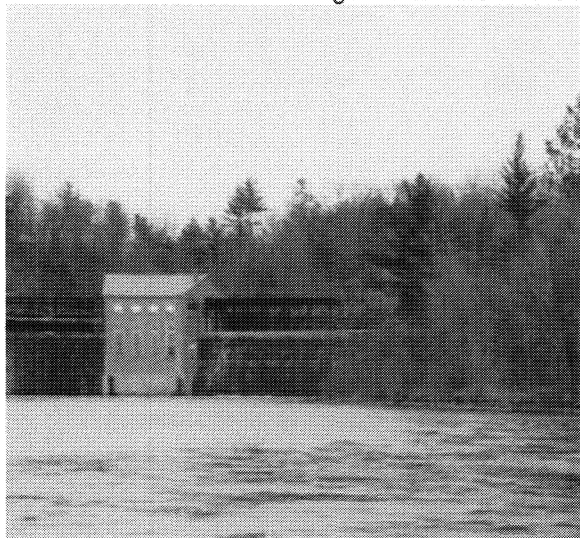
Photo taken looking upstream toward the dam and the monitoring site, which is near the location of the first large White Pine on the right below the dam.

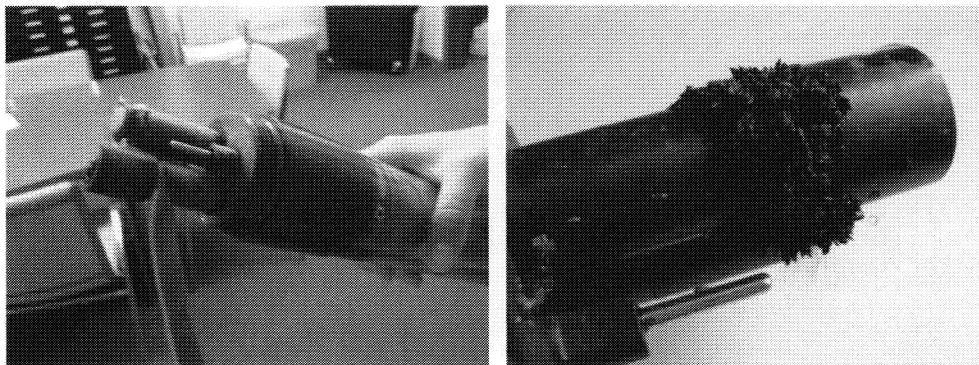
Pictured above: The Power Dam Unit with a 2 week accumulation of biofouling and iron filings in mid- June. This level of fouling was only experienced in early-mid summer and had a rather swift onset, likely due to the unusually warm water temps.

The Clark-type dissolved-oxygen sensor comprises a gold cathode and silver anode immersed in a potassium-chloride electrolyte; the electrolyte is retained by a thin, oxygen-permeable membrane. If a voltage of roughly 0.8 V is imposed between the cathode and anode, any oxygen gas at the cathode is ionized, giving up electrons in the process. Those electrons are an electrical current through the electrolyte, between the cathode and anode, the magnitude of which is related to the amount of oxygen present in the air or water outside the membrane. The sensor output is corrected for the temperature characteristics of the membrane, and for the temperature characteristics of oxygen saturation in water. Because the Clark sensor consumes oxygen, you must usually have a circulator to prevent oxygen starvation at the outer surface of the membrane. Clark sensor maintenance involves replacing the membrane after cleaning the sensor and refilling its electrolyte. Care was taken to exclude bubbles in the electrolyte, and to install the membrane tautly with no wrinkles or holes, as per manufacturers' instructions (Section E6 of the Manta2 Operator's Manual). A maintenance kit was purchased from the manufacturer which included the membranes and electrolyte solution. There was no specific guidance on when the membranes would need replacement. We originally anticipated this to occur monthly, but adapted our regime to bi-weekly as membrane fouling became more apparent in the middle of summer. Membrane replacement coincided with all calibration events after 5/19.
