March 28, 2000

FERC Project Nos. 2525,  
2595, 2522, 2560, & 2581

Peshtigo River Hydroelectric Projects Dissolved Oxygen Deficiencies

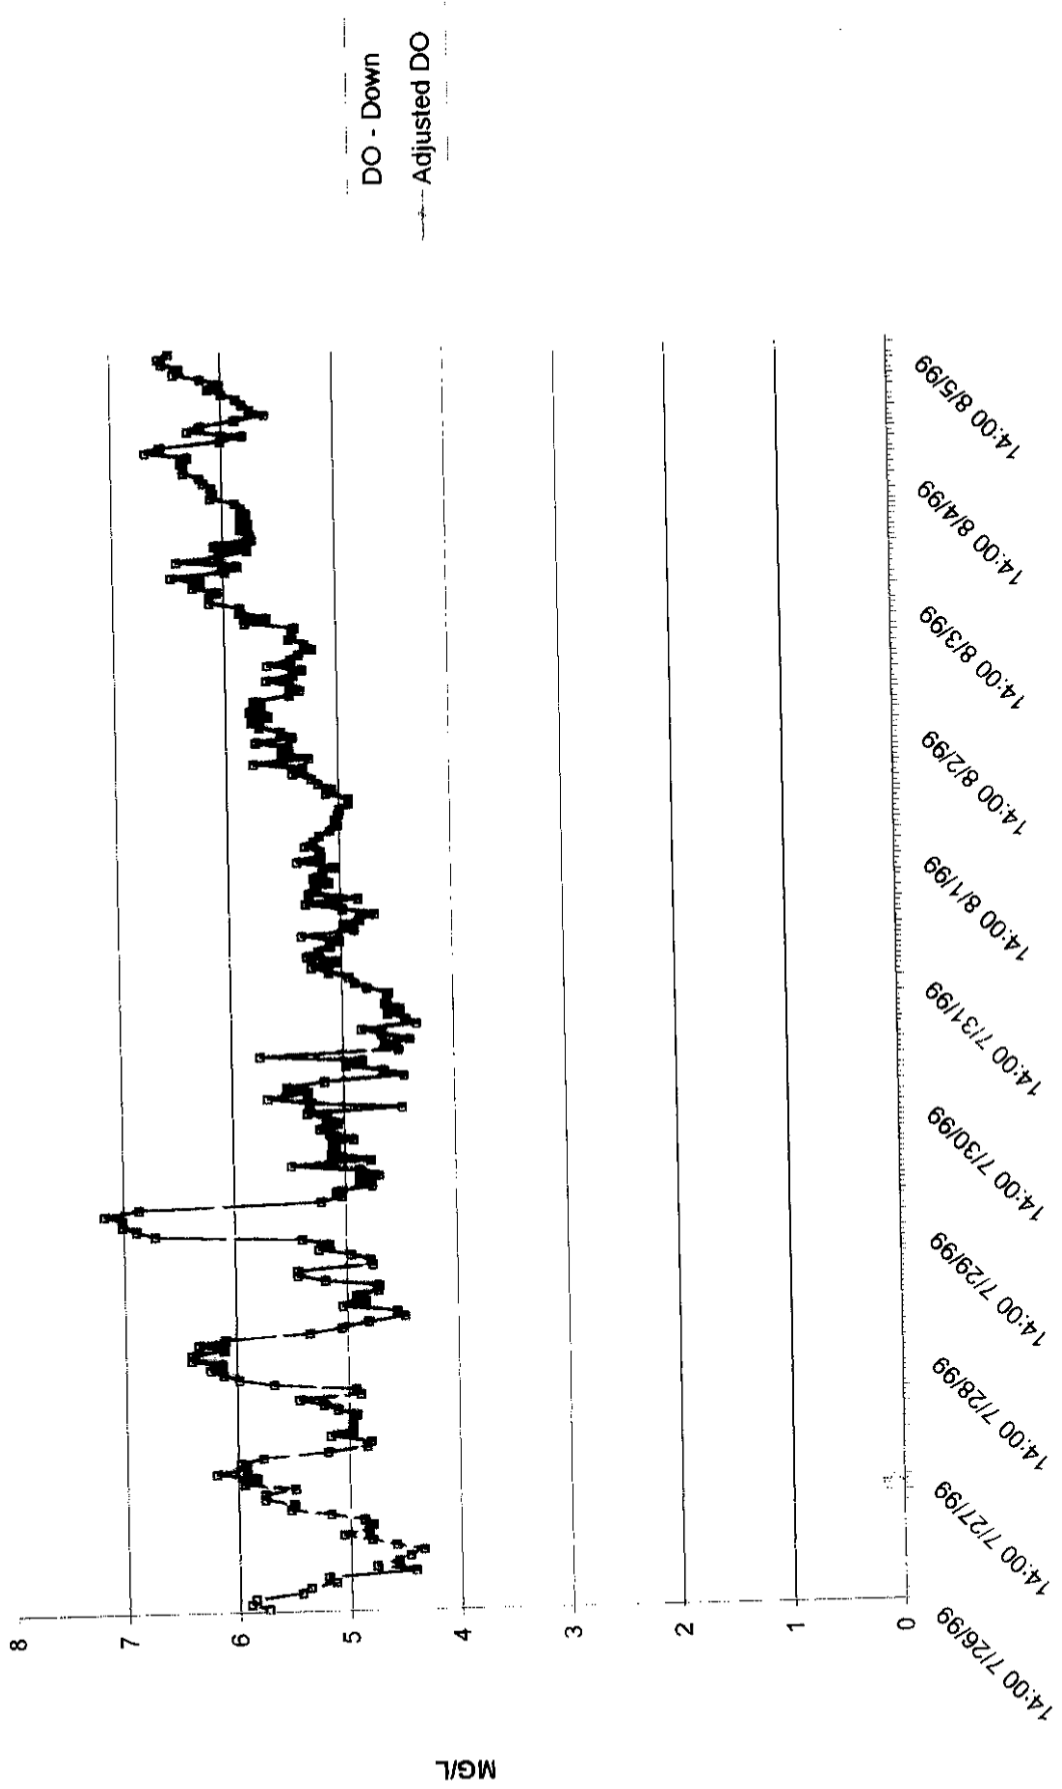
CALDRON - DISSOLVED OXYGEN - JULY 26 thru August 5, 1999

When operating in a peaking mode the periods of low DO measurements occurred when the units were not generating (See Appendix 3). During these periods, the only water that was passed downstream is approximately 25-cfs leakage through the wicket gates and 25-cfs being passed through a sluice gate.
