## Menomonee Fish Passage Barrier Survey

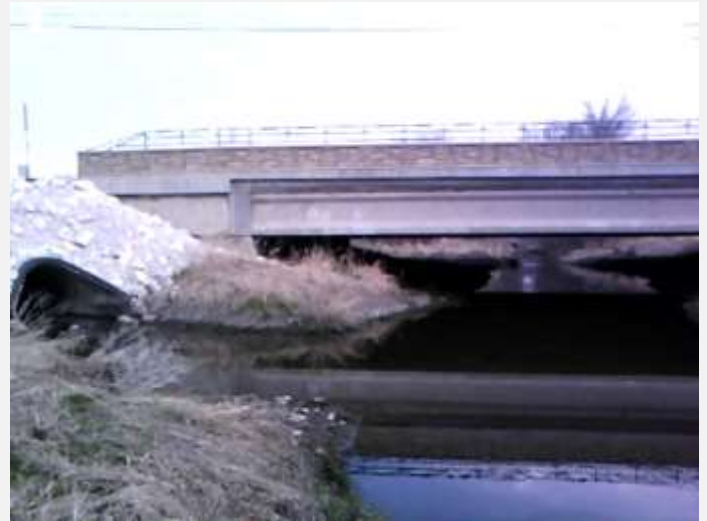
[Photo Outlet](#)

Free spanning bridge; 2 storm drains nearby.

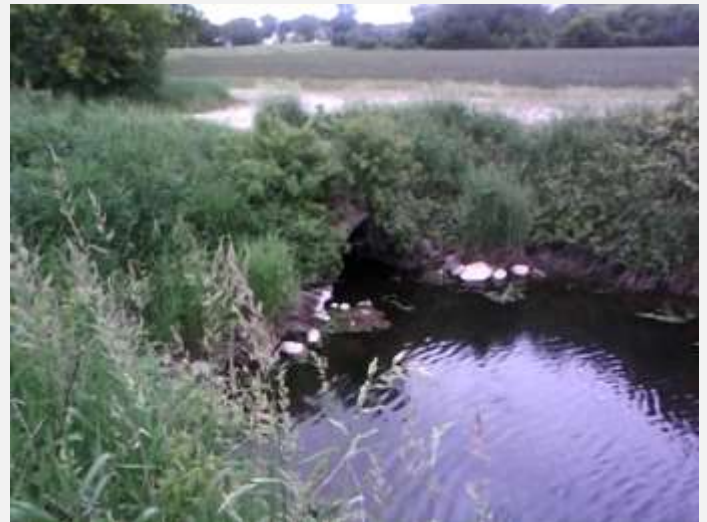
[Photo Inlet](#)

Rusty metal culvert.

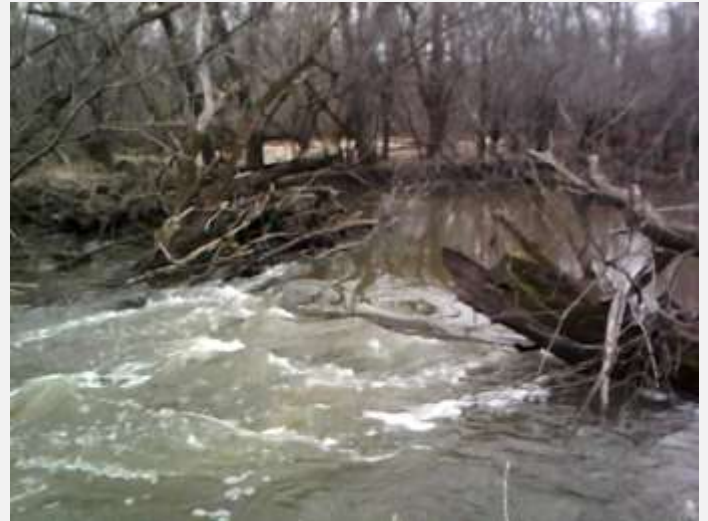
Photo Outlet

Debris jam possible habitat west bank.

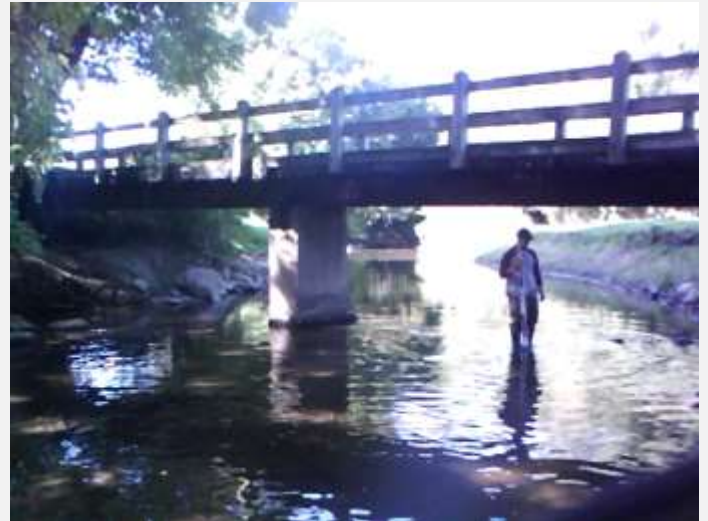
Photo Outlet

Free span bridge on golf course.

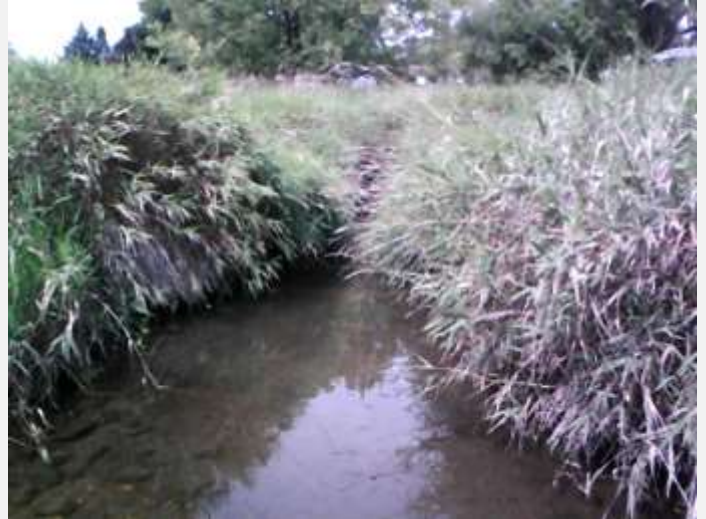
[Photo Outlet](#)

Outlet for ditch, observed lots of minnows, crayfish, small bass.

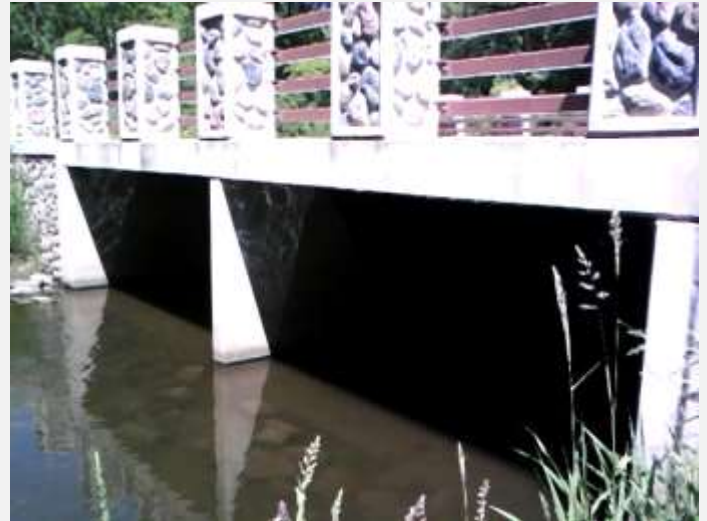
[Photo Outlet](#)

Free span road bridge.

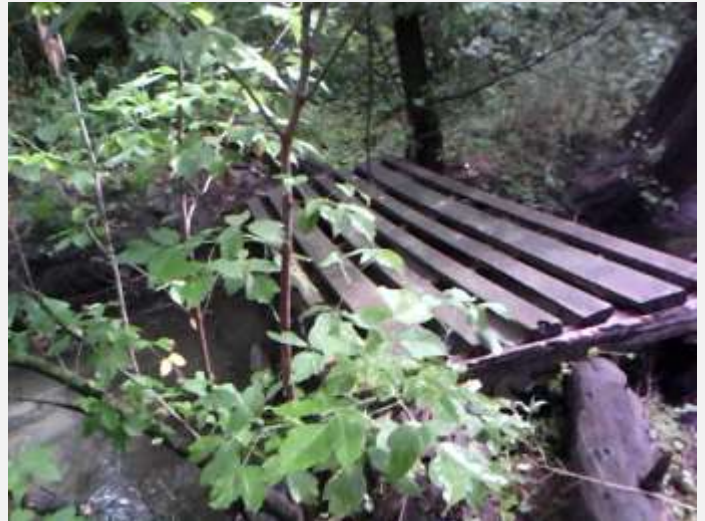
[Photo Outlet](#)

Makeshift footbridge potential cause of blockage.

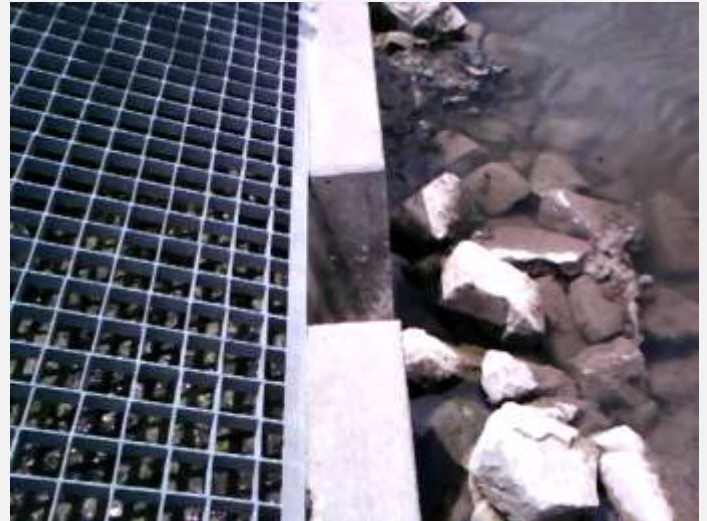
Photo Outlet

Potential access to pond for fish habitat, storm overflow culvert.
