Pioneer Lake 2019 Lake Assessment Report

Prepared by
Vilas County Land & Water Conservation

November 16, 2020

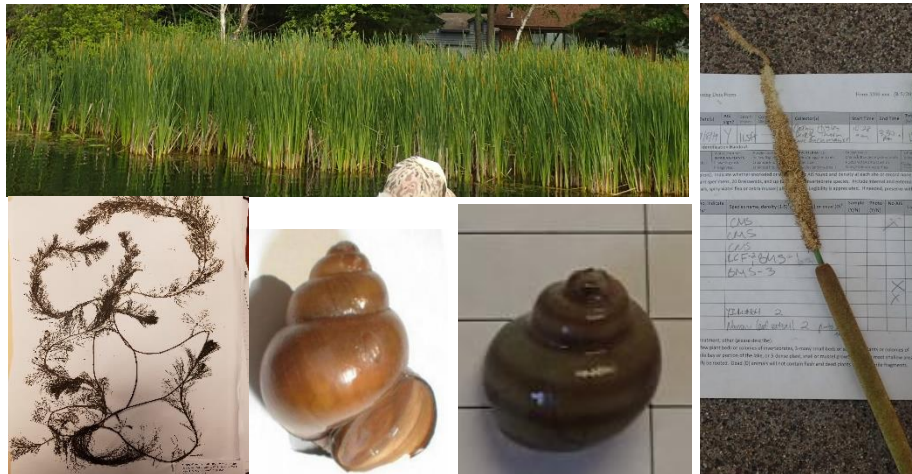
Figure 6. Verified invasives of Pioneer Lake and nearby Twin River (clockwise from top left): narrow leaf cattail area on Pioneer Lake; narrow-leaf cattail flower; Chinese mystery snail photo courtesy of Amy Benson; USGS, Banded mystery snail; and Eurasian watermilfoil found on the Twin River-Monheim Rd. crossing.

Due to the verified Eurasian watermilfoil in the Twin River, the suspected yellow floating heart, and narrow leaf cattail, AIS Early Detection Sampling was repeated in summer 2020 on Pioneer Lake, the Twin River up to the Monheim Rd. crossing, and on Pioneer Creek down to the obstacle located about ¾ of the way to the Church Rd. crossing. No new AIS were detected. Dredge samples for spiny waterfleas and plankton tows for zebra mussel veligers were also repeated in 2020 but results are not yet available.

- **Create an AIS monitoring group:**
 - Invasive Eurasian water milfoil was found in the Twin River at the Monheim Rd. crossing, and yellow iris is suspected but not yet confirmed. Monitoring for Eurasian water-milfoil and other AIS will be helpful so the association can respond in a timely manner if desired. Contact Cathy Higley from Vilas County Land & Water Conservation 715-479-3738 or cahigl@vilascountywi.gov for training and guidance on forming a group.

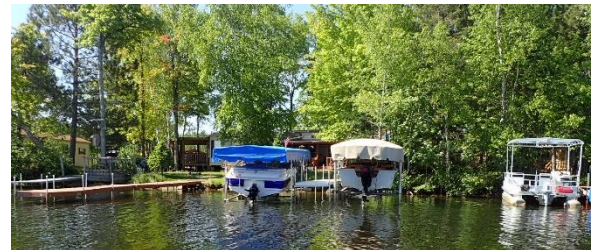
Figure 8. Dock density on Pioneer Lake was fairly high at 25.20 docks/mile. Having a lake-wide dock density greater than 16 docks/mile has been shown to have negative effects on fish diversity (Jacobsen et.al).

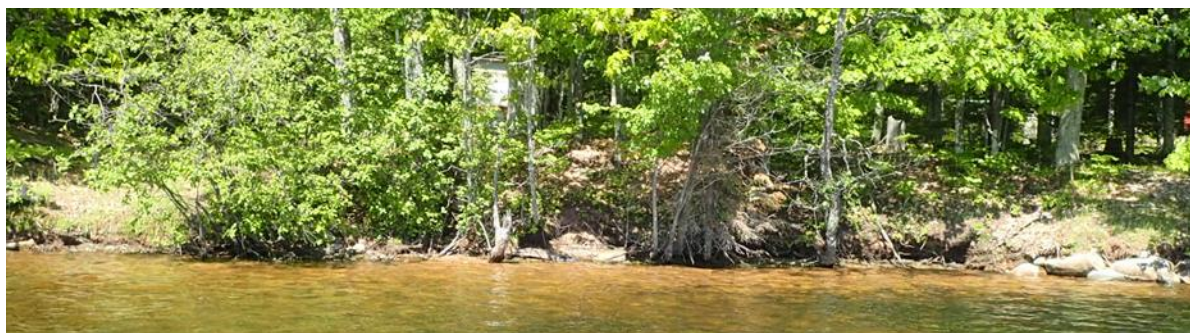
Figure 11. Bank erosion on Pioneer Lake likely caused by flank erosion from the adjacent riprapped area.

- **Address runoff and erosion concerns:**
 - Areas of bare soil in the riparian zone and bank erosion should be restored as they can add extra phosphorus into the water. Staff from Vilas County Land & Water Conservation are able to do site visits, recommend solutions, and in certain instances offer grant fund reimbursement for installing best practices. Contact Cathy Higley from Vilas County Land & Water Conservation 715-479-3738 or cahigl@vilascountywi.gov for assistance, questions, or possible funding.

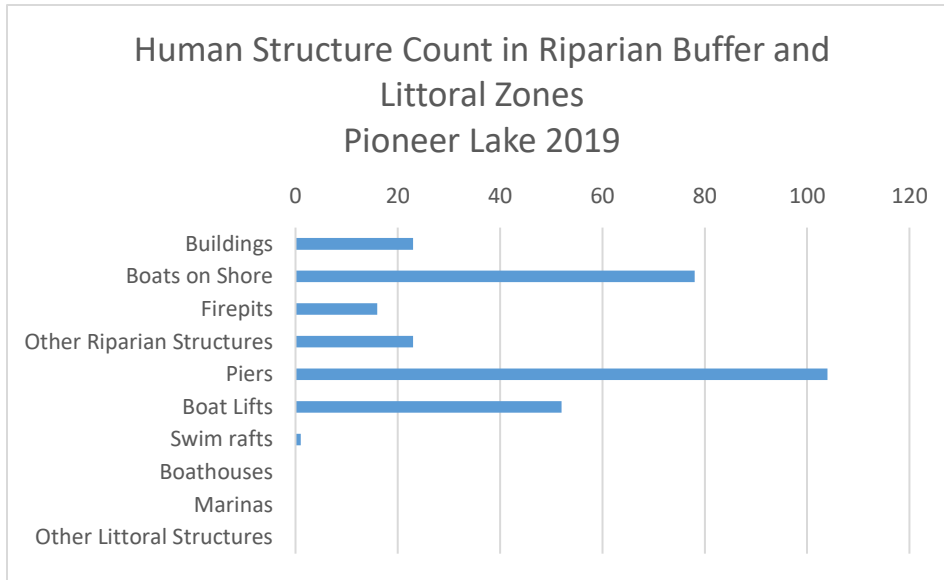
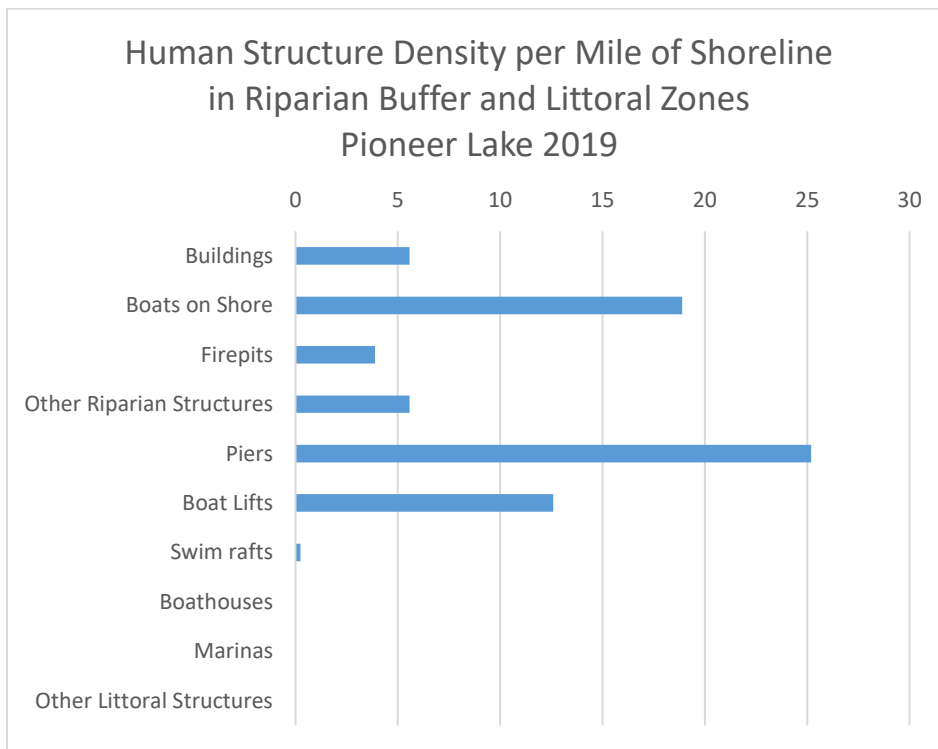
Figure 12. Number and density per mile of shoreline of human structures documented in the Riparian Buffer and Littoral Zones on Pioneer Lake 2019.

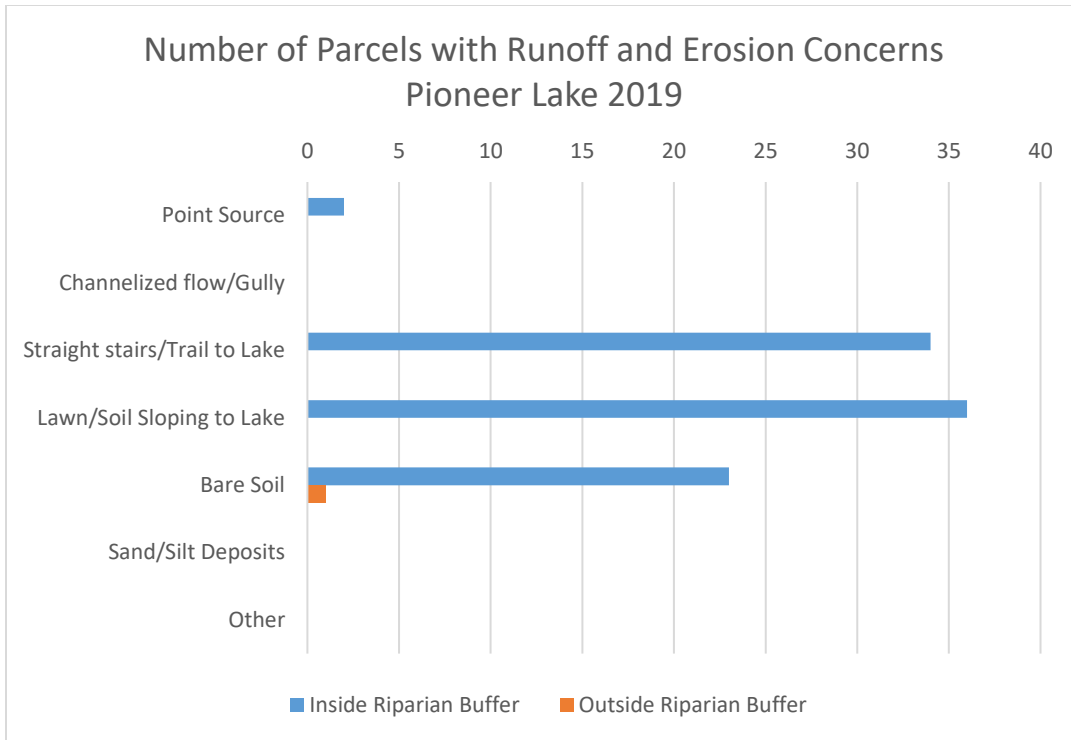
Figure 13. Number of parcels with runoff and erosion concerns in Riparian Zone and Outside Riparian Zone on Pioneer Lake 2019. Of the 80 parcels, 53 had erosion or runoff concerns (66%).

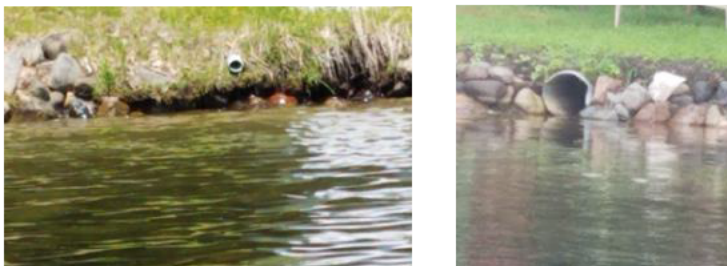
Figure 16. Point source pipes were found on Pioneer Lake.

- **Address point source sites:**
 - Follow up on the two point source discharges found for potential pollutants. If necessary/appropriate, encourage landowners to consider alternate ways to deal with their storm/waste water. Contact Melissa Yarrington of the WI DNR for assistance at 715-359-0192 or Melissa.yarrington@wisconsin.gov.

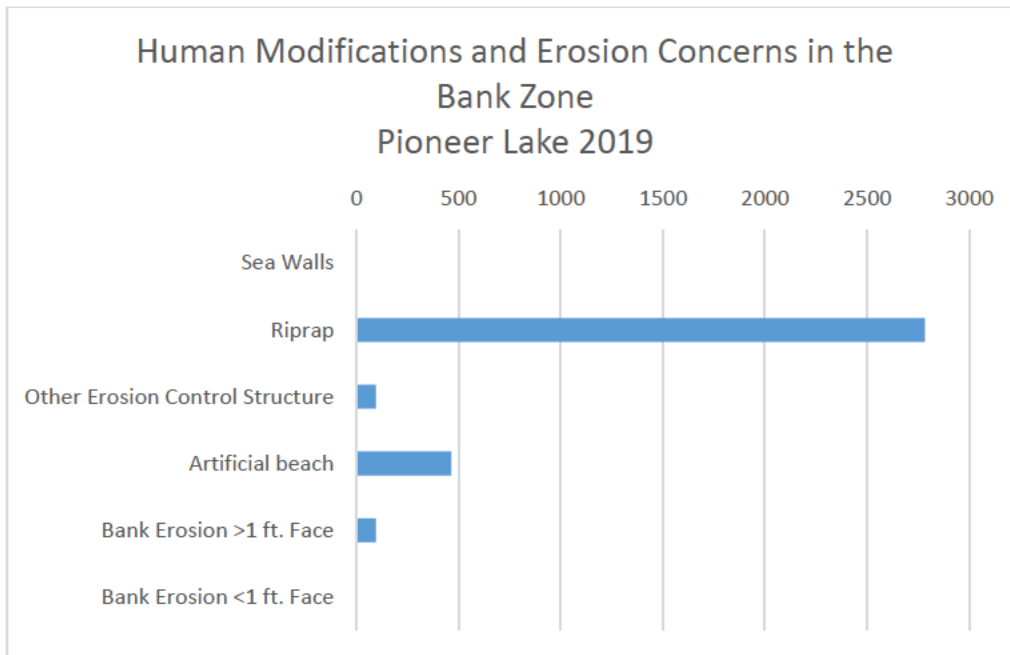
Figure 17. Length in feet of human modification and erosion concerns in Bank Zone on Pioneer Lake 2019. Riprap accounted for over 12% of the shoreline.

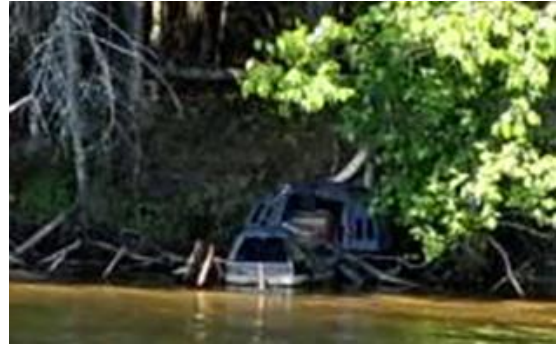
And old snowmobile was found sunk into the lake’s shoreland area. Residents indicate this had been there since the 1980’s.

Figure 18. An old snowmobile has been reported to have been sunk into the shoreline since the 1980’s.

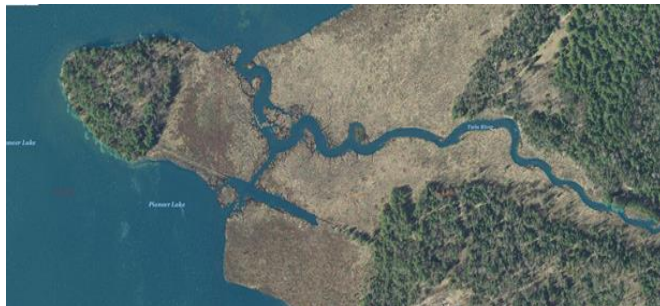
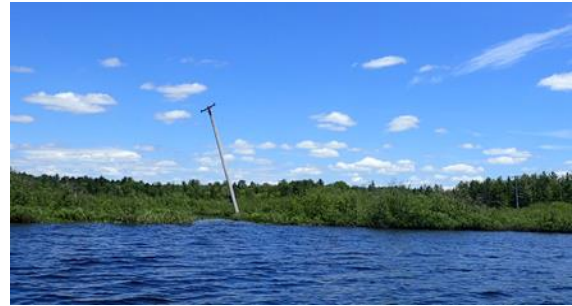
Residents reported that historically, a landowner of the peninsula area near the Twin River outlet had attempted to upgrade the log road to a gravel road. Upon adding the heavy gravel, a whole section of the road and underlying wetland sunk into the lake. The utility poles around this area also seem a bit unstable. See Figure 19.

Figure 19. Air photo of the “sunken land” described by lake residents and photo of a leaning utility pole in same area.

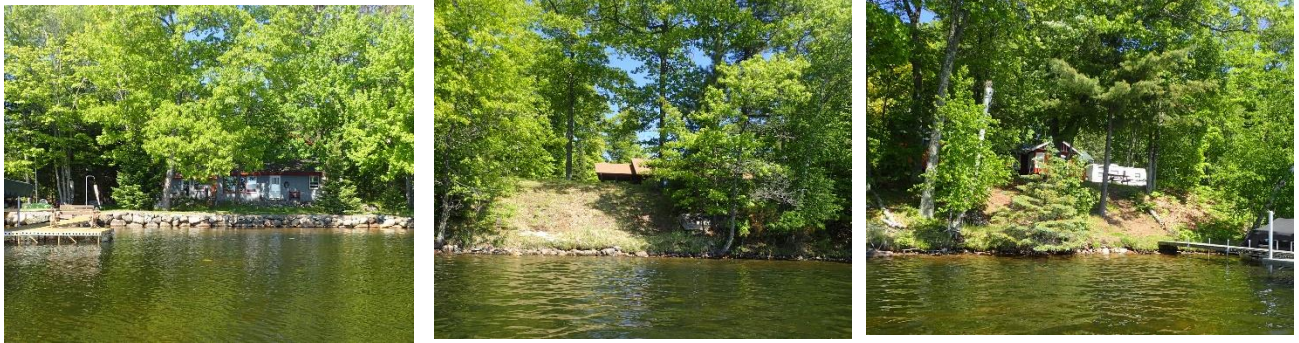
The majority of the parcels on Pioneer Lake did not have steep banks. However there were some areas that were steep. Sandy dry soil in these areas are quite prone to erosion, and can be difficult to get vegetation established.

Figure 21. The photo on the left show the gentle grade of the majority of Pioneer Lake's parcels. The middle and right photos show steeper slopes. Runoff and erosion are more of a concern on steeper areas that occur primarily on the northwest side of the lake.

- Where lake access trails/driveways slope down to the lake, encourage riparian owners to curve their access trails across the slope rather than going straight down to the lake. This switchback approach will allow stormwater to infiltrate into the soil (vs. becoming runoff) better than a straight trail would. Landowners should be mindful when curving or meandering an access path to comply with Zoning regulations on allowable access area width. See Figure 14 as an example. For assistance with properly placing this type of lake access with the viewing corridor contact the Vilas County Zoning at 715-479-3620.
