DATE: 8-23-2023 FILE REF: NA

SUBJECT: Clover Sanitary District Permit Reissuance, Tributary (no WBIC) to L. Superior, Bayfield Co.

Overview of issue

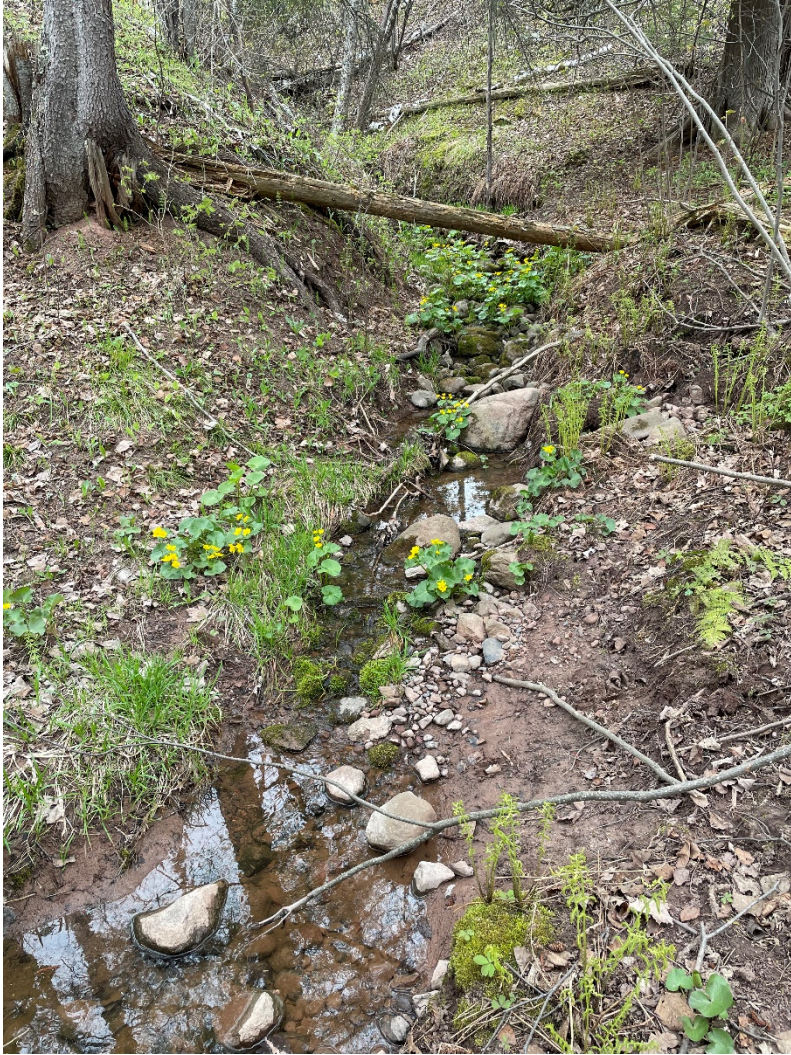
Upstream of Highway 13 the tributary was small but had good amounts of riffles and runs for its size (Photo1). Substrate consisted of cobble, gravel, and clayey sand (Photo 2). It has characteristics of a headwater stream. Depth could be a limiting factor for fish in this stretch. The west branch had better depth than the middle branch. Qualitative habitat score was 45 (Table 2). The culvert was in poor condition with the bottom on the upstream end rusted out and water flowing underneath the apron.

Photo 1. "Middle branch" looking downstream.

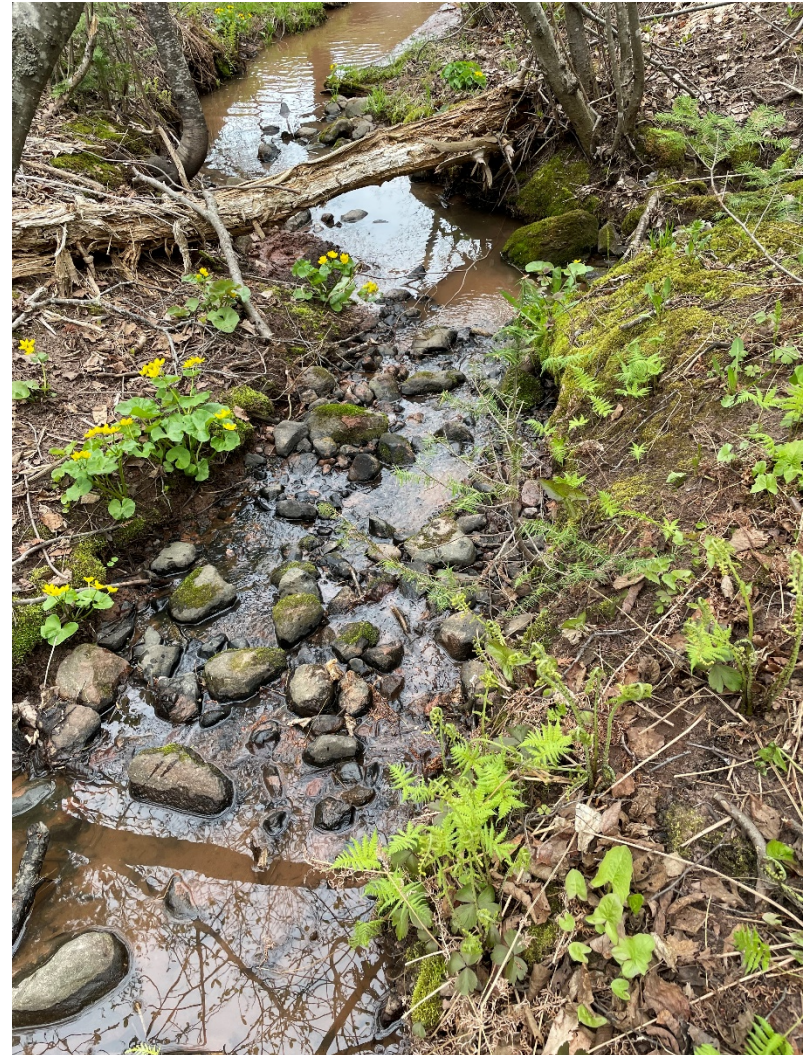
Photo 2. "Middle branch" looking upstream.

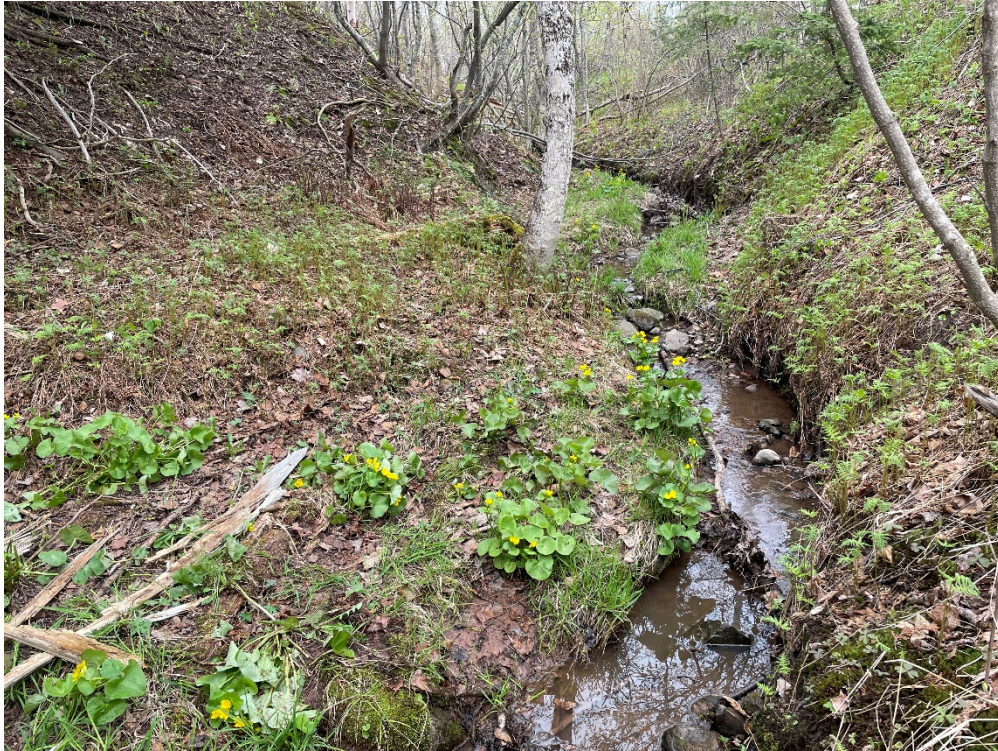
- **Segment 2:** Unnamed Tributary (“Middle Branch”; no WBIC) upstream (south) of Highway 13
 - Upstream of Highway 13 the tributary has three channels that combine into one channel before going under Highway 13 (Photo 4). Water was present in all channels, with the west branch having the most water (Photo 3). Iron bacteria were observed by the stream, indicating ground water influence. Marsh marigold were also present, which are a wetland species and indicate ground water influence as well. It is suspected that the middle branch receives the effluent from Clover SD, but that was not verified during this visit.

Photo 3. "West branch" looking upstream.

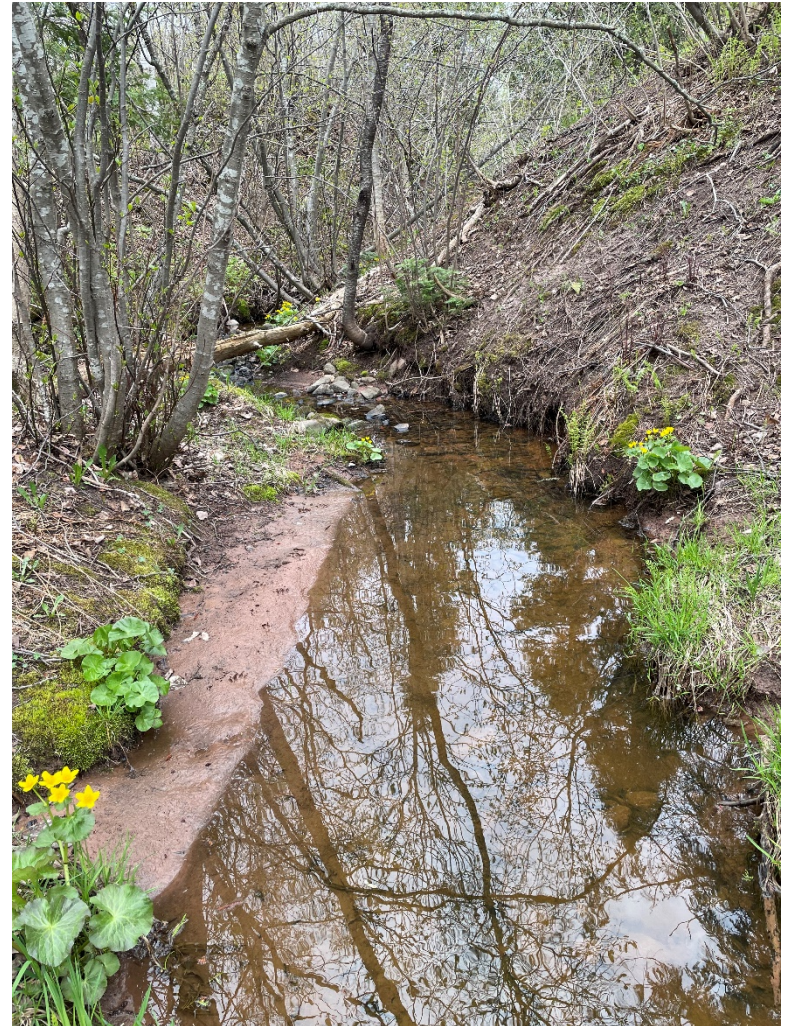
Photo 4. "Main channel" upstream of Highway 13 looking upstream.

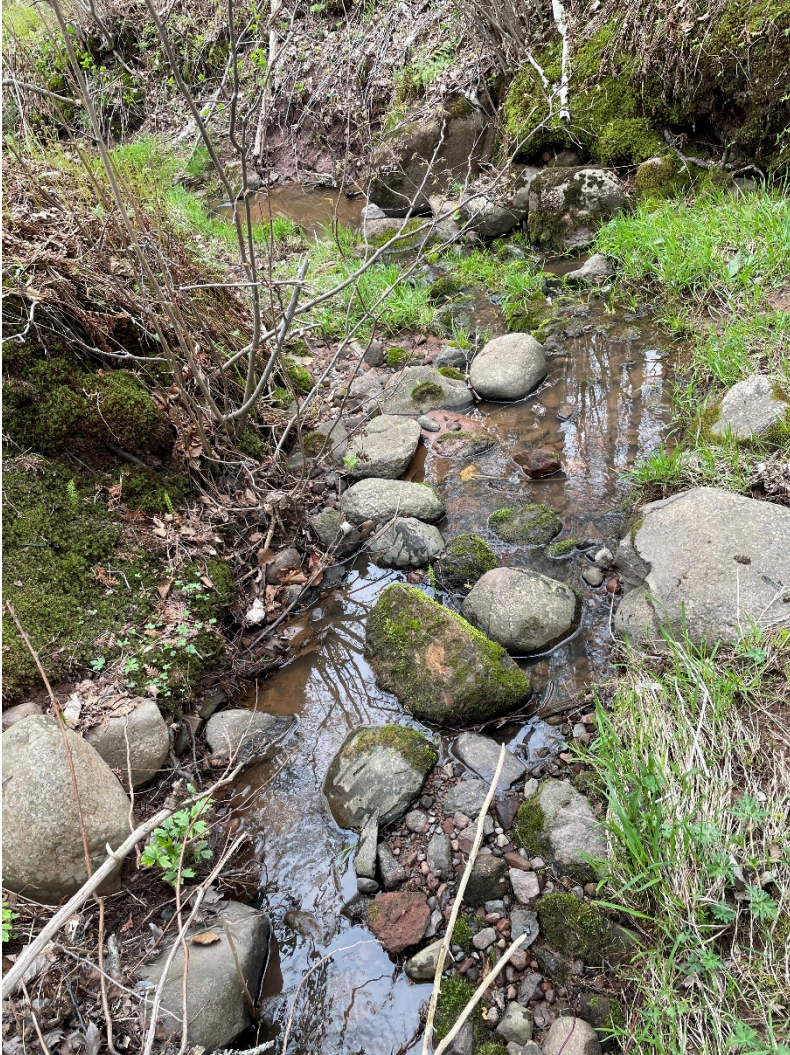
Downstream of Highway 13 the stream was larger and had good diversity of habitat within the survey area. Qualitative habitat score was 62. There were many riffles, run, and pools, some of which were deep (Photos 5-6). Depth was sufficient for fish. A lot of boulders, cobble, and gravel were present within the fish survey. The stream often dropped between six inches and up to a foot over boulders to a plunge pool due to the high gradient. These drops could make upstream movement difficult for fish. Downstream of the survey habitat was reduced as flows slowed, the stream became shallow, and then went underground (Photo 8). When the stream flowed again at the surface it was smaller than where the fish survey was

Photo 5. "Main channel" downstream of Highway 13 looking downstream.

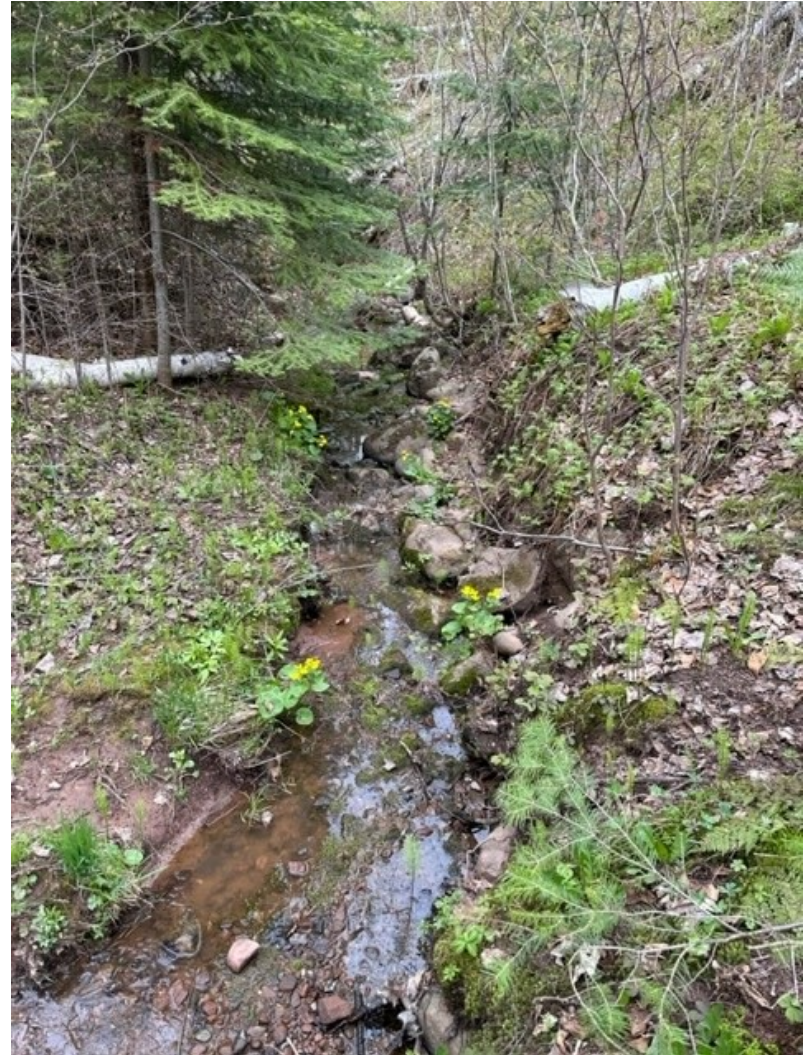
Photo 6. "Main channel" downstream of Highway 13 looking upstream.

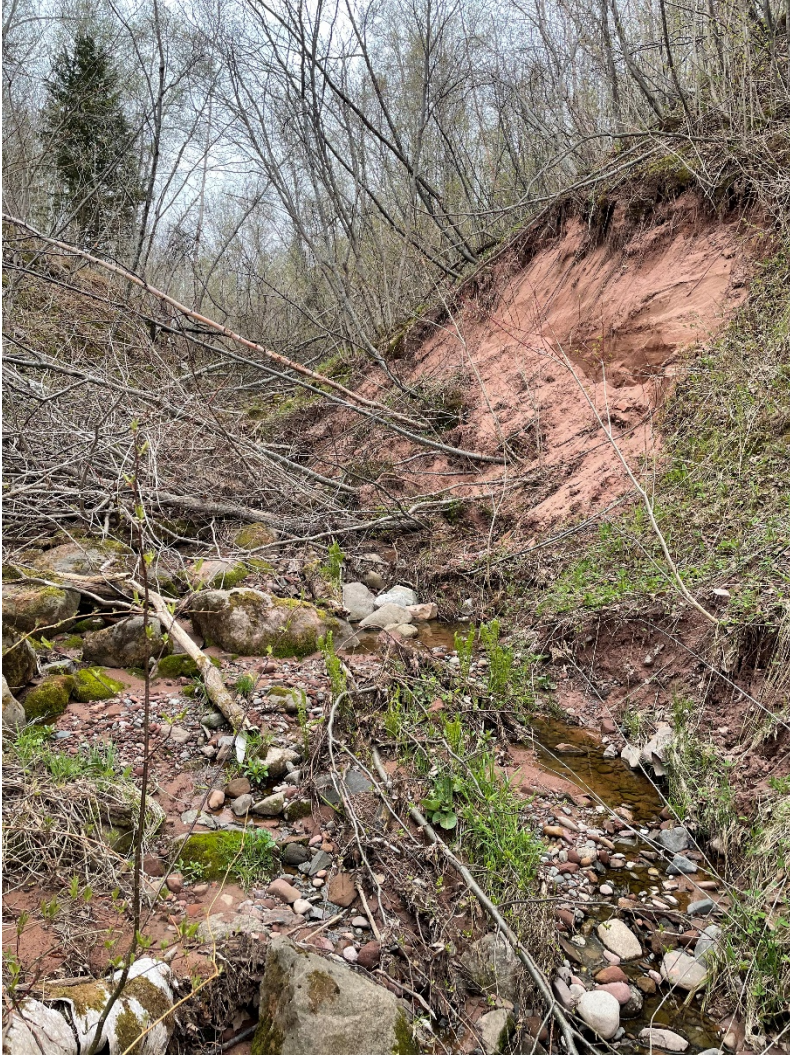
- Downstream of Highway 13 the stream flows through a steep ravine with a limited floodplain. Large bank failures and down trees were present (Photo 7), as were large boulders. The best stream habitat for fish was present in the fish survey downstream of the culvert. Closer to the mouth the stream switched to subsurface flow, then resurfaced to flow into Lake Superior. A woody debris pile was in the main channel at the mouth of the tributary (photo 10), but water flowed under it and over a beach to Lake Superior. The stream characteristics indicate that it receives high volumes of water at times.

Photo 7. "Main channel" bank erosion downstream of Highway 13 looking upstream.

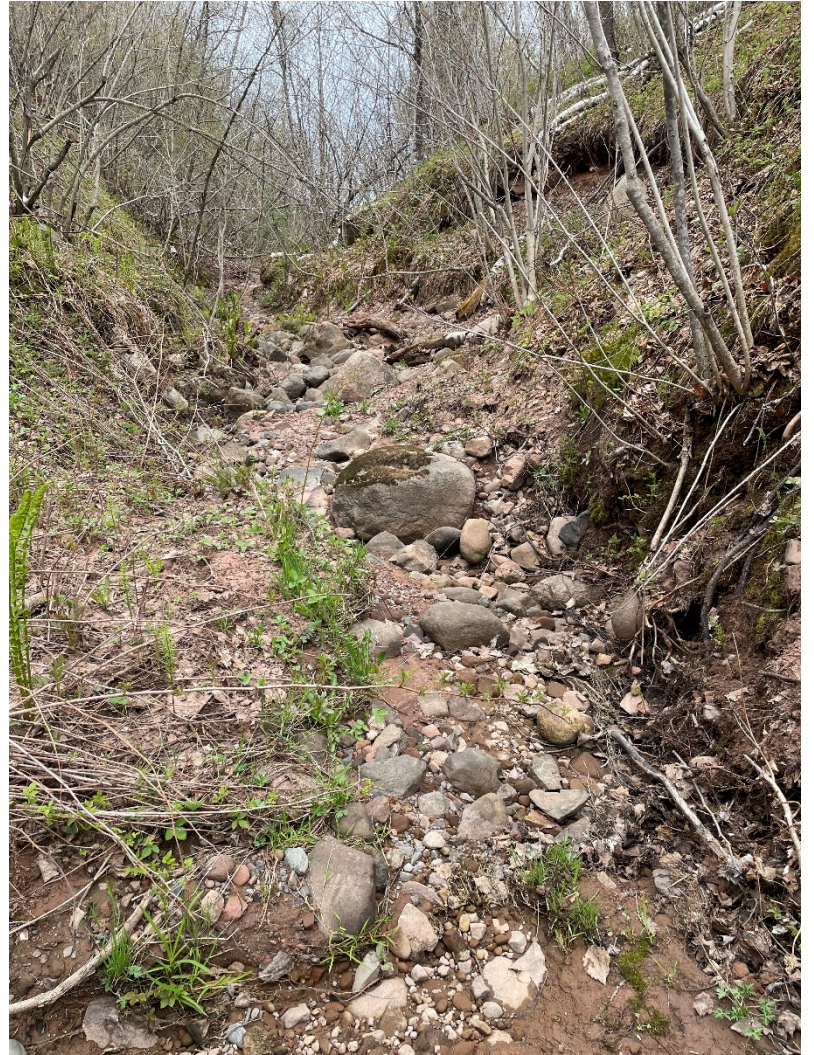
Photo 8. "Main channel" dry run downstream of Highway 13.

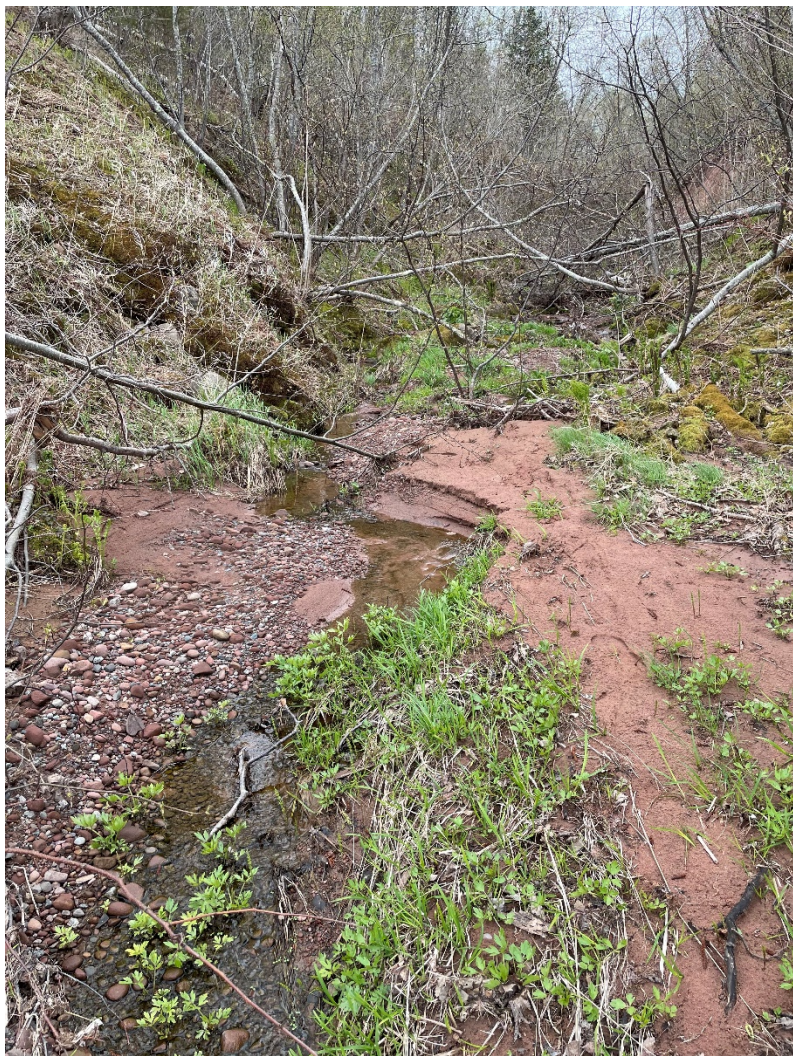
done (Photo 9). Fine sediments also increased downstream of the fish survey. Large bank erosion areas were observed below the fish survey.

Photo 9. "Main channel" downstream of Highway 13 near the mouth looking upstream.

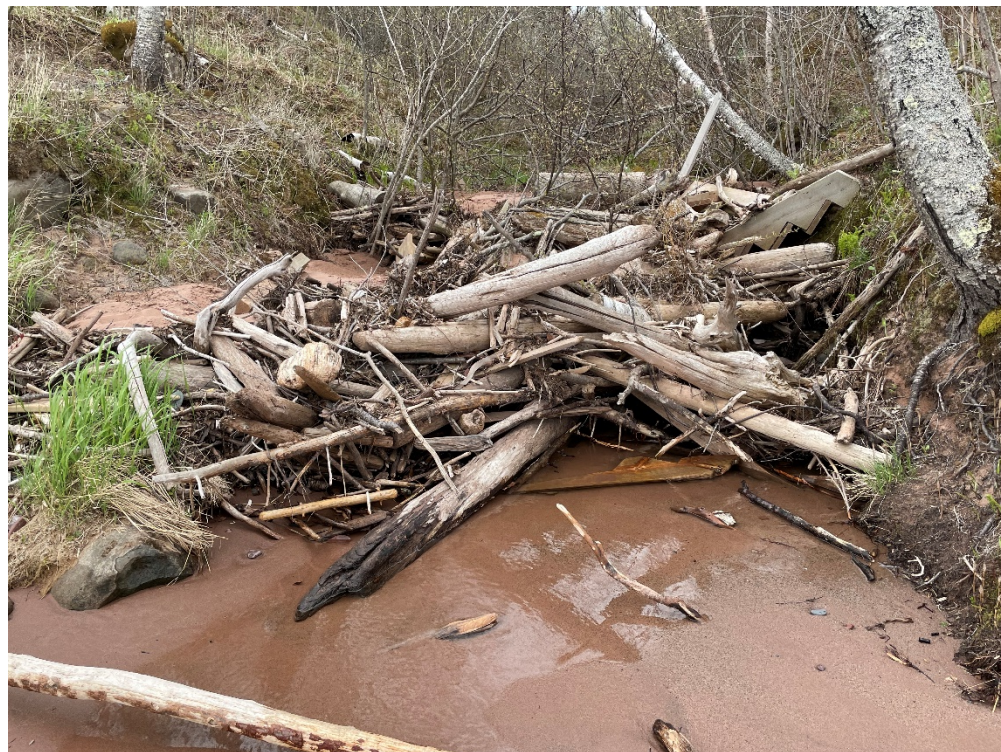
Photo 10. "Main channel" mouth flowing to Lake Superior.
