## Royal Scott S.D.

## New Franken, Wisconsin

## ROYAL SCOTT S. D. - NEW FRANKEN

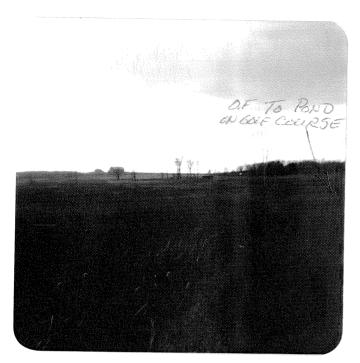
#2 Royal Scatt A.D.,

1 1 mile below STP

looking downstream

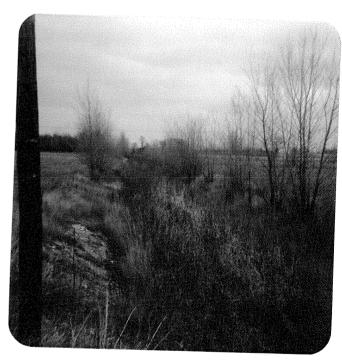
# 3 Royal Scott S.D.

2 ½ mile below STP

looking downstream
