STREAM CLASSIFICATION SURVEY ON WILLIAMS CREEK AND AN UNNAMED TRIBUTARY BELOW STAUFFER CHEESE, BLUE MOUNDS, WISCONSIN

Department of Natural Resources - Madison Area November, 1985 Prepared by Dave Marshall

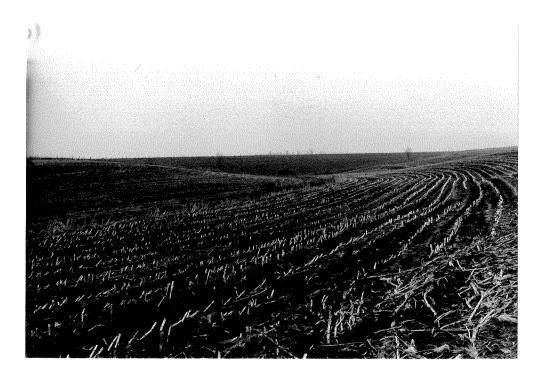
I HOTO I

The intermittent tributary which runs west of Stauffer Cheese to the confluence with Williams Creek was dry when inspected on October 8, October 31, and November 5, 1985. The intermittent nature of this drainage course cannot support permanent aquatic communities. Therefore, the classification of the tributary is marginal (MARG-E).

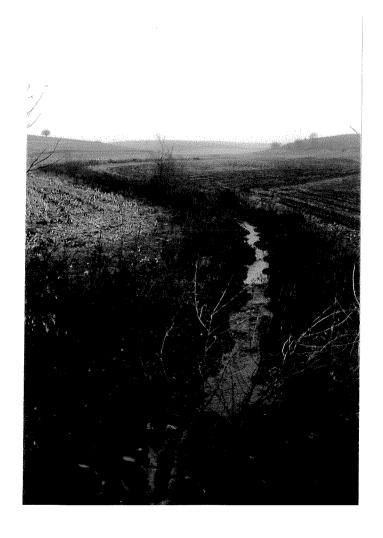
PHOTO 2

The current classification of Williams Creek is intermediate fish and aquatic life (INT-D) from the Blue Mounds Wastewater Treatment Plant downstream to Section 14, NE $\frac{1}{4}$, SE $\frac{1}{4}$, T6E, R5E. Based on a reclassification survey, the current classification is correct. Fish samples collected above E. Brigham Road (Section 13) consisted of only three brook sticklebacks and three creek chubs; both species categorized as tolerant forage. The Biotic Index indicated good water quality, however, the stream substrate was covered with silt, sludge, and filamentous algae. The stream above E. Brigham Road had good gradient and numerous riffles. In many areas, groundwater recruitment was revealed by the presence of watercress. A benthic community consisting of mostly Gammarus pseudolimneus is supported by the good reaeration potential in the stream. More diverse aquatic communities are limited by cropland erosion, manure runoff and low flow conditions. The overall habitat was rated as poor.
