**Re: Oconto Falls (Upper)**  
**FERC Project, No. 2523**  
**N.E.W. Hydro, Inc.**  
**Article 407, Purple Loosestrife & Eurasian Watermilfoil Inventory**

**Oconto Falls Upper Project Purple Loosestrife & Eurasian Watermilfoil Inventory  
August 1, August 2, & August 3, 2007  
FERC Project #2523 Article 407**

**NEW Hydro, Inc.  
116 State St.  
Neshkoro, WI 54960**

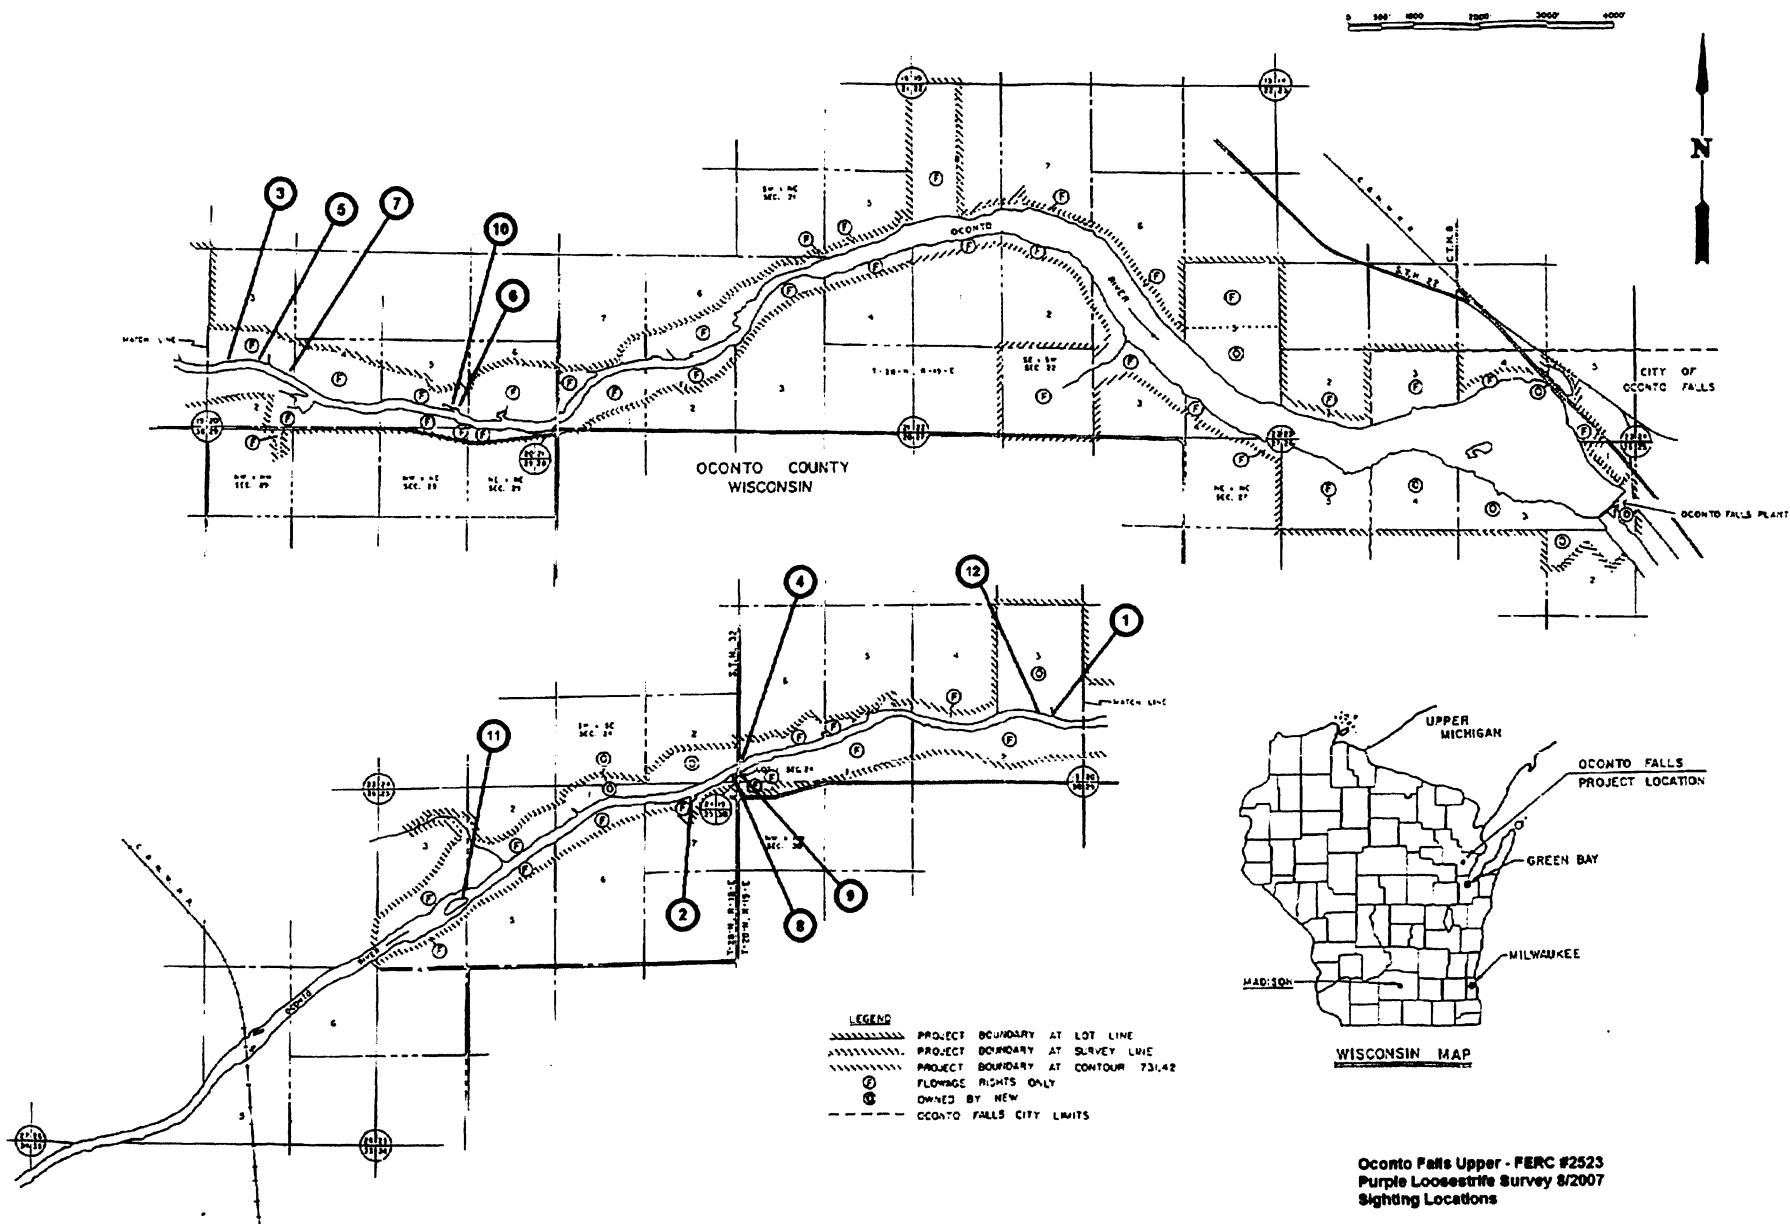
Oconto Falls Upper - FERC #2523  
Purple Loosestrife Survey 8/2007  
Sighting Locations

*The headwaters* were surveyed by boat. Seven occurrences of purple loosestrife plants were observed in this area and are noted on the lake map and survey comments at the end of this report. One of these occurrences appears to be on project owned land and is so noted.

Sighting #1 (located on project owned land) was observed in 2000, 2001, 2002, 2003, 2004, 2005, 2006 and 2007 and appears to have reduced in numbers. In 2002 seed heads on three of the plants nearest the main river were removed, bagged, and burned to reduce possibility of spreading. In 2003, 2004, 2005, 2006, and 2007 all plants at this location were sprayed with an herbicide. It should also be noted that, in 2005 and 2007, a few mature plants appeared to have insect damage such as that produced by *Gallerucella* beetles. In 2007, *Gallerucella* beetles were positively identified on a number of plants.

Sighting #2 was observed in 2000, 2001, 2002, 2003, 2004, 2005, 2006, and 2007 and appears to have reduced in density considerably since 2005. None of the plants were treated, pulled or had seed heads cut in 2000, 2001, 2002, 2003, 2004, 2005, 2006, or 2007. It should be noted that in 2006, the lower portion of the remaining plants appeared to have insect damage such as that produced by *Gallerucella* beetles.

Sighting #5 was observed in 2002, 2003, 2004, 2005, and 2006. In 2007, the number of plants appeared to have been reduced and all plants were pulled. Minor beetle damage was noted in 2007.

Sighting #6 was observed in 2002, 2003, 2004. In 2002, 2003, and 2004, seed heads on all of these plants were removed to reduce possibility of spreading. In 2005, no plants were observed at this location. In 2006, two plants were once again observed and were pulled. In 2007, 7 plants were observed and pulled. Minor beetle damage was noted in 2007.

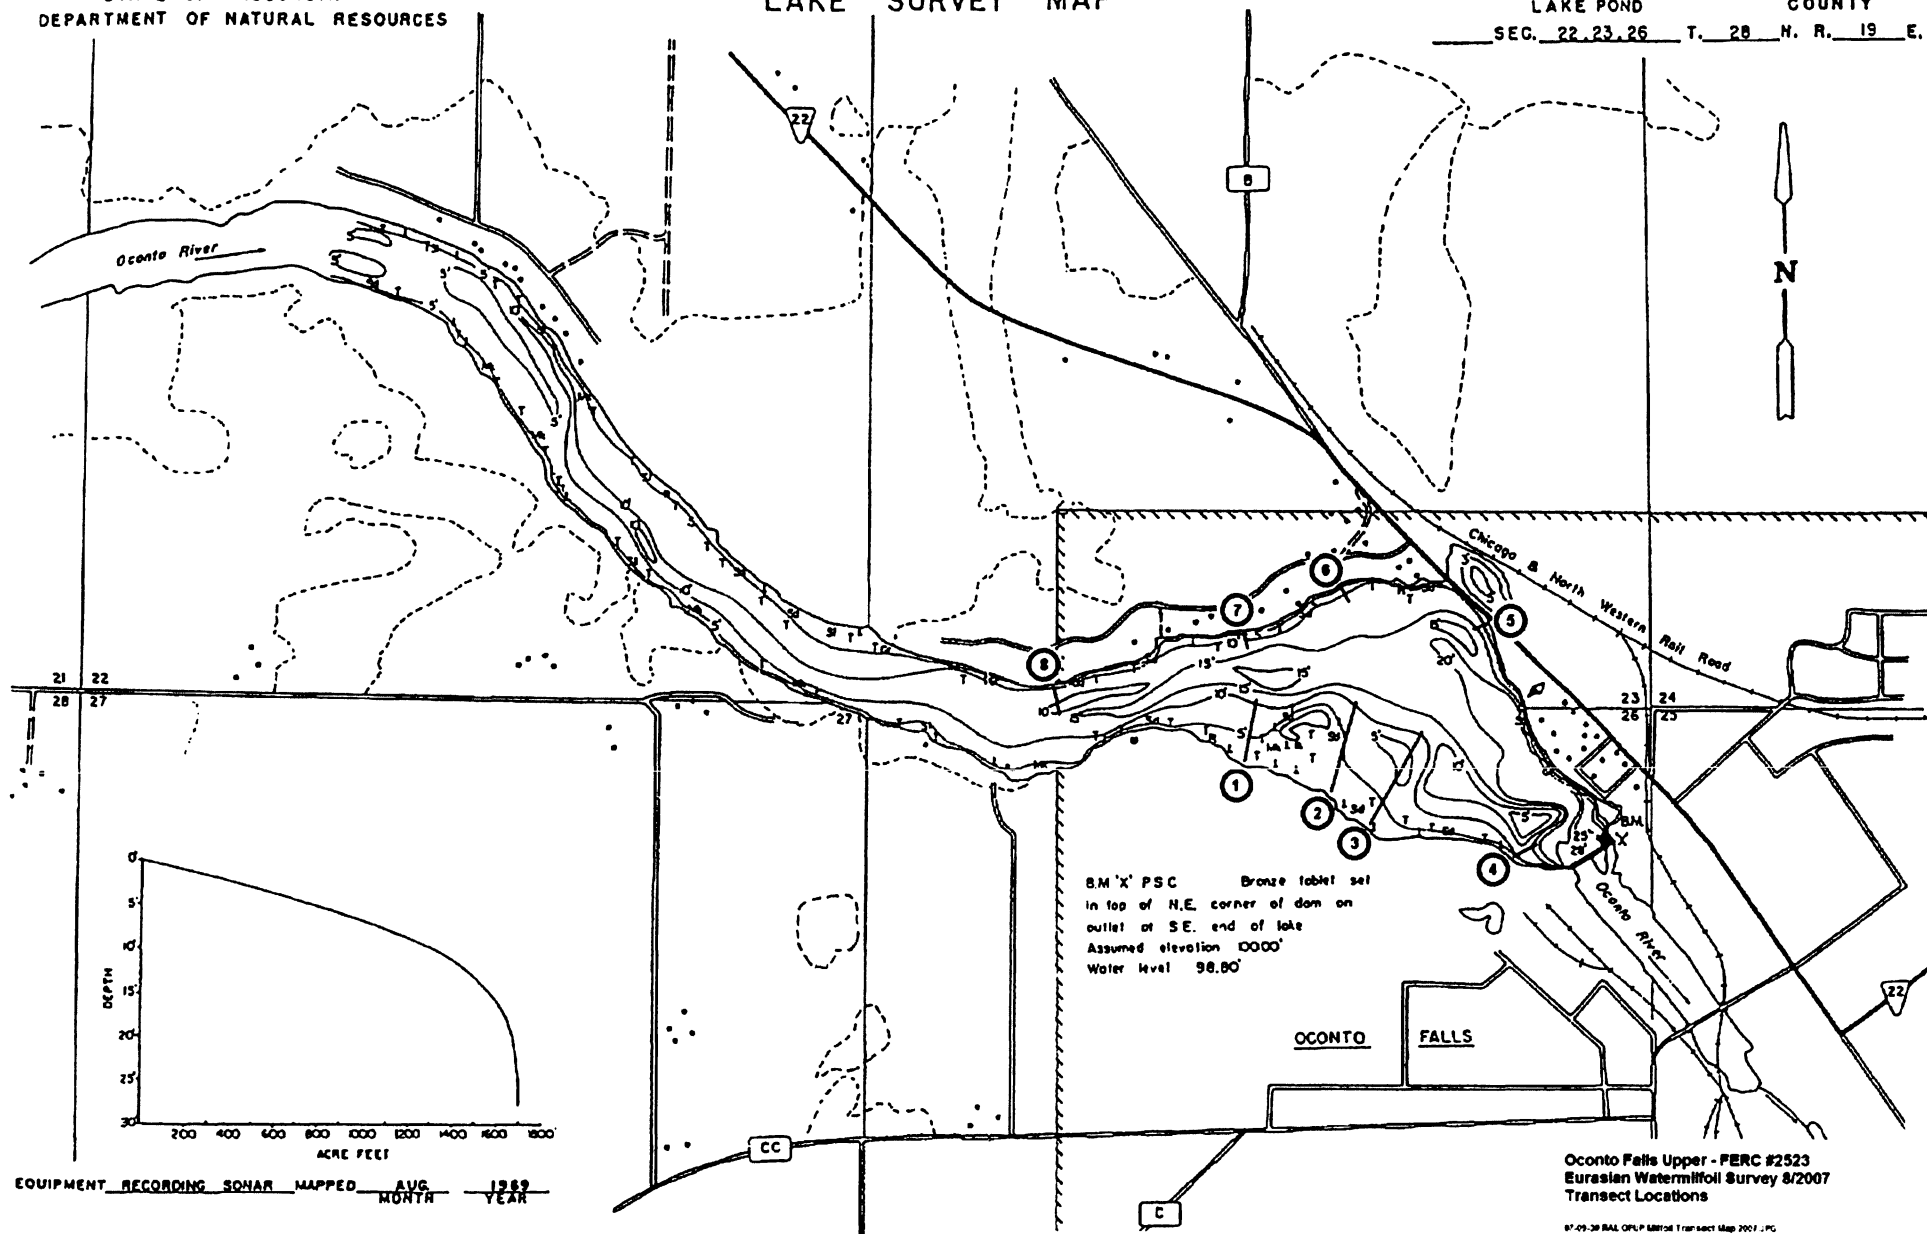
Oconto Falls Upper - PERC #2523  
Eurasian Watermilfoil Survey 8/2007  
Transect Locations

No Eurasian watermilfoil was detected at sampling locations with depths greater than 5'. Those occurrences at 5' depth and less were easily identified without the use of dredging techniques as the plants had grown to the surface and most had reddish tops.

Eleven mats containing Eurasian watermilfoil were identified within the project boundary of which mat #1, #2, #3, and #4 were first identified in the 2000, mat #5 was first identified in 2001, mat #6 and #7 were first identified in 2003, mat #8 was first identified in 2005, and mat #9, #10, and #11 were identified in 2006. All eleven mats were discovered using the visual search method. All of these mats were interspersed with other types of plants and all of the mats had Eurasian watermilfoil densities as noted in the survey comments at the end of this report. Mats #1 through #10 are located in the *main basin* while mat #11 is located in the *headwaters*.

Eurasian watermilfoil weed densities, overall, increased noticeably from 2006 to 2007. It seems to be at its highest density and is located furthest upstream since surveys began in 2000.
