Appendix 3

Shoreland Inventory Photographs

## Appendix 4

### Shoreland Inventory Results for Amnicon and Dowling Lakes

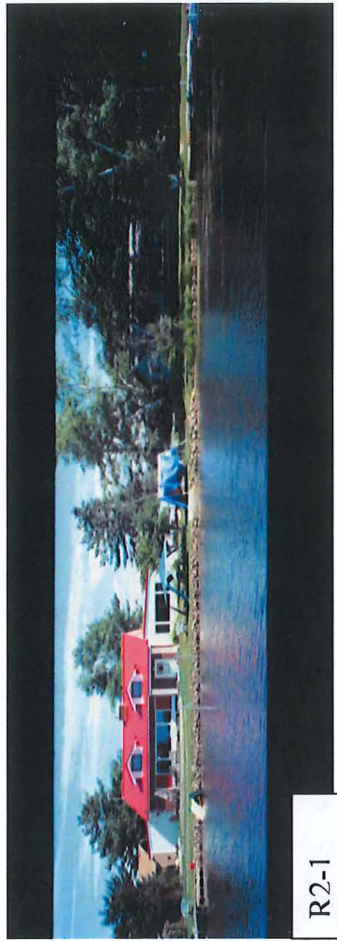
| ID # | Natural Upland Condition | | Natural Shoreline Condition | | Shoreline Erosion | | # of Lots | Undev. Lots | Shoreline Structure | | | Comments |
|---|---|---|---|---|---|---|---|---|---|---|---|---|
| R2-1 | | | | | X | | 1 | | X | X | X | Also a retaining wall for a patio |

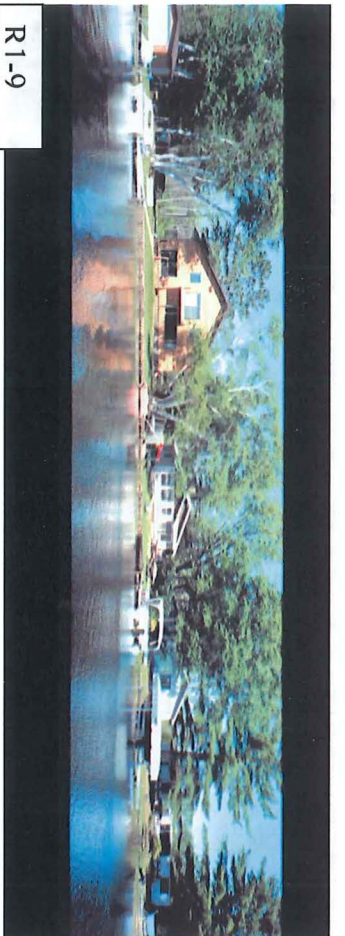
| ID # | Natural Upland Condition | | Natural Shoreline Condition | | Shoreline Erosion | | # of Lots | Undev. Lots | Shoreline Structure | | | Comments |
|---|---|---|---|---|---|---|---|---|---|---|---|---|
| R1-9 | | | | | XX | | 2 | | X | | X | Wood Retaining Wall |

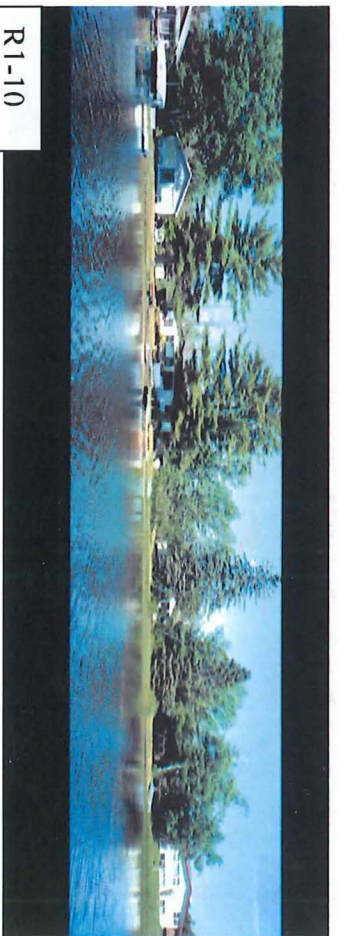
| ID # | Natural Upland Condition | | Natural Shoreline Condition | | Shoreline Erosion | | # of Lots | Undev. Lots | Shoreline Structure | | | Comments |
|---|---|---|---|---|---|---|---|---|---|---|---|---|
| R1-10 | | | | | XXXX | | 4 | | XX | | XX | Both 1 foot high wood walls |

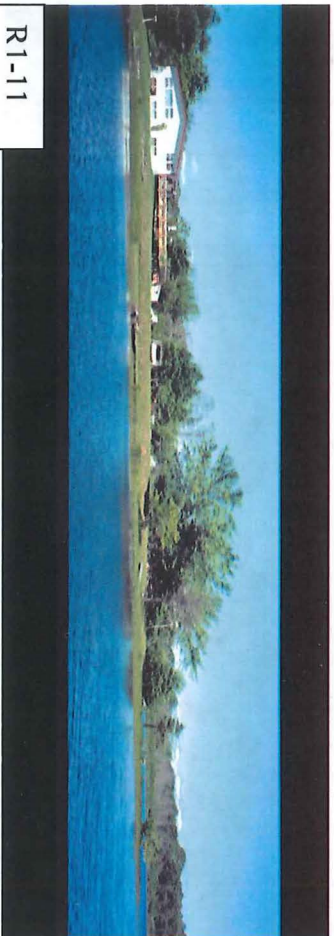
| ID # | Natural Upland Condition | | Natural Shoreline Condition | | Shoreline Erosion | | # of Lots | Undev. Lots | Shoreline Structure | | | Comments |
|---|---|---|---|---|---|---|---|---|---|---|---|---|
| R1-11 | | | | | | slight | 1 | | X | | | Erosion on east bank |
