for Flambeau Crowley Hydroelectric Project FERC Project #2473 Flambeau Hydro, LLC Price County, Wisconsin

Summary of Purple Loosestrife Inventory for Flambeau Crowley Hydroelectric Project, FERC #2473

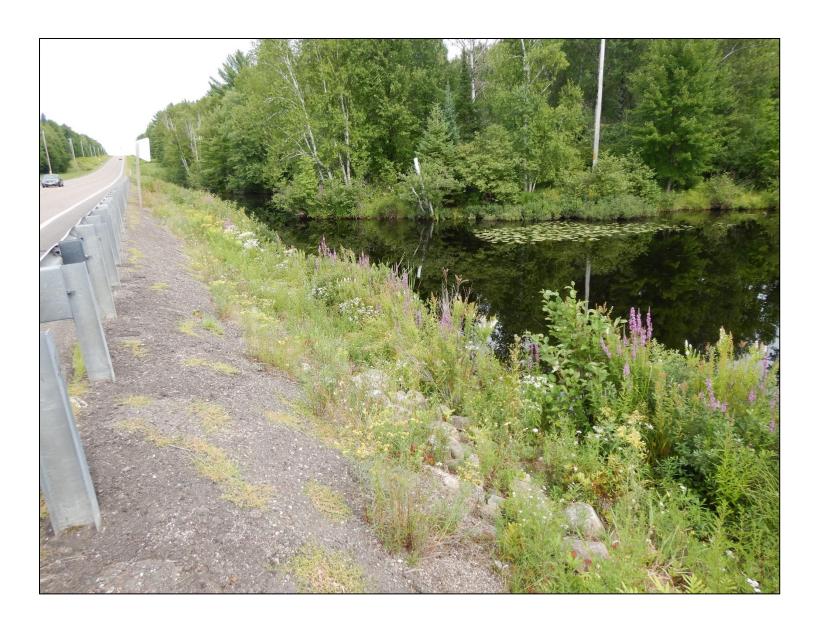
Photo 1. Purple loosestrife growing along roadside.

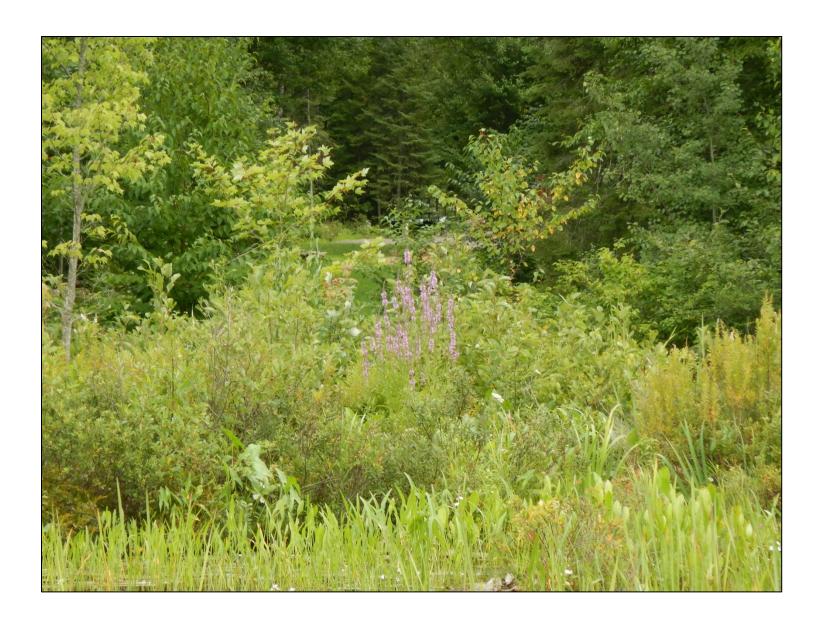
Photo 2. Purple loosestrife growing on wooded bank.

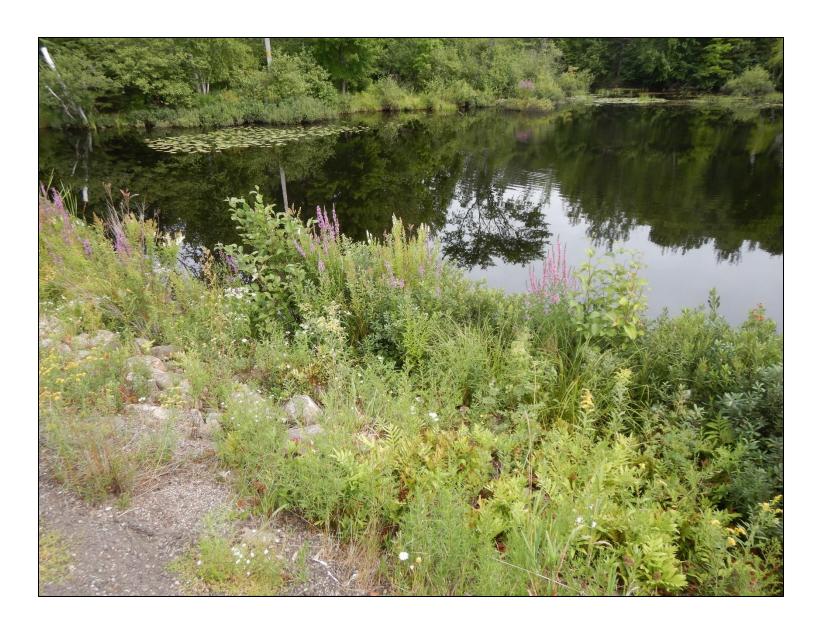
Photo 3. Purple loosestrife growing along roadside.
