## Anvil Lake Association Healthy Lakes Report

Grant Number: LPT61419

Grant Sponsor: Anvil Lake Association

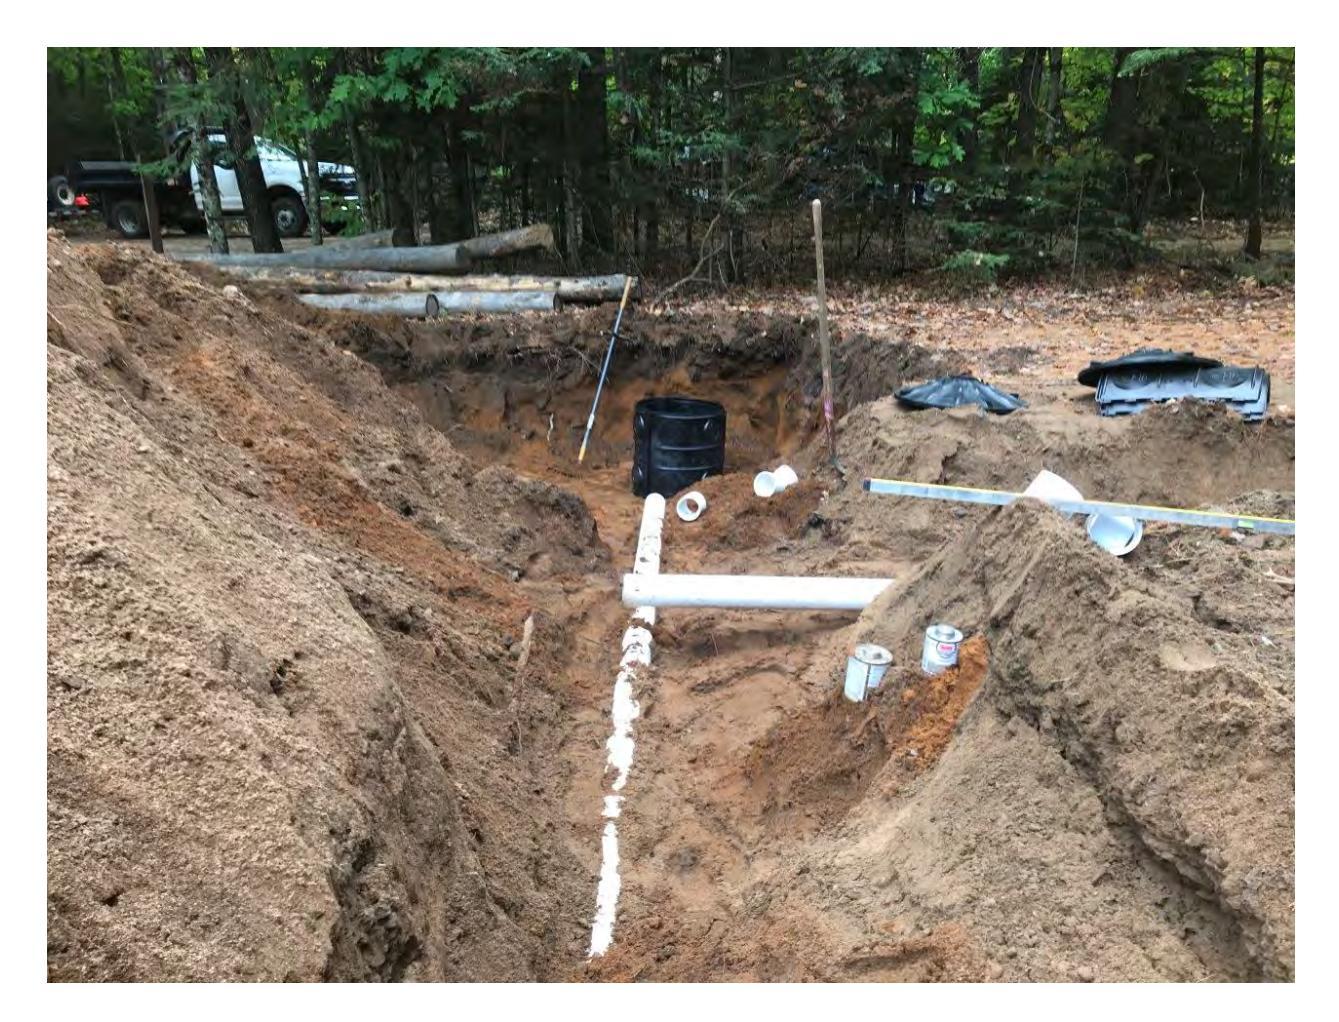
This is a photo taken in October of 2019. The run off from the roof of the garage will be channeled from gutters through the pipes being laid to the black cistern. The water will filter directly into the sandy subsoil and disperse into the ground, returning the rain to the property's aquifer. The surface water from the surrounding landscape drains into the superficial area of the rain garden.

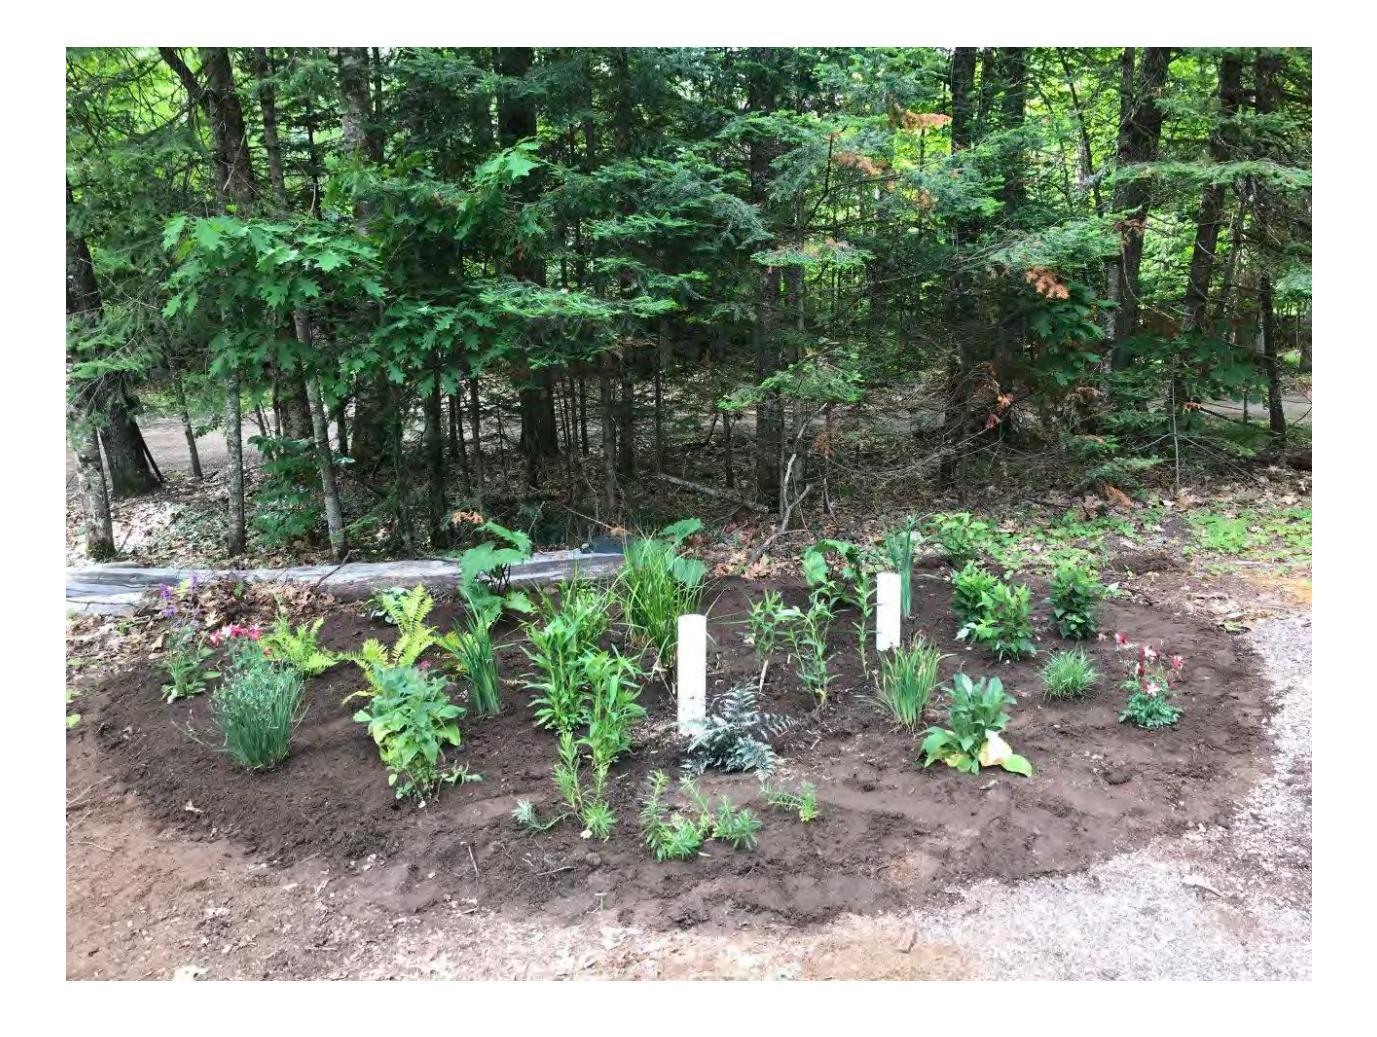
The next picture was taken in June of 2020, at the completion of the project. The rain garden site has been filled with a 12 inch layer of a blend of planting soil and compost over a layer of small stones. More than twenty different species of perennials were planted. They were selected for their hardiness, their natural look and their deer resistance.

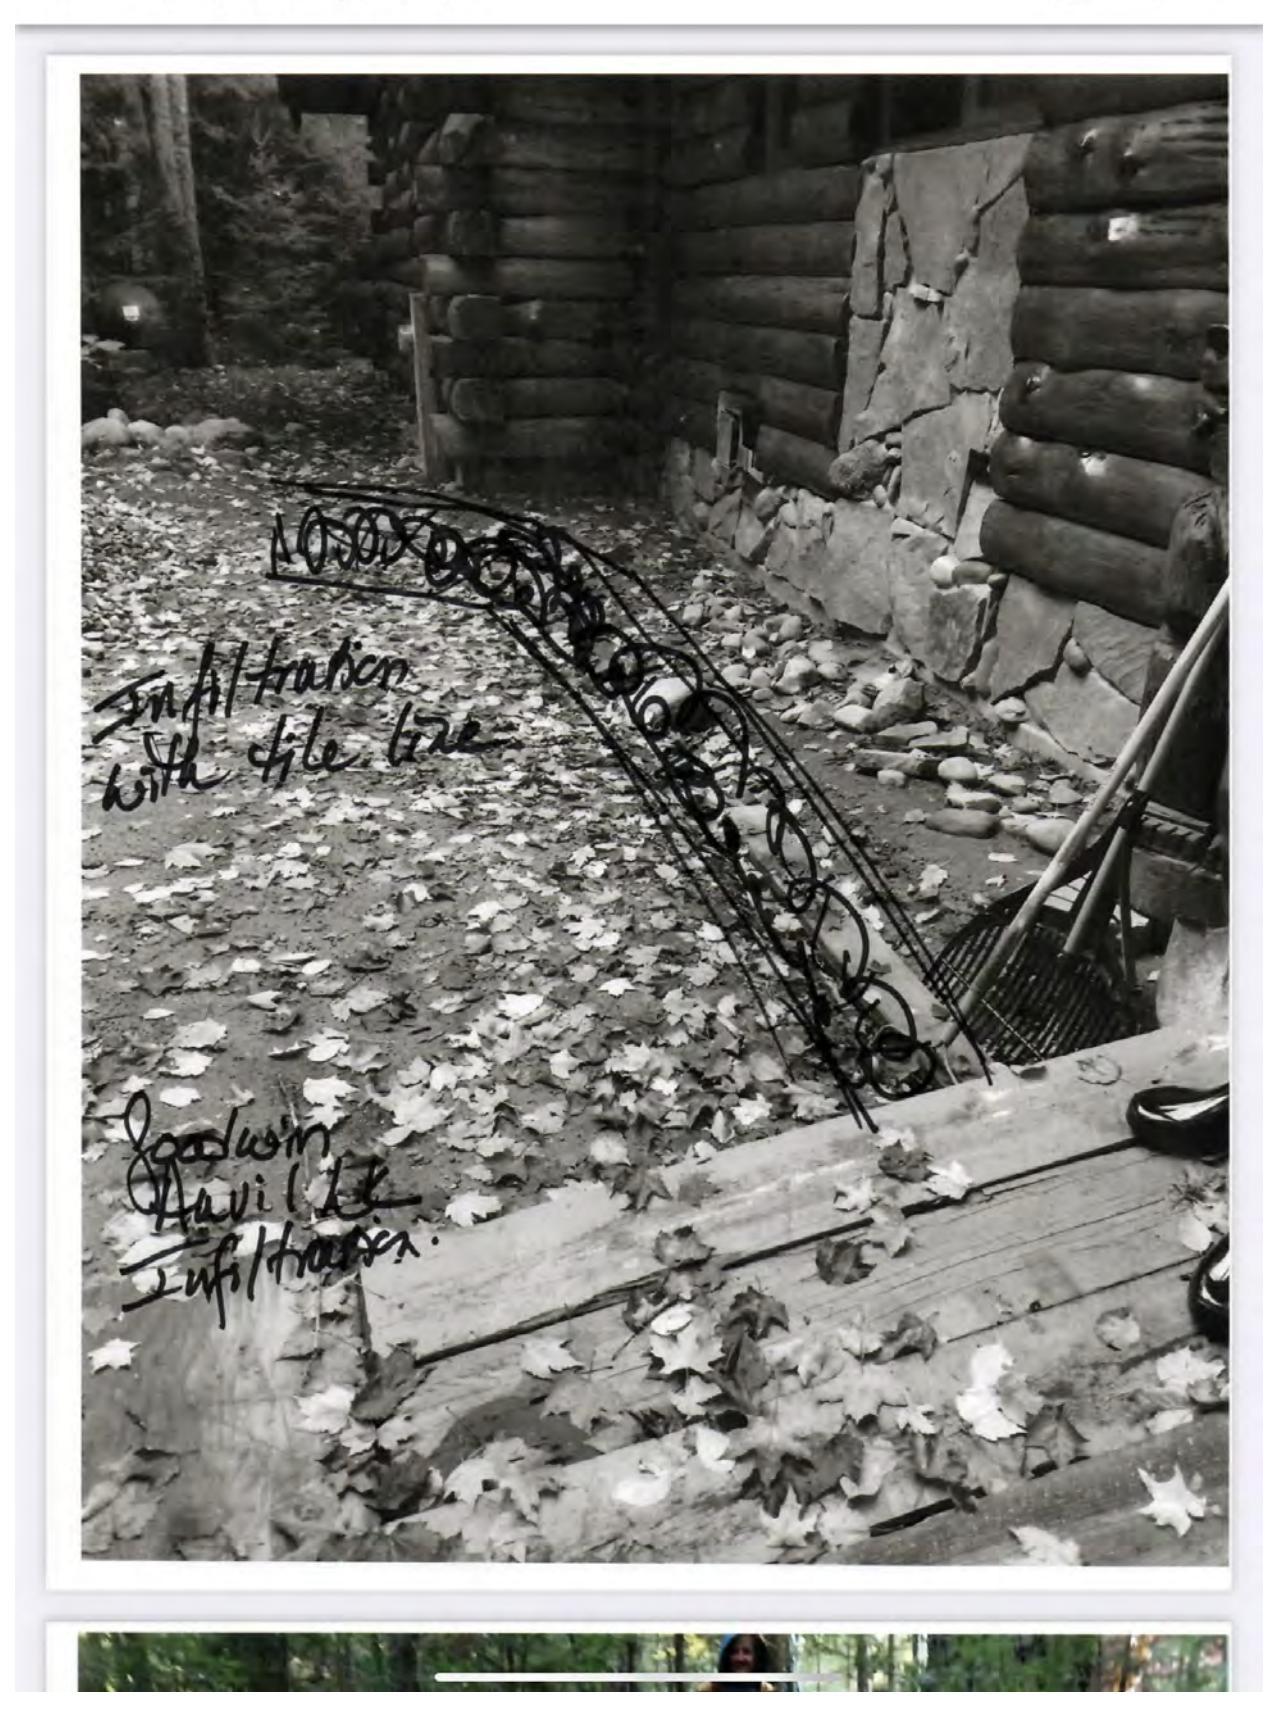
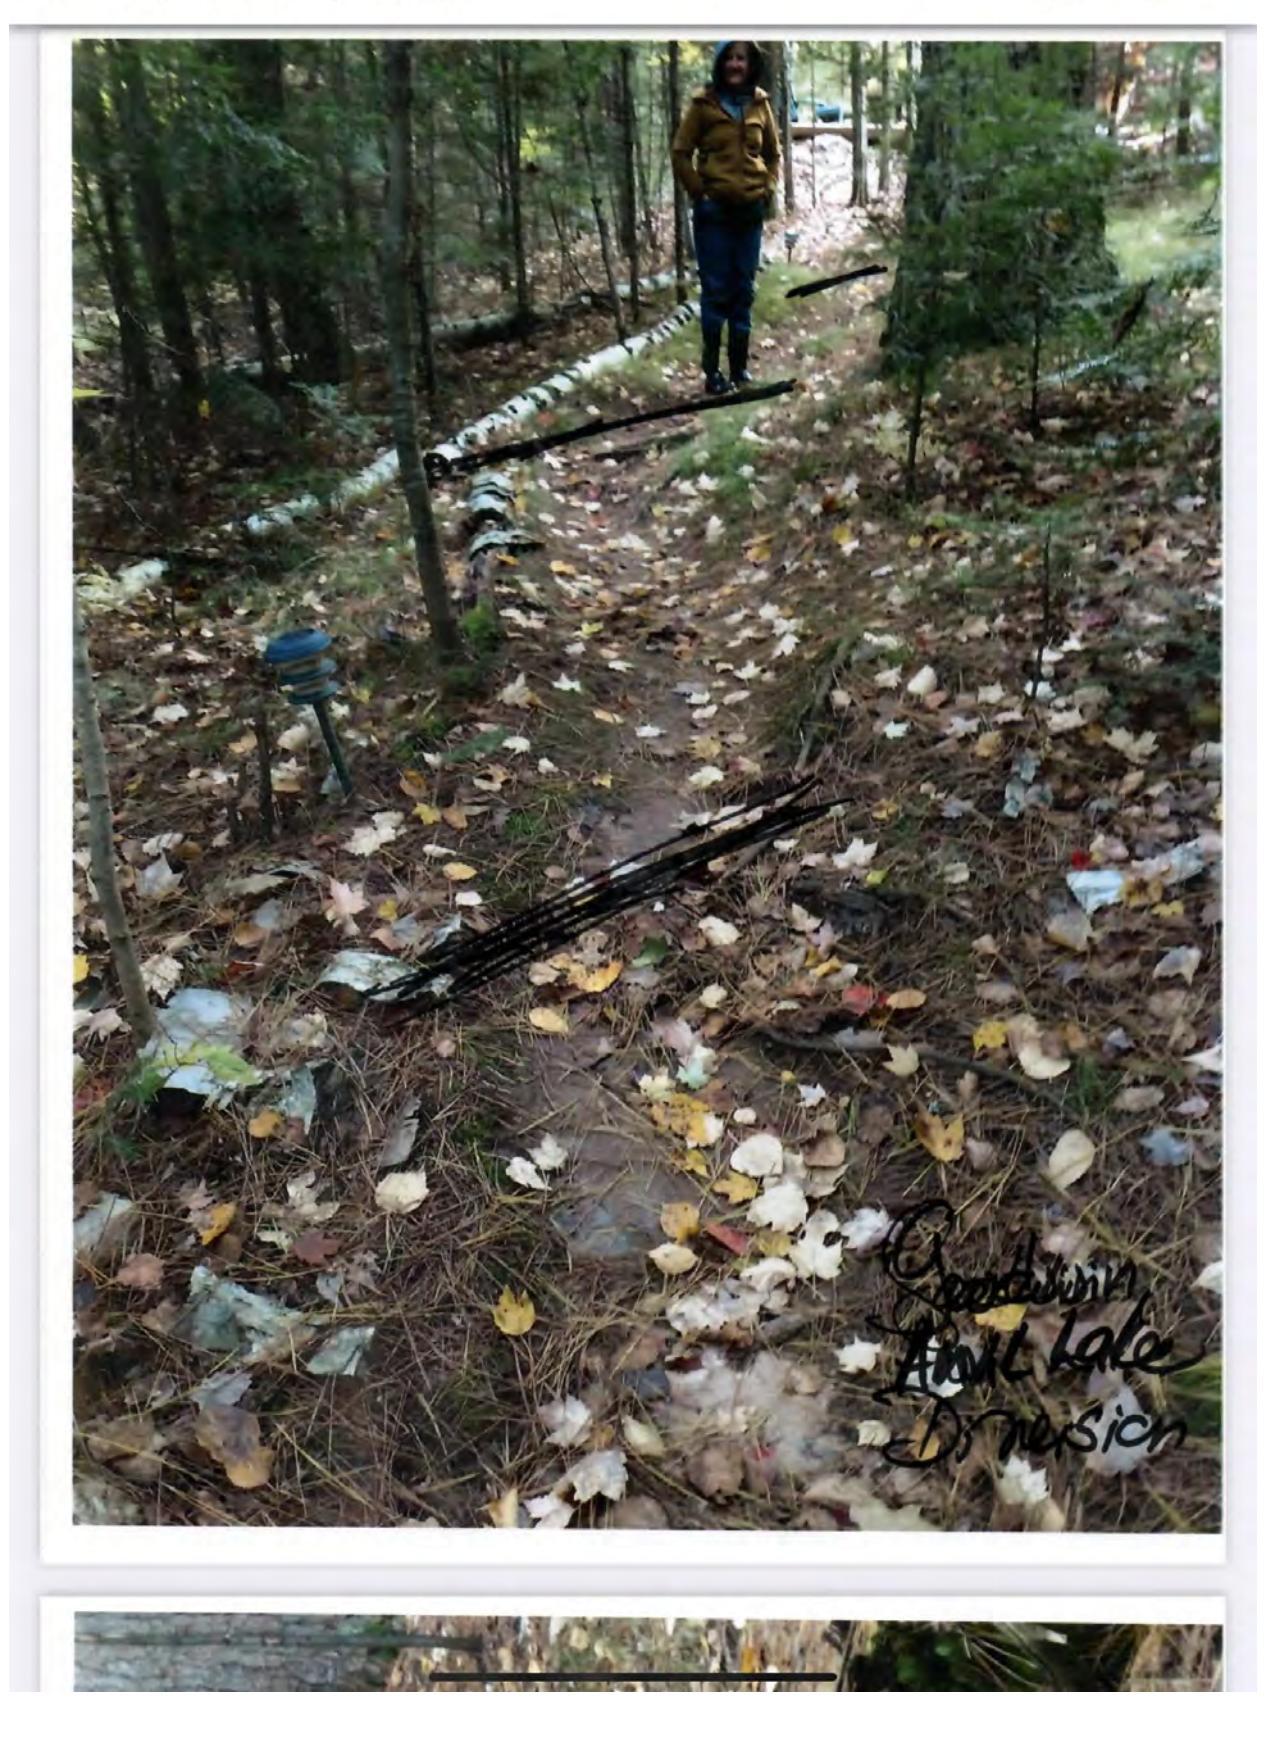
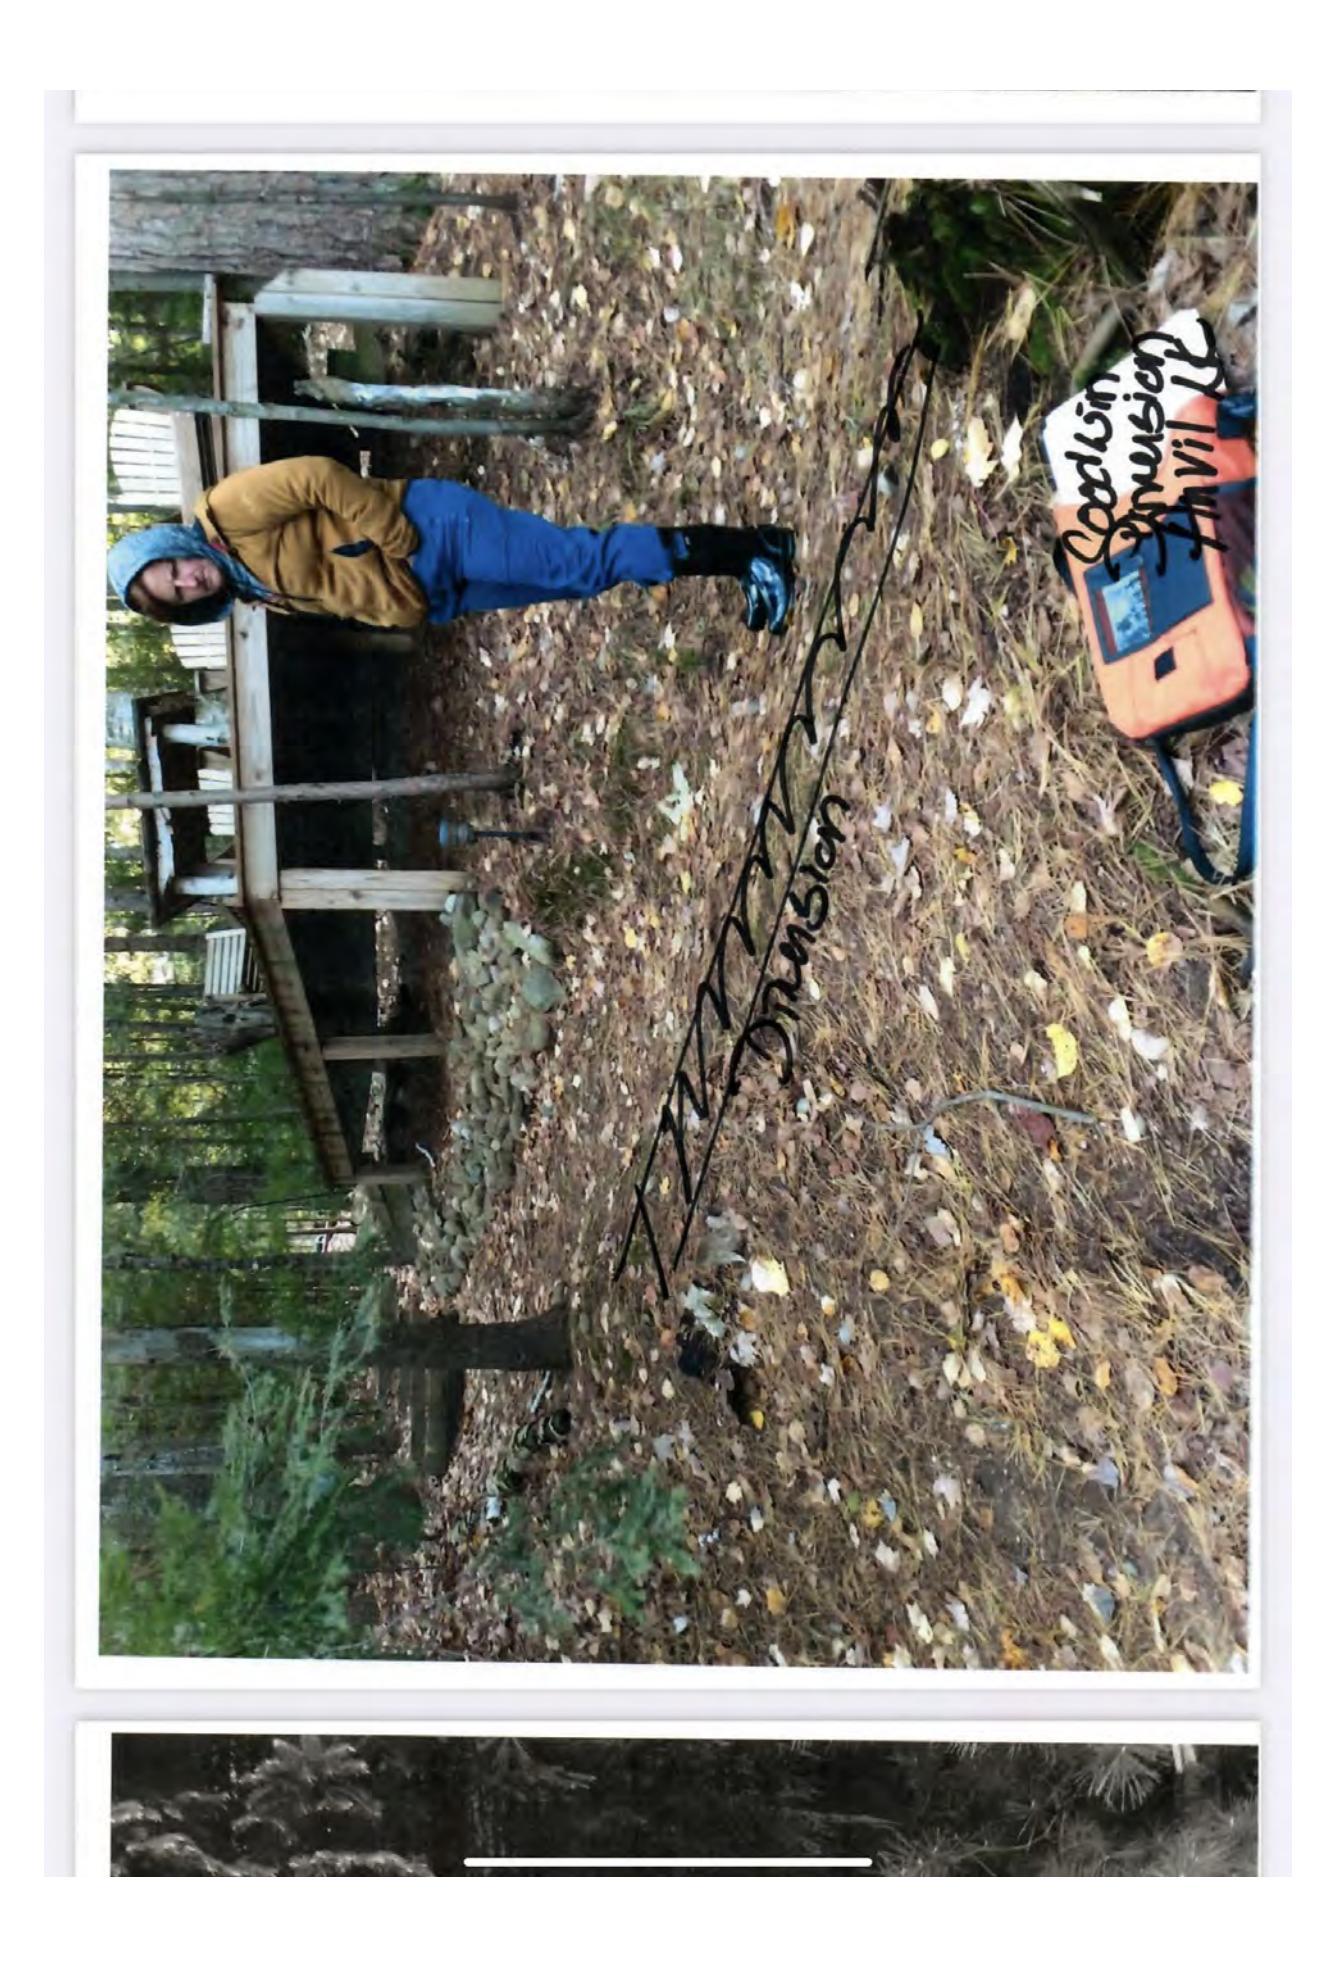
**Before Pictures** In order, the first picture is of the rock infiltration areas. It now catches the rain water off of the roof. The second and third pictures are the areas that now divert water off the path to the lake. The fourth picture is the area at the end of the path that leads right to the lake. It now captures rain water off both the path and the roof line of the shed.

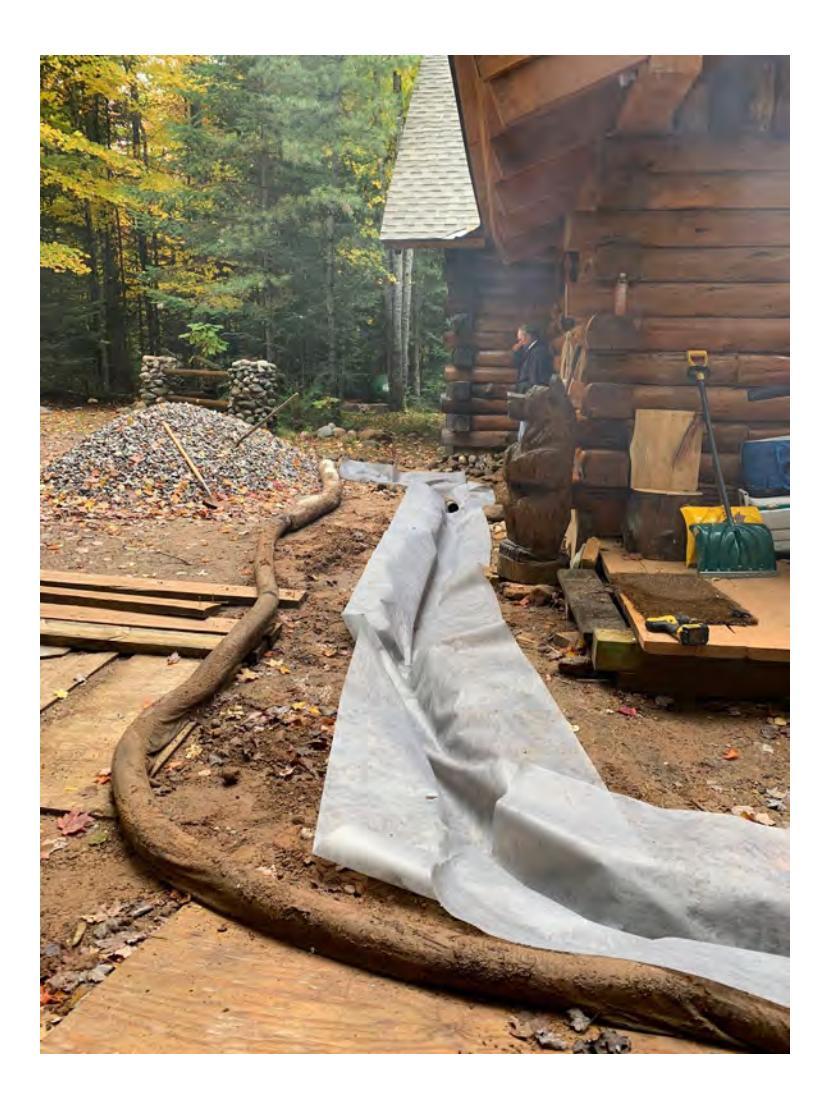
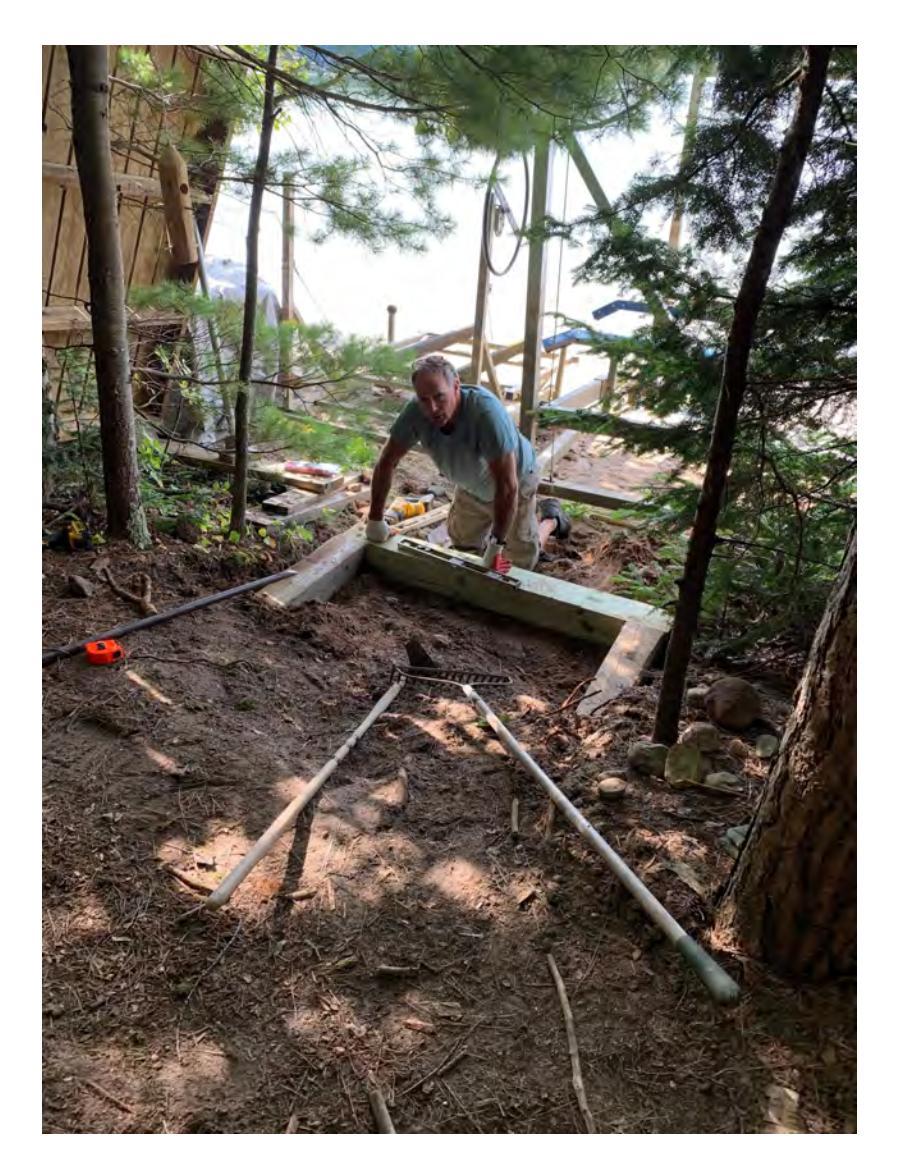
**During Pictures**: In order, the first picture is the rock infiltration area being dug out and lined. The second picture is the other rock infiltration area being framed.

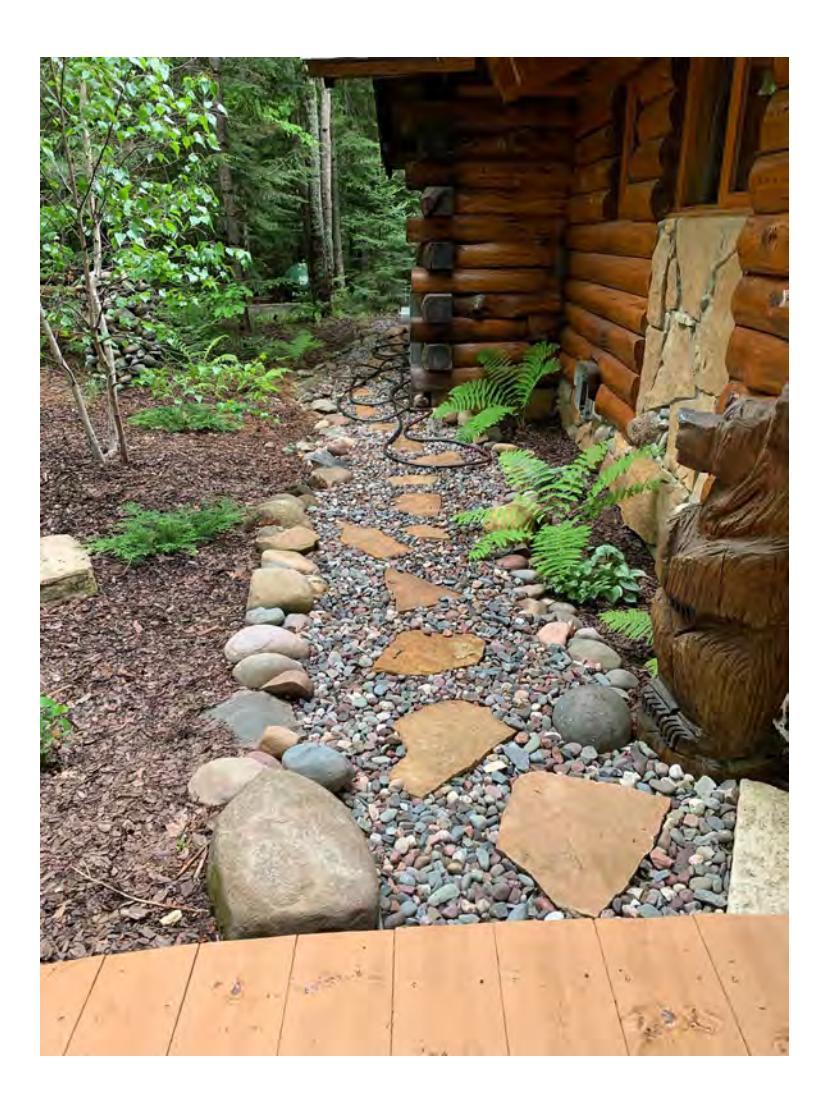
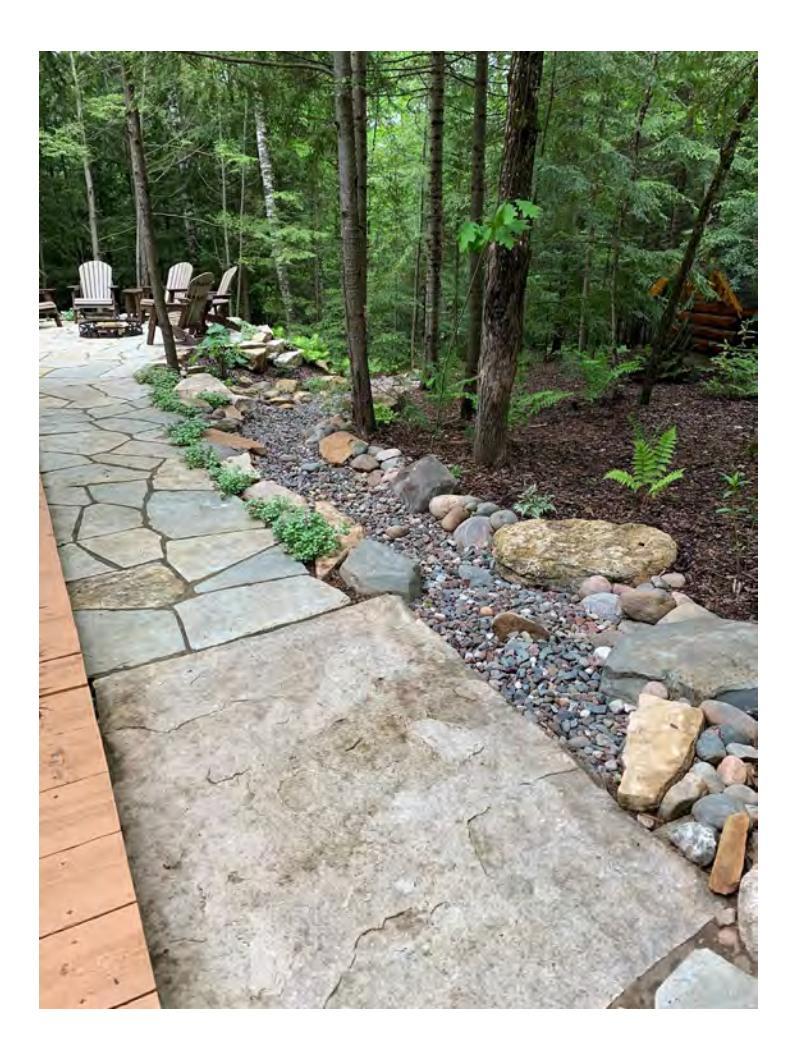
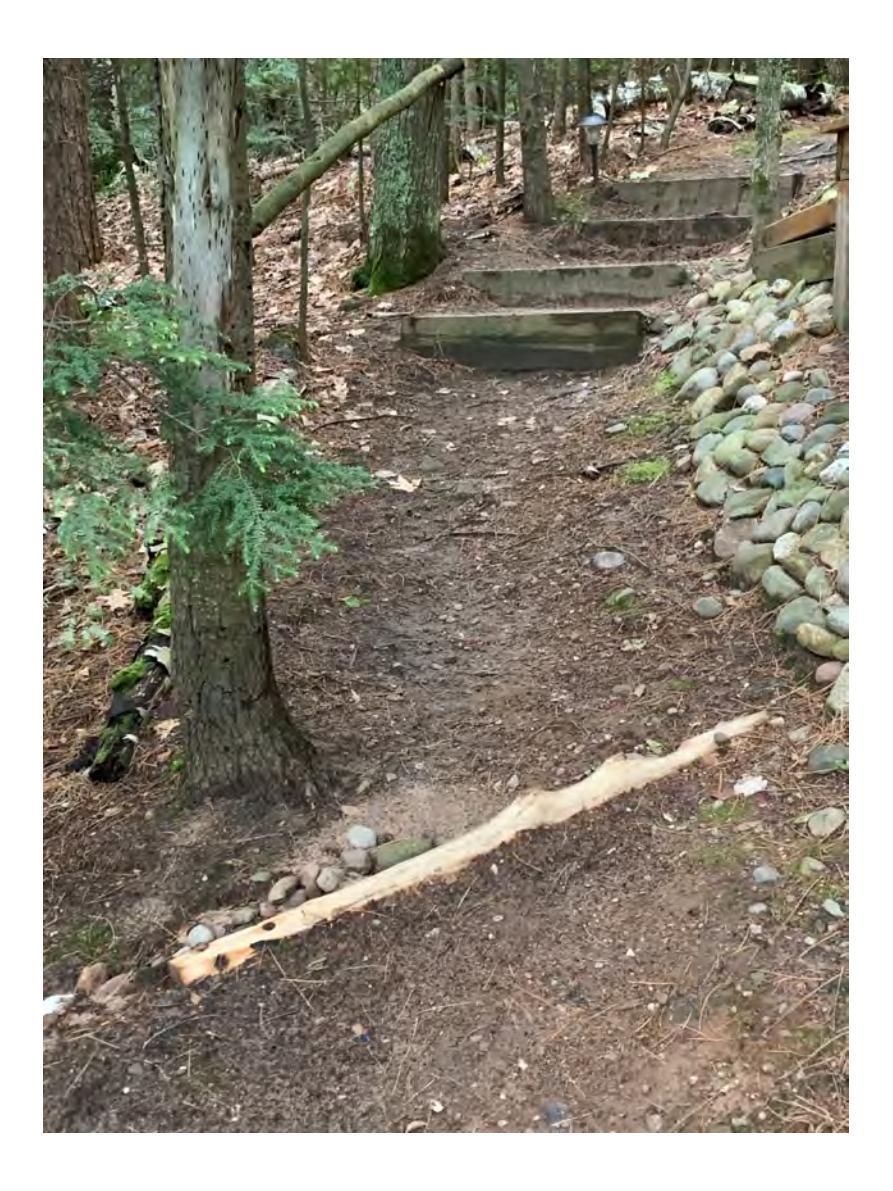
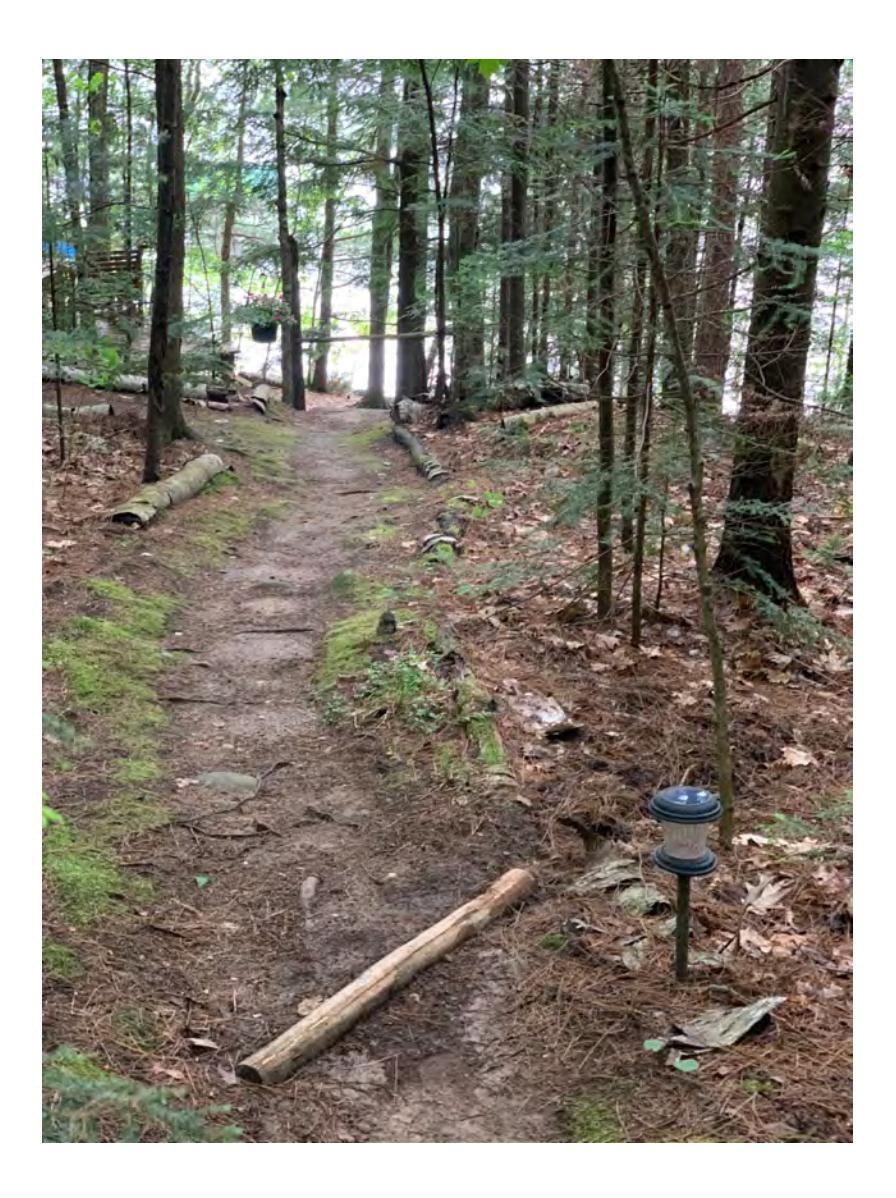
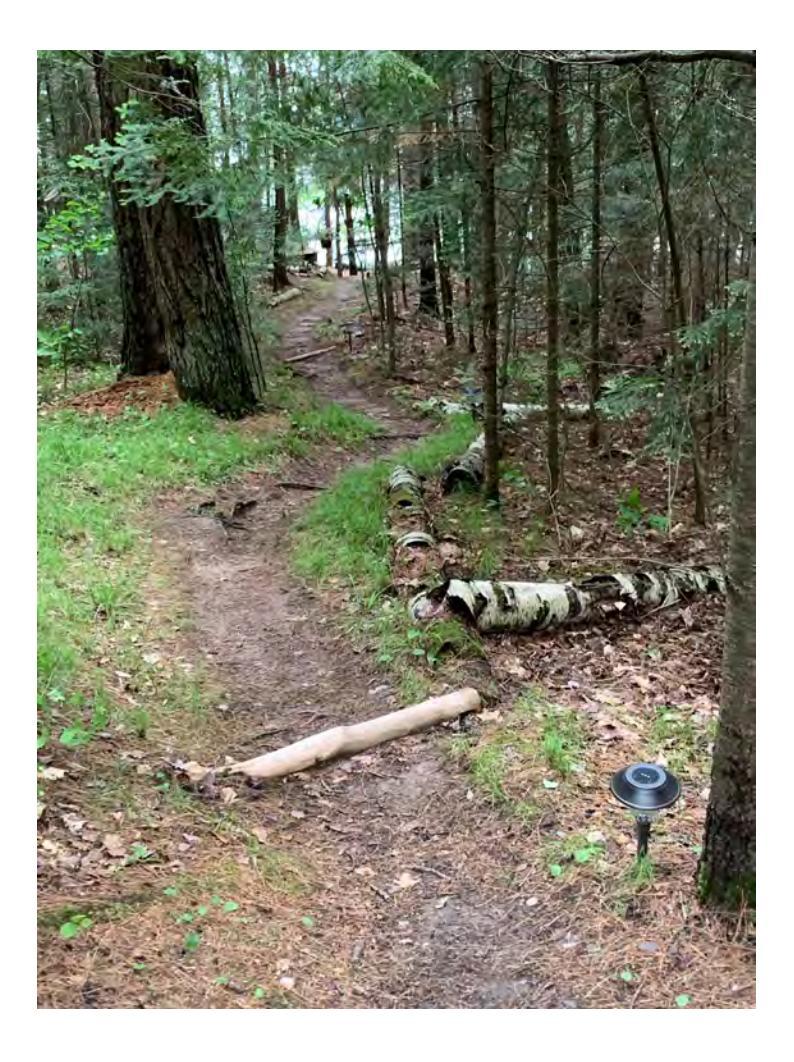
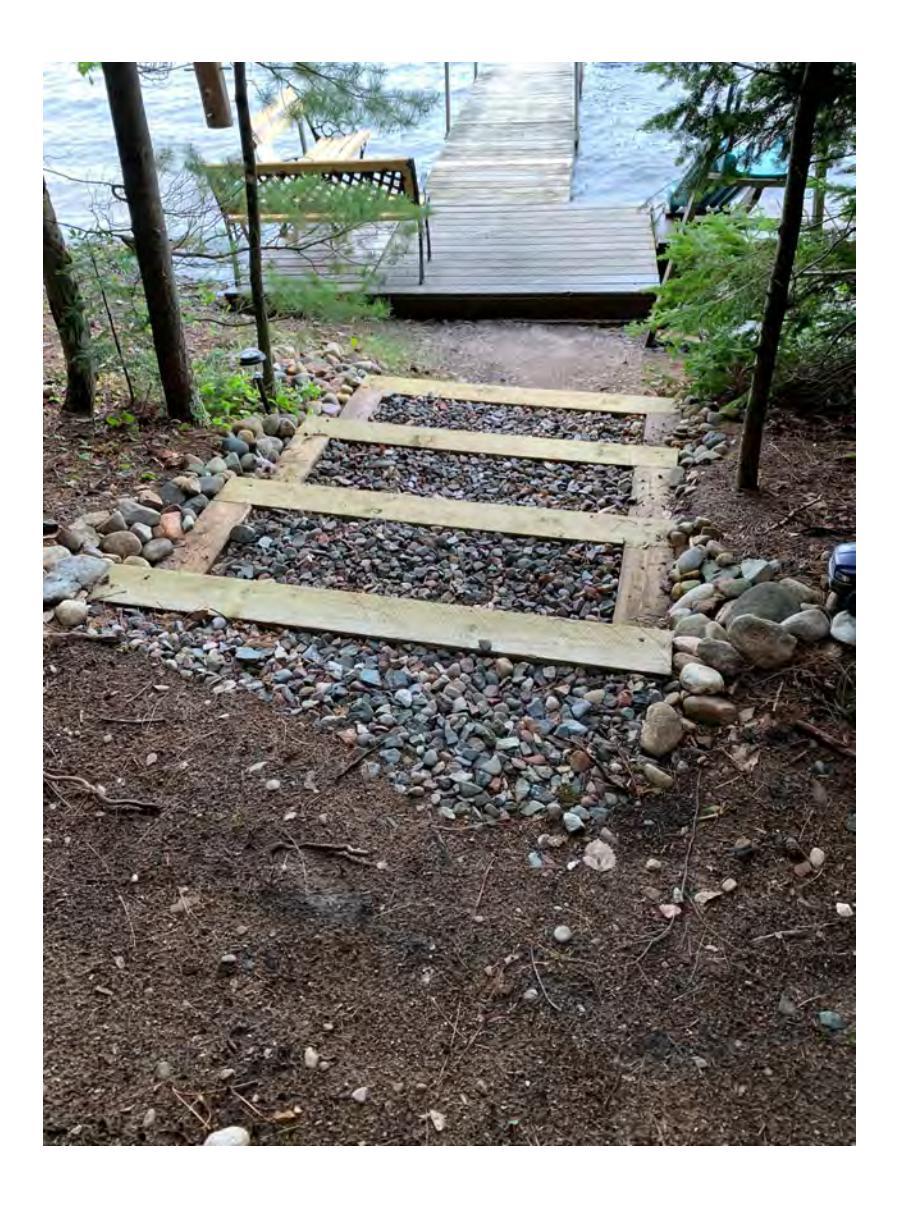
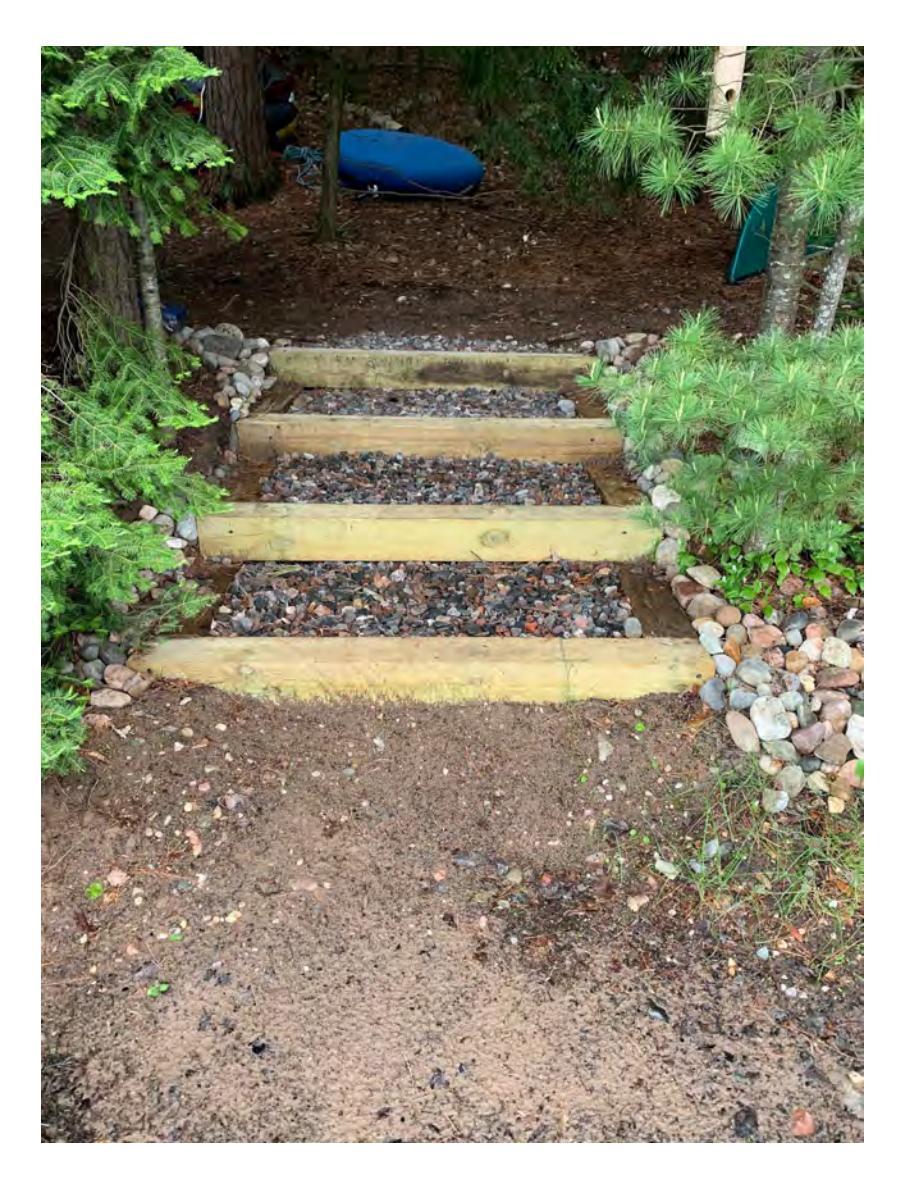
**After Pictures**: In order, pictures 1 and 2 are of the rock infiltration that captures the roof run off. Pictures 3-5 are of the divergersion down the path to the lake. Pictures 6-7 are of the rock infiltration area at the end of the path and near the lake entry.
