Figure 1. Willow Creek Watershed

Project Information
Project Number: 0010-0099-01
Modified: May 19, 2011

Appendix C

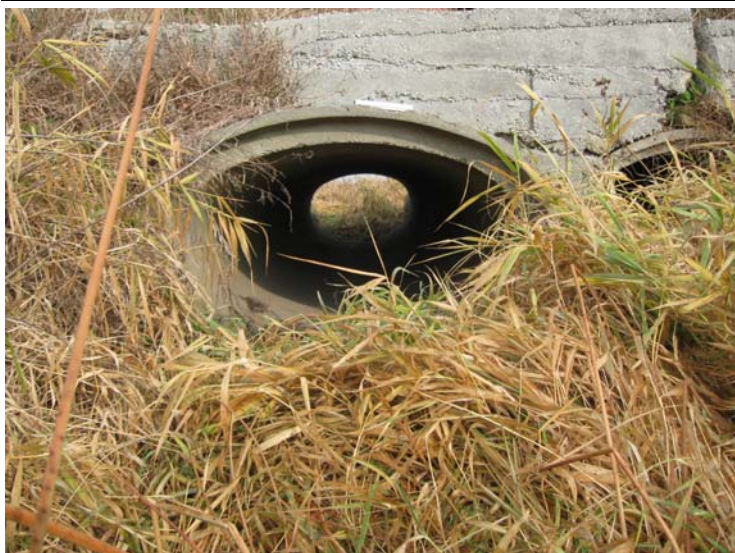
Photo 1 – C3 outlet

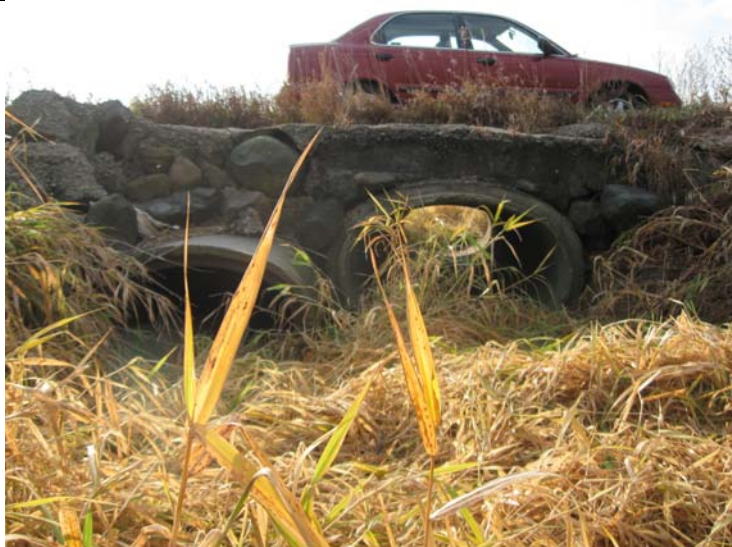
Photo 2 – C3 inlet

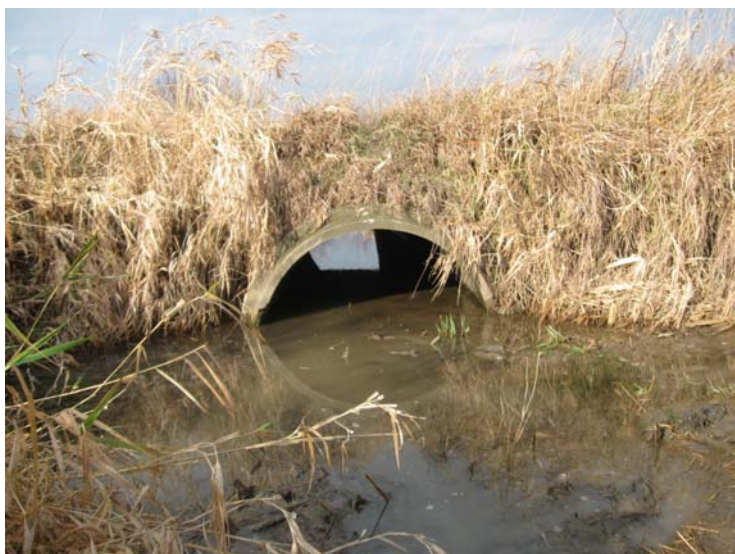
Photo 3 – C2 outlet

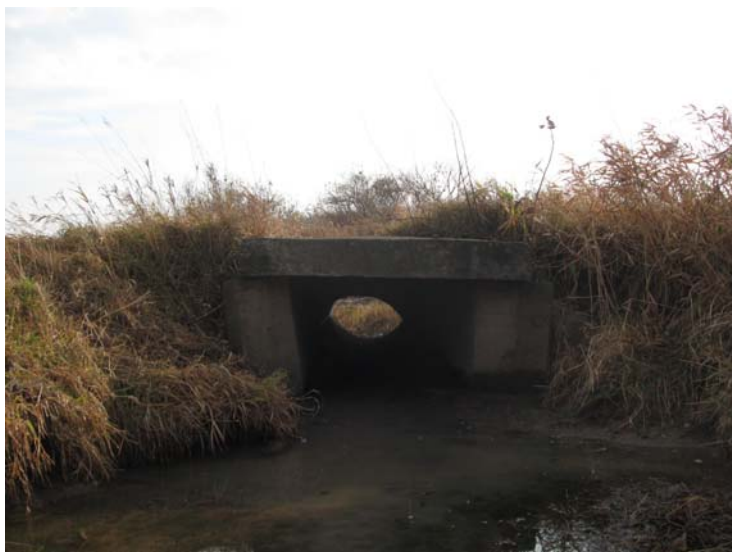
Photo 4 – C2 inlet

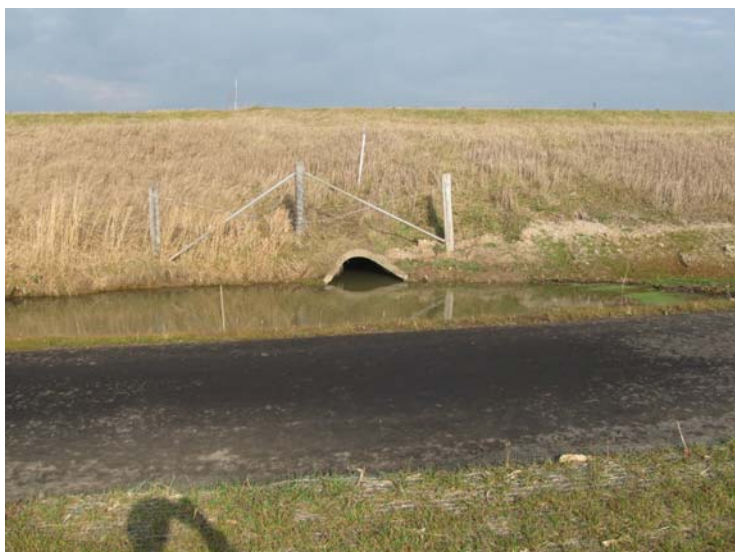
Photo 5 – C1 outlet

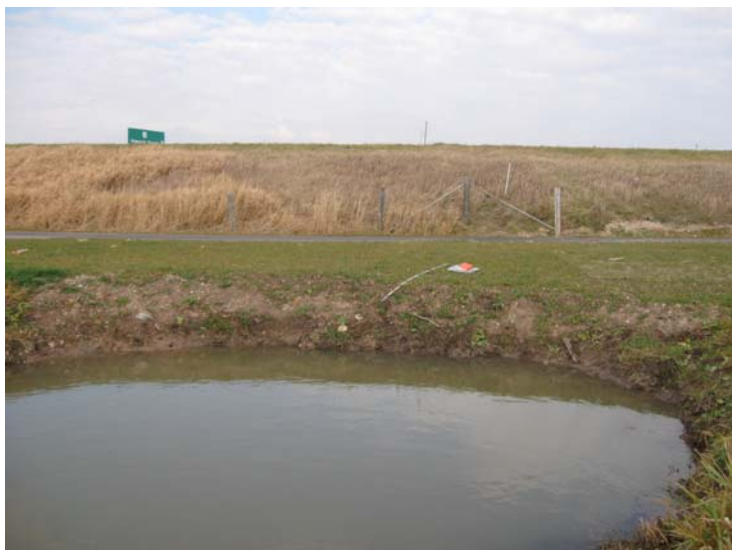
Photo 6 – C1A inlet

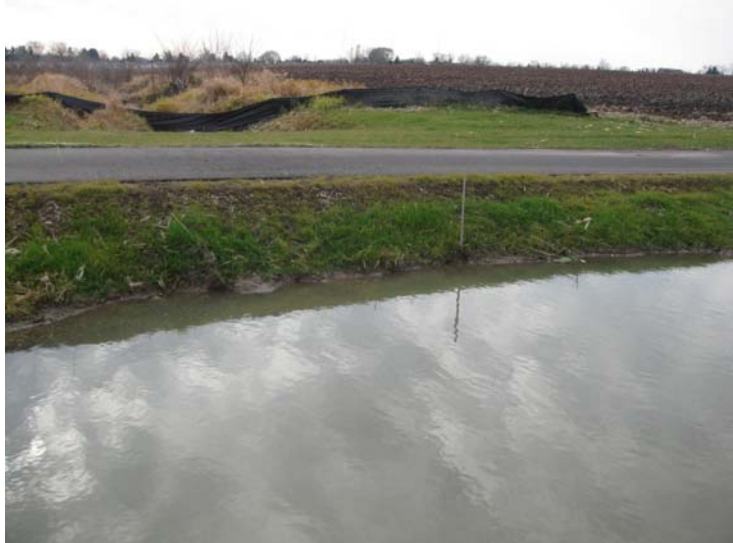
Photo 7 – C1A outlet

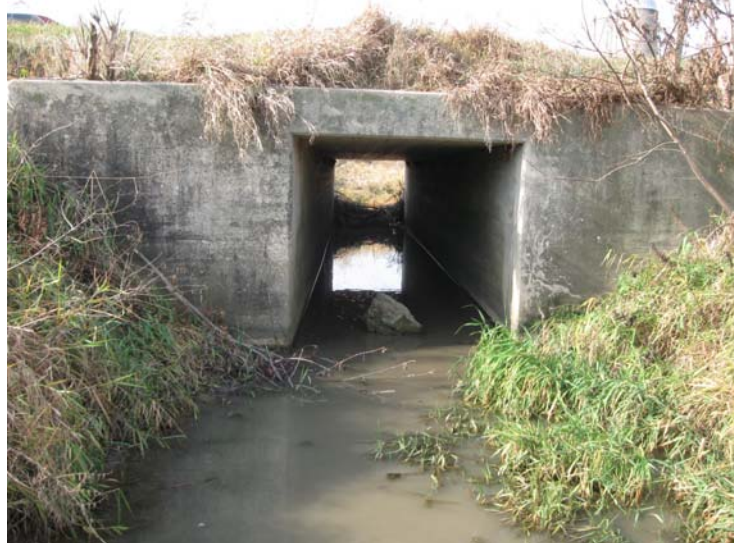
Photo 8 – C4 outlet

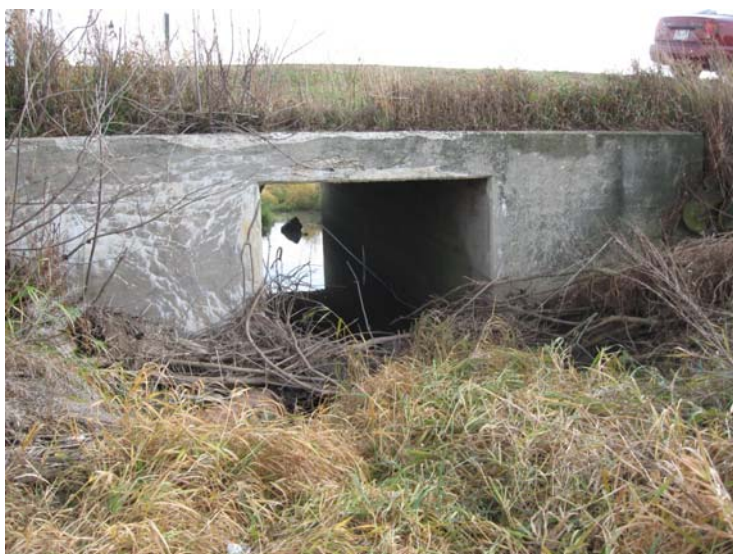
Photo 9 – C4 inlet

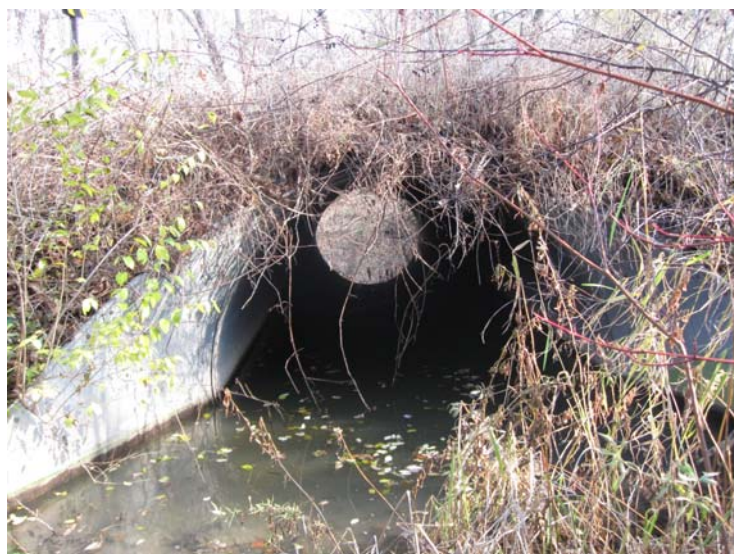
Photo 10 – C5 inlet

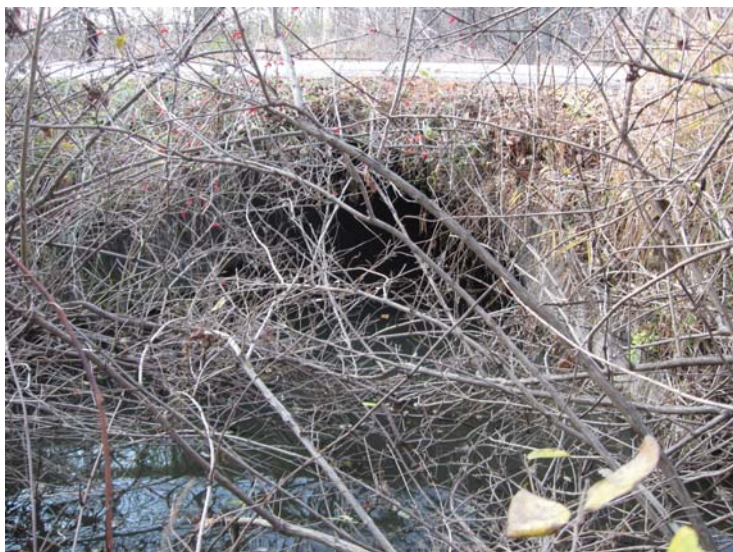
Photo 11 – C5 outlet

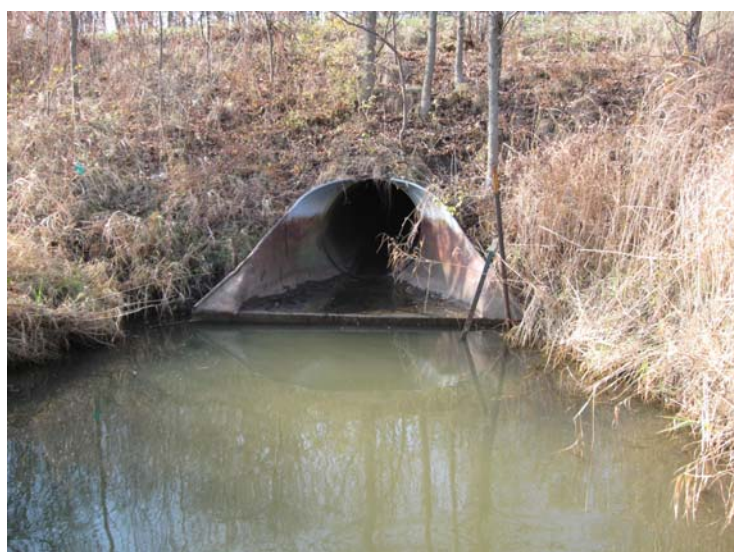
Photo 12 – C6 outlet

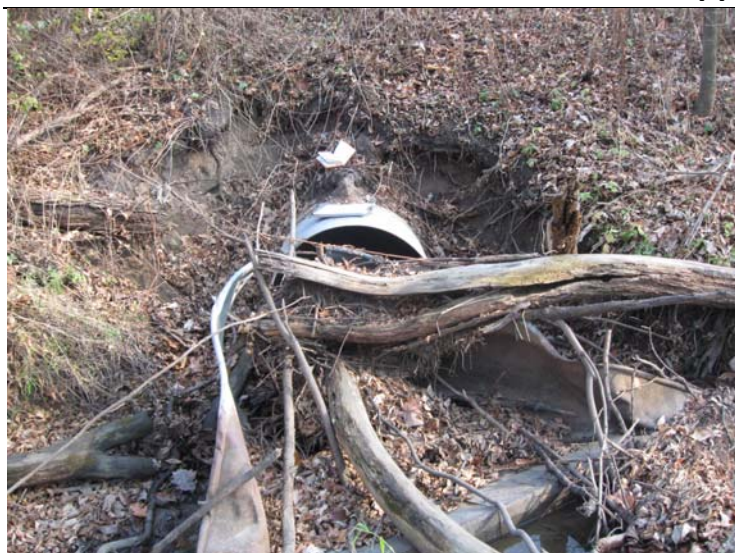
Photo 13 – C6 inlet

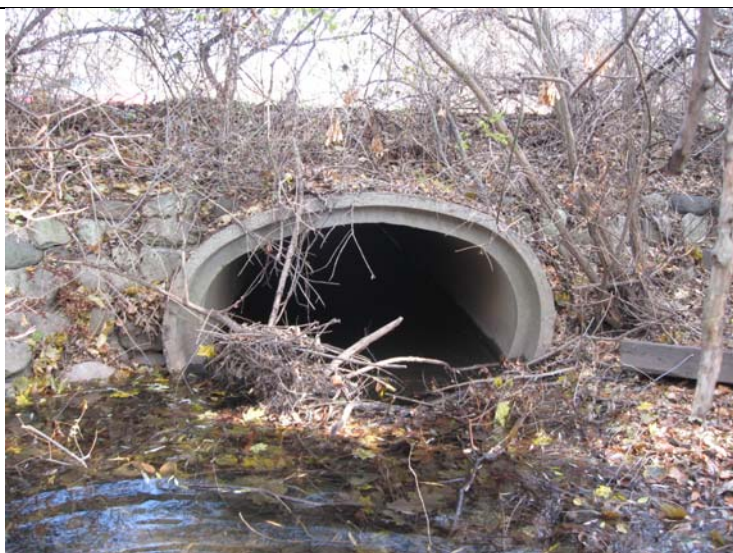
Photo 14 – C7 inlet

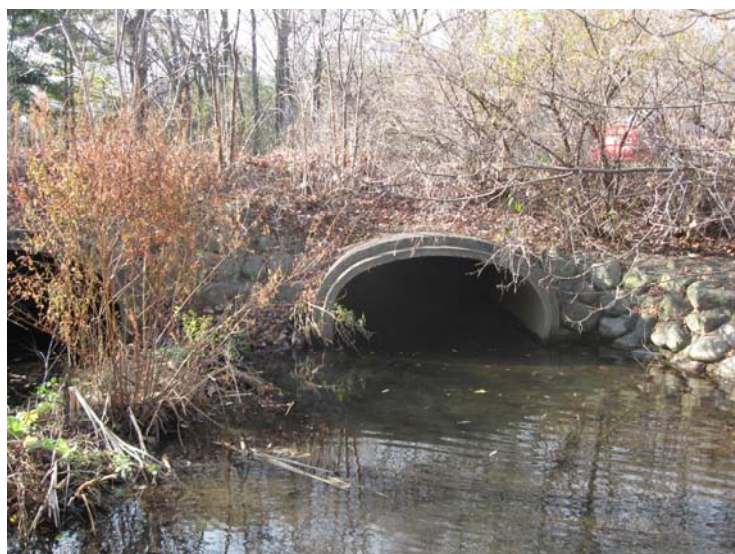
Photo 15 – C7 outlet

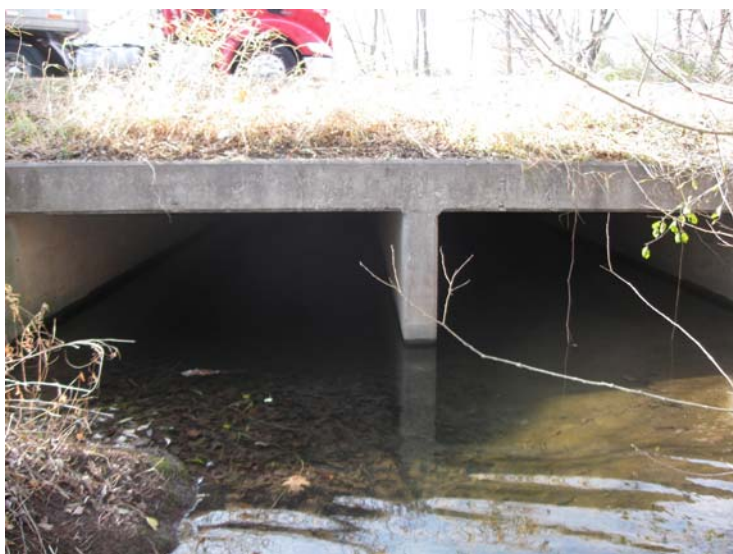
Photo 16 – C8 outlet

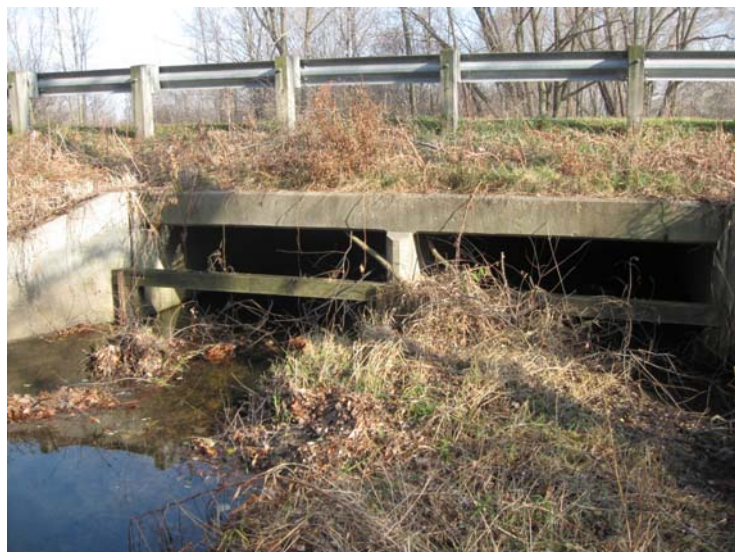
Photo 17 –C8 inlet

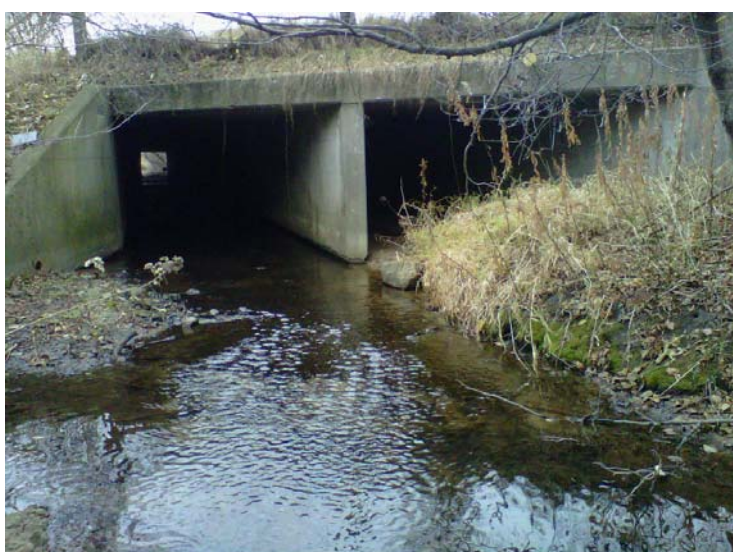
Photo 19 – C9 outlet

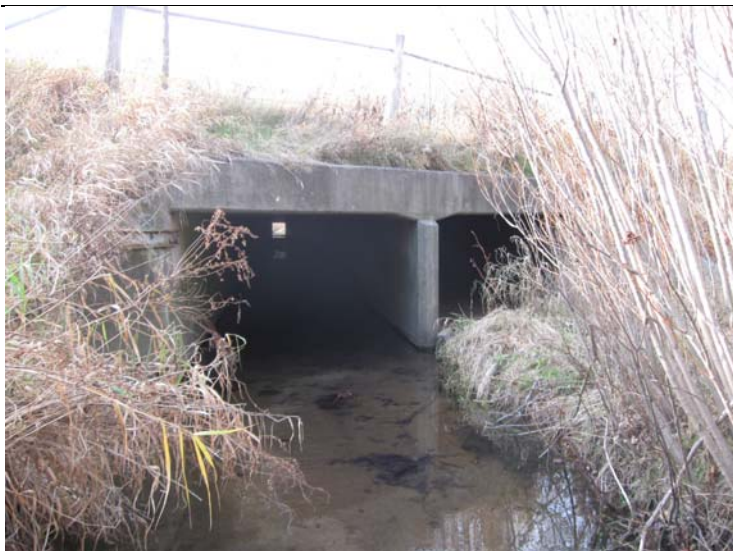
Photo 20 – C10 outlet

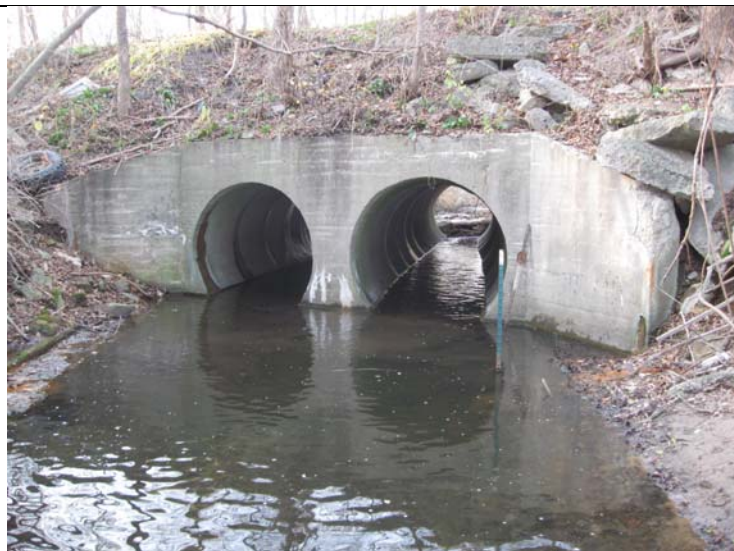
Photo 21 – C11 outlet

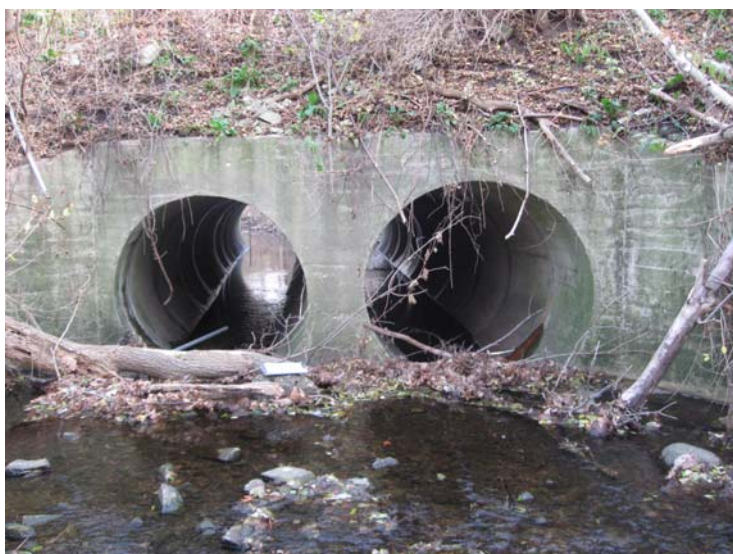
Photo 22 – C11 inlet

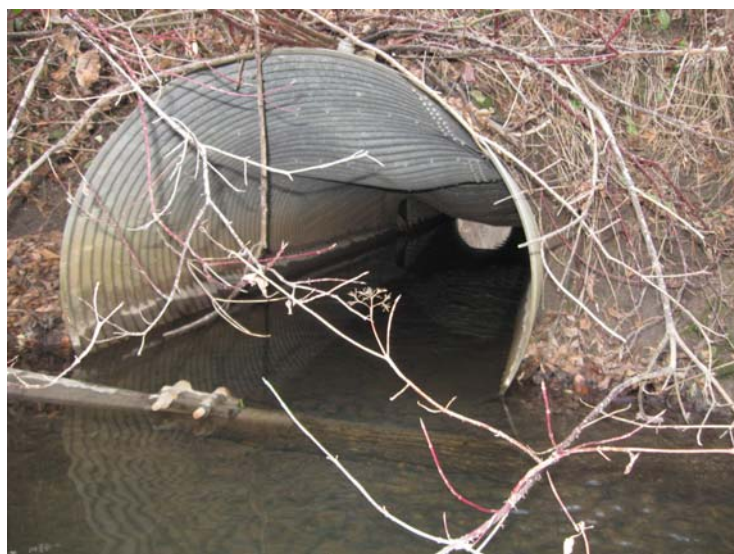
Photo 23 – C12 outlet

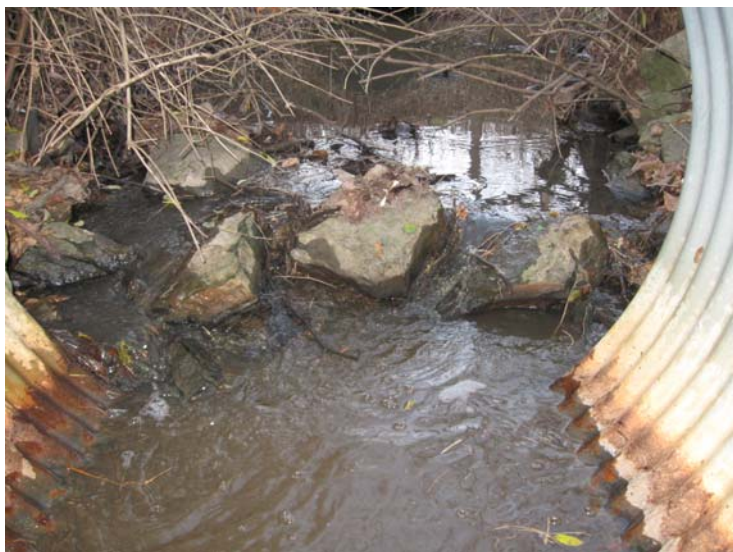
Photo 24 – C12A inlet

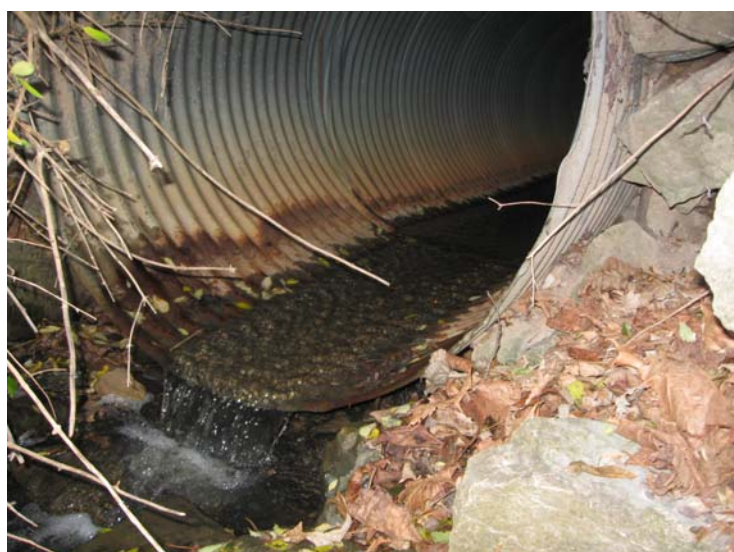
Photo 25 – C12A outlet
