# Continuous Water Quality Monitoring Survey in Halfway Creek Upstream and Downstream of Metallics Incorporated's Outfall

March 1997

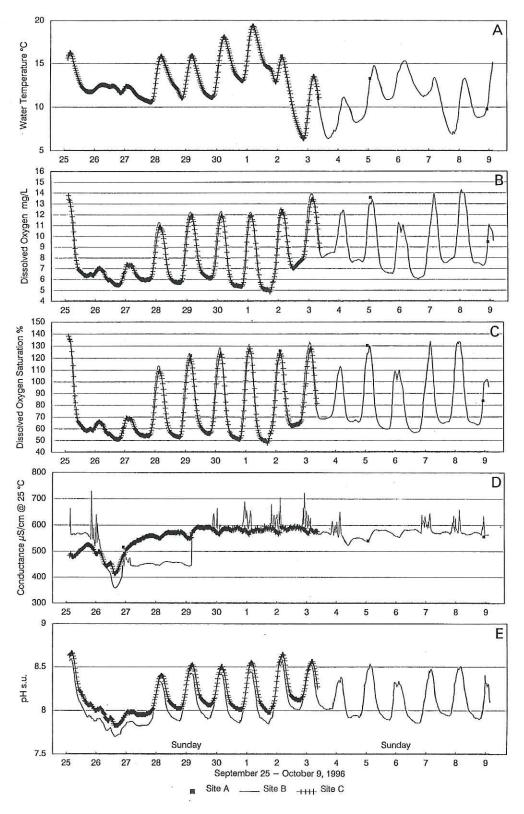
Stream temperatures ranged from 6 to 19°C during the monitoring period (Figure 2A). Daily temperature fluctuations were about 4 to 8°C and are likely characteristic of fall weather. A relatively large daily temperature change of 10°C was noted between October 2 and 3. The flat temperature profile recorded on September 26 and 27 reflected a period of cloud cover and runoff.

DO concentrations (Figure 2B) and DO saturation (Figure 2C) showed moderately large diurnal variations following the initial runoff period. These diurnal "swings" are typical of a stream that is moderately to heavily vegetated by submersed macrophytes. There was little change in DO between the three sites. This would indicate photosynthetic and respiratory processes (ie. chemical and sediment oxygen demand) were similar in the stream reach. The lack of diurnal DO swings during September 26 and 27 resulted from cloud cover and turbid water which greatly reduced photosynthetic activity during this period.

Adjusted continuous conductivity measurements at Sites B and C were influenced by the initial runoff period and by Metallics' discharge at Site B. The initial runoff event contributed to a dilution of dissolved solids in the stream as reflected by the downward conductivity profile (Figure 2D). This is best illustrated by the conductivity measurements recorded at Site C. Measurements at Site B were similarly affected, but this station had an unusual and unexplained flat response between September 27 and 28.

Sporadic spikes in corrected conductivity measurements recorded at Site B (Figure 2D) reflect pulses of Metallics' wastewater discharge. The conductivity of Metallics' effluent was measured

Changes in stream turbulence and flow in combination with Metallics' effluent conductivity variability resulted in the "spiky" pattern observed at Site B. This pattern was absent on weekends when there was no wastewater discharge (Figure 3A). Grab conductivity measurements made at Site B with the YSI SCT meter (Table 2) also showed moderate variation and was again attributed to Metallics' discharge.

Site B pH had consistently lower pH than Site C (Figure 2E). However, this difference was only about 0.2 pH units which was equivalent to the reported accuracy of the YSI 6000 monitors. The maximum difference between these sites seemed to be greater during the morning hours prior to daylight. The reason for this response was not determined. The pH differences between the two sites was not expected since temperature and dissolved measurements were very similar. Metallics' effluent was not believed to be a factor since the pH differences were still present during weekends when Metallics was not discharging wastewater (Figure 3A and B). It was suspected the spatial pH difference was primarily due to instrument error.

Figure 2. Water quality monitoring in Halfway Creek above (Site A) and below (Sites B & C) Metallics' wastewater discharge to Halfway Creek during later September and early October 1996. The data include: water temperature (A), dissolved oxygen (B), dissolved oxygen saturation (C), conductivity (D), and pH (E). Site A data are grab sample measurements. Site B and C data represent automatic monitoring data collected at 30 minute intervals.

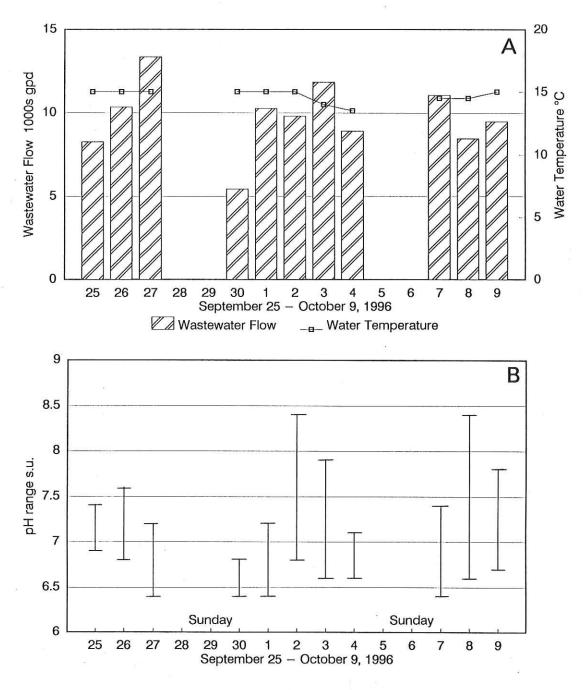
Figure 3. A. Metallics' wastewater flow and temperature. The flow data do not include non-contact cooling water. B. Metallics' effluent pH range. Data obtained from discharge monitoring reports submitted to the Wisconsin Department of Natural Resources by Metallics, Inc. for September and October 1996.
