Goose Pond Tributary  
at Arlington

Triennial Standards Review

October 1993

Bureau of Water Resource Management  
Wisconsin Department of Natural Resources

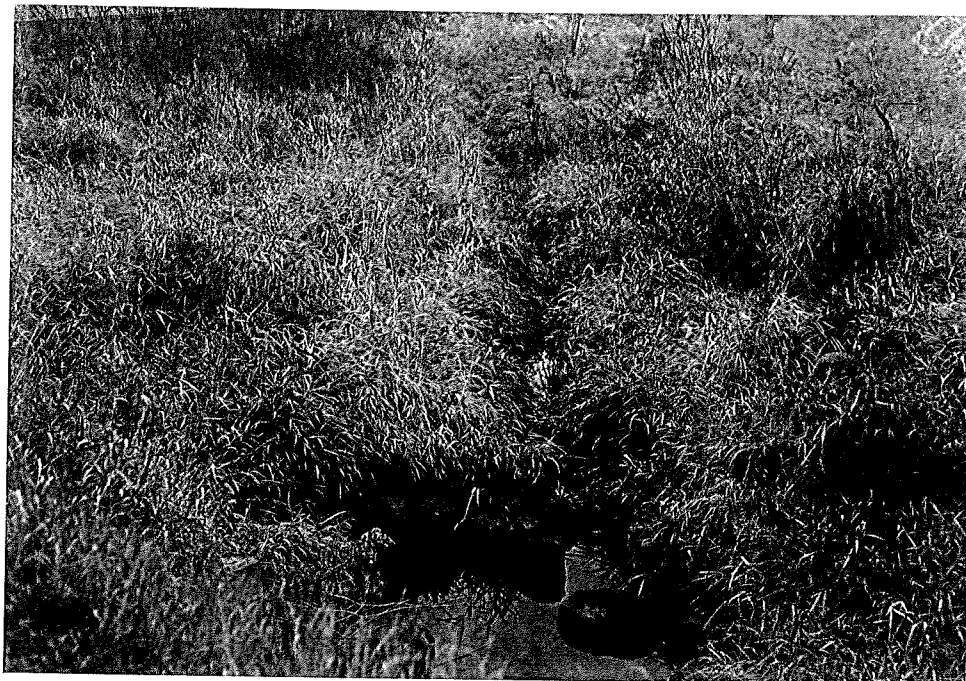
The width of the stream averages less than 2.0 m with depths typically less than 1.0 m. Channelization is obvious along most of the stream's route limiting available aquatic life habitat (photo 1).

Photo 1 - Channelization downstream from Kampen Road limits habitat. The banks are dominated by wetland grasses. The boulders in the picture are not typical of the entire tributary.

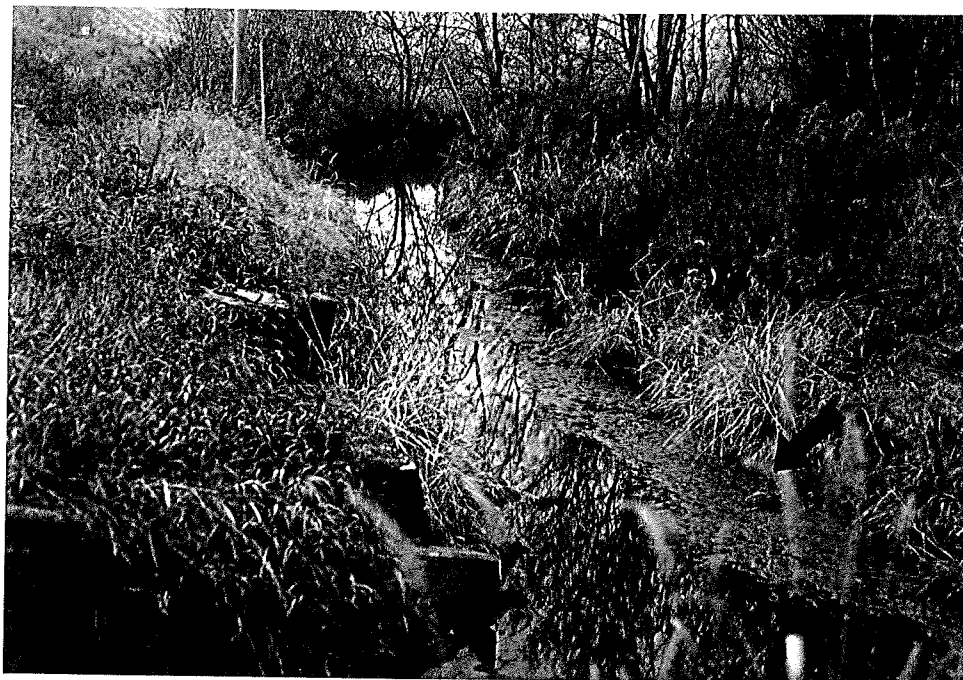
Instream, riparian, and overhead cover is lacking. The banks are characterized by tall wetland grasses with few trees or bushy areas limiting overhead canopy. In areas where the stream has been ditched, plants such as burdocks and smartweed dominate the disturbed banks. Instream vegetation, along with instream cover such as boulders and logs, is also sparse providing little suitable aquatic habitat (photo 2).

Photo 2 - Upstream from Kampen Road, habitat is also limited. The only instream cover came from filamentous algae shown here.
