Region NER County Fond du Lac Report Date October 1993 and August 1975 Classification LFF  
 Water Body: Alto Tributary to the South Branch of the Rock River  
 Discharger: Alto Creamery

ALTO TRIBUTARY TO THE  
SOUTH BRANCH OF THE ROCK RIVER

TRIENNIAL STANDARDS REVIEW

OCTOBER 1993

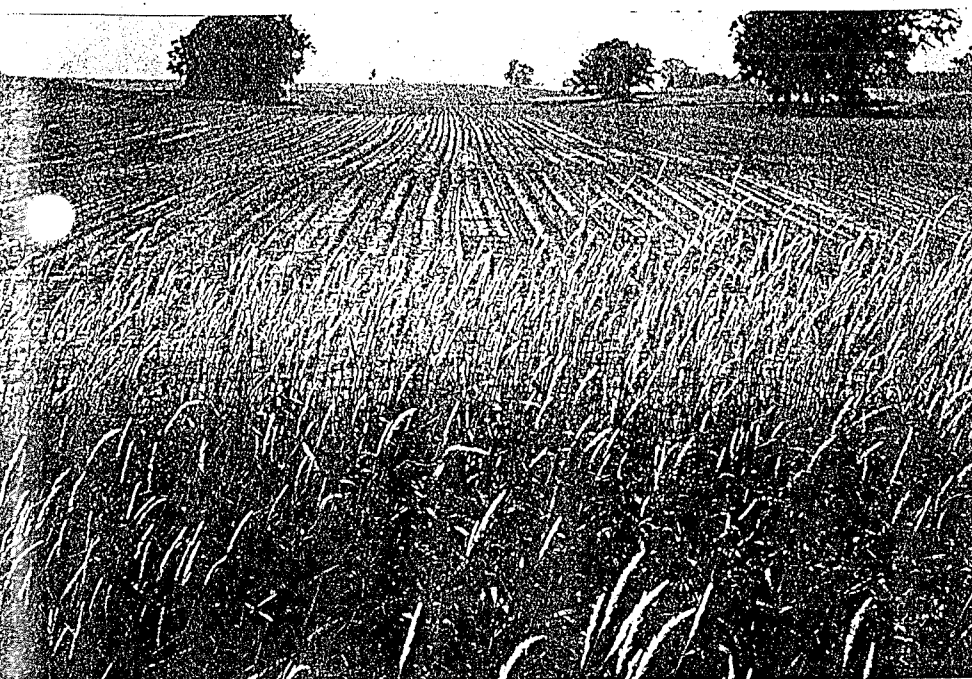
Habitat and water quality conditions are poor. Pasturing close to the stream and nearby cropland runoff has resulted in the stream not reaching it's full biological potential (photo 1). Discharges of hazardous substances in the past from the Alto Coop Creamery have also caused degradation of the stream.

Photo 1 - Near site 2.  
Upstream from Alto  
Creamery. Row cropping  
increases the erosion  
potential. Bank cover  
is dominated by grasses.

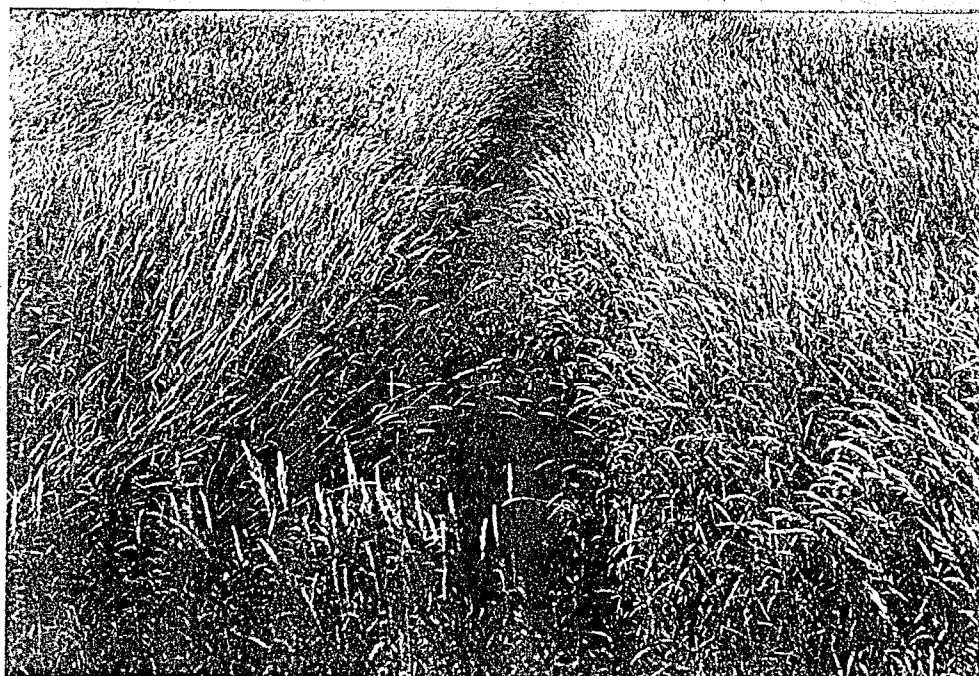
Downstream from the Alto Creamery, the riparian areas are dominated by grassy wetlands and cropland. The row cropping along with nearby pastures, causes severe habitat degradation. The stream has also been ditched which has resulted in a loss of habitat for fish and wildlife (photo 2).

Photo 2 - Upstream of Lake  
Maria Road (site 1).  
Channelization is severe  
limiting habitat.

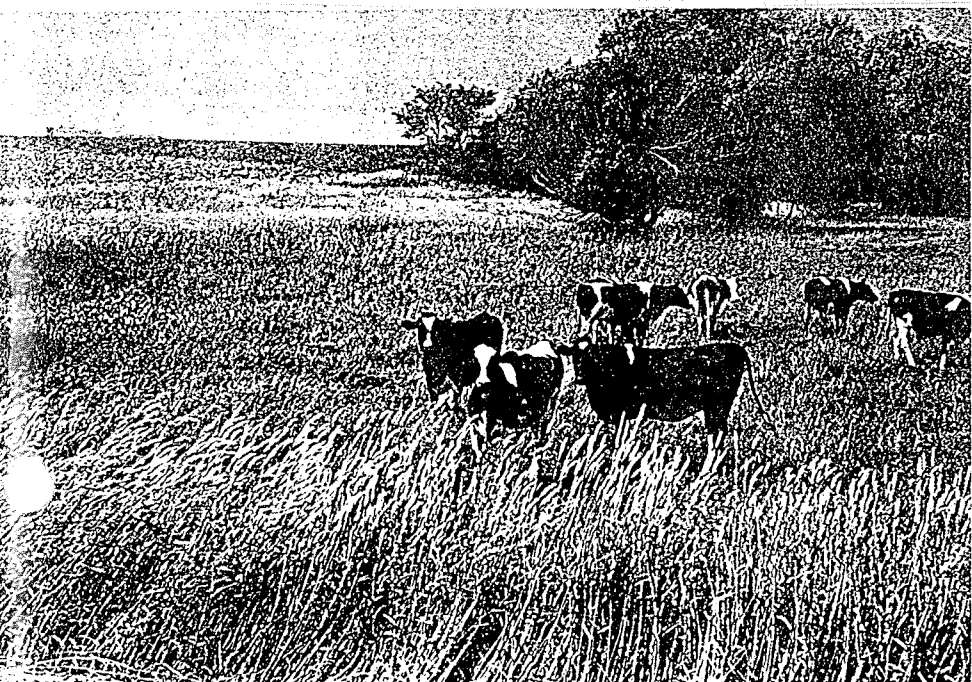
Wetland losses in this section are evident due to both cropping and pasturing which occurs directly in the wetland (photo 3). Ditching has also caused a loss of wetland areas.

Photo 3 - Upstream of site 1.  
Pasturing occurs in wetlands  
near Alto Trib. The stream  
flows through the tall grass  
in the picture.

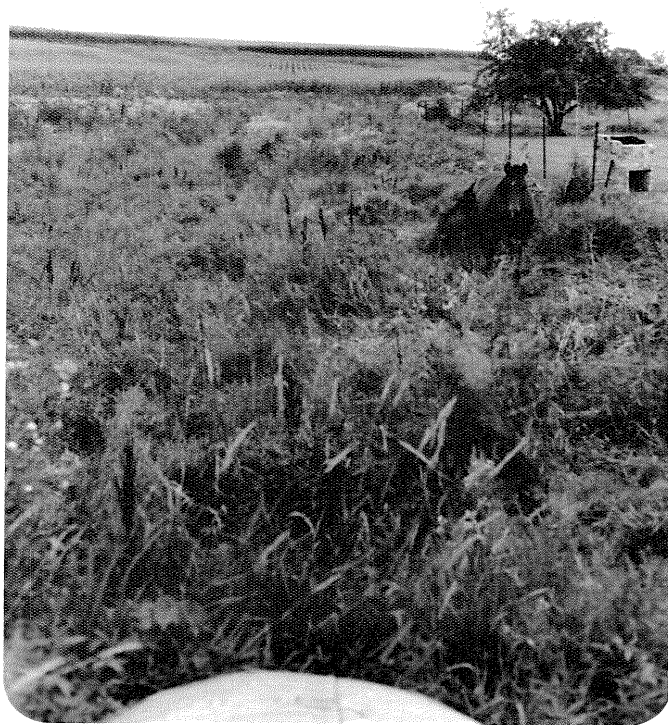
Dry streambed at County "EE" above  
Alto Co-op Creamery.

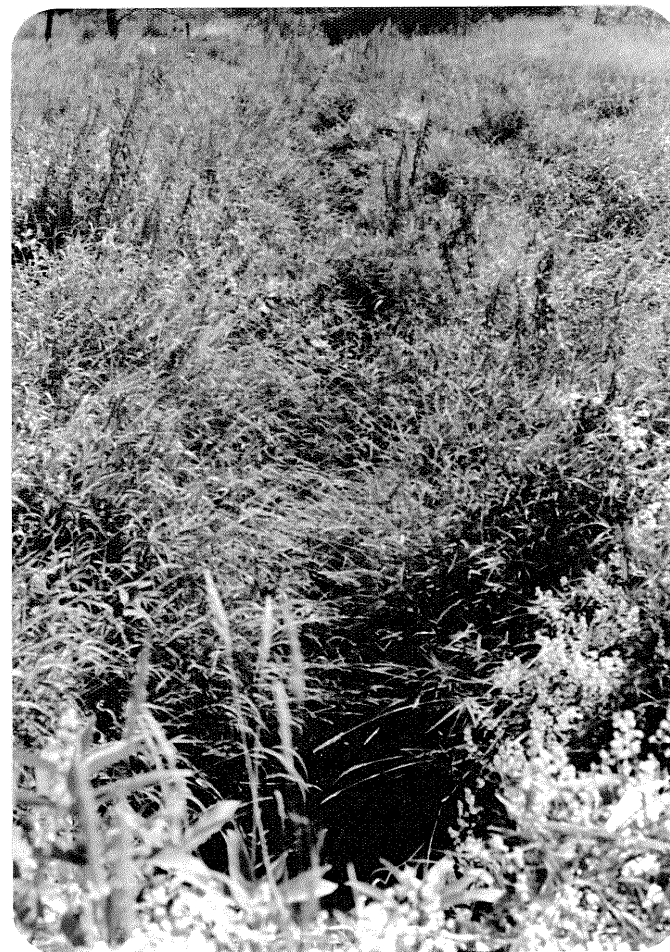
Stream at County "EE" below Alto  
Co-op Creamery.
