SUBJECT: Surface Water Classification  
(NR 104) - Hayward, Sawyer County

## Rejustification of the Stream Classification for Bradley Brook

## Stream Classification Worksheet

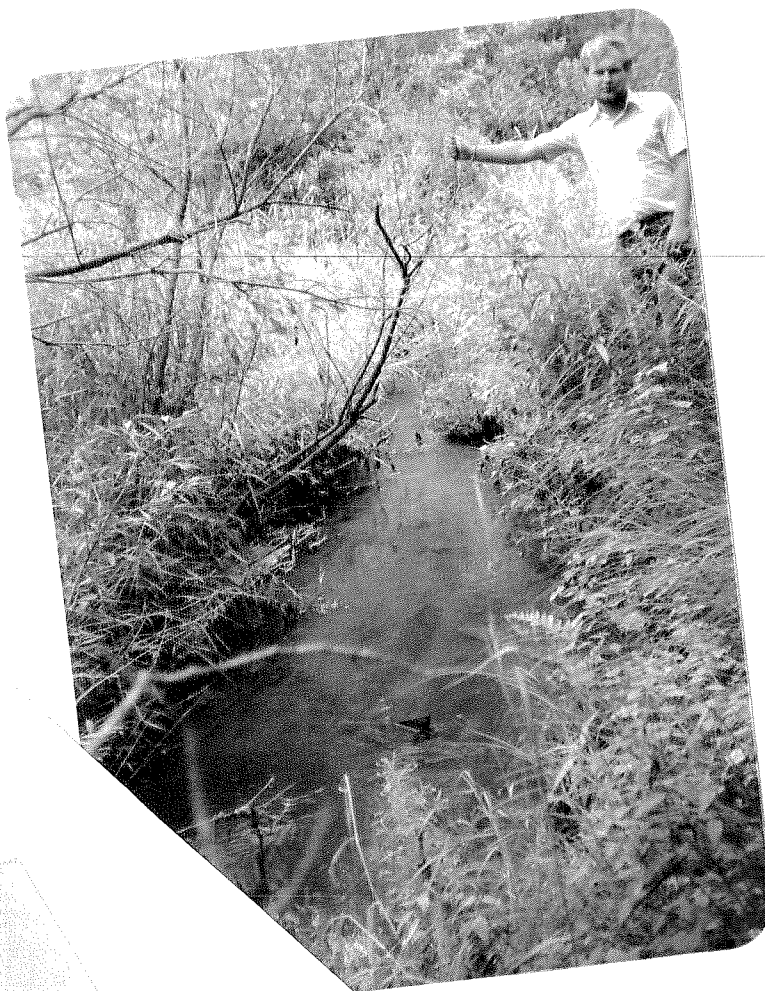
BRADLEY BROOK  
ABOVE HAYWARD STP

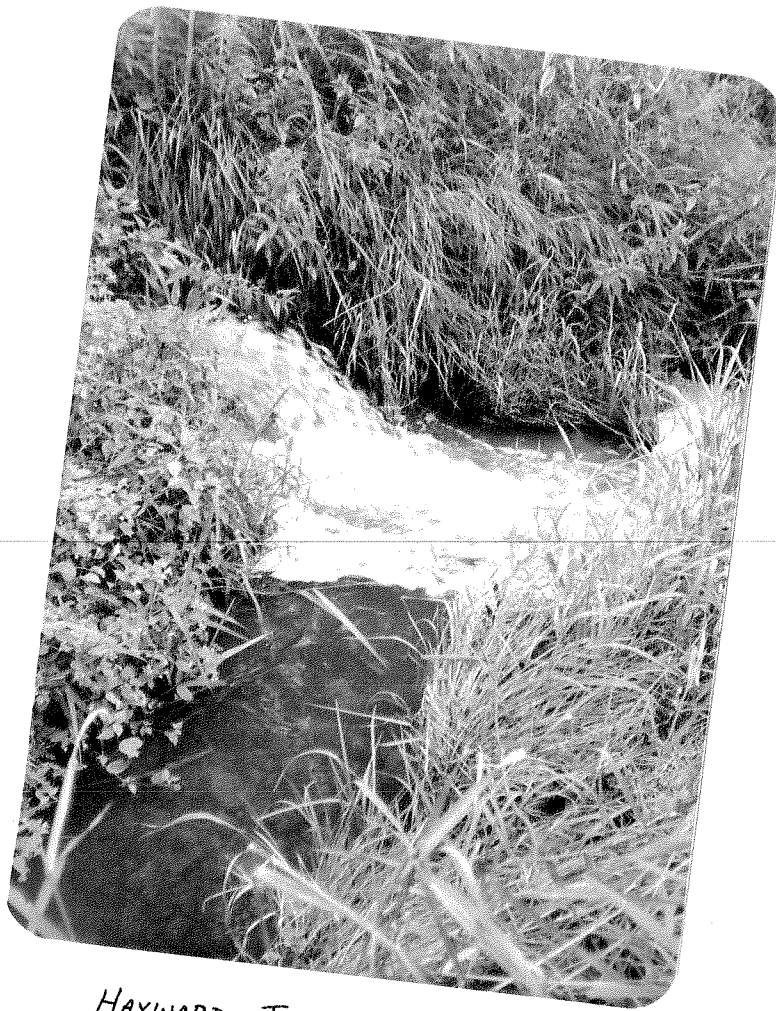
HAYWARD TREATED EFFLUENT  
ENTERING BRADLEY BROOK
