## CORRESPONDENCE/MEMORANDUM

Subject: Mud Cr/Kasson Cheese

On 5-11-82 and 6-2-82, I re-evaluated Mud Creek using the new Stream Classification Guidelines.

# Reedsville - Photos

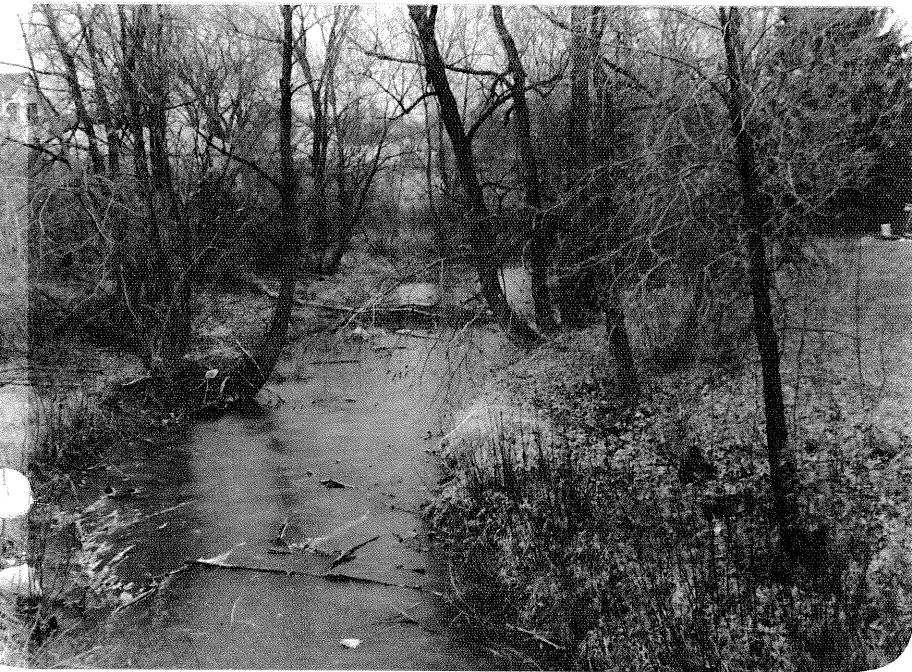
② Mud Creek  
at Hwy 10  
- Downstream  
- Above STOP

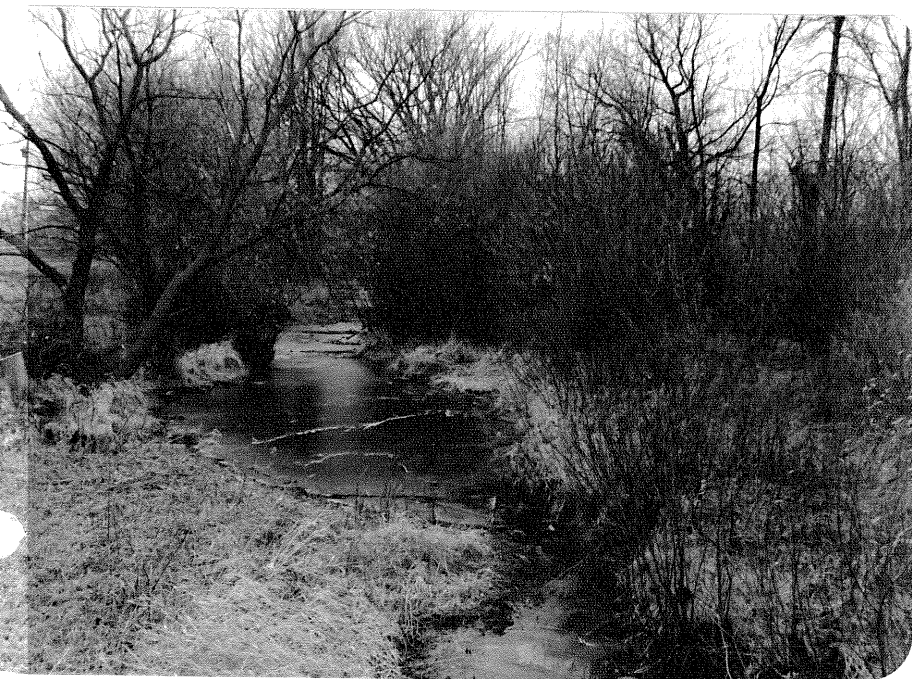
③ Same location  
- Upstream

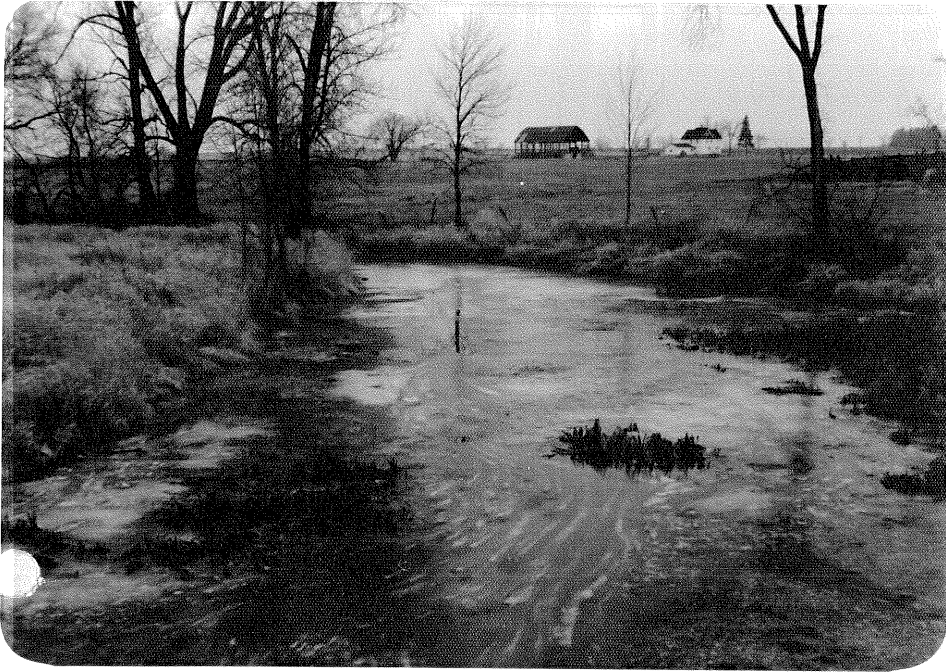
④ W. Goodwin Rd  
- Downstream  
- Below STP

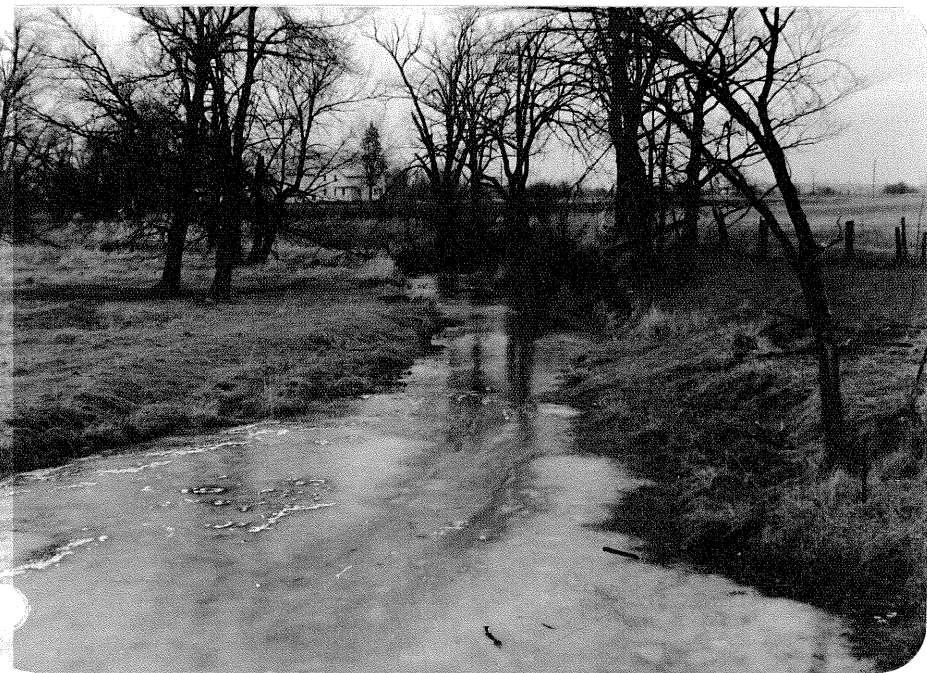
⑤ Same location  
- Upstream
