**From:** Ackerman, Jeff A - DNR  
**Sent:** Thursday, August 21, 2014 10:34 AM  
**To:** 'stephen.mcclure@gardnerdenver.com'; Mark McColloch (mmccolloch@newfields.com)  
**Subject:** DB Oak file review  
**Attachments:** 3851\_001.pdf

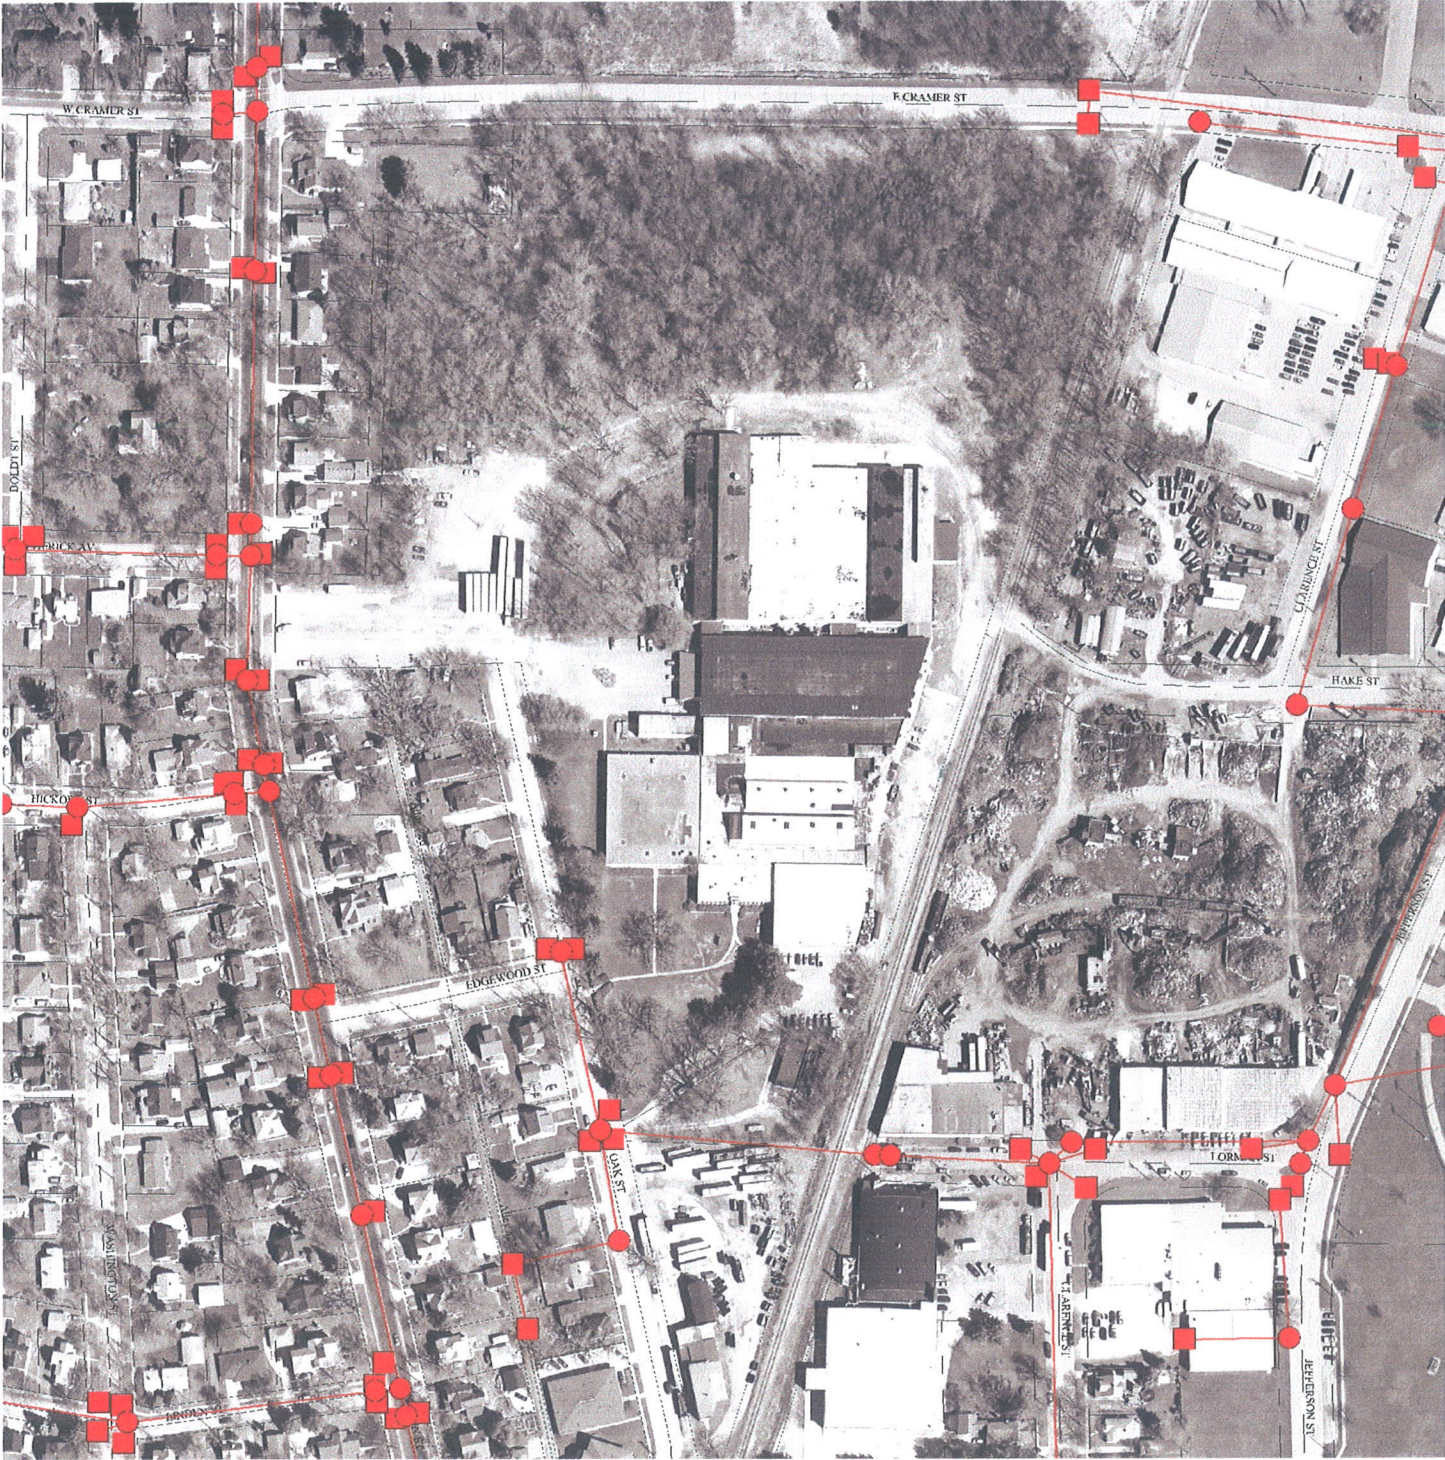
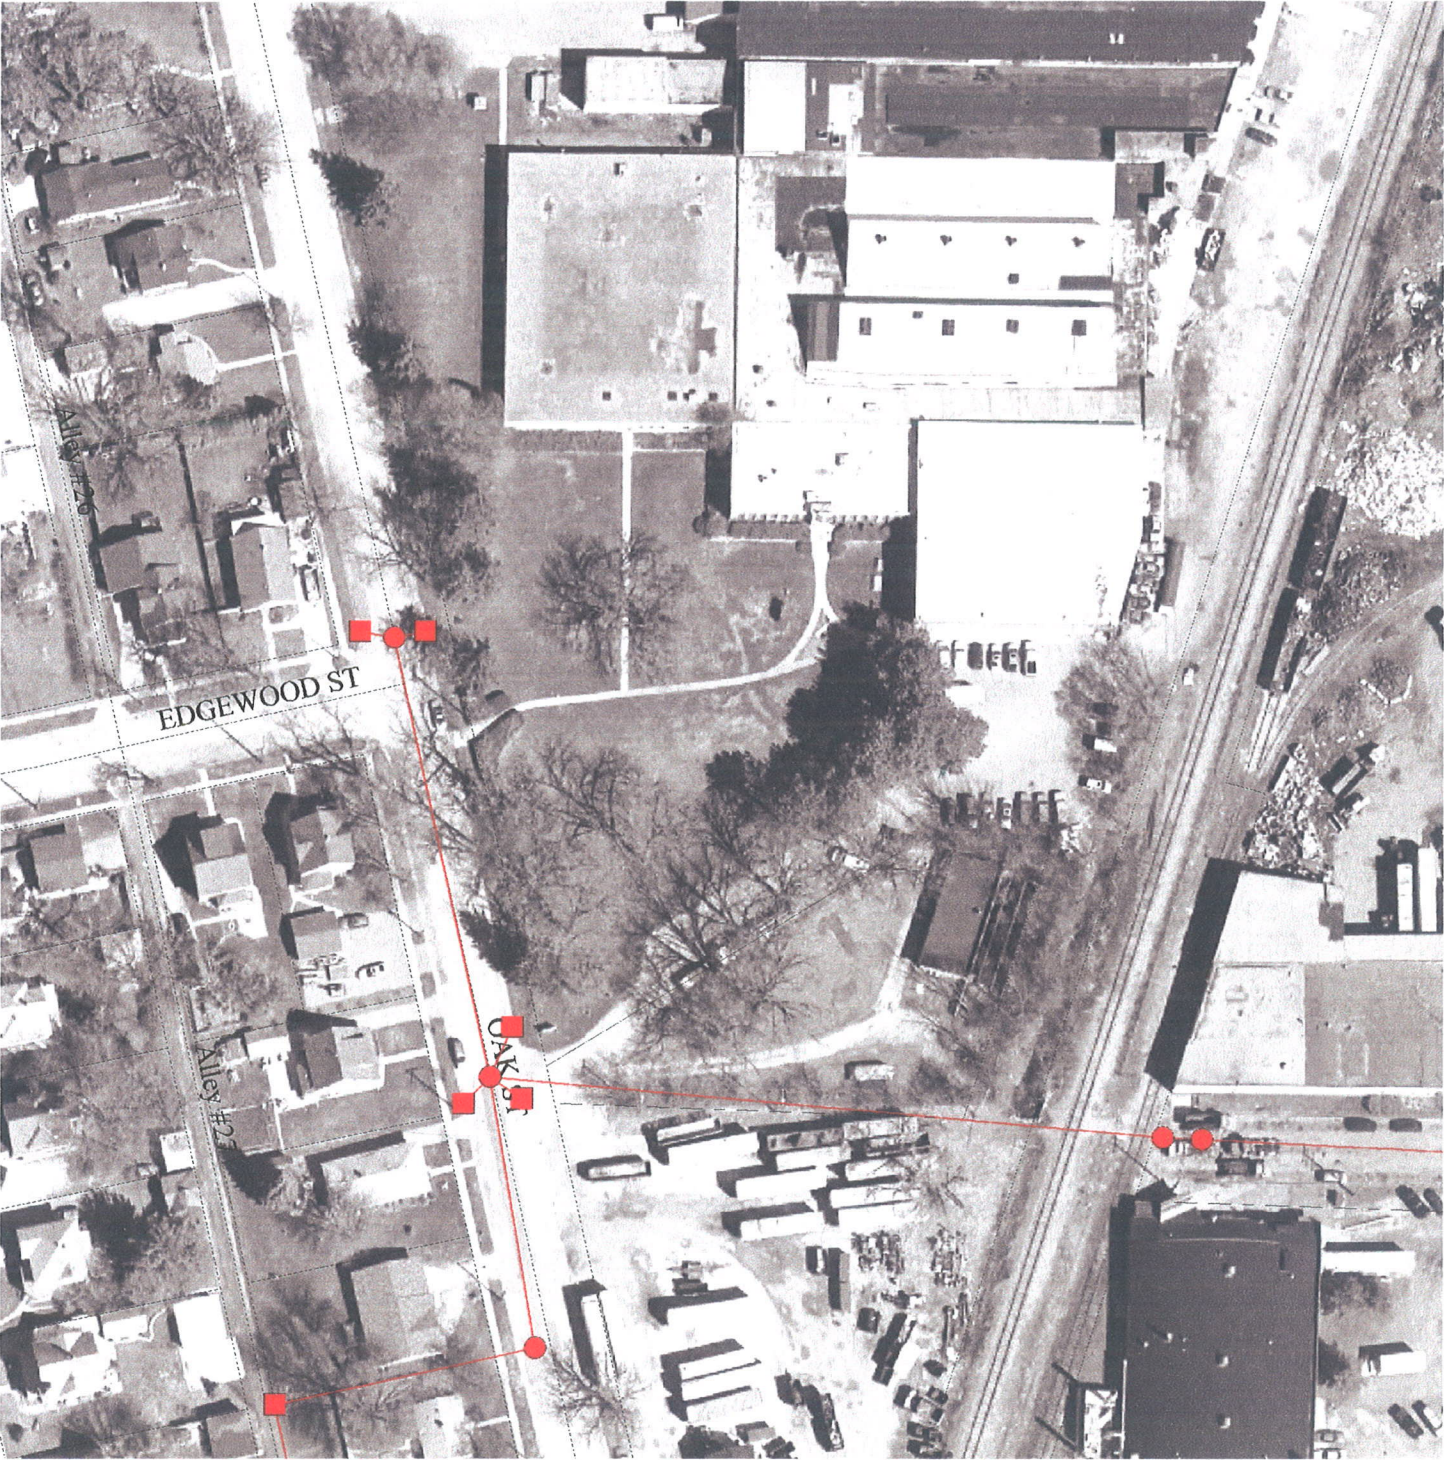
- Vapor migration pathway(s) should be evaluated. This should be the priority for future work. Here is the link to our vapor guidance <http://dnr.wi.gov/topic/brownfields/vapor.html>
- The site map should show more features, including subsurface utility lines (and especially those that could act as a conduit for groundwater, including the sewer lines and SVE system), potential source areas like the degreasers and wastewater tanks (which were discussed in Newfields' February 11, 2005 report), and the surface topography. Surface topography is probably more important at this site than at others because parts of the site are internally drained.

Attached is a map of storm sewers, which was sent to me by the City of Fort Atkinson engineering department.
