From: Mark Fryman <mfryman@consulttruenorth.com>
Sent: Tuesday, October 3, 2023 1:47 PM
To: Koepke, Cynthia L - DNR
Subject: Frei Oil
Attachments: B.2.b.-ResidualSoilCont-Clarification.pdf

ATTACHMENT B.2.b.

**RESIDUAL
SOIL CONTAMINATION**

SITE LOCATION
FREI OIL COMPANY (Former)
207 HIGHWAY STREET
HORICON, WI 53032

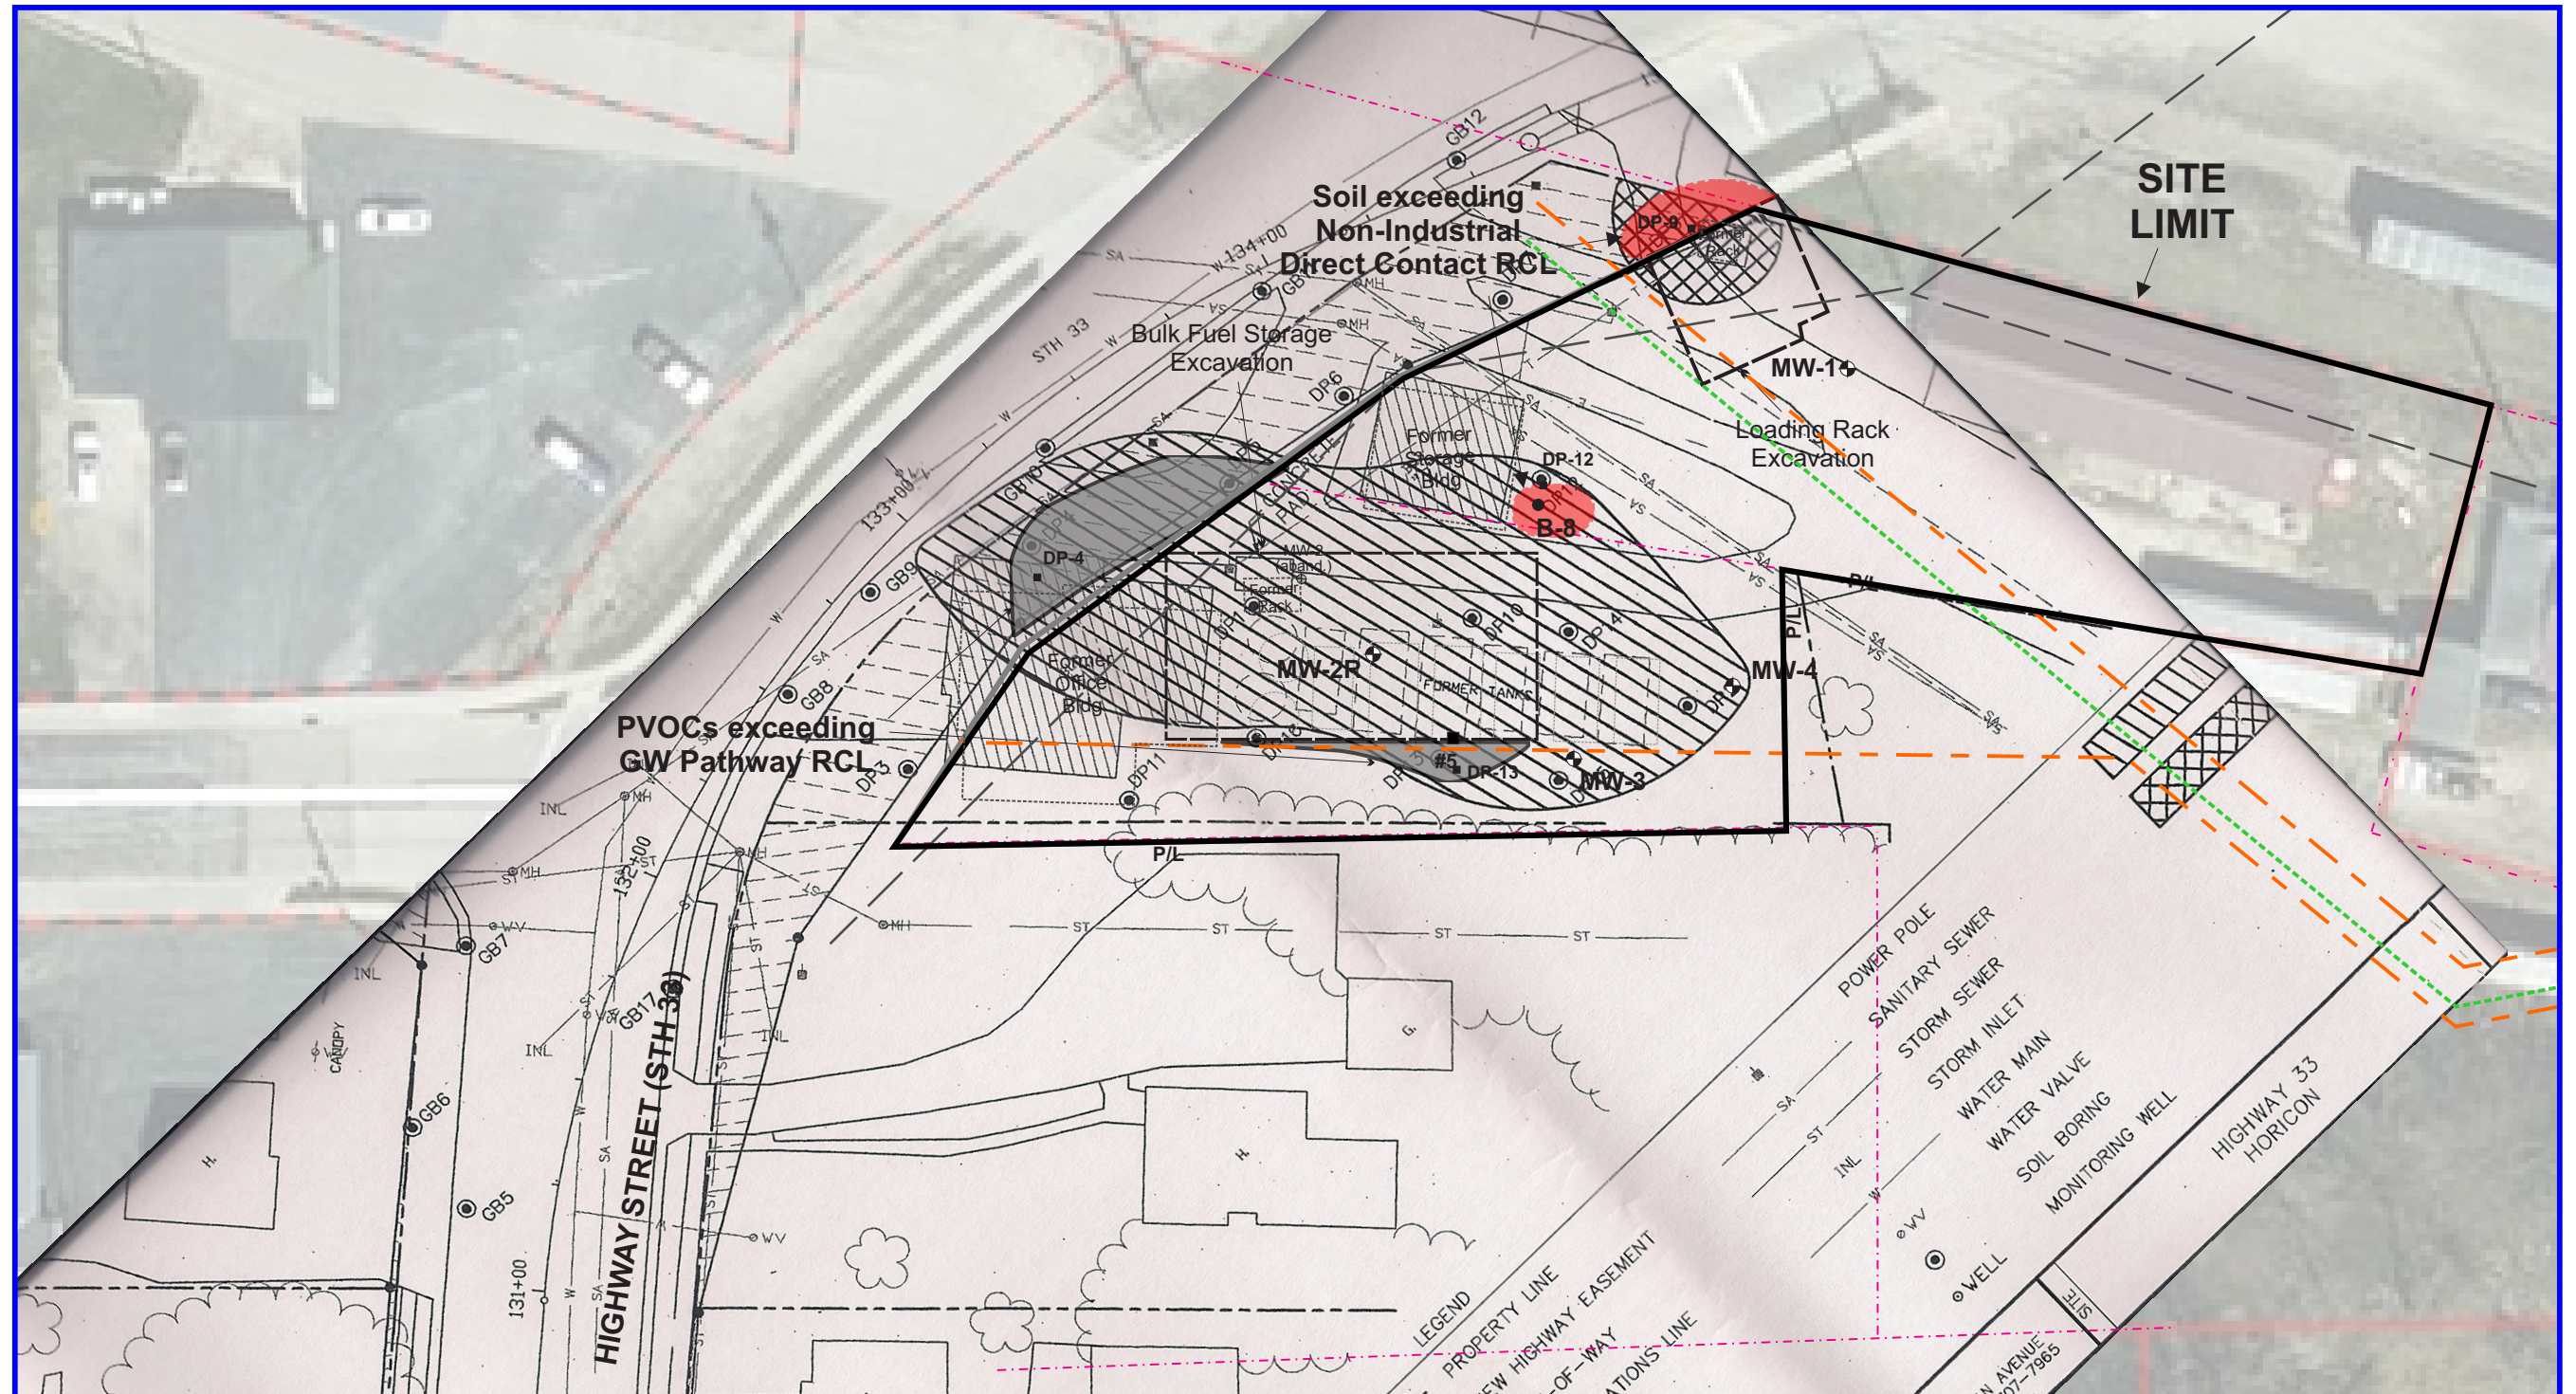
I looked through the file information to try to figure out the surface cover at the old boring GP-9 where shallow soil exceeding the industrial direct contact RCLs was identified during the WDOT assessment in 2006. I did figure out a few things from the file.

I could not find any information regarding whether the impacted soil at GP-9 may have been removed during the road reconstruction. There was a statement in the BT2 assessment report mentioning material management and building demolition for the road work but I did not find anything documenting soil removal. Therefore, I believe that we need to assume it is still there.

The boring with the bad soil, GP-9, was located right along the edge of the line of the proposed new WDOT right-of-way. Because of this, I am confident that the boring is located "beneath" the existing sidewalk since that sidewalk runs along the edge of the new ROW. I have attached a PDF that shows this. I created the PDF so that 4 layers are maintained. Those layers are; the figure border, the residual contamination details (from B.2.b.), the original map from the DOT work created by BT2, and a current county aerial photo. Because I maintained the layers in the PDF, you can turn each of those 4 elements on/off independently. I think the comparison of the BT2 map, and the current aerial photo clearly shows that GP-9 is covered by the sidewalk.

Sorry, that this is the best I can do with the information. I guess there will have to be a statement that the sidewalk needs to be maintained as a cover in the closure letter.
