FILE REF: BRRTS #0246000767

DATE:	March 29, 2017

SUBJECT: Cook Composites/Former Freeman Chemical site visit, March 22, 2017

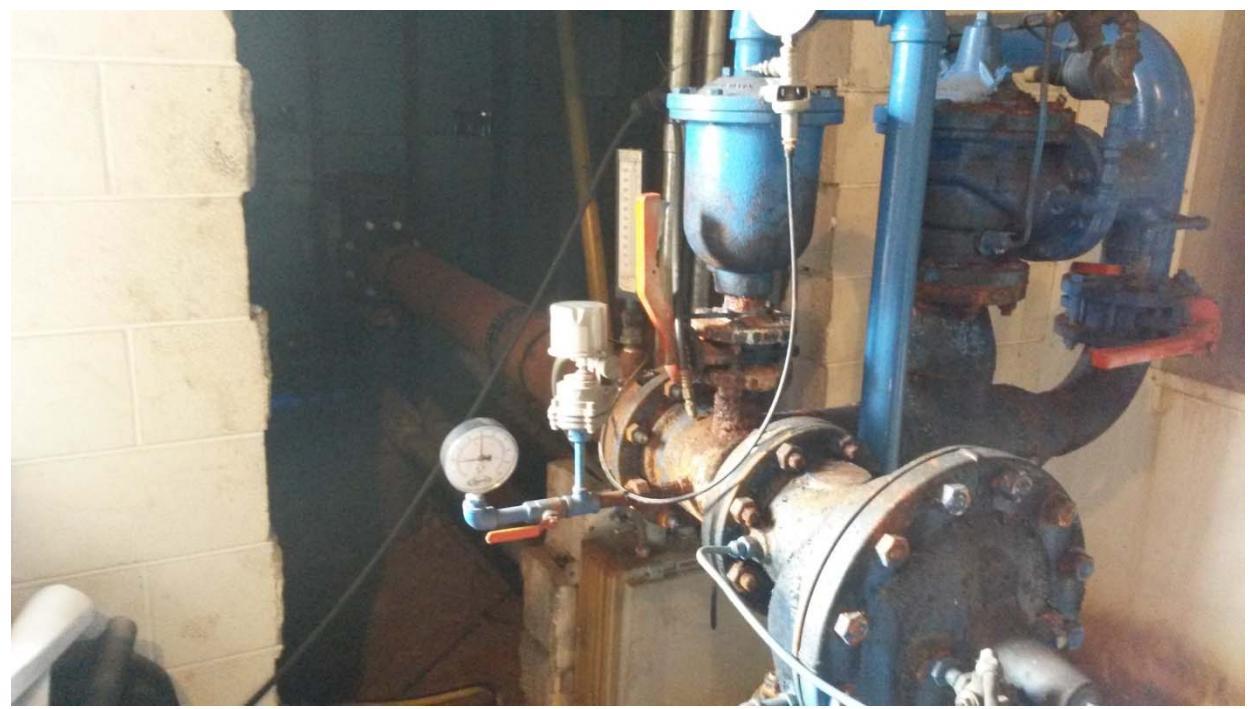
- The deep extraction well (Photo 1) was running according to the telemetry mounted on the wall in the building (Photo 2) that housed the well and remediation equipment. Pumping rate is recorded on a gauge labeled "DEEP WELL GPM READOUT" (Photo 3).

Photo 1. The deep extraction well, W-30.

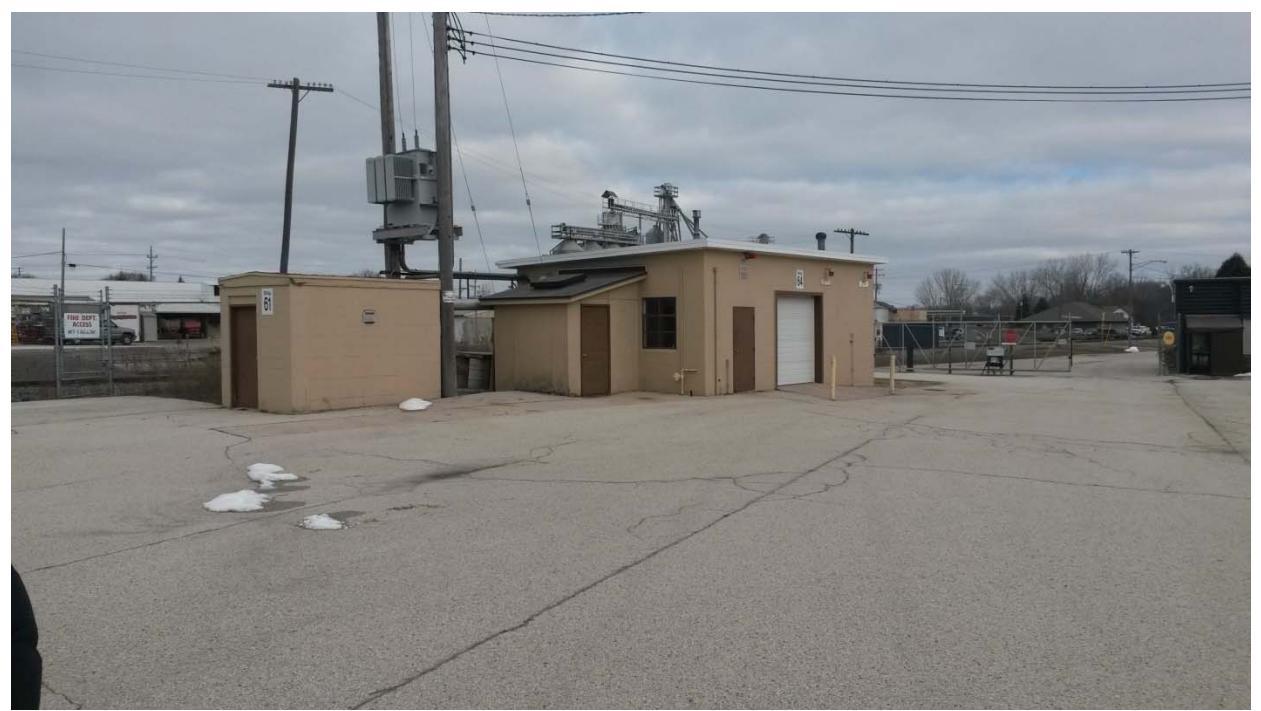
Photo 2. The building housing the deep extraction well and telemetry.

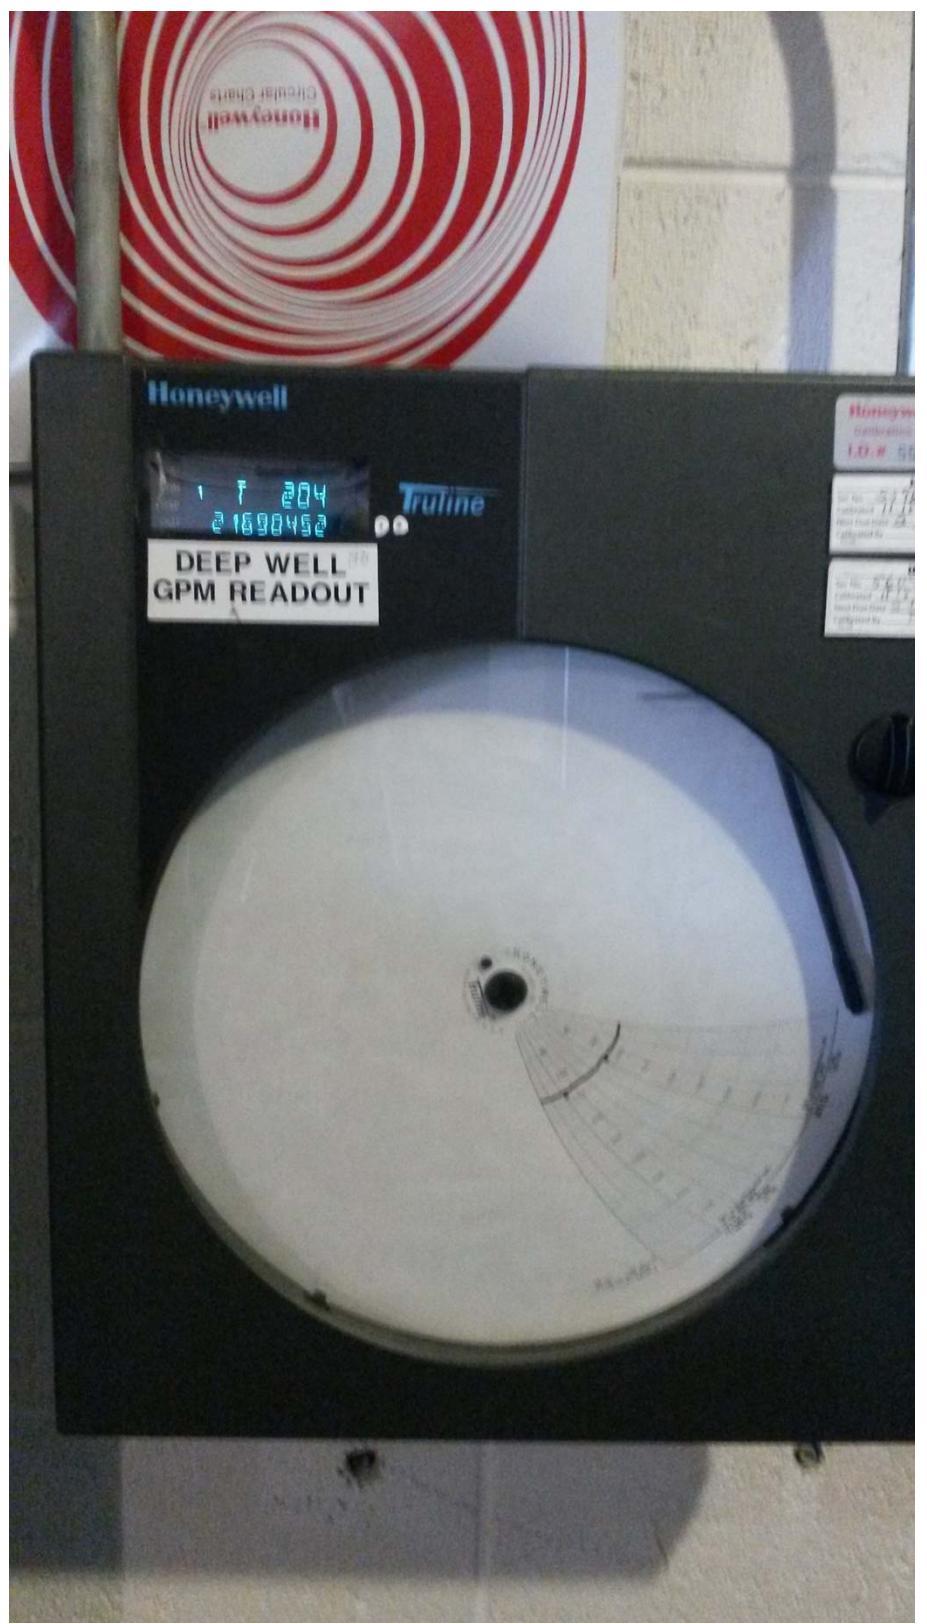
Photo 3. Gauge for the deep extraction well.

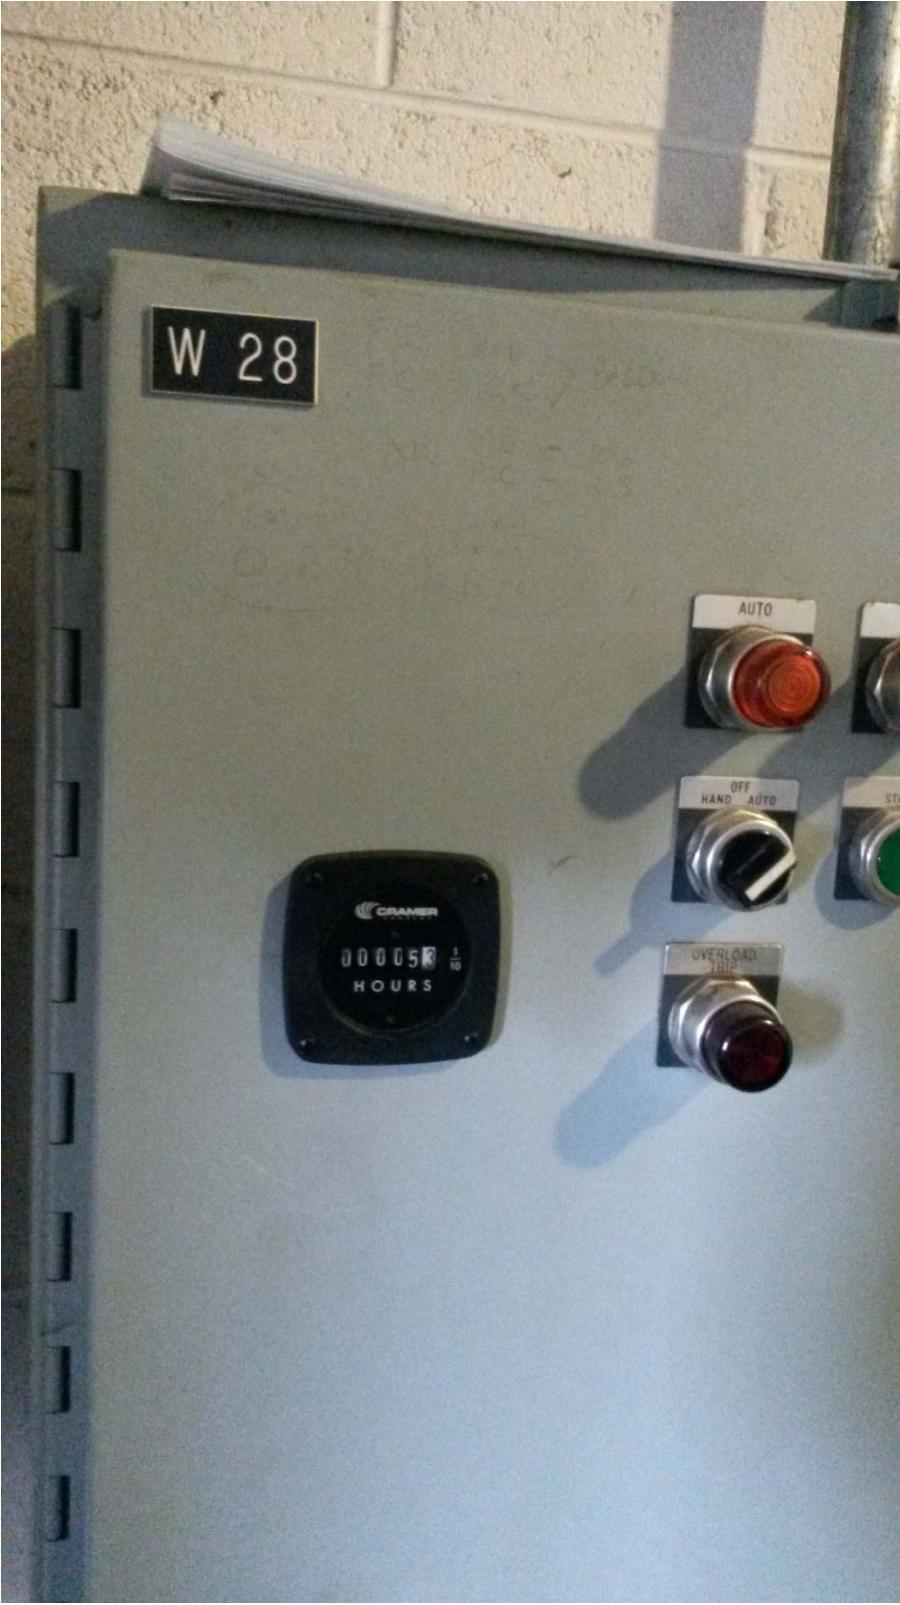
- The intermediate extraction well was running according to the telemetry mounted on the wall next to the deep well telemetry in the same building. Pumping duration is recorded on a gauge labeled "W 28", and "Hours" (Photo 4).

Photo 4. Gauge for the intermediate extraction well.

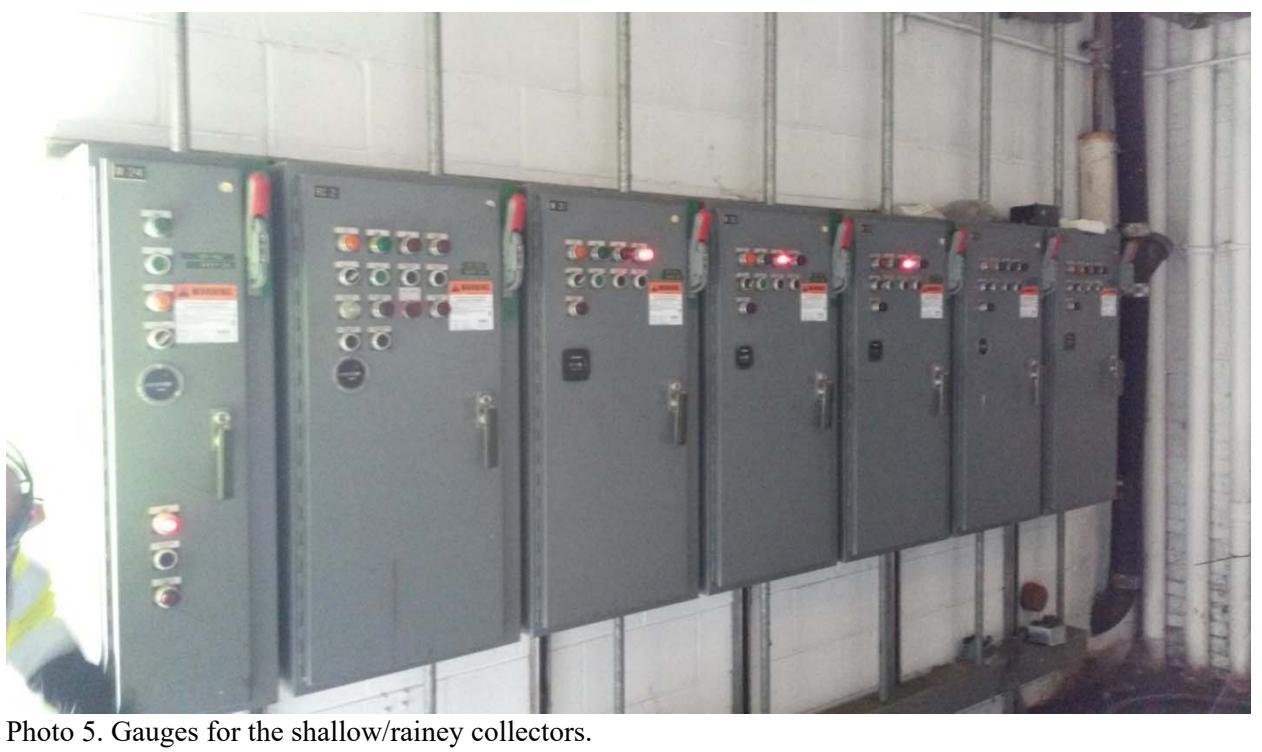
- Rainey/shallow extraction wells were running according to telemetry mounted on the wall in a building near the central part of the site (Photo 5). Some of the hour-count gauges were observed to have low hours, or the individual well was in need of reset. Cigale stated this was the normal operating condition.

Potentially follow up with Cigale on all O&M documentation (run times, rates, etc), just to verify appropriate function of the system. For example: some wells/pumps don't run because other wells are pumping (drawdown/radius of influence), etc. The third bullet point on the summary. Thanks.

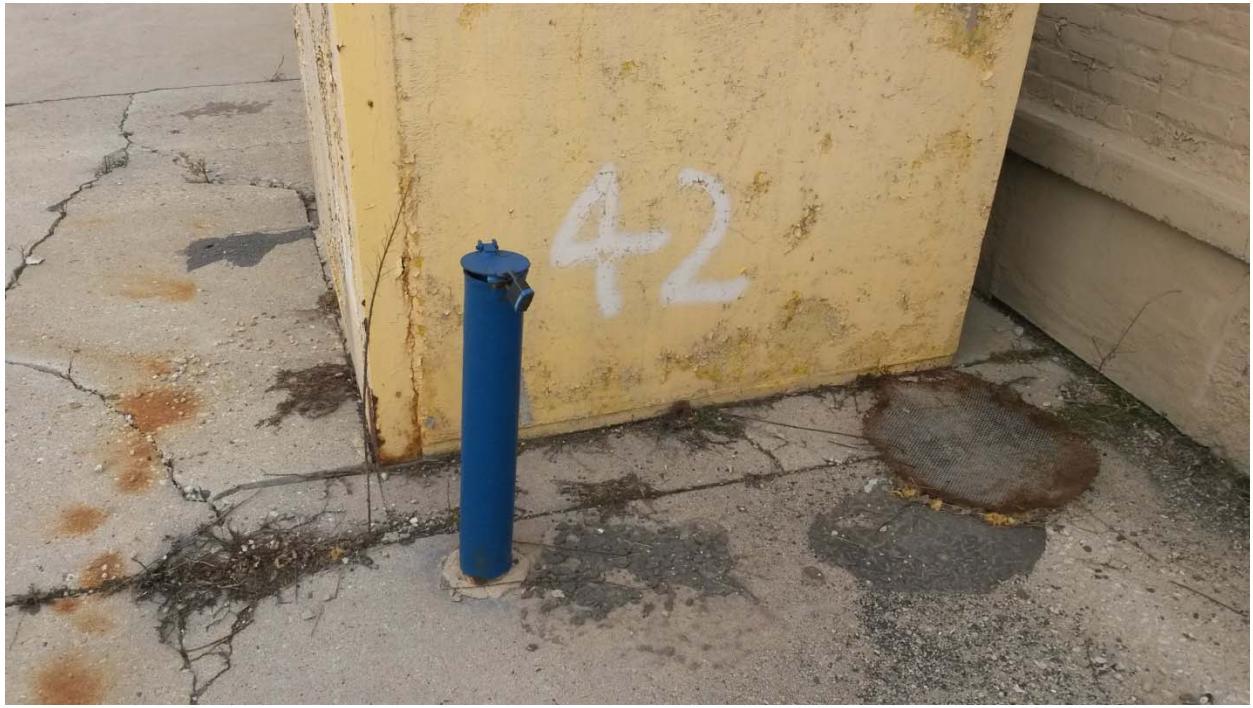
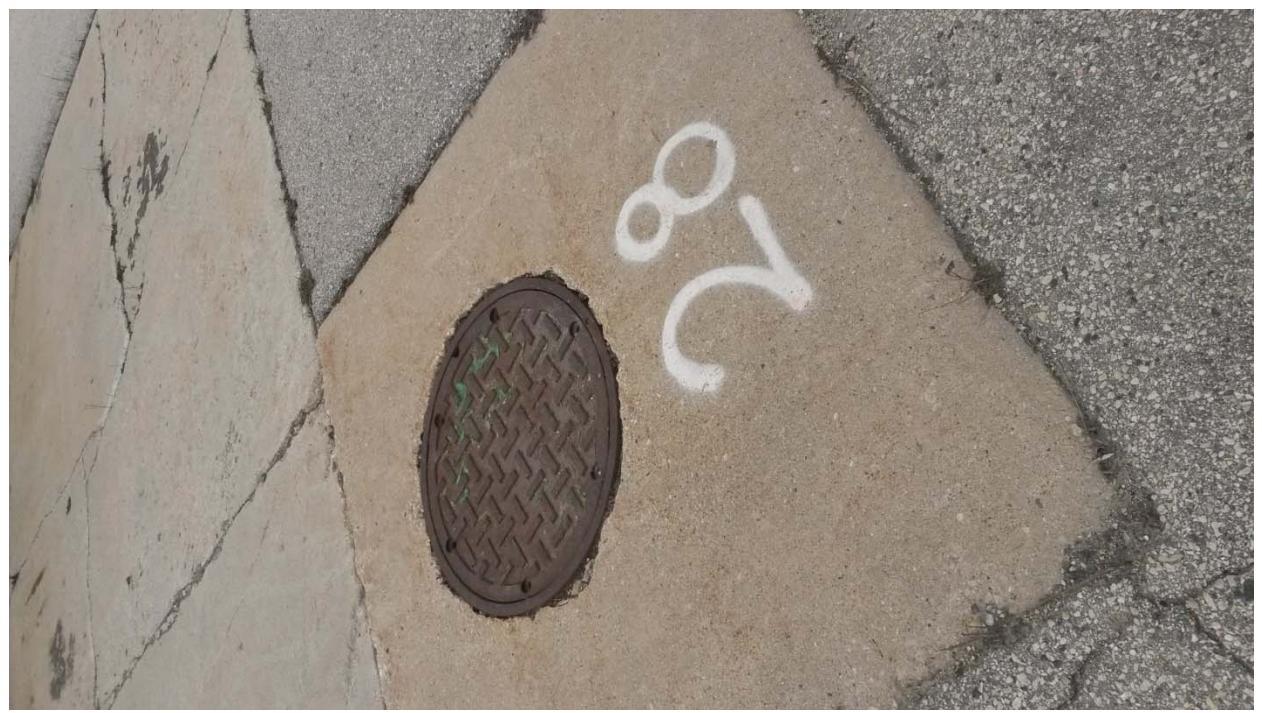
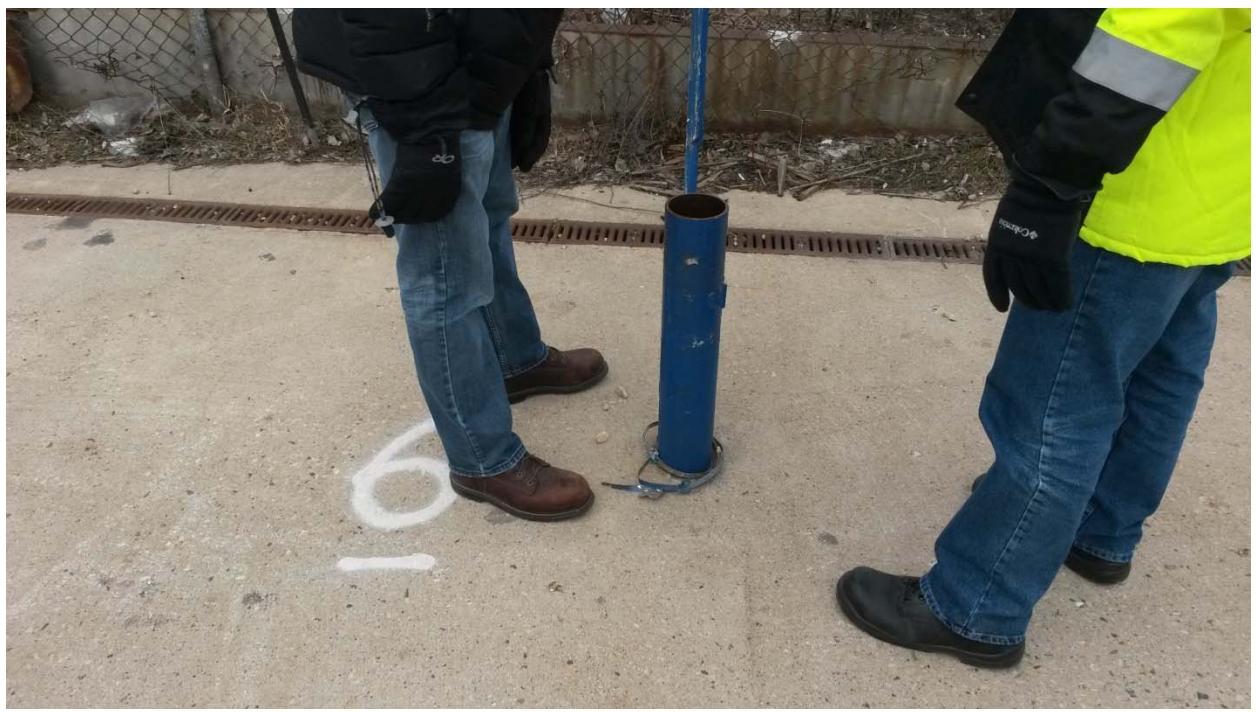
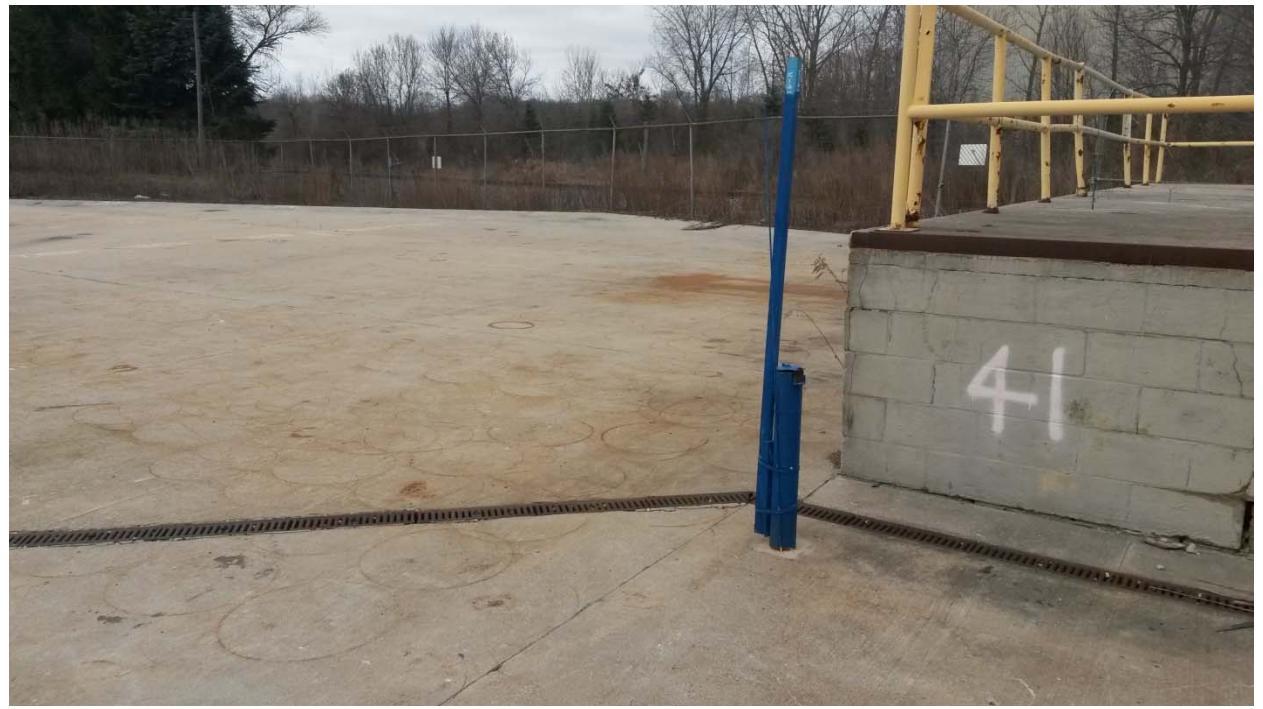
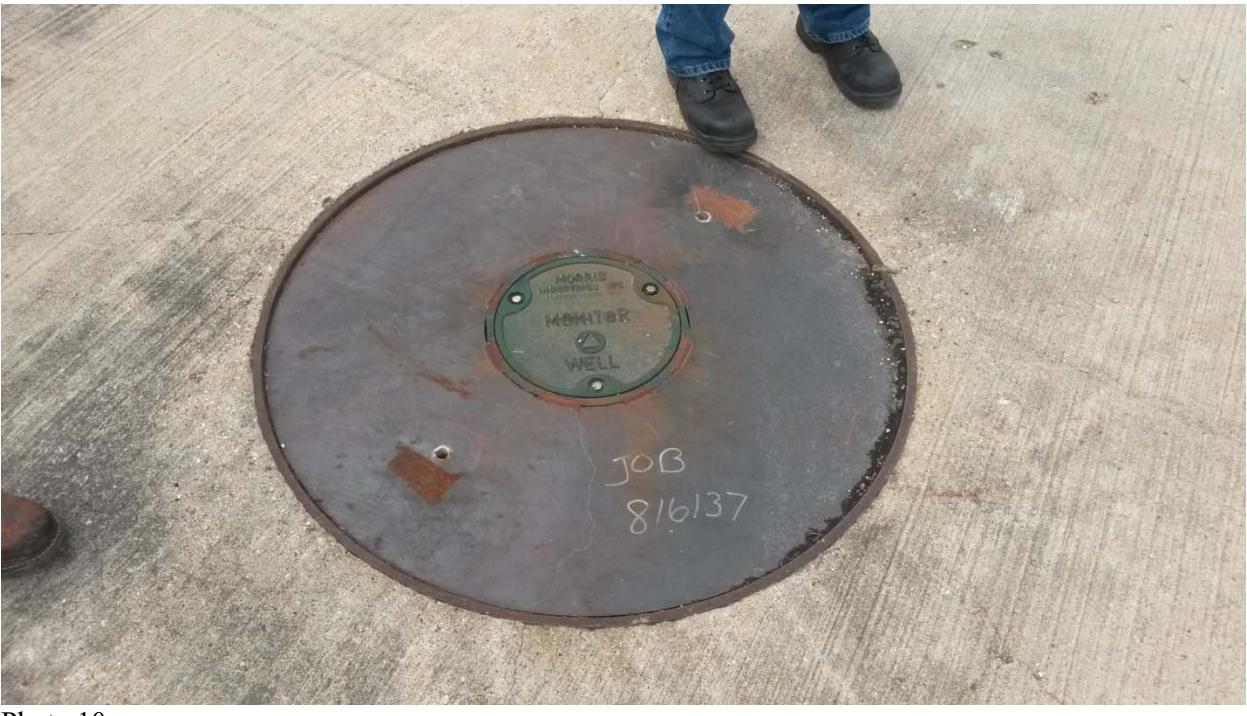
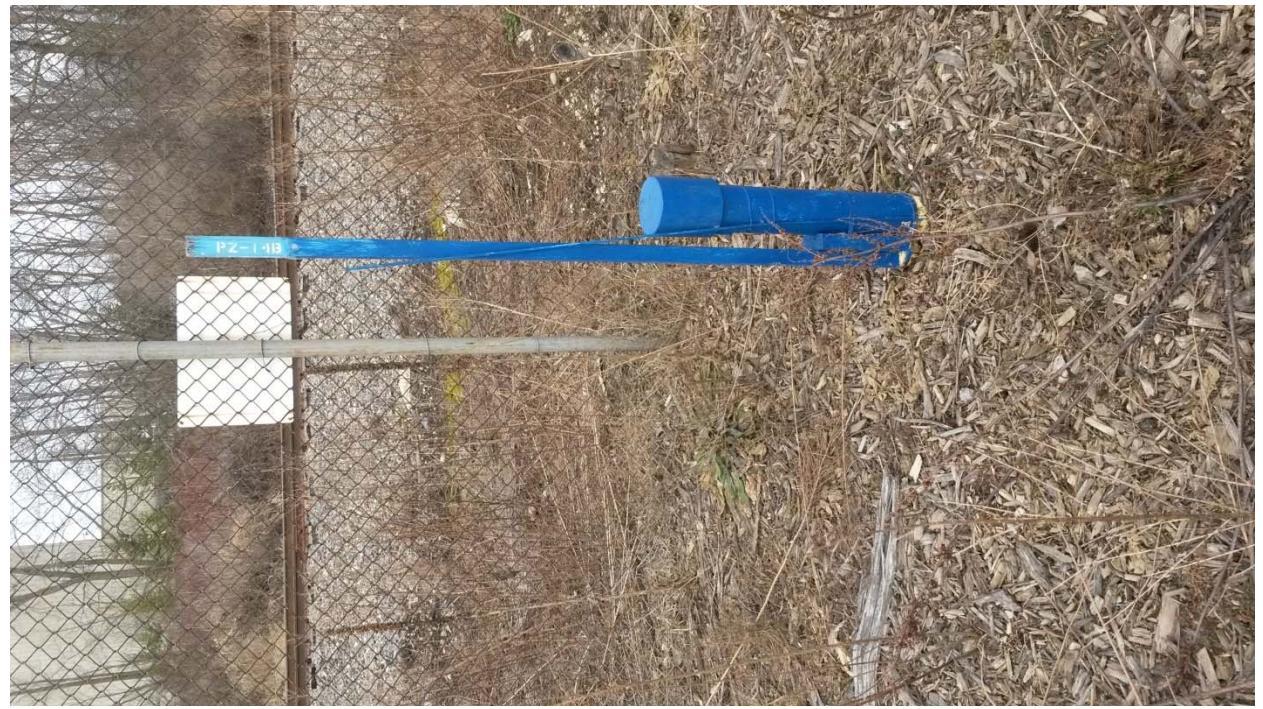
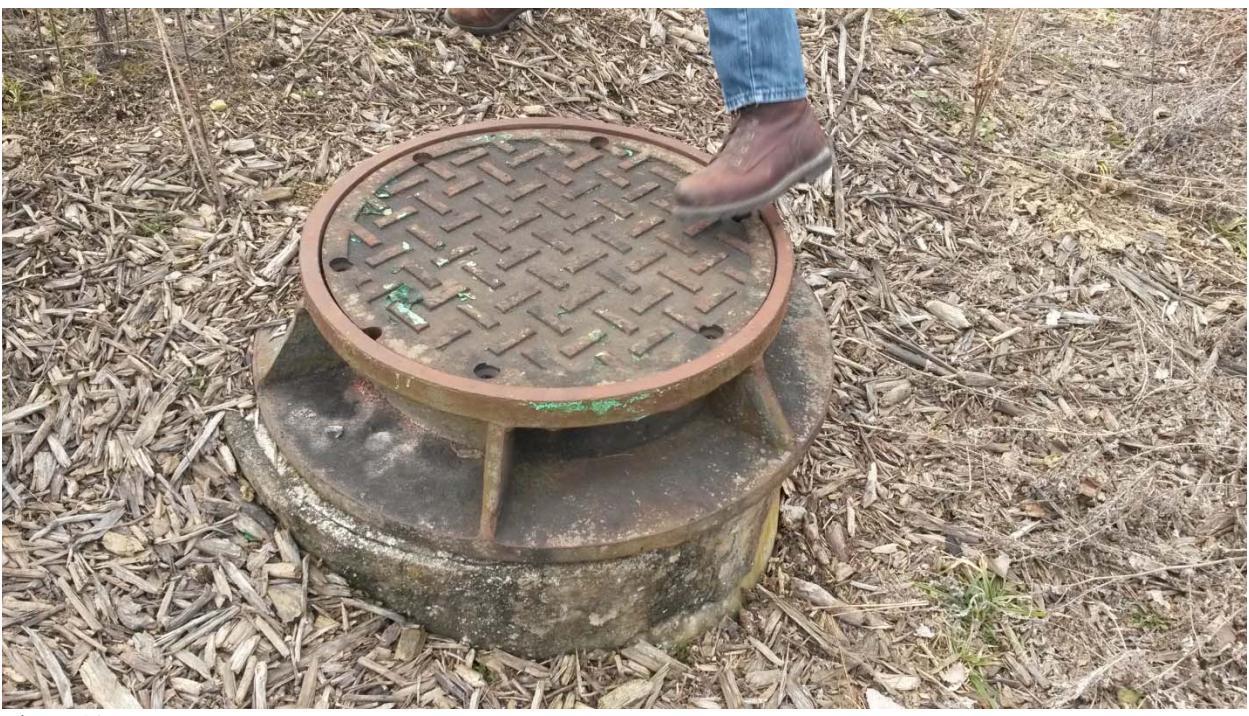
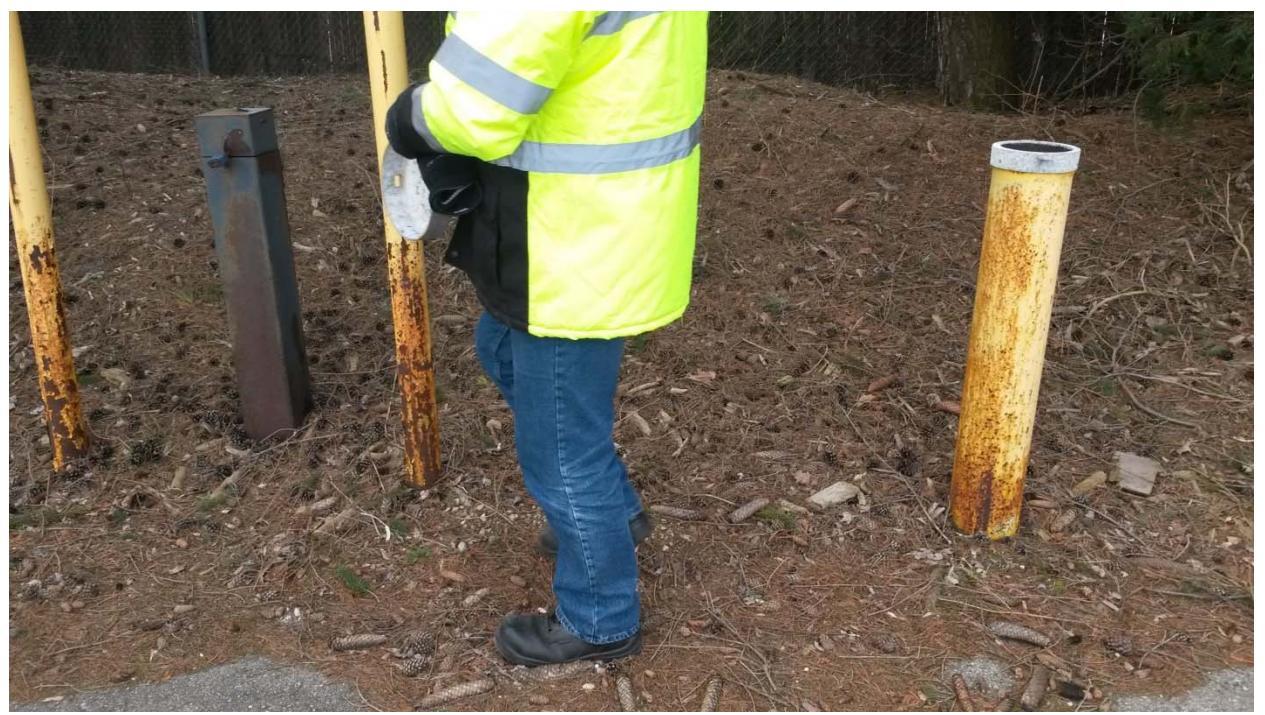
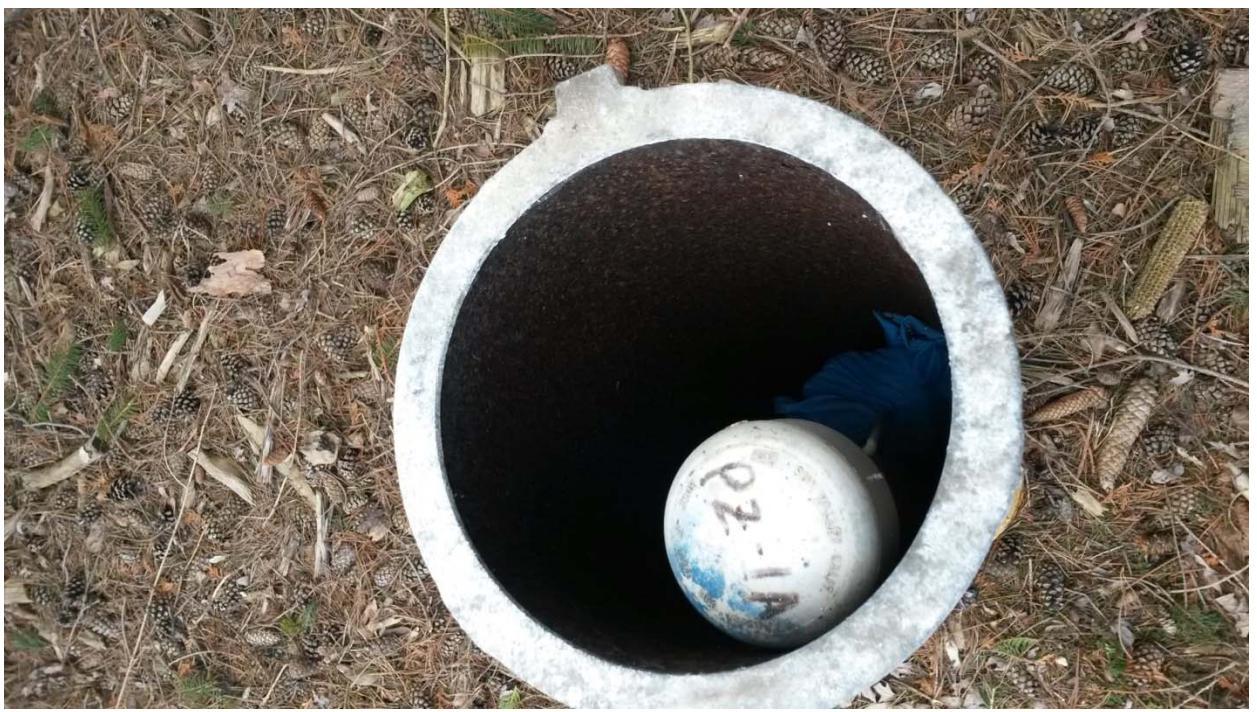
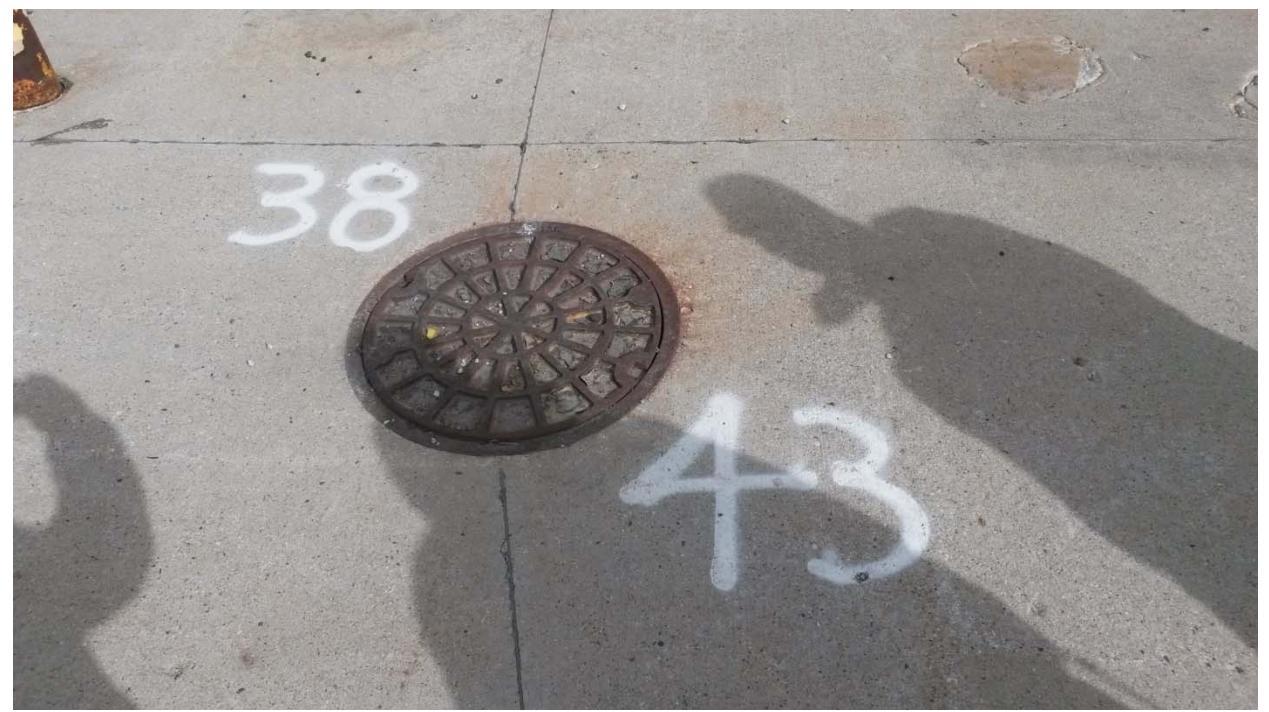
- No surface-seal or well integrity problems were observed (Photos 6-15).
- The Northern Signal site was observed on the other side of the fence and railroad tracks to the west of Cook Composites (Photo 16).

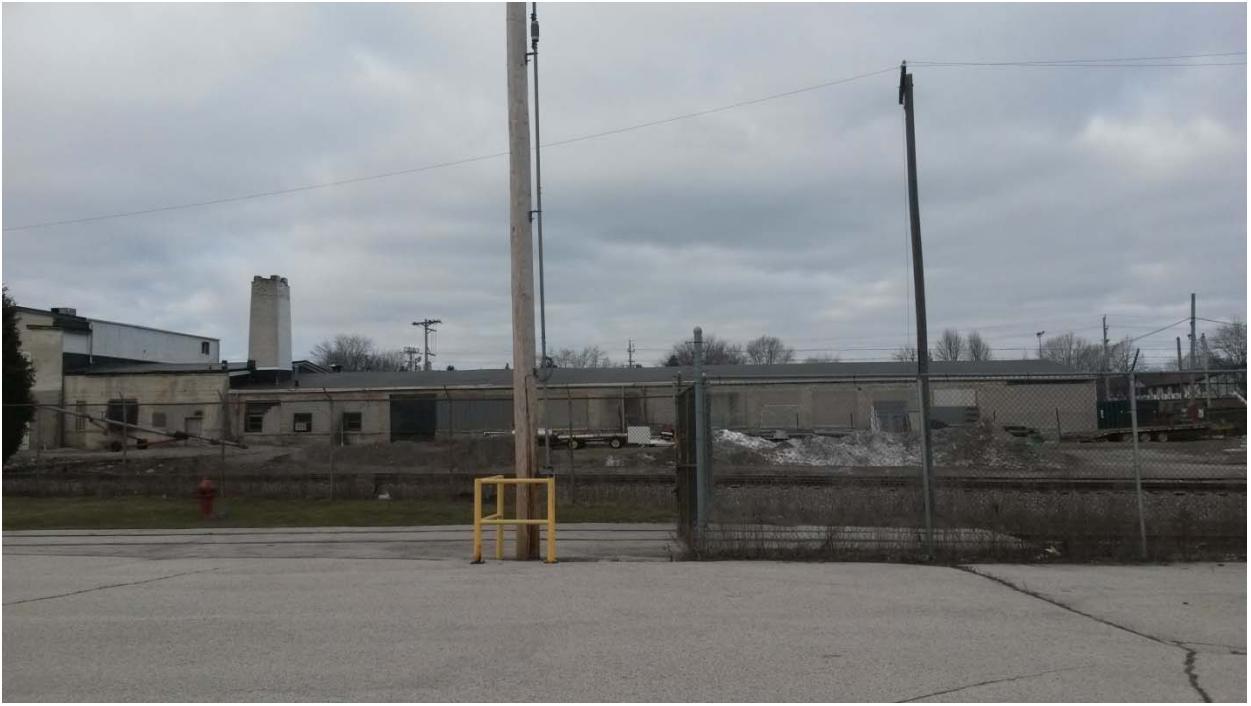
Photo 16. The Northern Signal site.

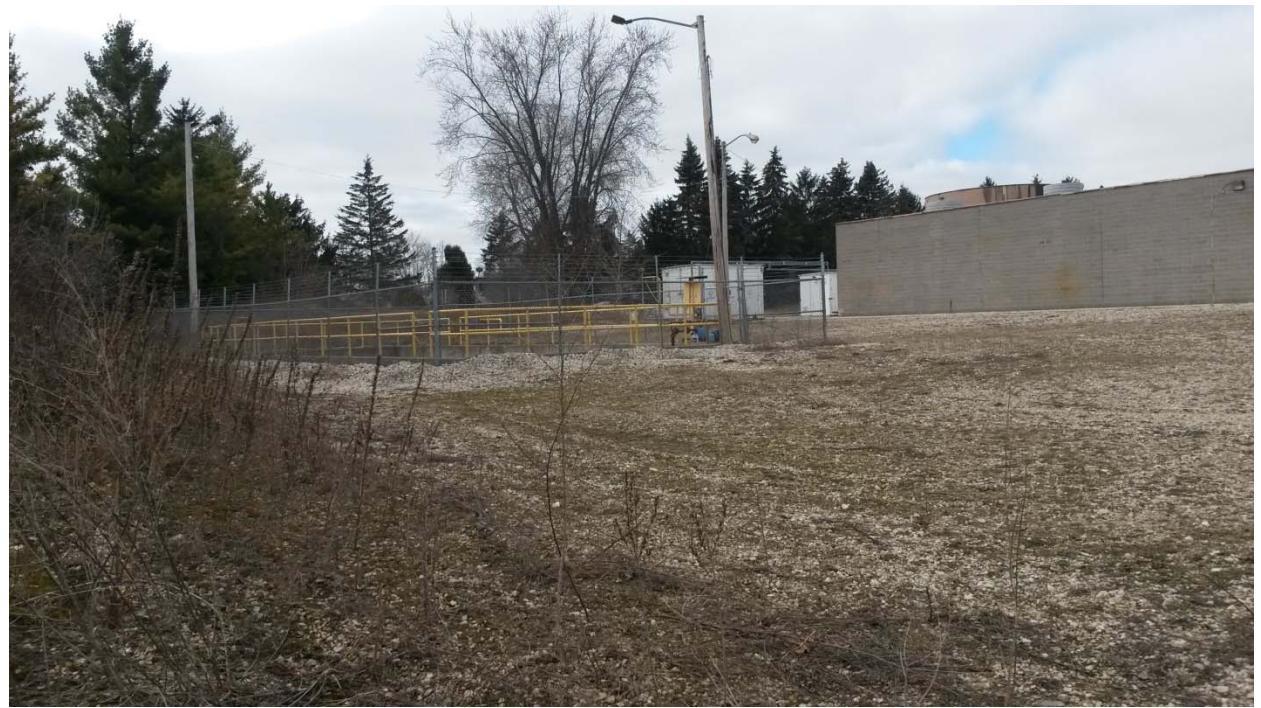
- At the wastewater pretreatment holding pond and outfall location (Photos 17 and 18) a sweet odor was observed characteristic of the historic wastewater odor at the site. Cigale stated that the intermediate and deep wastewater discharge to the outfall under permit, while the Rainey collector wastewater goes to the POTW.

Photo 17. The pre-treatment pond.

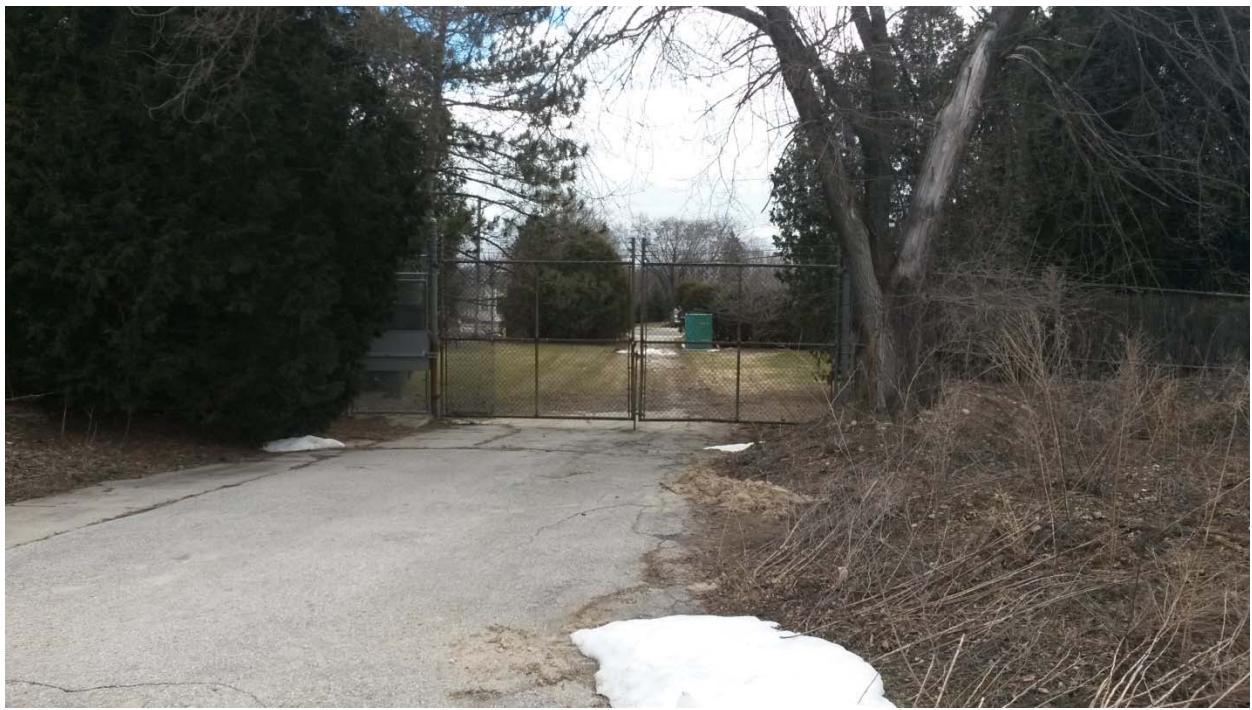
Photo 18. The outfall.
