Subject: Case Closure Addendum for Jacobus Oil Co.  
N116 W16261 Main Street, Germantown, WI  
BRRTS #: 02-67-000801, FID #: 267054920

**Project # 17016.020**  
**Saxony Village Development Project**  
**Village of Germantown**  
**Washington County, Wisconsin**

## COVER / BARRIER / VENTILATION MAINTENANCE PLAN

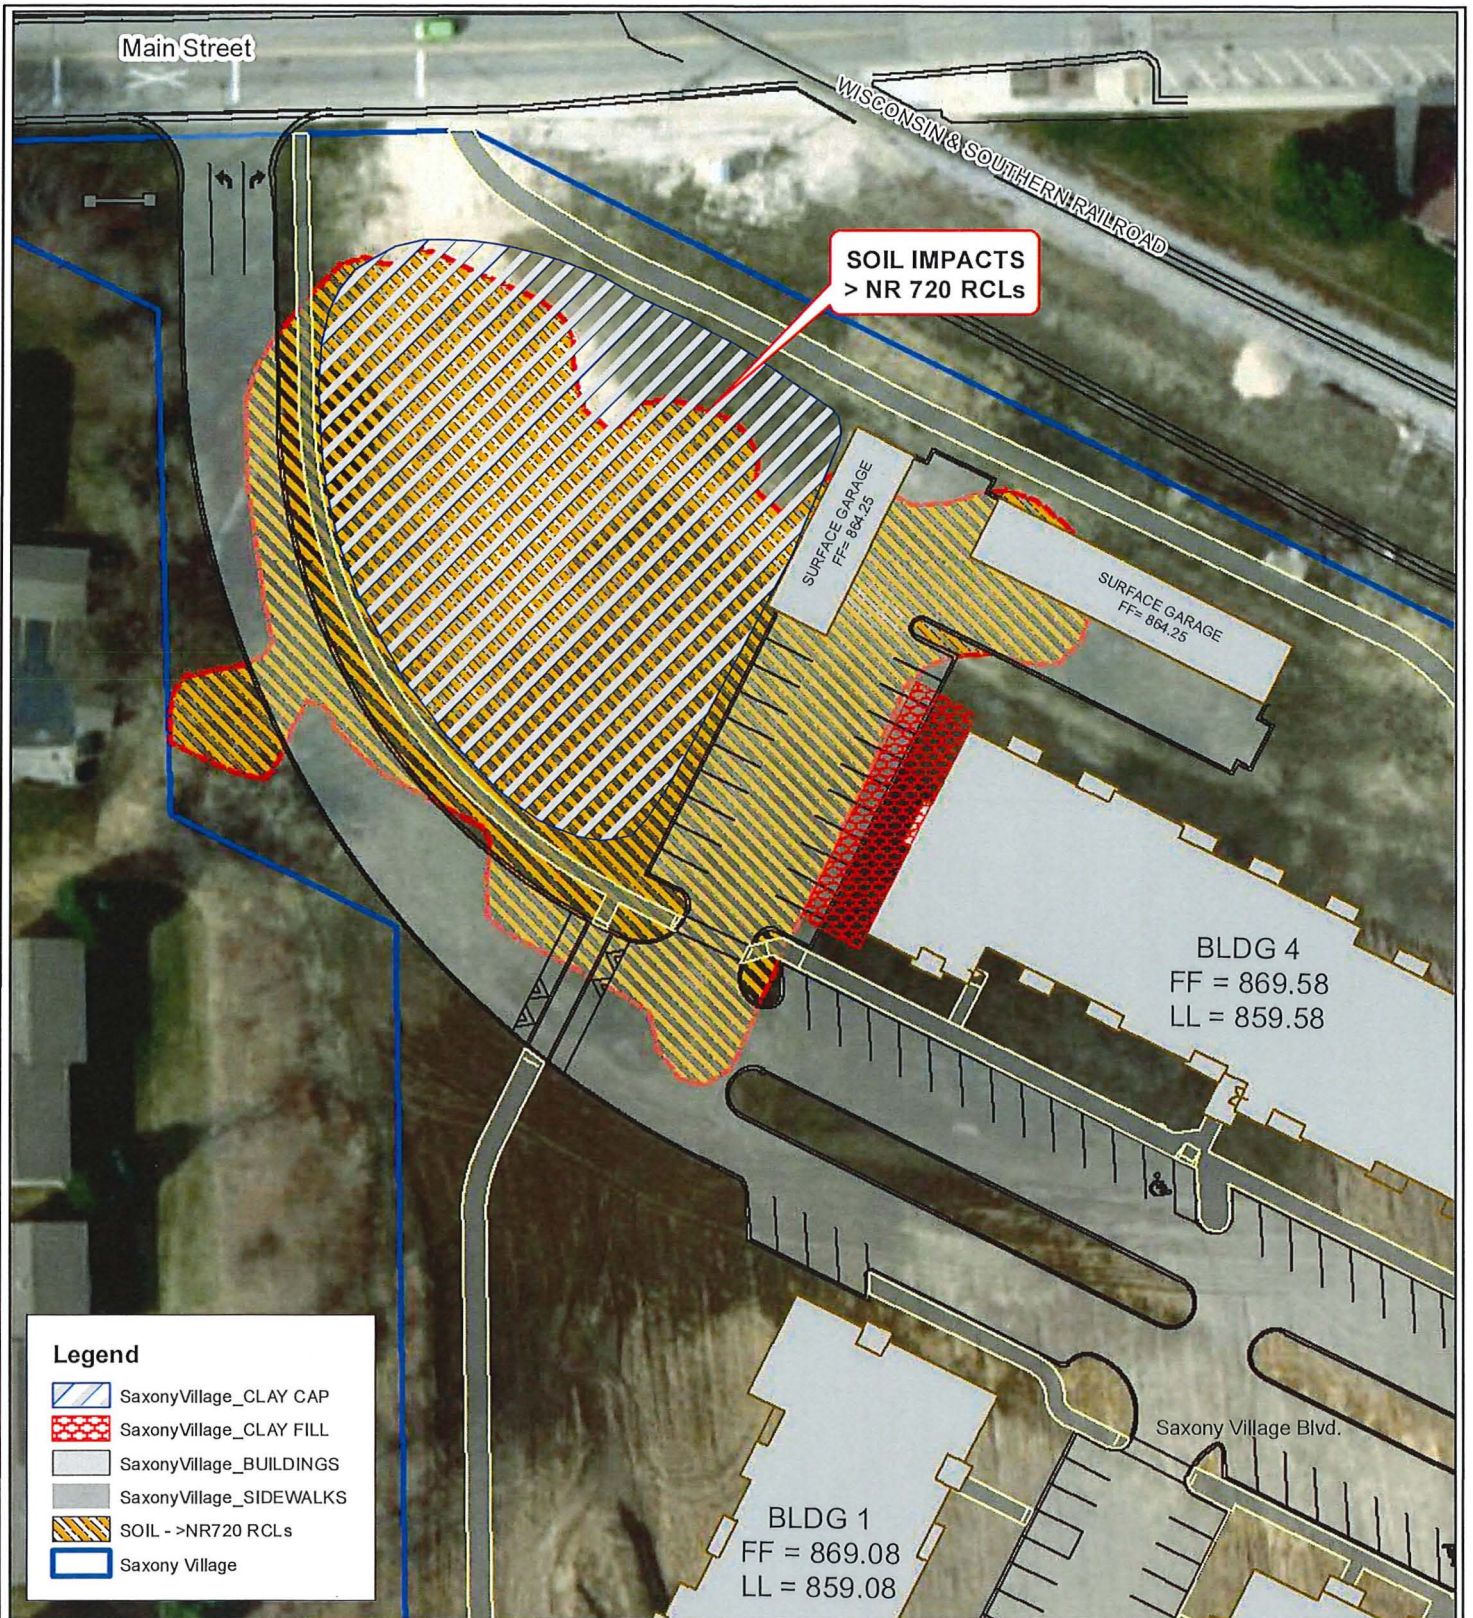
**Figure 4: Barrier Installations for Soil Contamination**

1. At the location of the former Jacobus and CMC sites, the grade was raised with three feet of clean, imported soil in the area of residual contamination. Following the grade change, a surface cover was constructed, consisting of pavements, building foundation, and six inches of clay material, followed by one to two feet of topsoil in landscaped areas. The cover and barrier areas that are to be maintained are illustrated by Himalayan's Figure 4 and Figure 5, Barrier Installations for Soil Contamination and Barrier Installations for Groundwater Contamination, June 21, 2018.

The pavements, building foundations, and clay and soil covers that exist in the locations shown on the attached maps, Figure 4 and Figure 5, Barrier Installations for Soil Contamination and Barrier Installations for Groundwater Contamination, June 21, 2018, shall be maintained in compliance with the attached maintenance plan to minimize the infiltration of water and prevent additional groundwater contamination that could pose a vapor intrusion threat, and to prevent direct contact with residual soil contamination that might otherwise pose a threat to human health.

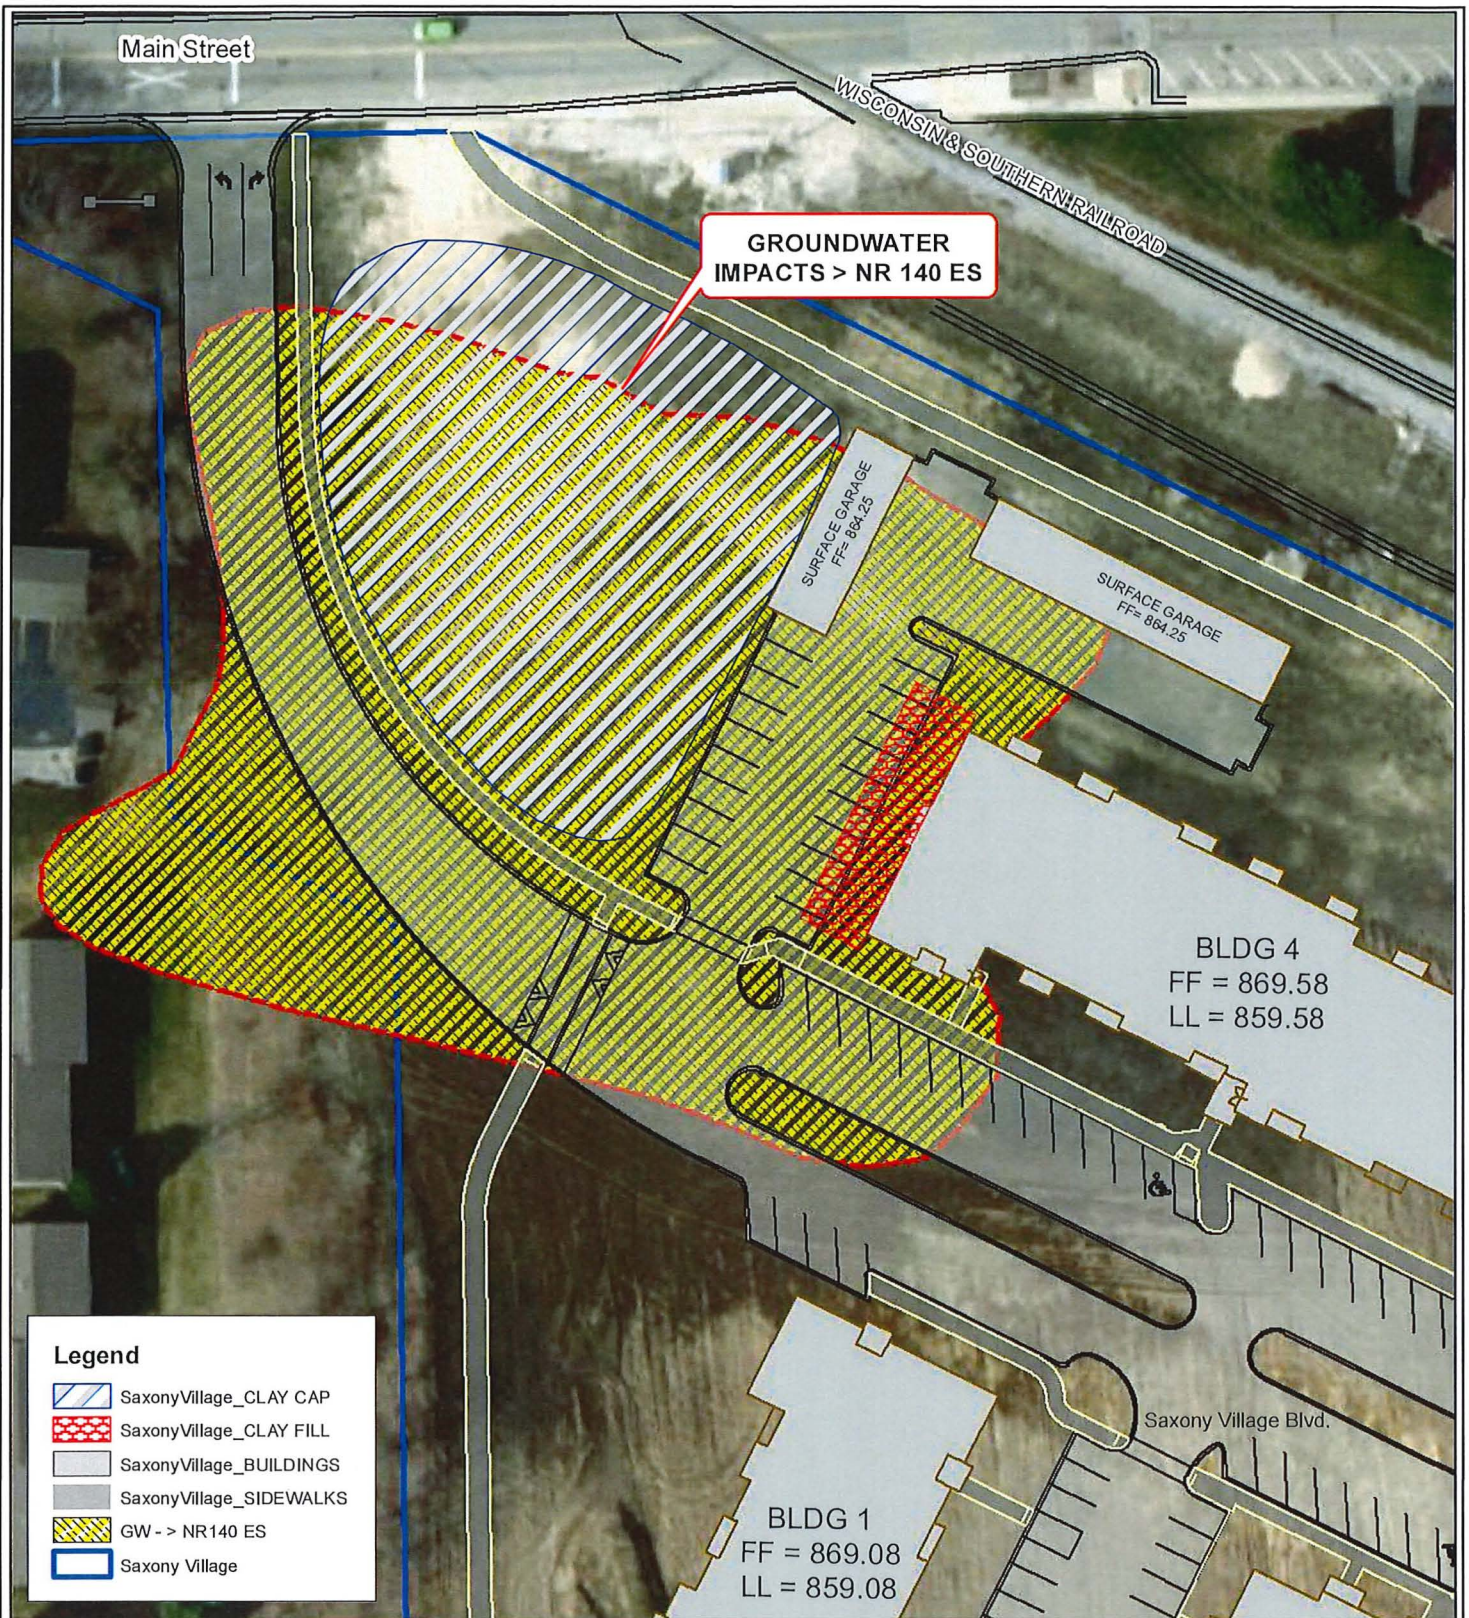
**Figure 5: Barrier Installations for Groundwater Contamination**

2. A vertical clay barrier wall was constructed between the northwest end of Building 4 and the residual soil and groundwater contamination, the dimensions being 85 feet long by 20 feet wide to a depth of 2 feet below the building footings. Approximately 125 cubic yards of impacted soil were excavated for the barrier wall, from 3-5 feet below ground surface (bgs), temporarily stockpiled, and then placed under the upper clay and topsoil cover described above.

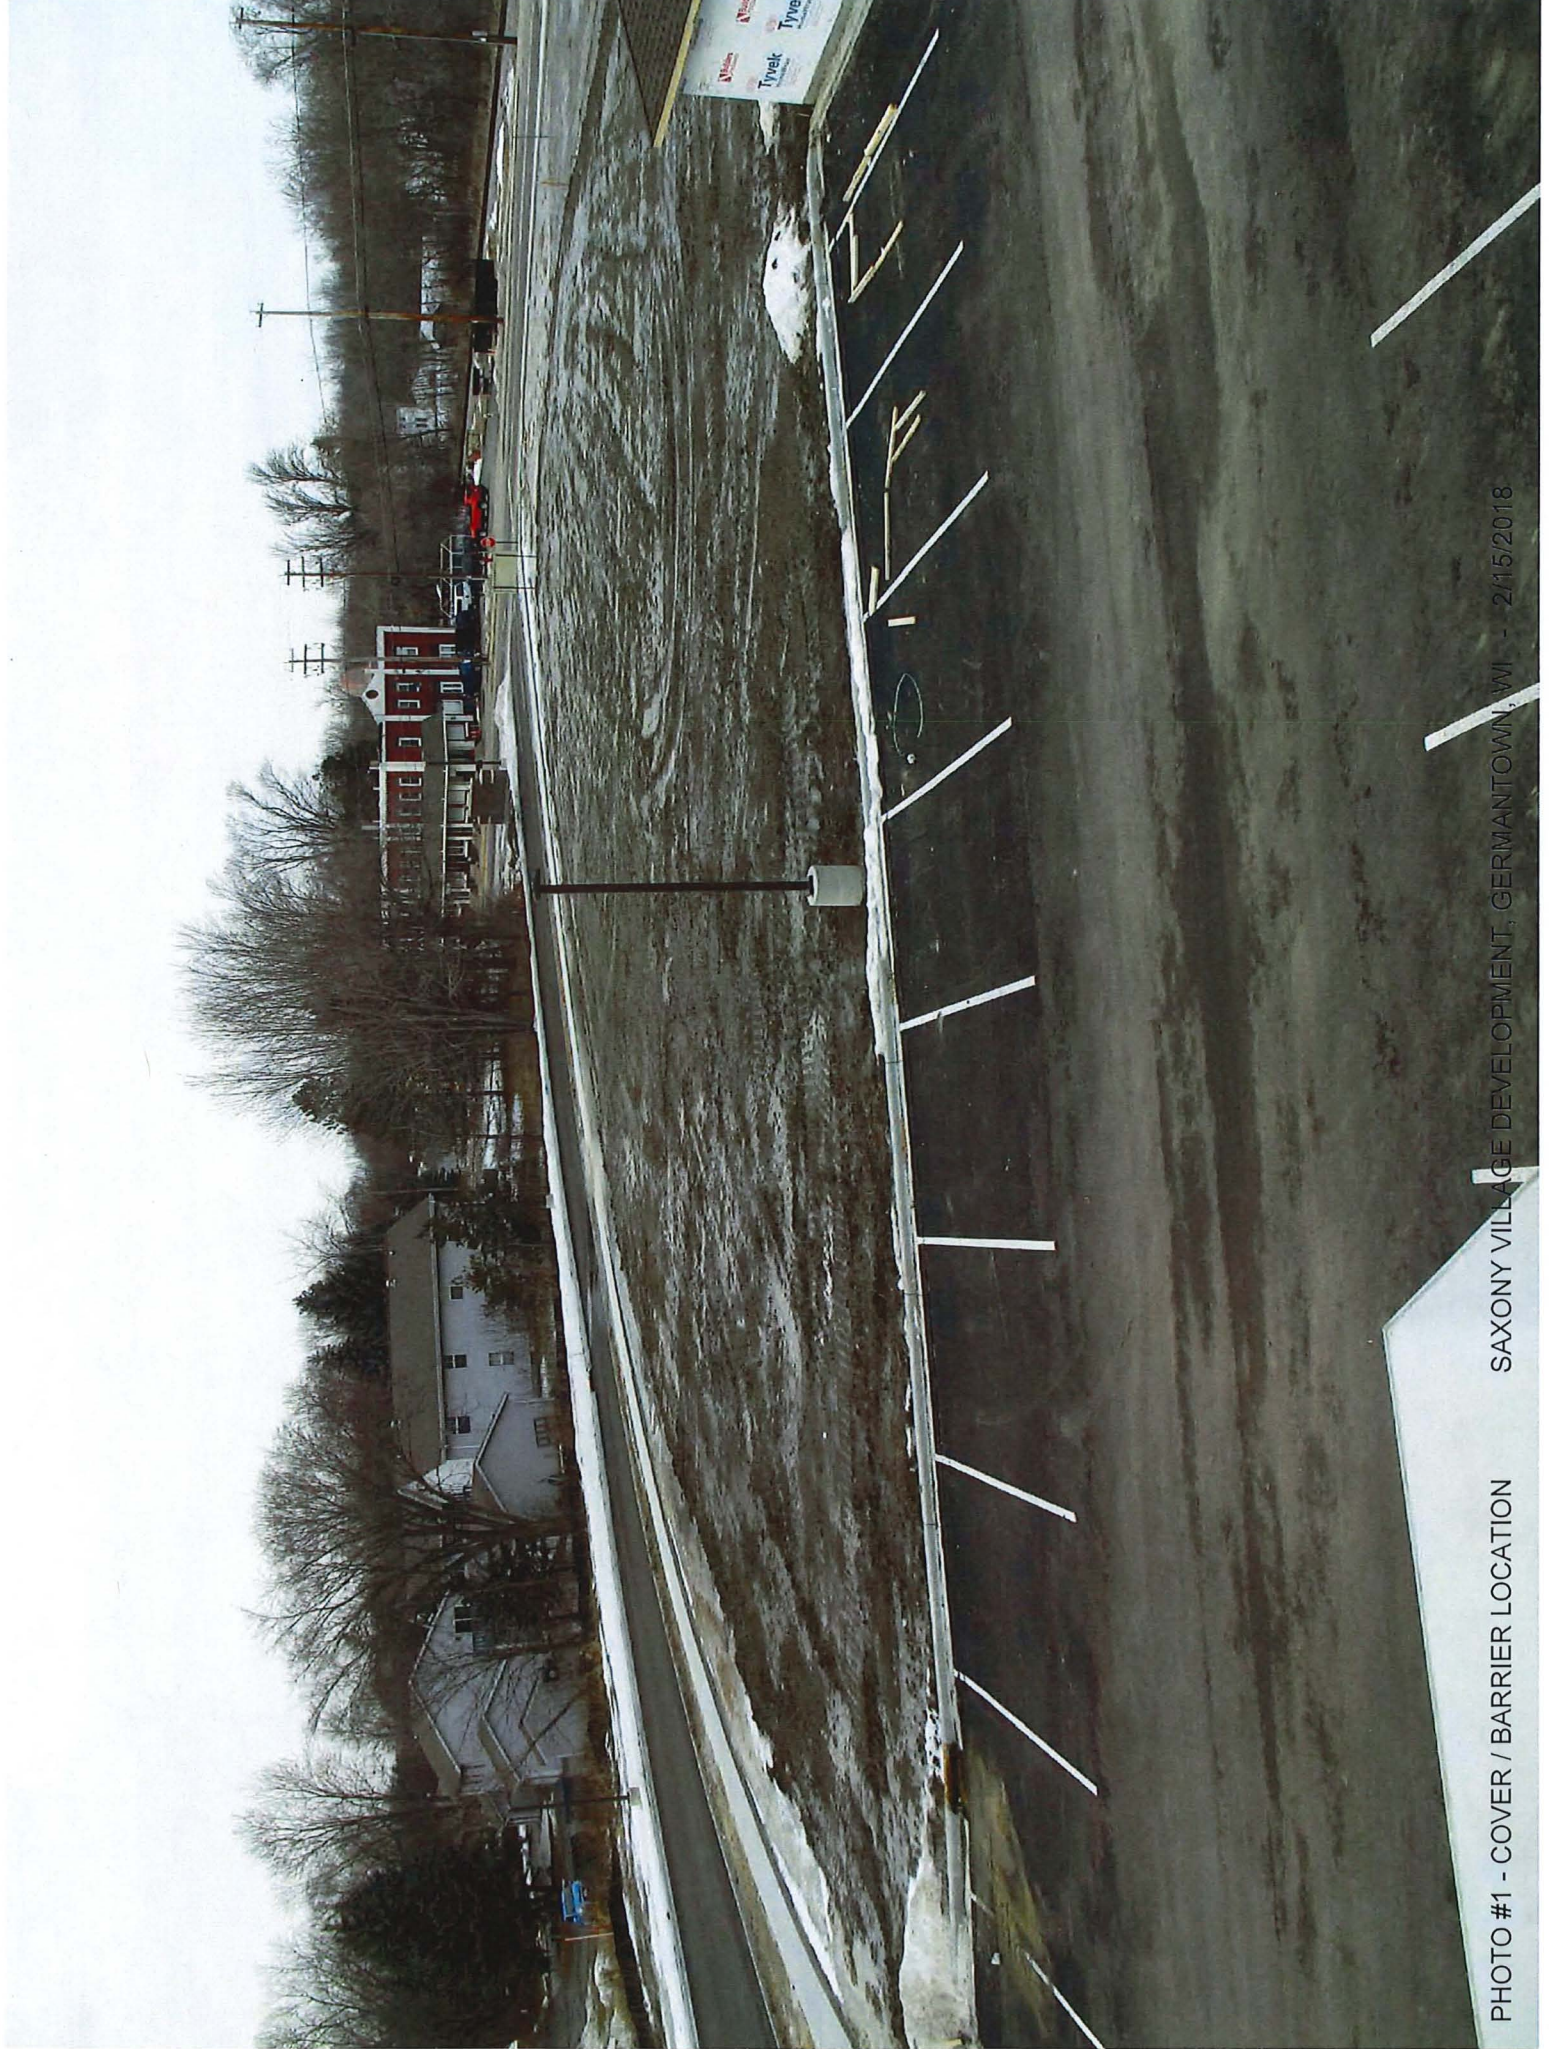
PHOTO #1 - COVER / BARRIER LOCATION

The cap consists of approximately 6 inches of non-contaminated clay over most of the contaminated soil and groundwater remaining at the site. The cover system includes vegetation, one to two feet of clean topsoil and fill, concrete sidewalk, asphalt pavement on the parking lot and entranceway road, and garage building foundations. An additional barrier exists between Building #4 and the contaminated area, consisting of approximately 5 feet of non-contaminated clay. This barrier is a 20 x 85-foot area along the northwest side of Building #4, and extends about 2 feet below the building footing. The cover/barrier/cap system is located between the south side of Main Street and the north/northwest sides of Building #4, as shown on the attached Figures 4 and 5.

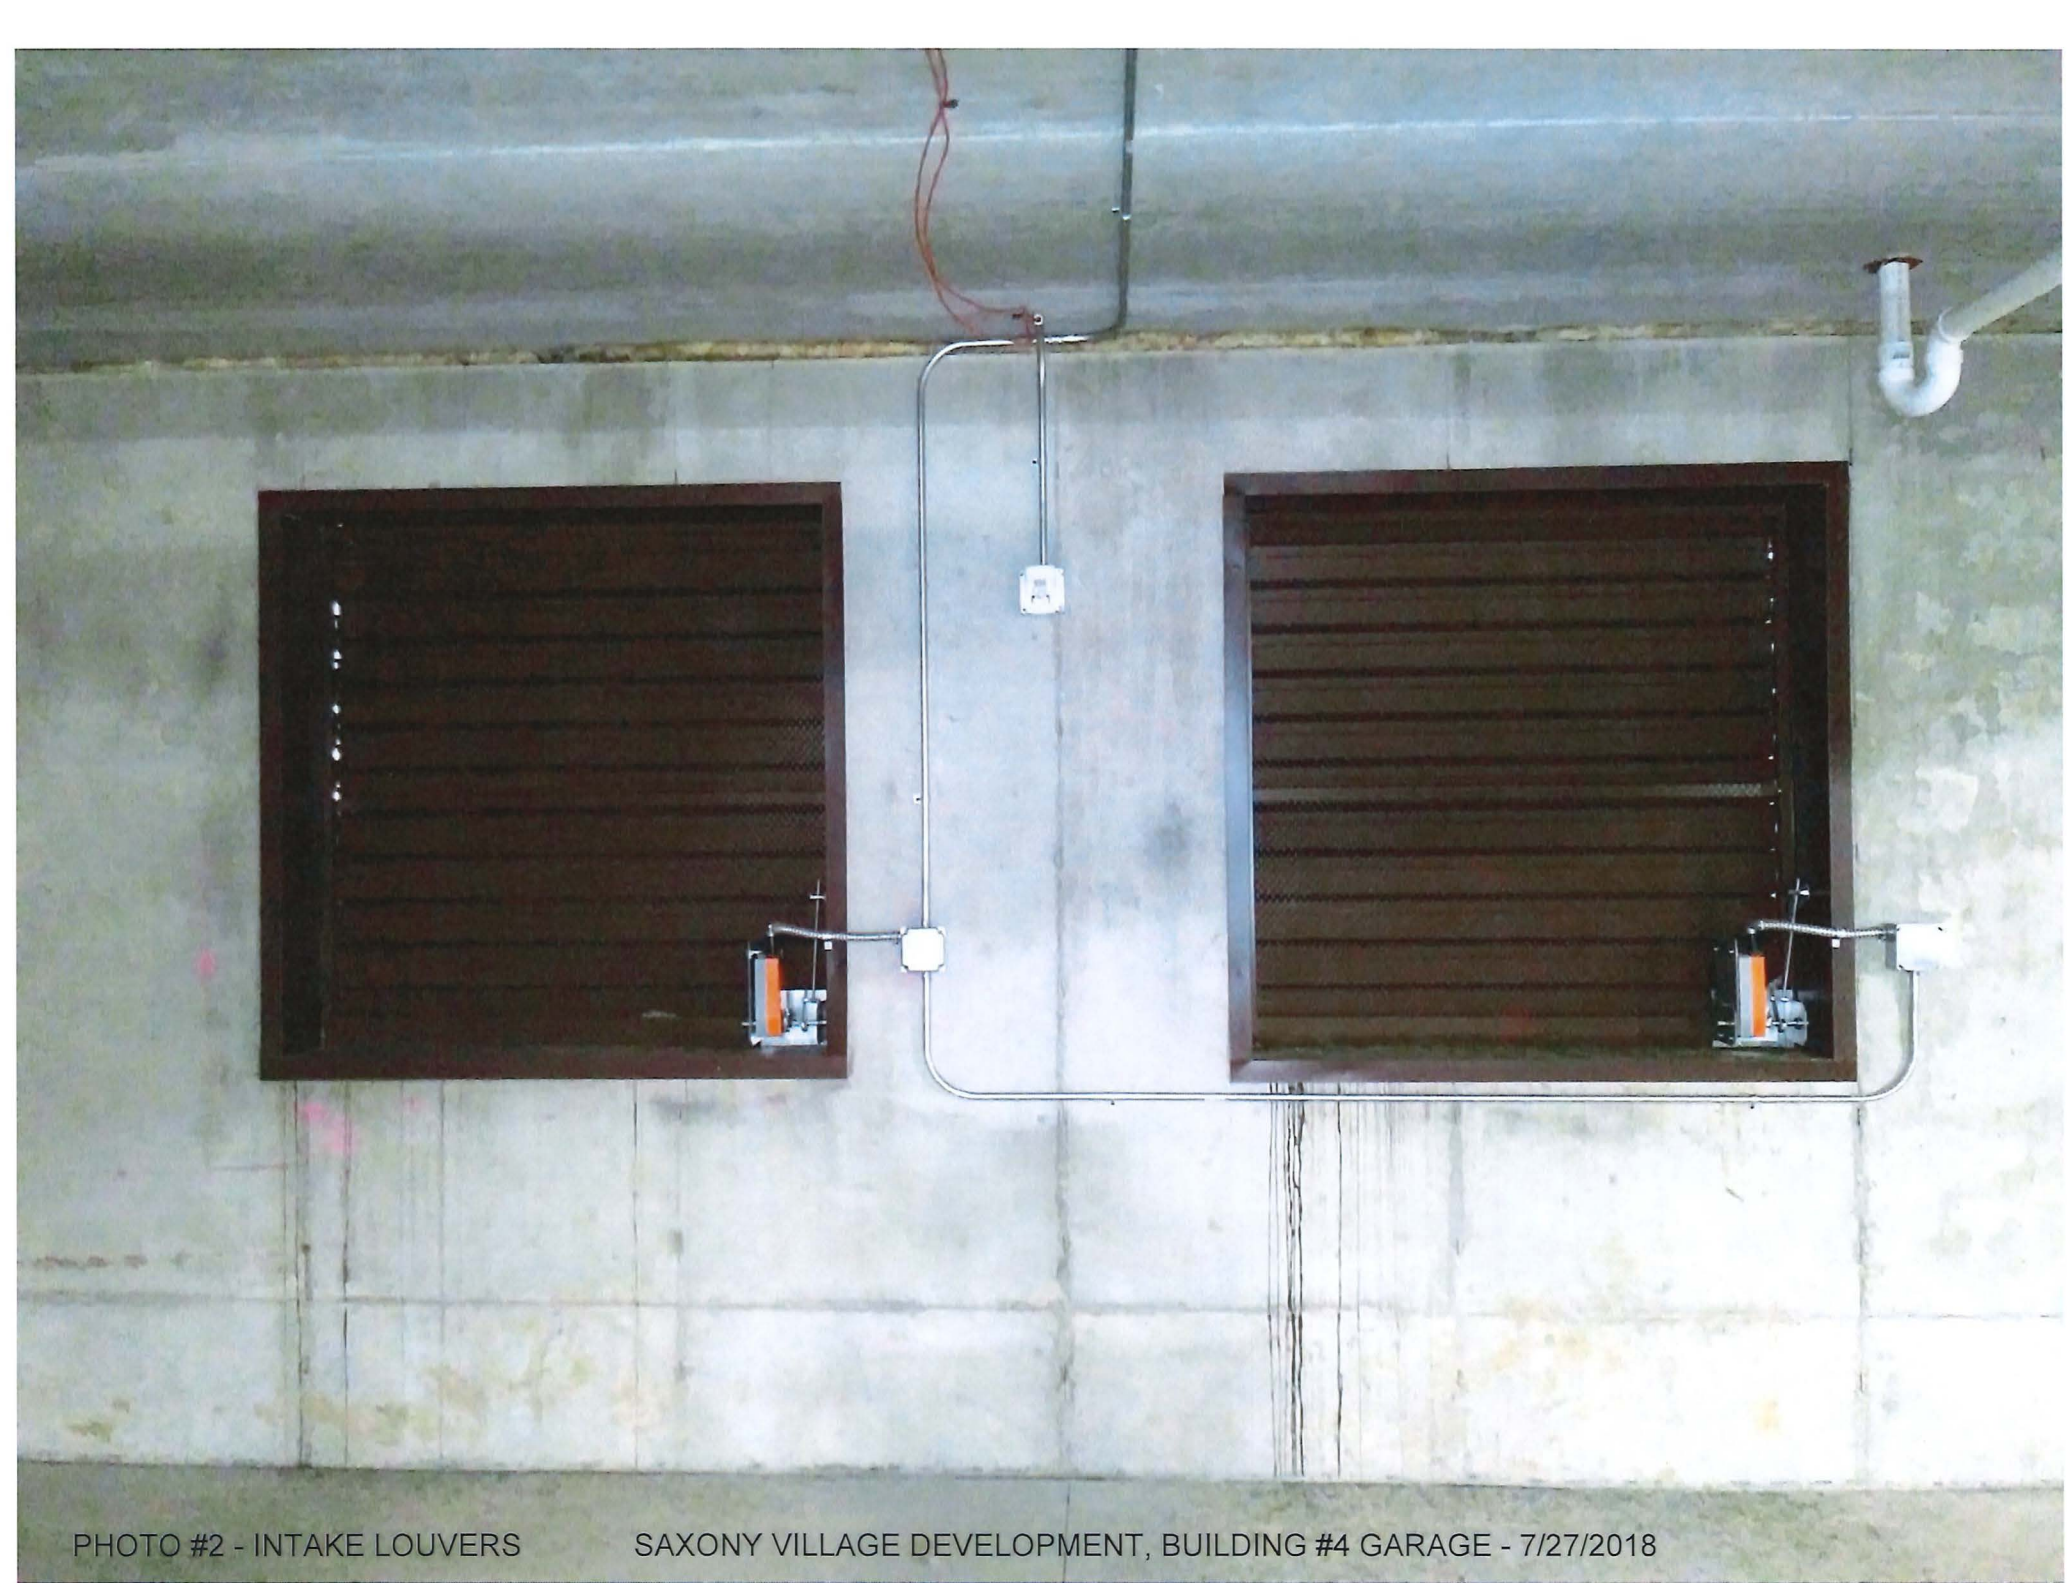
PHOTO #2 - INTAKE LOUVERS

The vapor mitigation system consists of ventilation equipment designed for the periodic removal of automobile exhaust from the underground parking structure in Building #4. The ventilation equipment includes intake louvers (Vent Products Model 2000-31) located in the northeast corner of the garage, a CO / NO<sub>2</sub> detector (Brasch Model GSE-NCM-LL1) near the center of the garage, and an exhaust fan (S&P Model LCE48-ASSY) located in the southeast corner. Based on an intermittent ventilation design (i.e. time clock and CO/NO<sub>2</sub> detection), air flow within the parking structure will reach ¾ cfm per square foot or a minimum of five air exchanges per hour. The location of ventilation equipment in the underground parking structure is denoted in Figure 6 and photos of the equipment are included in Photo #2 - #4.

If problems to the ventilation system are noted during the annual inspections or at any other time during the year, repairs or replacement of system components will be scheduled immediately upon discovery of a malfunction. Repairs and replacements can include electrical connections, time clock and CO/NO<sub>2</sub> detector, intake louvers, and exhaust fan assembly.

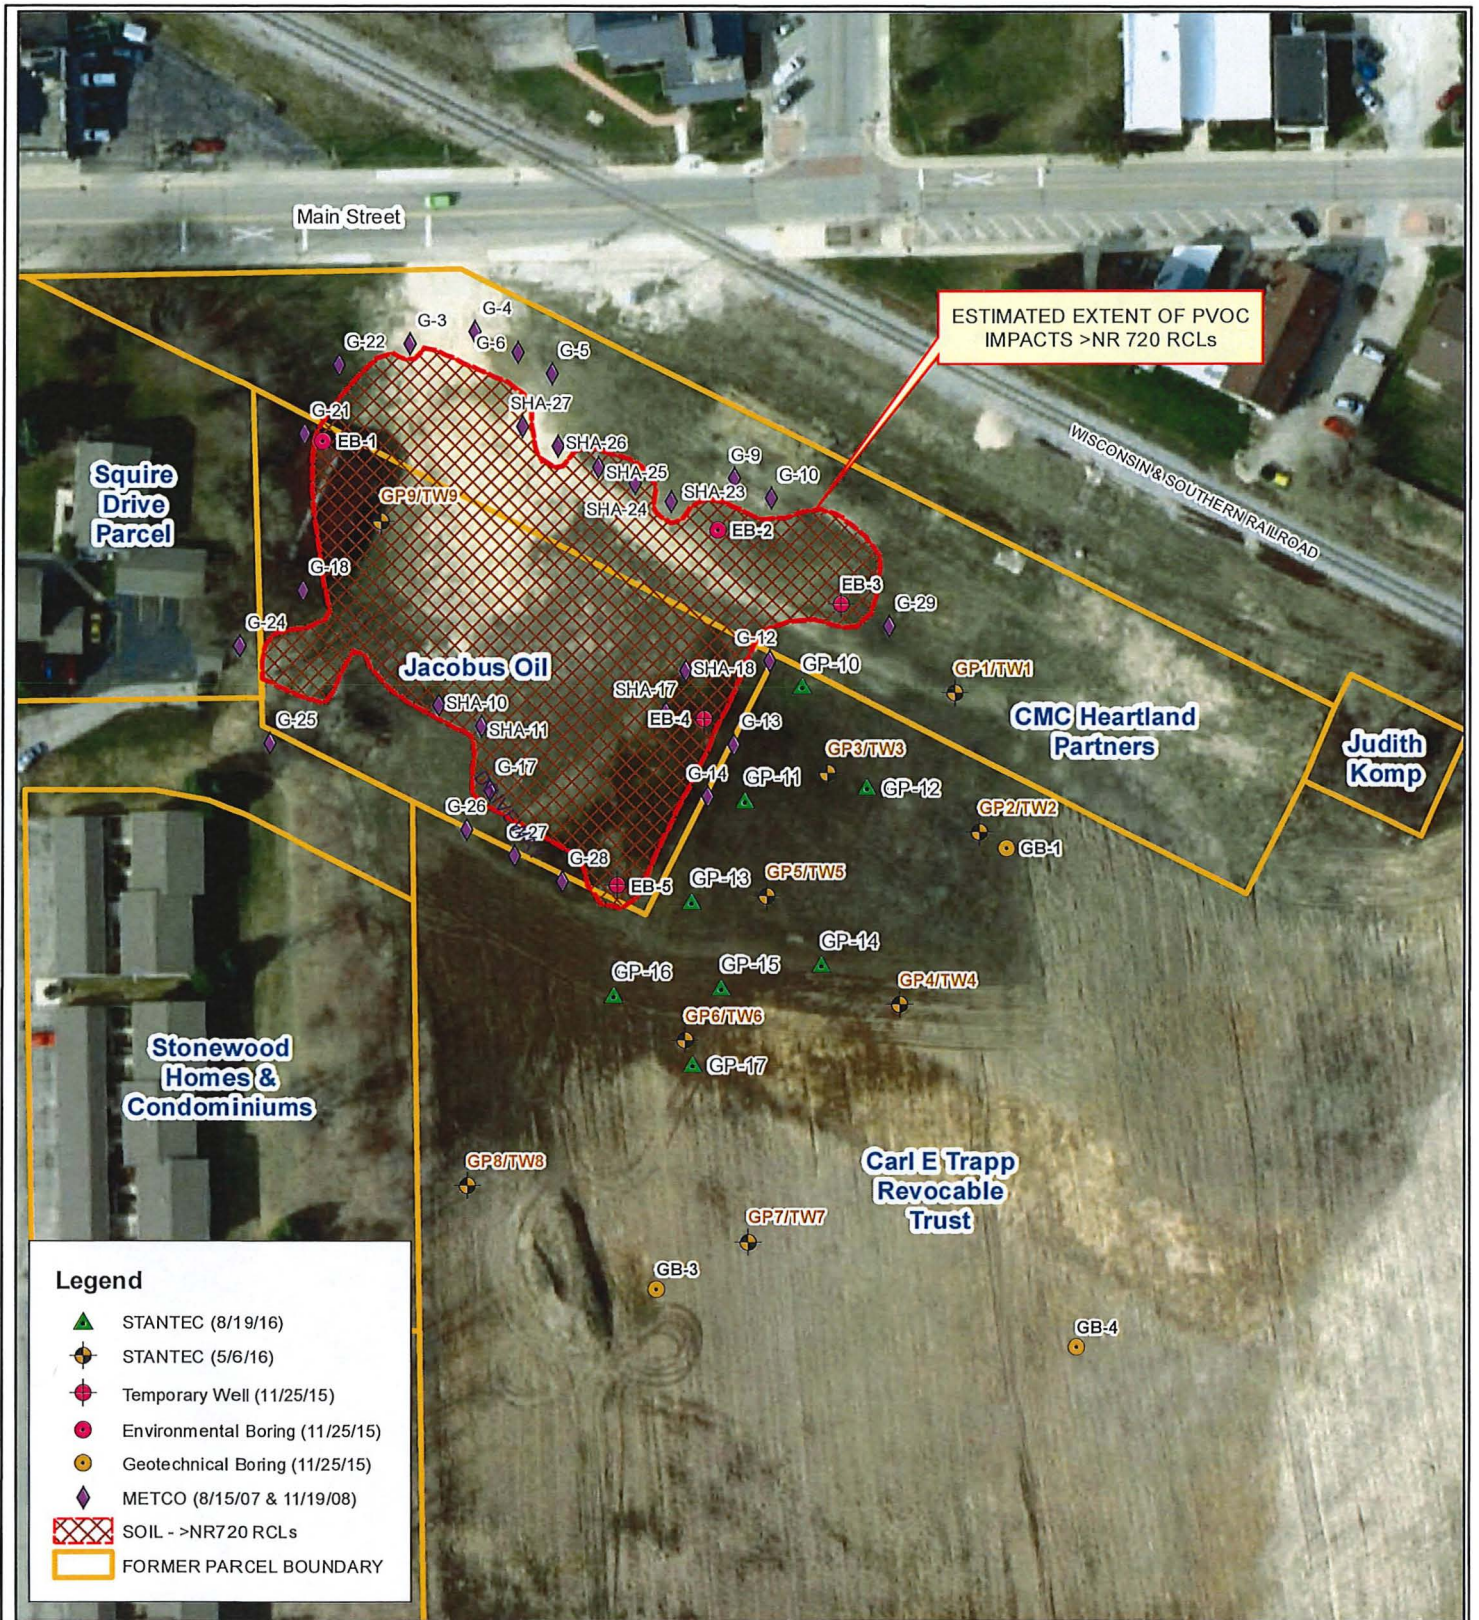
**Figure 1: Soil Quality Map**

Soil contaminated by petroleum is located at a depth of 2 to 10 feet at the source property and several adjacent properties owned by Stonewood Homes & Condominiums (GTNV 224148 to 224163), Germantown Manor Apartments (GTNV 224026001 to 224026002 – Former Squire Drive Parcel), Heritage Place Joint Venture (GTNV 224992002 – Former Carl E Trapp Revocable Trust), and MCB Investments (GTNV 224025001 – Former CMC Heartland Parnters). Several areas have been identified with petroleum VOC concentrations above their respective NR720 RCLs. Groundwater contaminated by petroleum is located at a depth of 10 to 30 feet (+/- 5 feet). Several areas have been identified with petroleum VOC concentrations above their respective NR140 ESs. Previous investigation and remediation activities at the source property have been conducted in conjunction an adjacent ERP site to the northeast [CMC Heartland (BRRTS #02-67-000341)]. Contamination at both sites is assumed to be co-mingled and the estimated extent of the soil and groundwater contamination is shown on the attached Figures 1 and 2. The Saxony Village Development is comprised of two parcels associated with the ERP sites and the Heritage Place Joint Venture parcel to the south, for a total of approximately 23.8 acres of land. Phase 1 was completed in 2017, including Building #4 and roadway construction and infrastructure installation (water, storm and sanitary sewer, ponds, and electrical) for the remaining multi-family apartment complex. Management of contaminated material generated during these
