Phase I Environmental Assessment

City of Kenosha Department of City Development

Former C&L Industrial Cleaners 8927 Sheridan Road Kenosha, Wisconsin

STS Project No. 86415XA

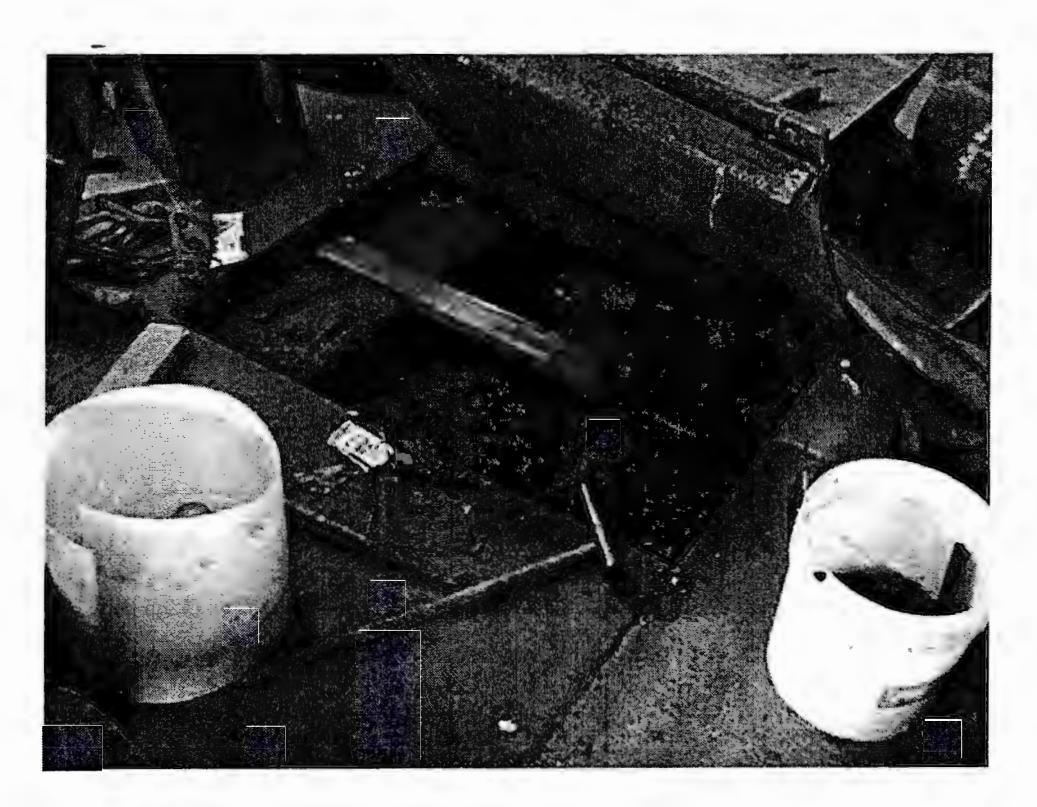
• Pit #1 and Pit #2 are 45-feet long and run parallel to the length of the garage. Both pits appear to have been covered with wood at one time. At some later date the wood covering the pits was paved over with concrete except for a 3-foot by 4-foot section near the east end of Pit #1. A rust-like substance was observed below the wood covering the 3-foot by 4-foot section in Pit #1. It is not known whether Pit #2 was completely filled before it was paved over.

The pits described above are all considered recognized environmental conditions.

Pit #1. Note the rust-like substance in the pir.

STS recommends that a Phase II ESA be conducted on the site. The Phase II ESA should include soil borings near the pits in the garage and main building, near the drums along the south side of the shed and loading dock. Several of the soil borings should be converted to temporary groundwater monitoring wells. Soil samples from the soil borings and groundwater samples from the monitoring wells should be analyzed for volatile organic compounds (VOCs), polynuclear aromatic hydrocarbons (PAHs), and metals. Tests pits should also be excavated through some of the concrete piles to determine if fill materials pose a risk at the site.

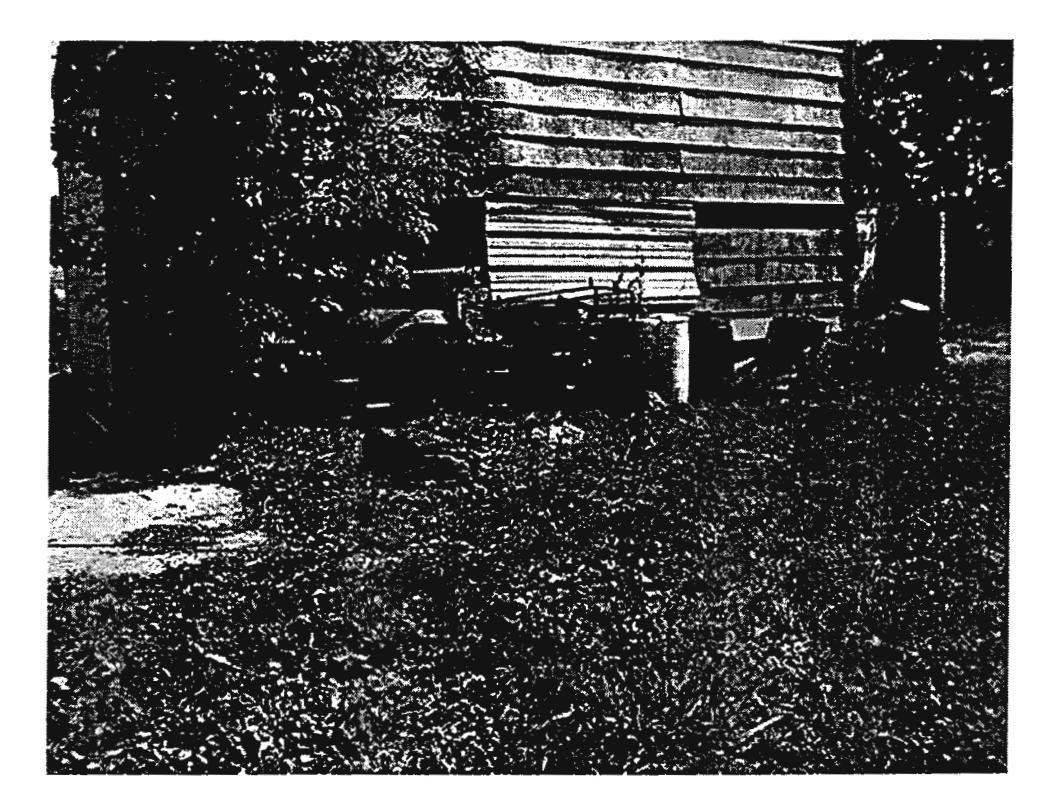
Nine steel drums were observed along the south side of the shed. The drums were rusted and contained one-gallon paint cans, rubber, concrete and other miscellaneous refuse. Many of the drums were dented. One of the nine drums had been crushed. The nine steel drums are considered recognized environmental conditions.

Drums containing used paint cans, concrete rubble, and miscellaneous refuse on the south side of the shed.

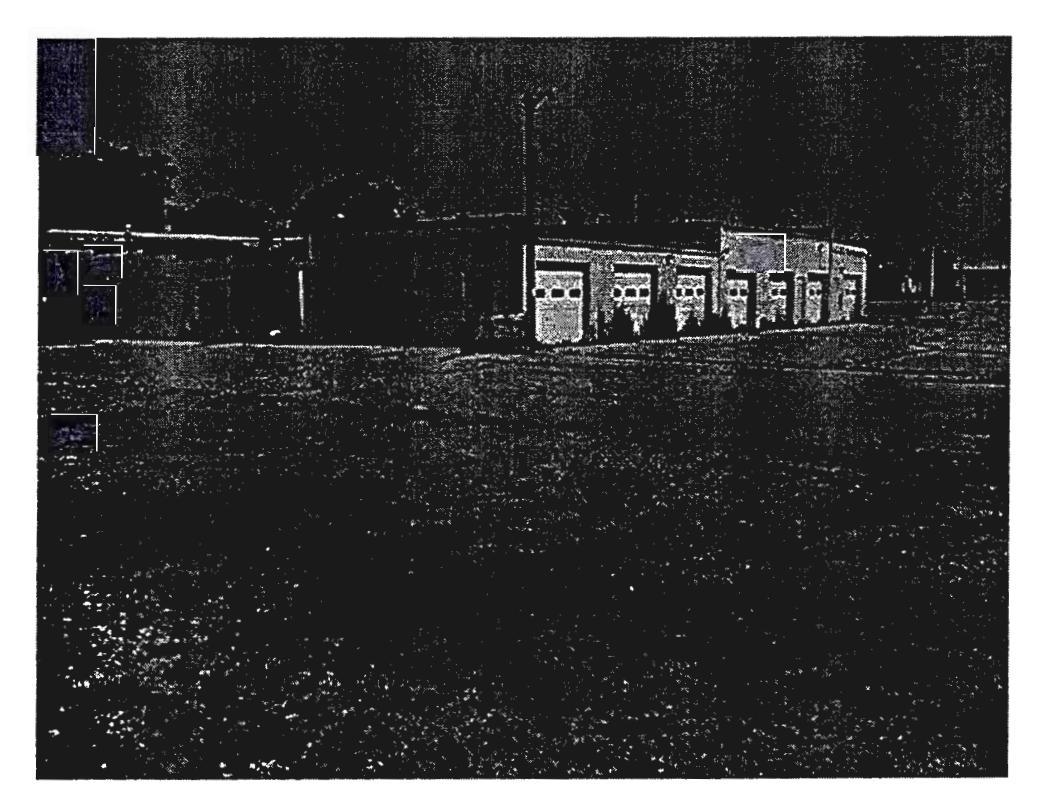
An aboveground storage tank (AST), approximately 200 to 300 gallons in size, was observed near the southeast corner of the vacant building on the adjacent property to the north. The AST is located approximately 100 feet from the north property line of the subject site. The AST is not registered with the Wisconsin Department of Commerce. The AST appeared to be a fuel oil tank and should be considered a potential recognized environmental condition to the subject site. No recognized environmental conditions were observed on the properties to the south, east, and west of the site.

Adjacent property north of C+L Industrial Cleaners. Note the aboveground storage tank next to the corner of the building.
