May 17, 2021

Trevor Bannister
Hydrogeologist – Remediation and Redevelopment Program
Wisconsin Department of Natural Resources
3911 Fish Hatchery Road
Fitchburg, Wisconsin 53711

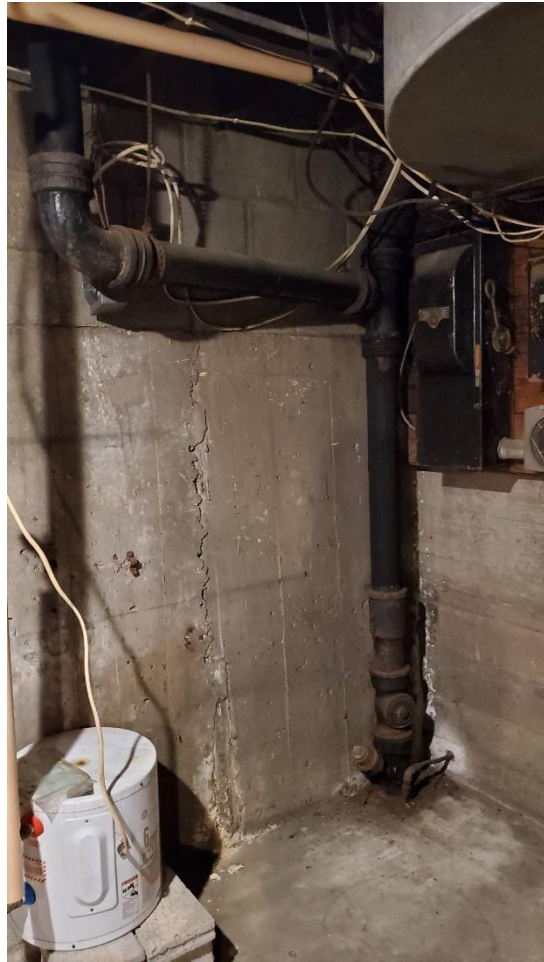
Photo 4: Basement- Northeast corner of basement. Plumbing stack, electric water heater, and electrical panel shown. Minor cracking along concrete forms shown.

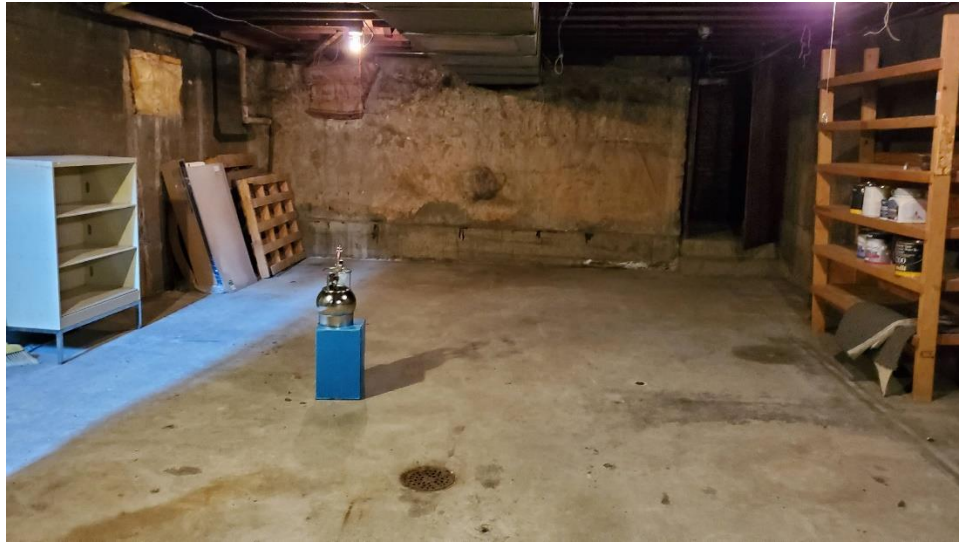
Photo 5: Basement view to the west- Wall separating furnace room and floor drain shown. Likely window well on left side (south wall along alley) with insulation also shown.

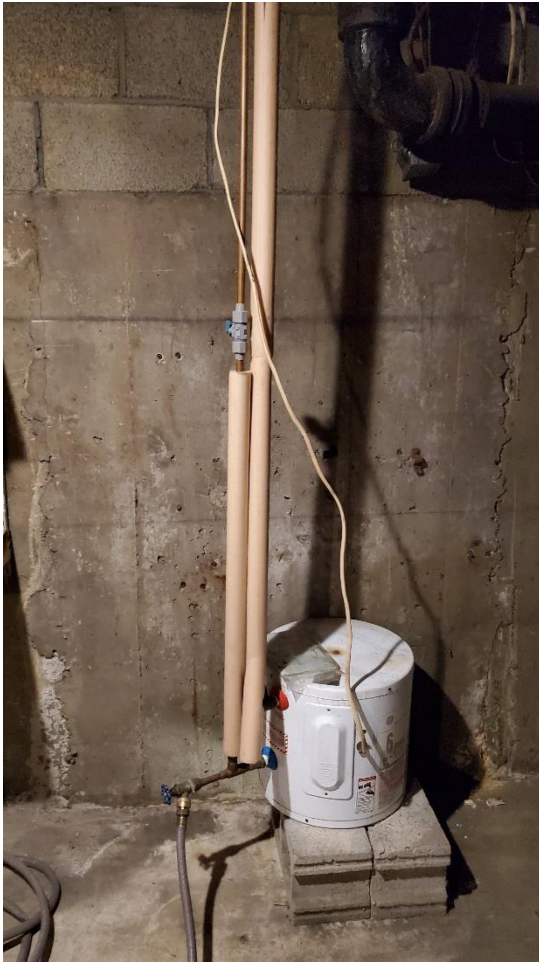
Photo 7: Second view of the basement-Electric water heater, and minor cracking along concrete forms, and transition from poured wall to blocks shown.

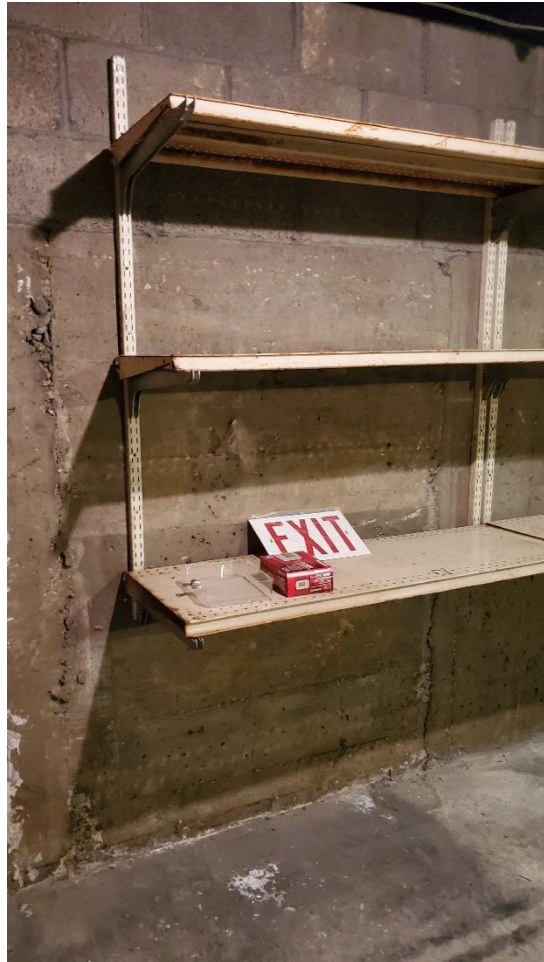
Photo 8: North basement wall, west of Photo 7, minor cracking along concrete forms, and transition from poured wall to blocks shown.
