From: Ryan Nehls <rnehls@reaeng.com>
Sent: Friday, June 24, 2022 11:41 AM
To: Koepke, Cynthia L - DNR
Cc: Bill Buckingham; Brian Flad
Subject: Shorewood Commons BRRTS #02-13-560698
Attachments: HydroGraph.pdf; Well Screen & Water Levels.pdf; Site Map.pdf

GROUNDWATER ELEVATION MAP (5/20/22)
 PHASE II INVESTIGATION
 SHOREWOOD COMMONS
 3330 UNIVERSITY AVENUE
 SHOREWOOD, WI 53705

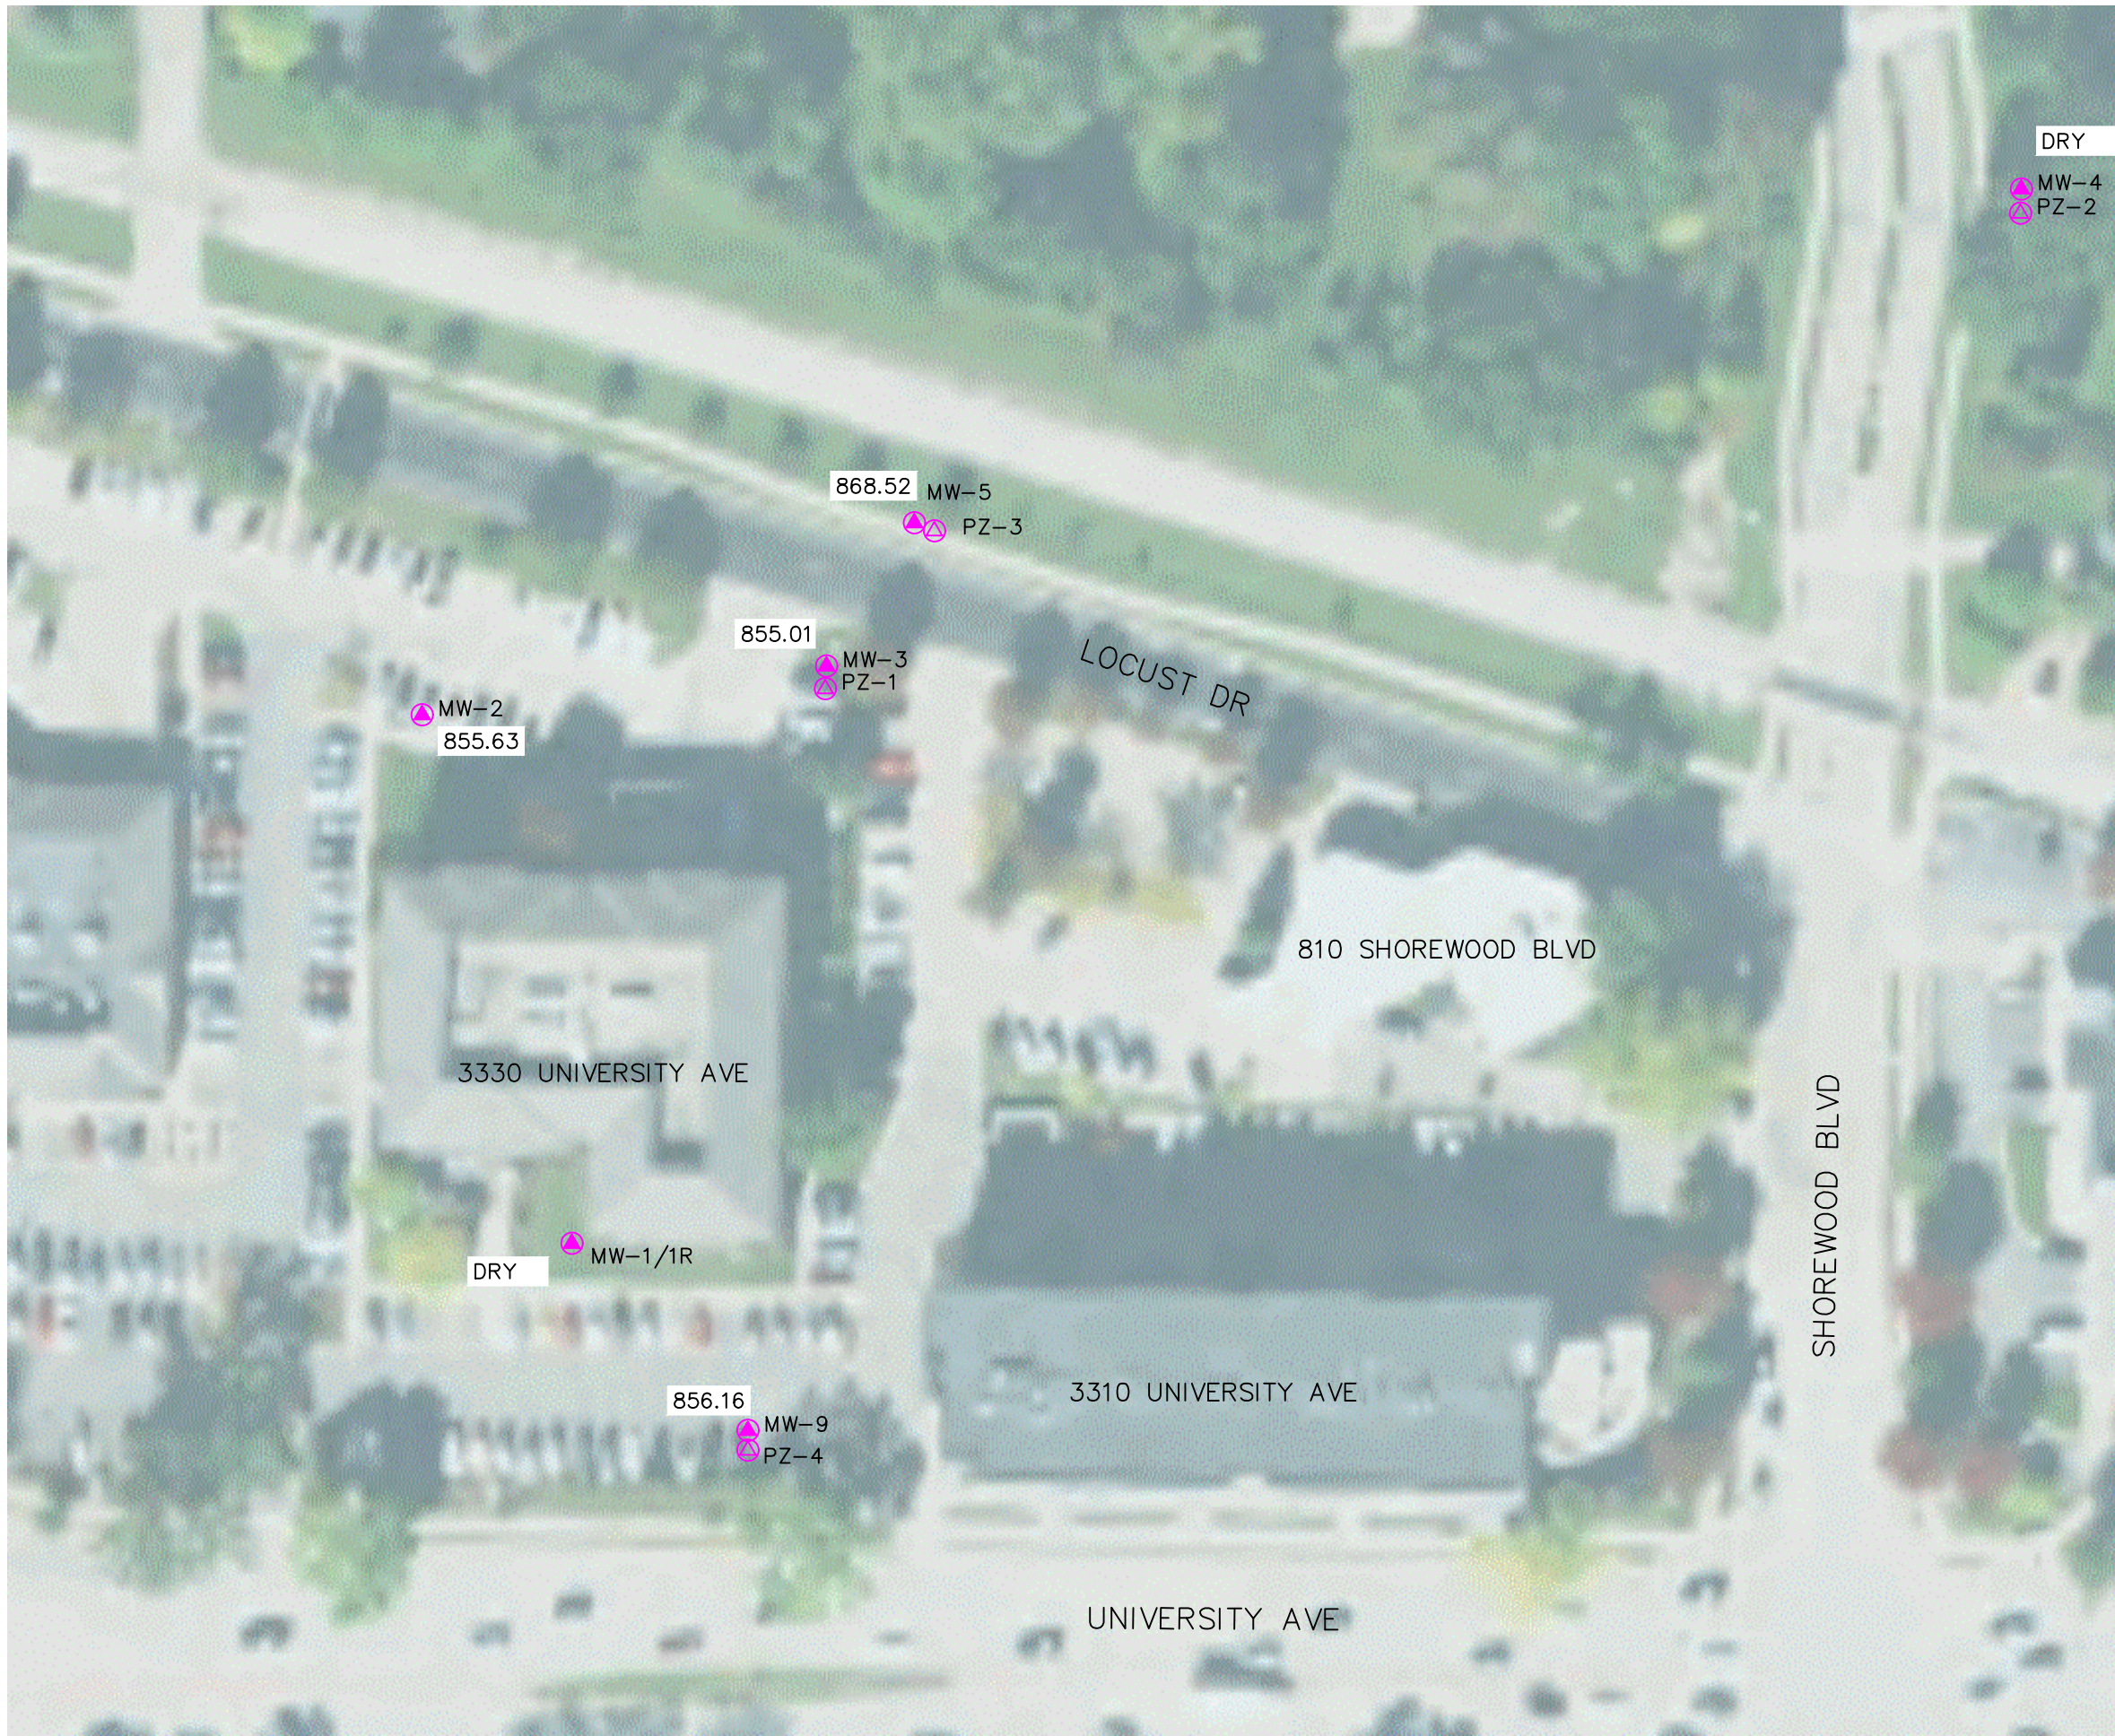
FIGURE 2.1

DRY

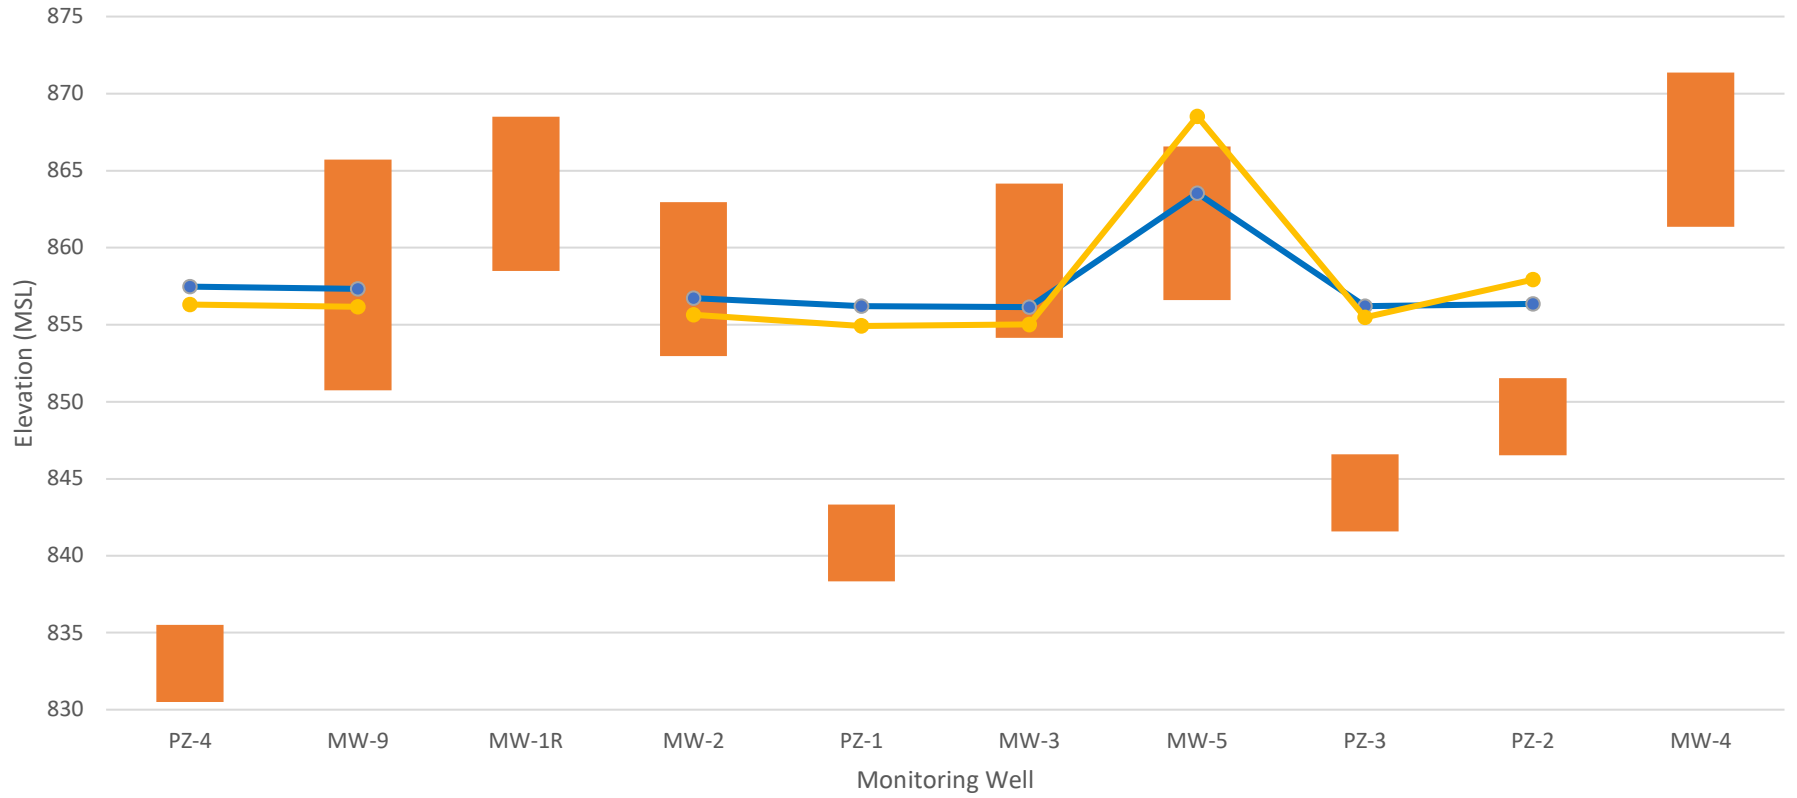
Well Screens & Water Elevation

2. Some cross-sections and a chart showing the well screen depths can help show if the wells might be in different units with different hydraulic conductivities or with the screen submerged etc.
See attached Well Screen & Water Levels. The wells are ordered in what is assumed upgradient to downgradient. We're below the screens on MW-1R and MW-4.
