Environmental and Geological  
Scientists and Engineers

**PHASE I  
ENVIRONMENTAL SITE ASSESSMENT**

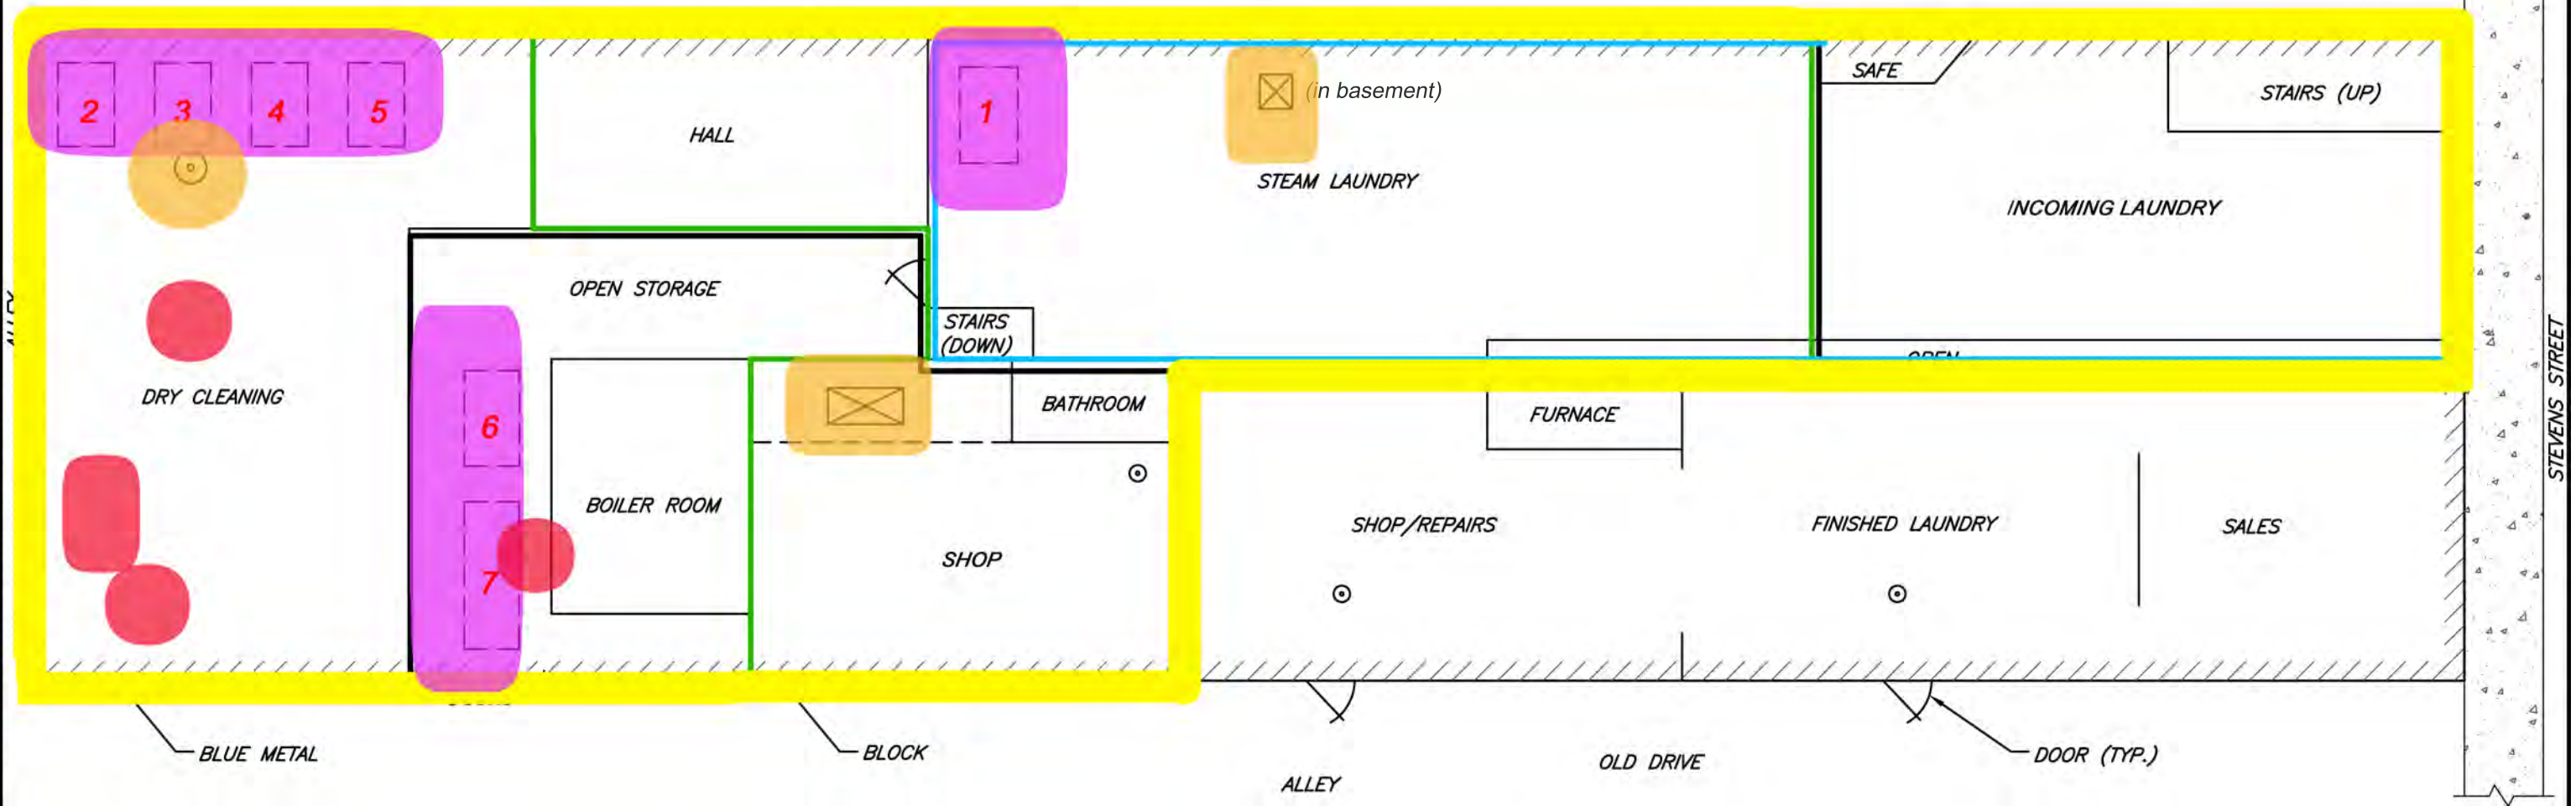
- REC 1  Former USTs. Not all are shown because not all UST locations are known
- REC 2  Liquid hazardous waste >20 gallons (likely flammable and explosive) in open containers (a person can walk up and look at the liquid in open drums or machines)
- REC 3, 4, 5  Identified possible waste disposal areas
- REC 6  All areas known to have hosted dry cleaning operations ~1920 to 2010.

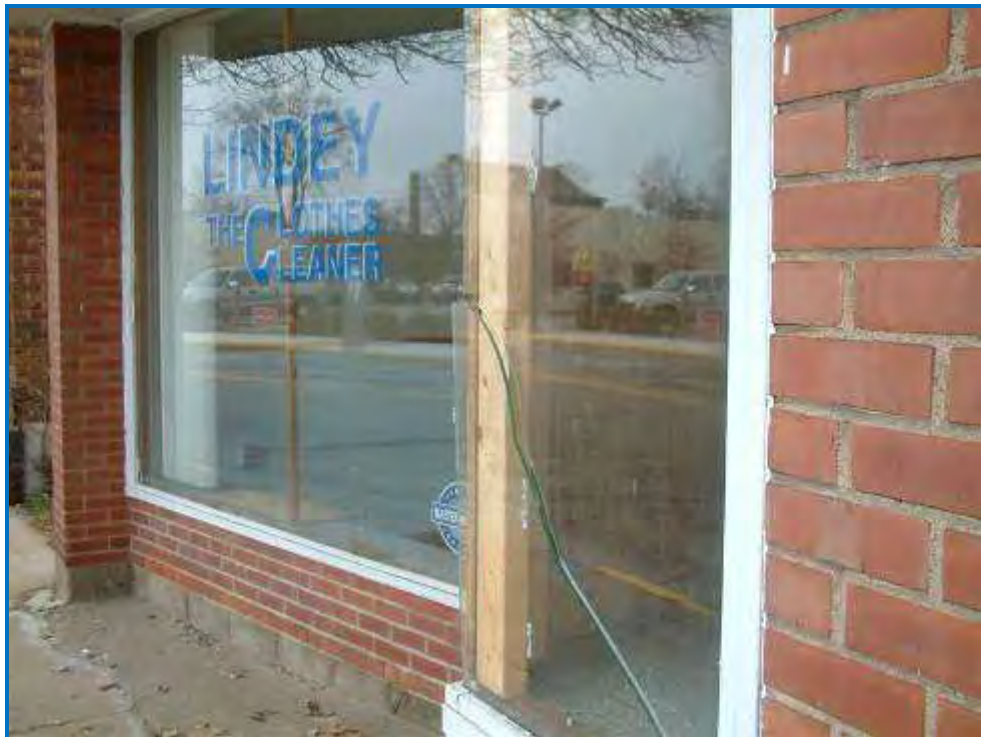
**Photo #6** Broken glass is noted in the storefront and could pose a safety hazard or point of illegal entry.

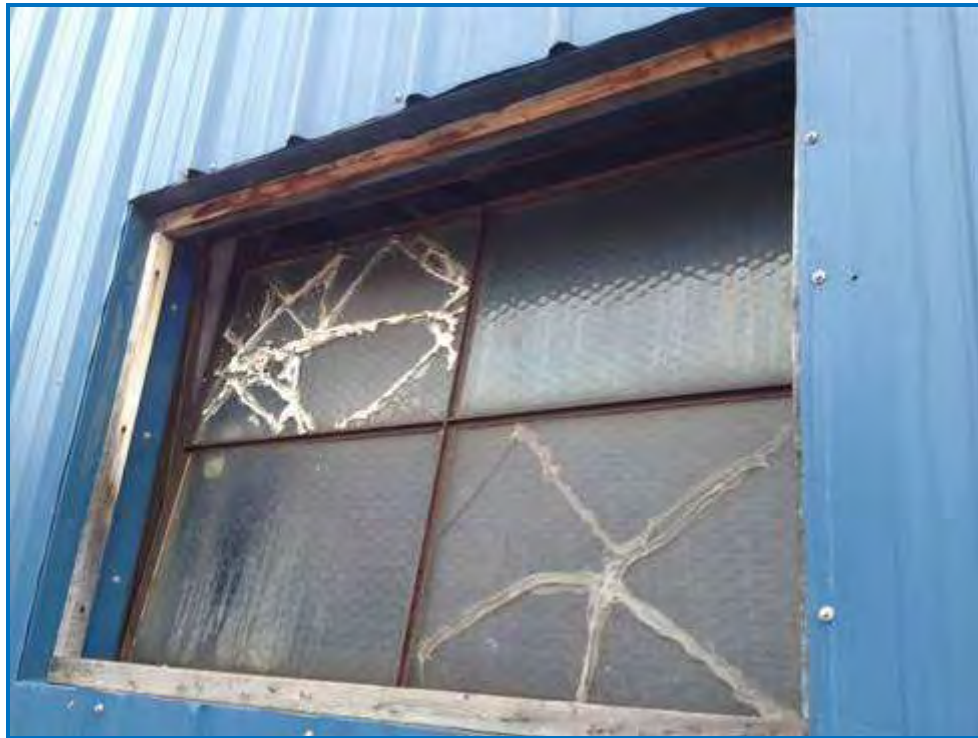
**Photo #7** Back of the building. Open windows are allowing rain to pour in, and could be an entry point for illegal access.

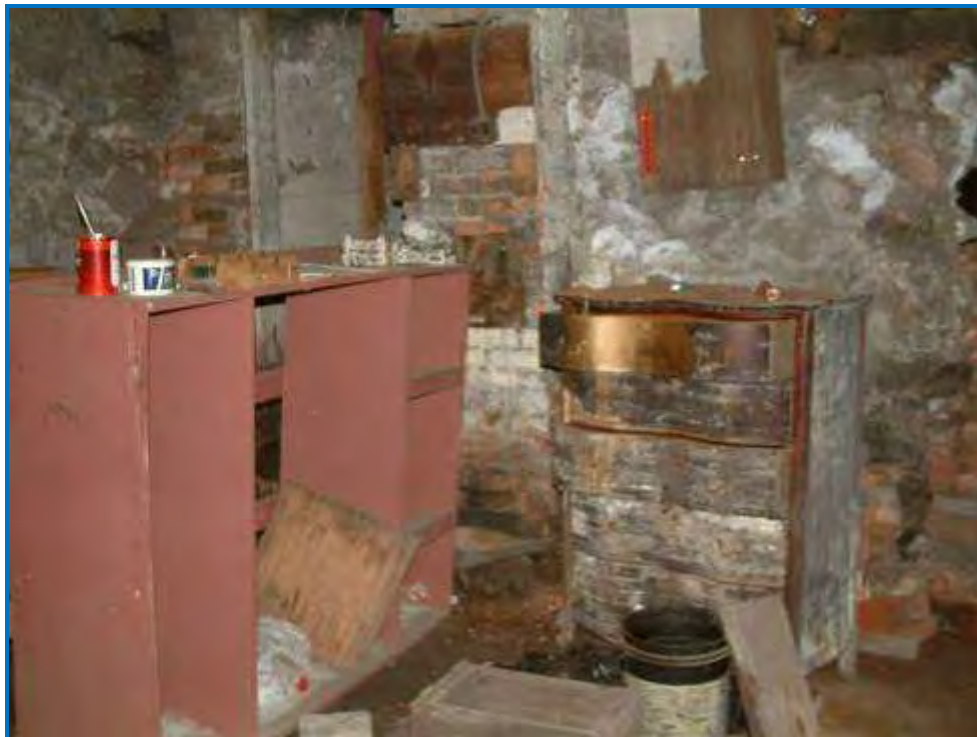
**Photo #10** Basement. Evidence of water damage.

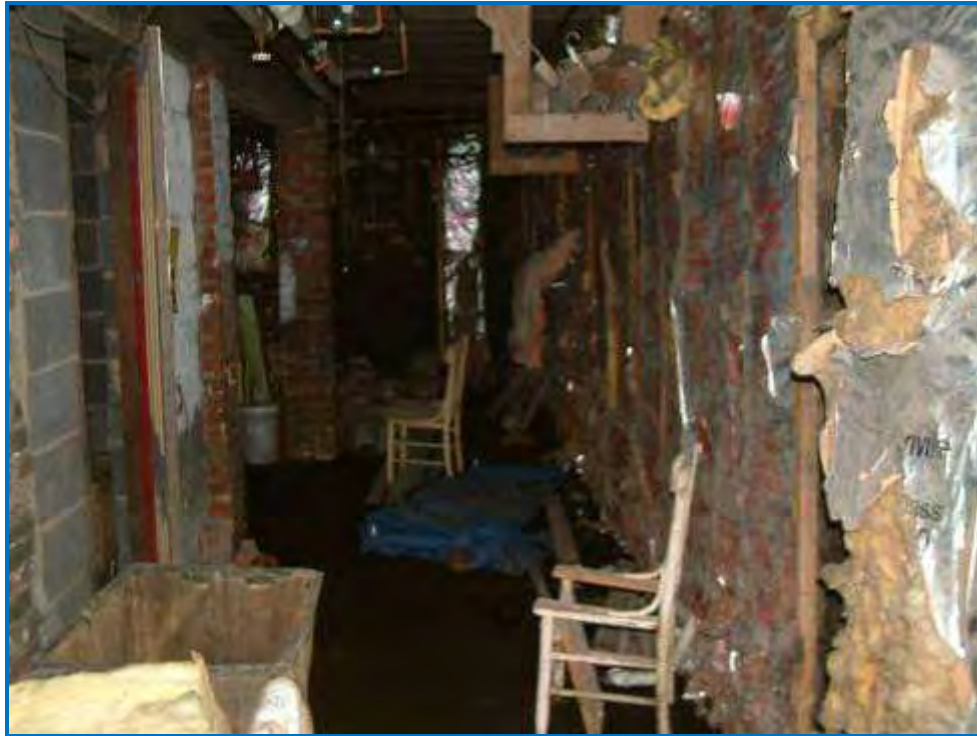
**Photo #11** Basement hall, looking east toward Stevens Street.

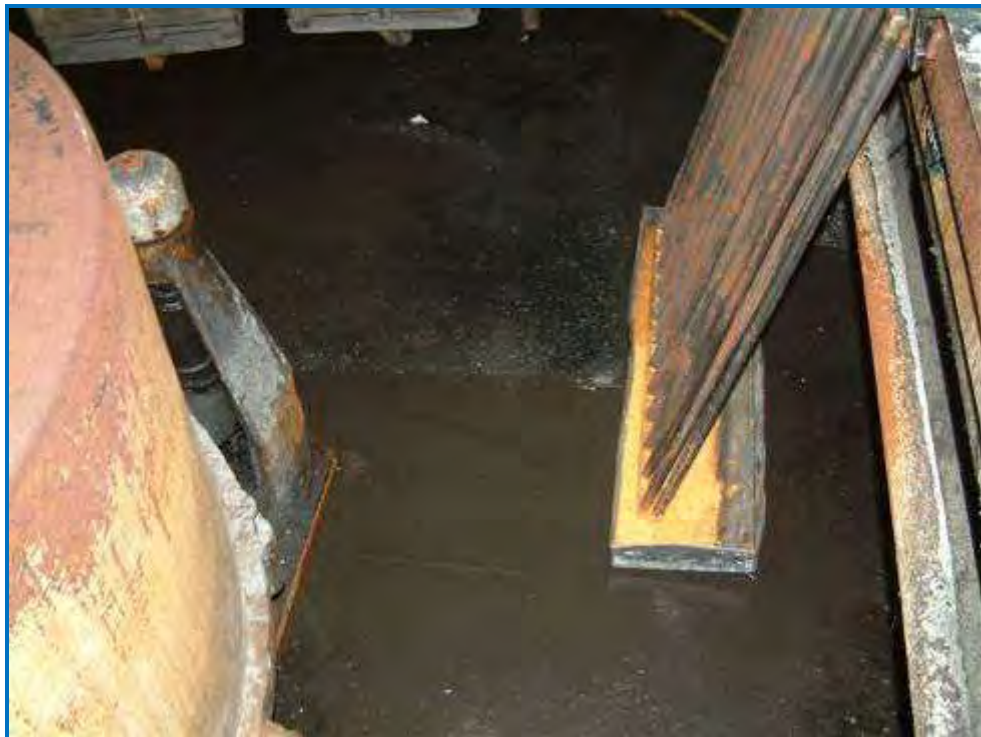
**Photo #26** The entire dry cleaning area floods when it rains from leaks in the roof, walls, and windows.

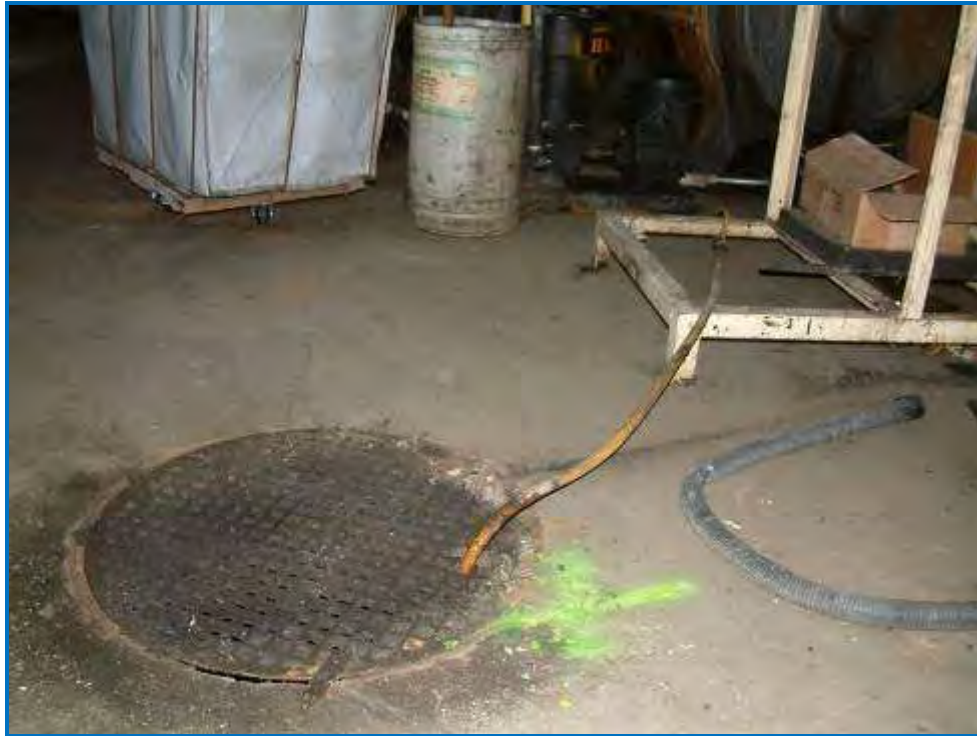
**Photo #27** Old brick sanitary sewer (36-inch) in modern dry cleaning room. This brick sewer leaks, as evidenced during rain storms and dropping water levels. Notice the yellow hose draining into the sewer (see Photo 28 for more).

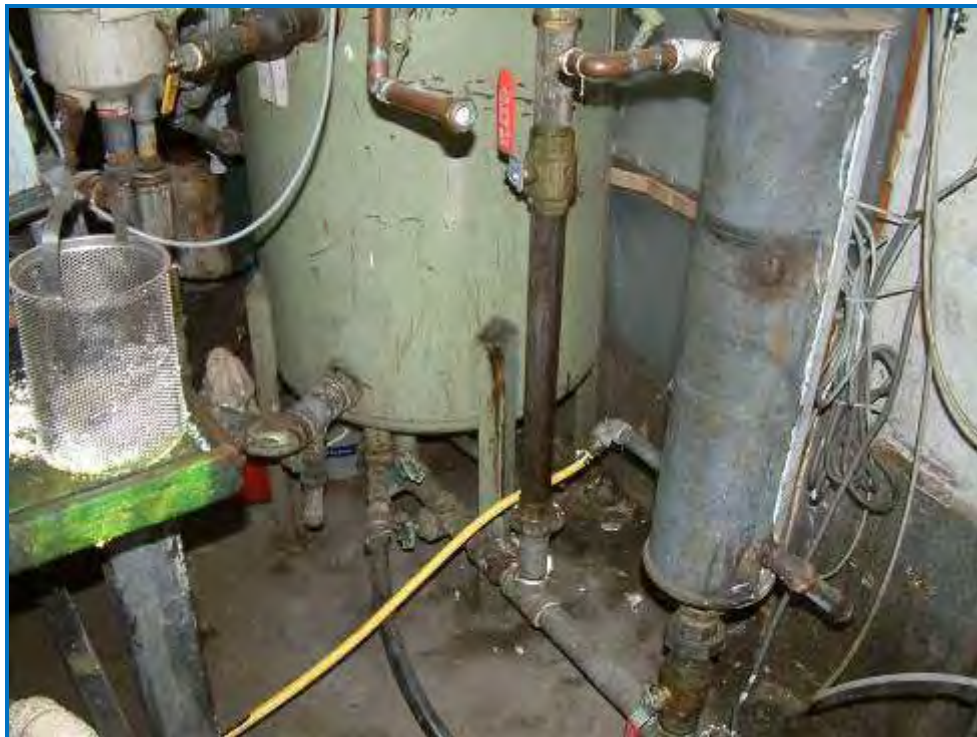
**Photo #28** This is the other end of the yellow hose in Photo 27. Note it is permanently connected to the solvent filter tank, suggesting spent solvent may have been discharged to the sewer regularly.

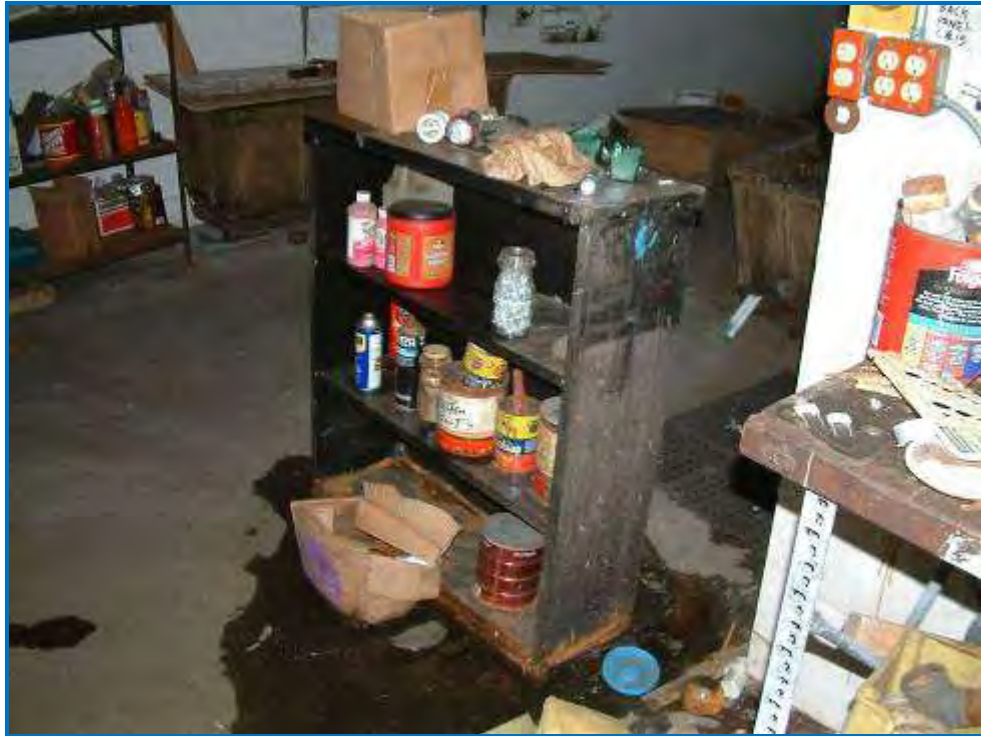
**Photo #33** In the shop/repair room.

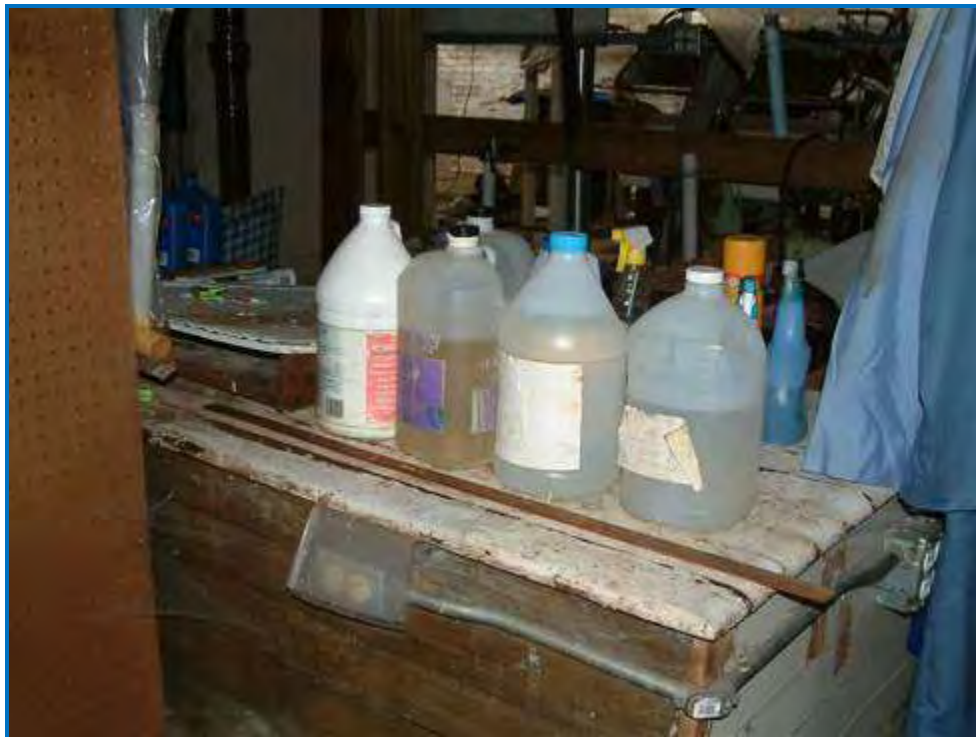
**Photo #34** Spot cleaning chemicals. Some of these jugs are labeled, and some are not. Some are non-hazardous (i.e., citric acid) and others may be solvents.

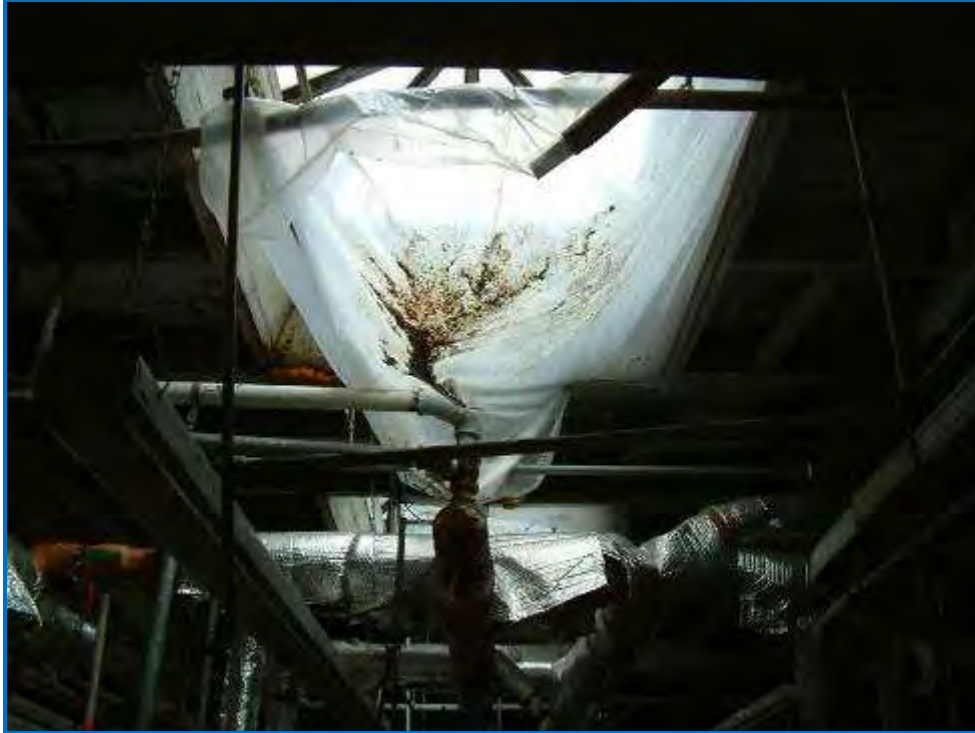
**Photo #35** The roof in the steam laundry is in rough shape. The rain falls on the asbestos and causes it to disintegrate.

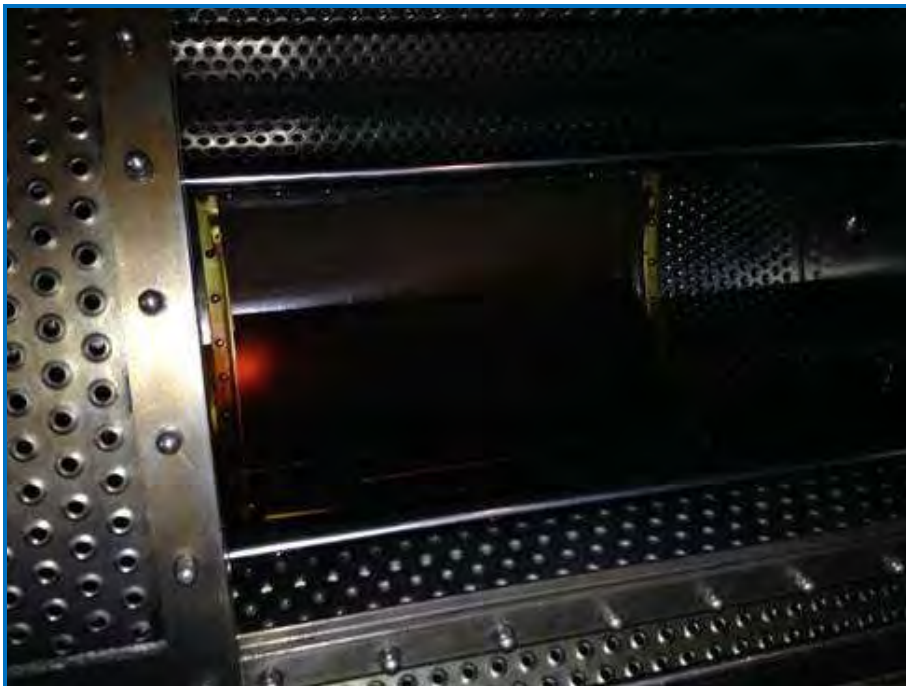
**Photo #36** Dry cleaning solvent is seen in the bottom of this dry cleaning machine (the red hue). This is likely Stoddard Solvent and has a flash point of ~140 Degrees F. This and other open exposures to solvents and unknowns is cited as a REC.

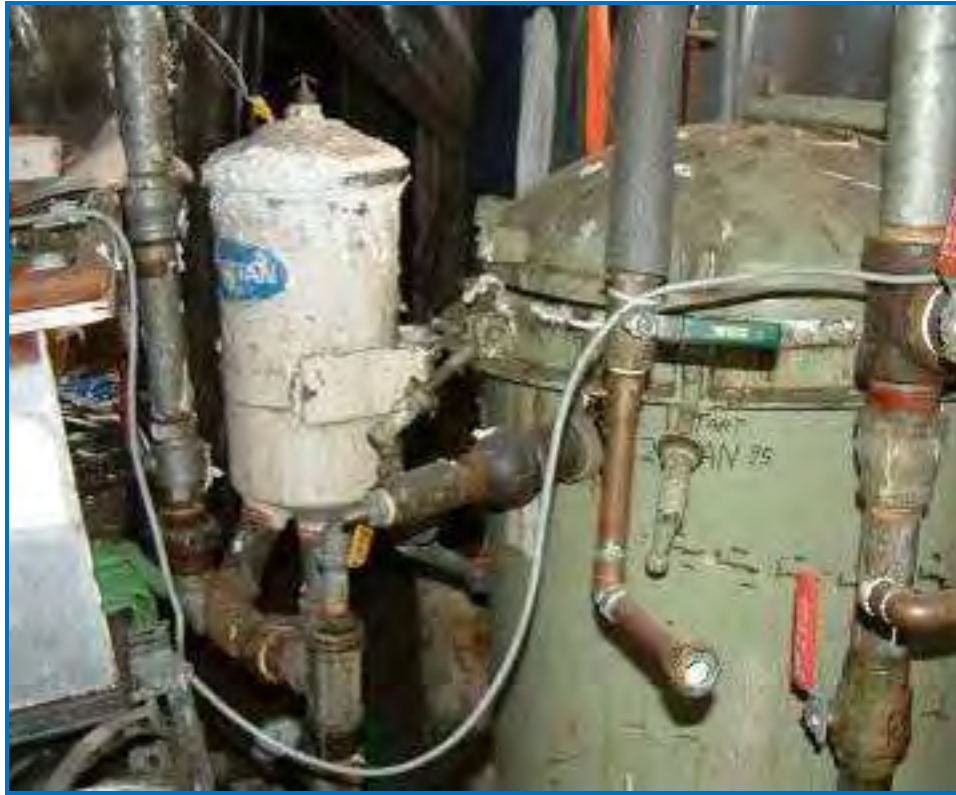
**Photo #37** Lint and button filter in the dry cleaning cycle. Filter materials are hazardous waste.

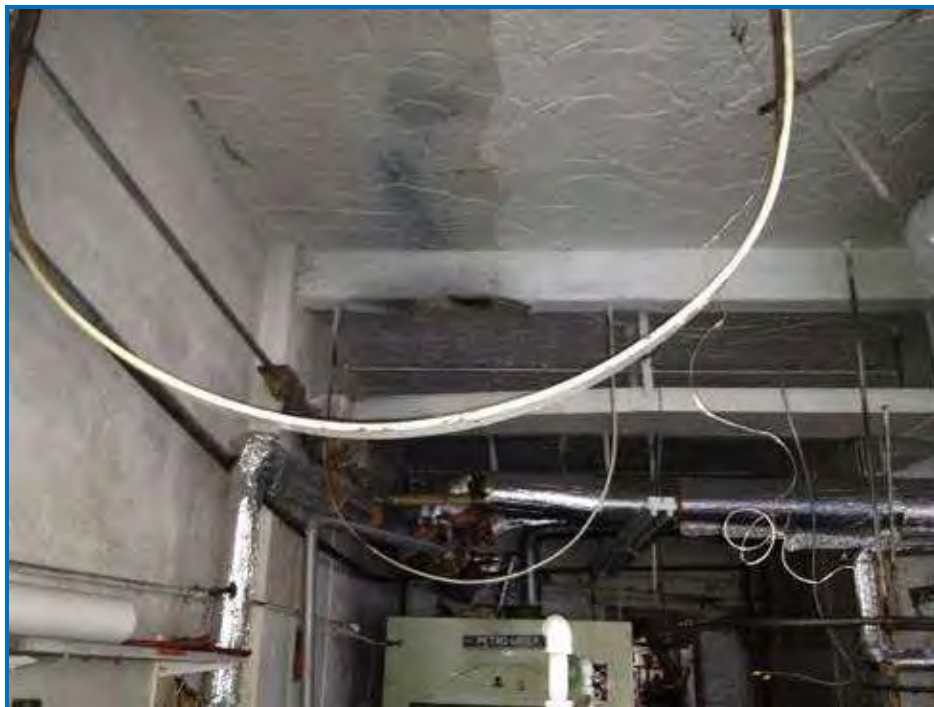
**Photo #38** Dry cleaning room. Stirrups are what used to hold an aboveground solvent tank.

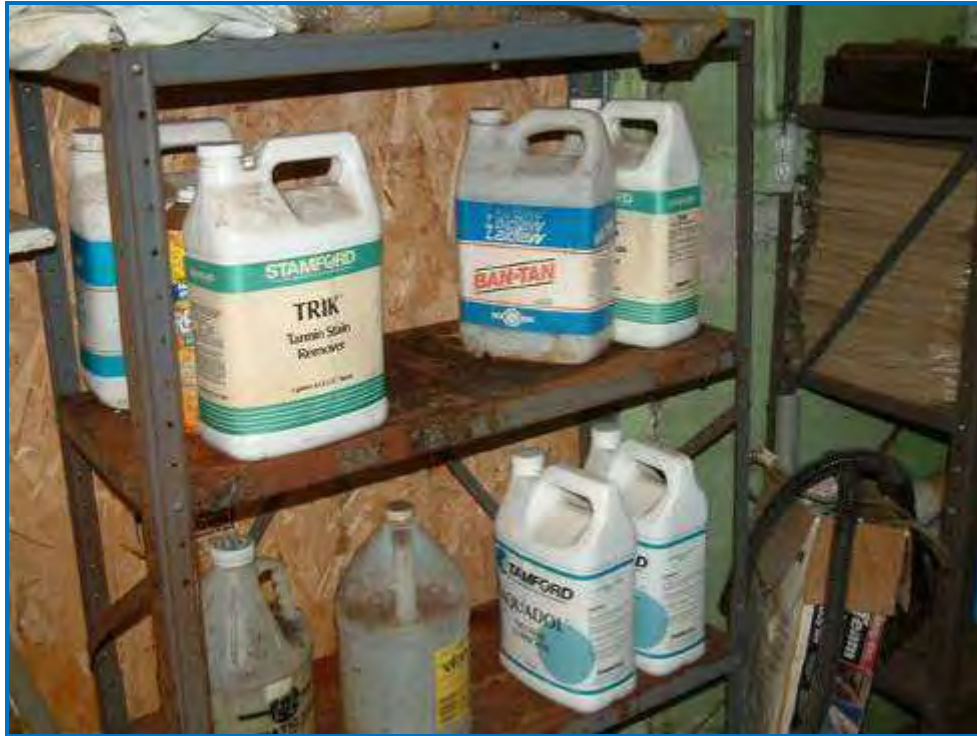
**Photo #43** Miscellaneous stain removers. Jugs like these are throughout the building. Assuming the labels accurately reflect content, not all of them are hazardous substances.

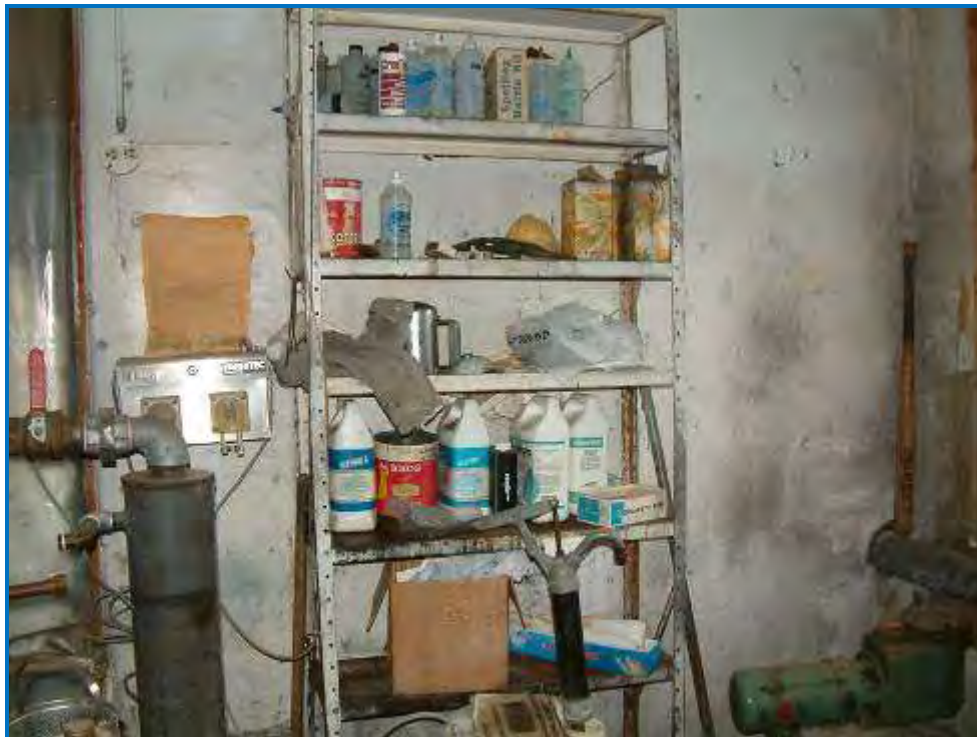
**Photo #44** More spot removers and other chemicals, some are labeled (known) and some are not.

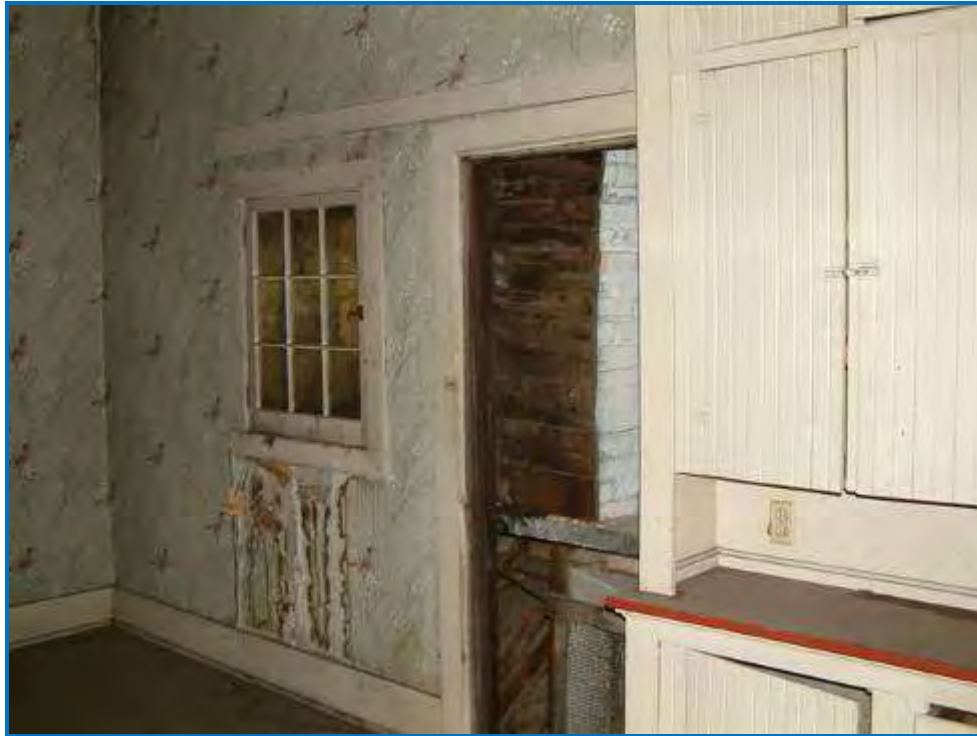
**Photo #51** Second floor, kitchen. Water damage is everywhere.

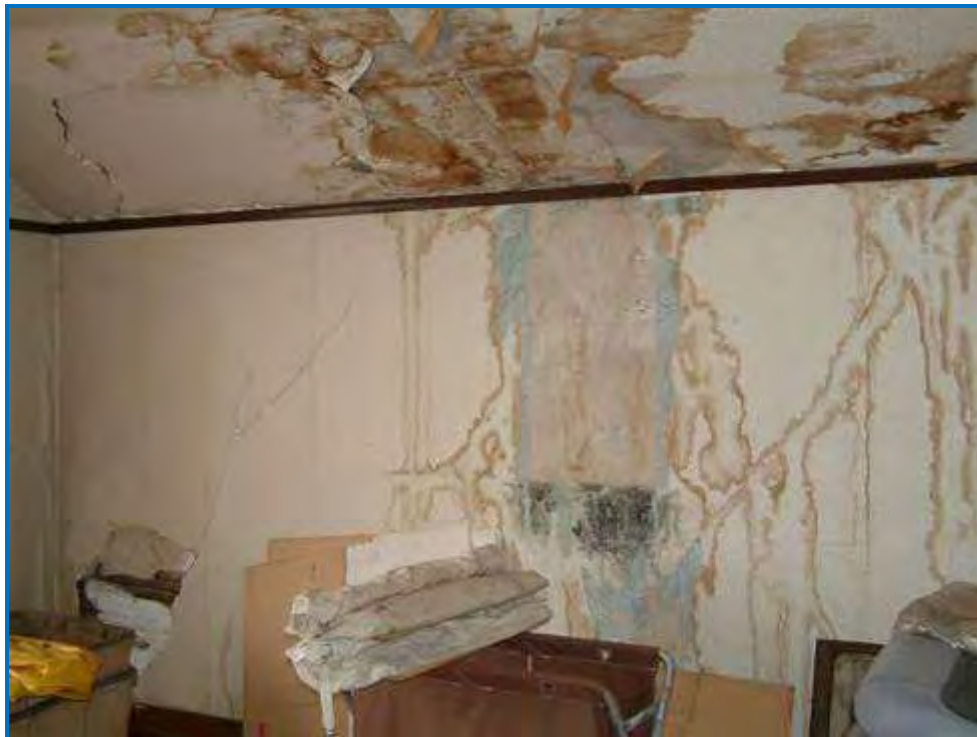
**Photo #52** Second floor apartment. Water damage looks like this throughout the second floor, and indicates failure of the second floor structure is in progress.
