RE: *Modification Request*
WPDES Permit Number WI-0046566-07-0
Carol Investment Corporation
Sunrise Shopping Center (Ace Hardware Store)
1009 Marquette Avenue
South Milwaukee, Wisconsin 53172
BRRTS #: 02-41-576336 & 02-41-579429
FID #: 241828620
FIN #: 63340

**FIGURE 1
ACE HARDWARE SUMPS AND
TREATMENT SYSTEMS WITH
DISCHARGE PIPING LAYOUT**

ATTACHMENT 2
PHOTOGRAPHIC DOCUMENTATION
(SUMPS, TREATMENT SYSTEMS, AND DISCHARGE OUTFALL 011)

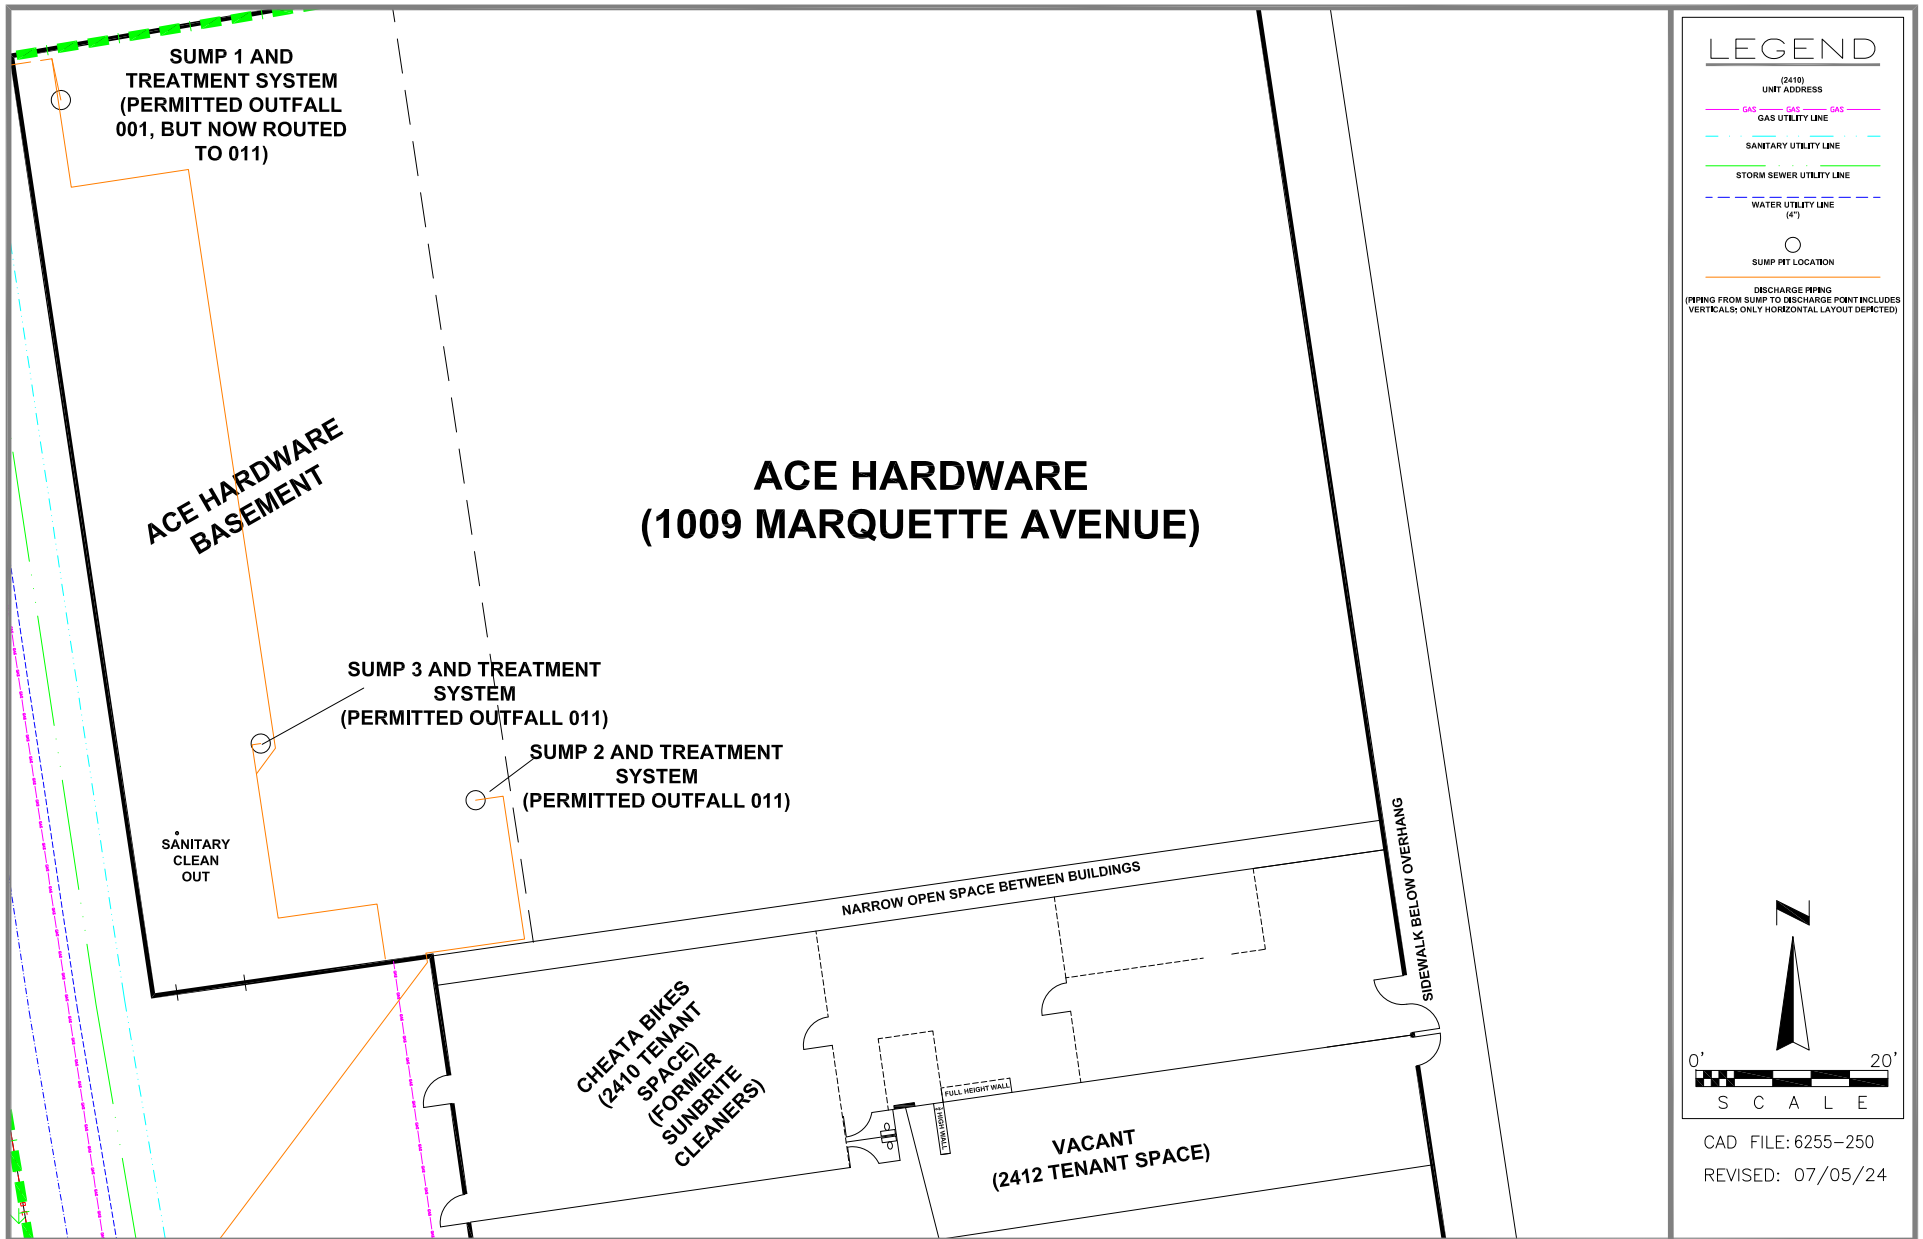
In May 2024, discharge to Outfall 001 from Sump 1 was discontinued as a result of a damaged backflow valve and the collapse of the discharge line running from the northwest corner of the Ace Hardware to the adjacent stormwater sewer system. After evaluation of the collapsed discharge line by the plumbing contractor (Bohmann Plumbing), it was determined that the faster, more cost effective (and less environmentally obtrusive) option for the repair was to connect the Sump 1 riser piping to the combined discharge piping associated with Sumps 2 and 3 (i.e., water from Sump 1 now discharging to Outfall 011 along with water from Sumps 2 and 3). The connection was accomplished by running PVC piping along the ceiling of the Ace Hardware

basement and connecting to the Sump 3 riser piping. No other changes have occurred. All three (3) sumps are active, as are the three (3) associated treatment systems. Therefore, the only modification to the existing permit conditions is that Outfall 001 is no longer use (i.e., no discharge) and all water now discharges through Outfall 011 as of May 22, 2024. All discharge sample results remain in compliance with the permit limits and the previously provided discharge management plan remains valid. The figure included as Attachment 1 depicts the sump locations and the associated piping layout. Photographic documentation of the modified connection is provided in Attachment 2.

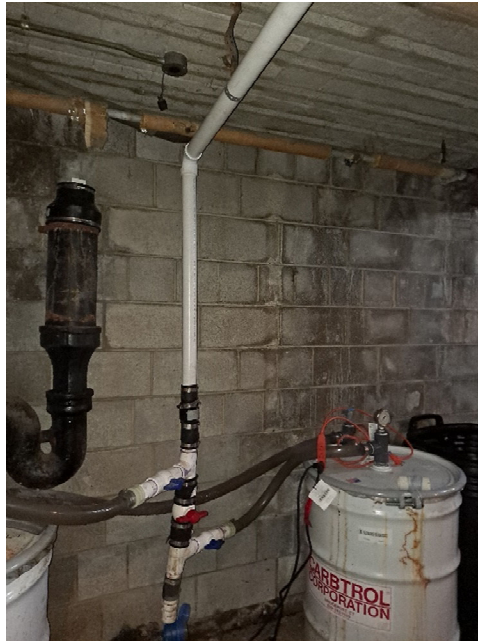
PHOTO #1

IMAGE OF SUMP 1 AND ASSOCIATED REMEDIATION SYSTEM; PVC PIPING CONNECTS TO SUMP 3 PIPING THAT RUNS TO DISCHARGE THROUGH SOUTHERN WALL OF ACE HARDWARE BASEMENT (OUTFALL 011); SUMP 1 NO LONGER DISCHARGES TO OUTFALL 001 (OUT-OF-SERVICE)

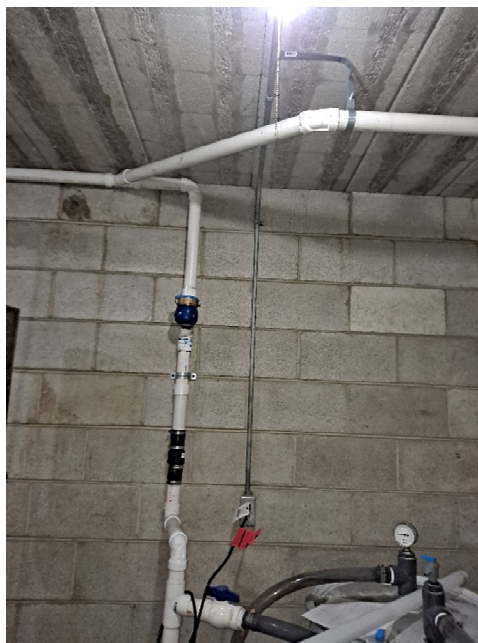
PHOTO #2

IMAGE SUMP 1 PVC PIPING CONNECTING TO SUMP 3 PVC PIPING

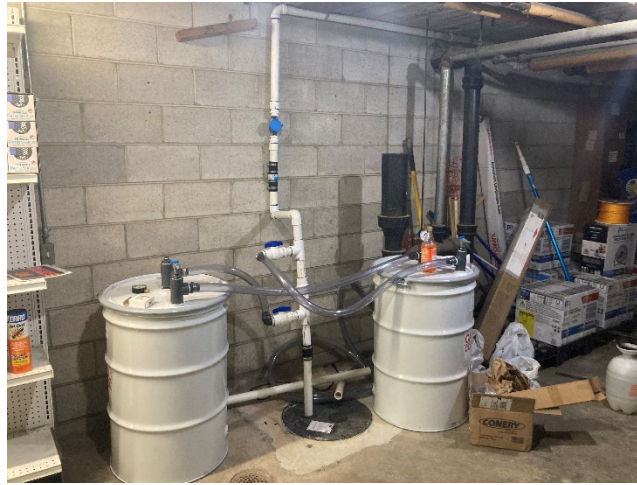
PHOTO #3

IMAGE OF SUMP 2 AND ASSOCIATED REMEDIATION SYSTEM; PVC PIPING CONNECTS TO DISCHARGE LINE THAT RUNS THROUGH SOUTHERN WALL OF ACE HARDWARE BASEMENT (OUTFALL 011)

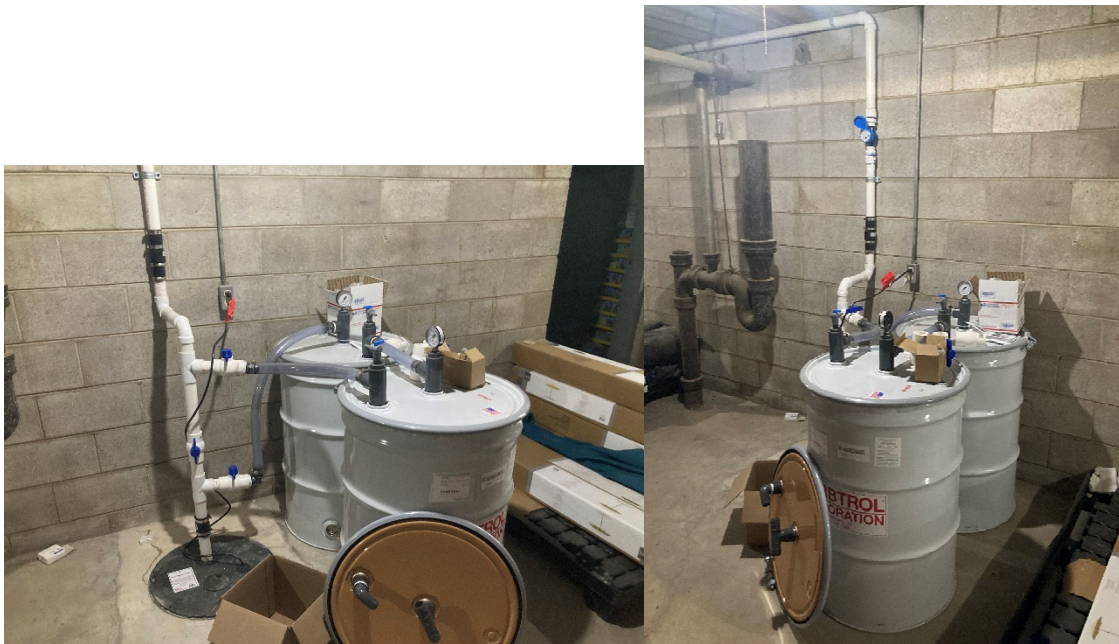
PHOTO #4

IMAGE OF SUMP 3 AND ASSOCIATED REMEDIATION SYSTEM; PVC PIPING CONNECTS TO DISCHARGE LINE THAT RUNS THROUGH SOUTHERN WALL OF ACE HARDWARE BASEMENT (OUTFALL 011)

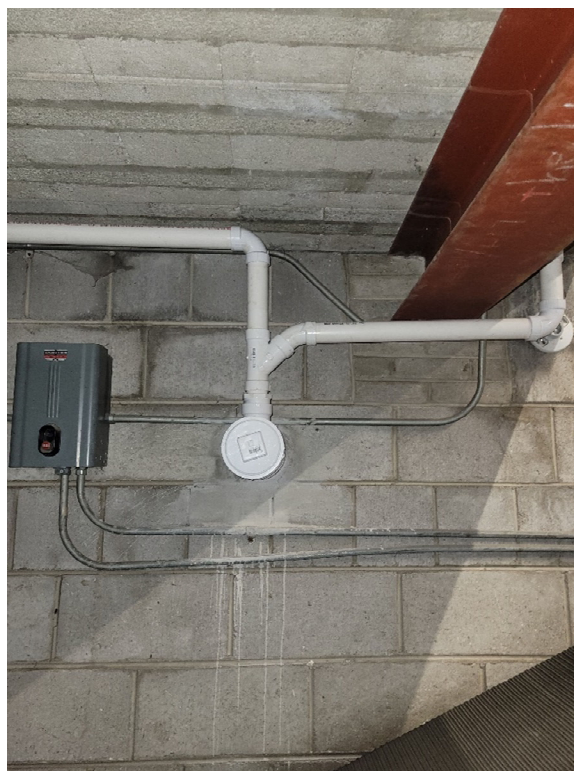
PHOTO #5

IMAGE OF DISCHARGE LINE THAT RUNS THROUGH SOUTHERN WALL OF ACE HARDWARE BASEMENT (OUTFALL 011); SAMPLE PORT IN BOTTOM OF DISCHARGE LINE NOT PICTURED
