From: Jeffrey Howard Danko <jeffrey.howard.danko@jci.com>
Sent: Tuesday, January 21, 2020 1:11 PM
To: Joslin, Richard R - DNR
Cc: Neste, David E - DNR; Chronert, Roxanne N - DNR
Subject: RE: Additional Questions / Documentation for JCI Spills (SERTS #s 20190925NE38-1; 20191015NE38-1; and 20191108NE38-1)

RE: Spill Report for November 7, 2019 Event
Tyco Fire Products LP Facility
2700 Industrial Parkway
Marinette, WI
SERTS ID: 20191108NR38-1

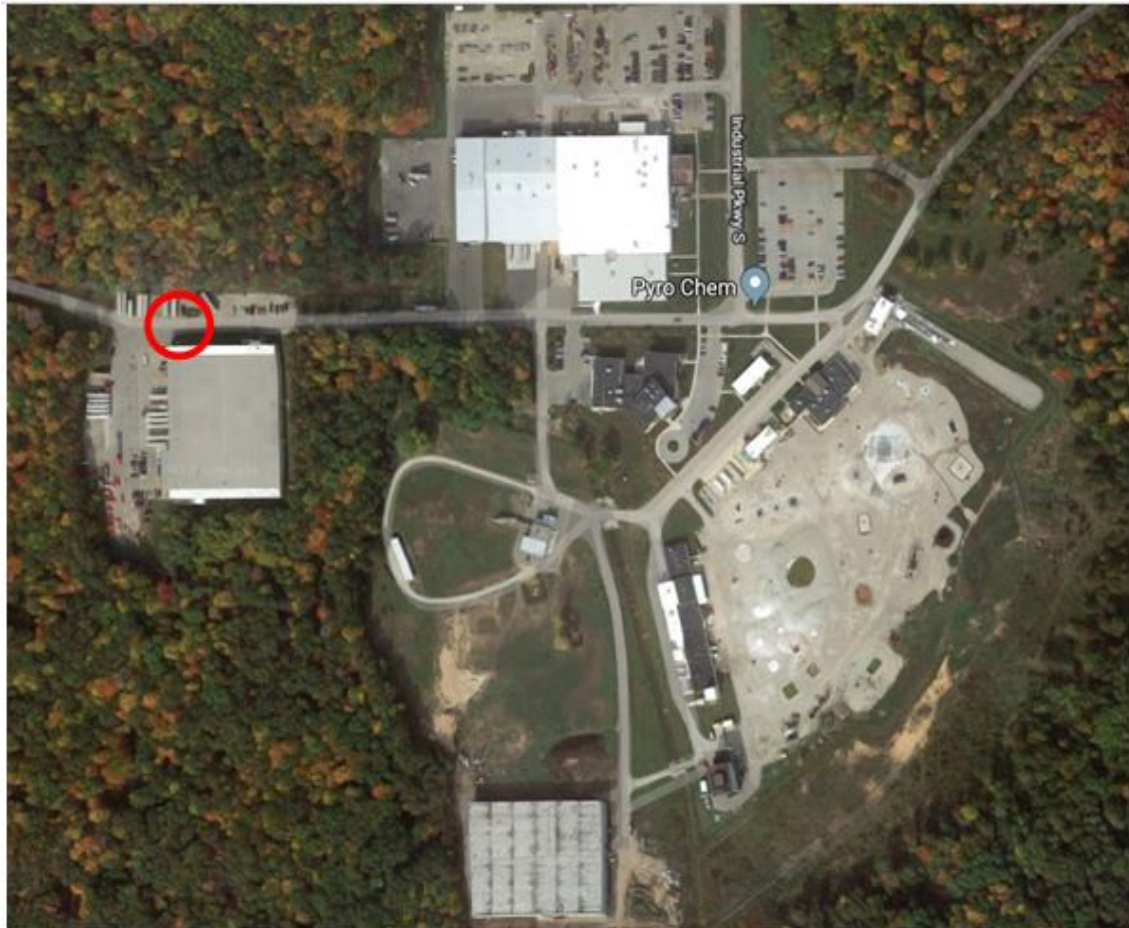
Site Figure showing location of foam/water release at 2700 Industrial Parkway South, Marinette, WI.
