Appendix D

HYDROLOGY AND DRAINAGE

Hooker Lake Drainage Meeting MEETING MINUTES DECEMBER 12, 2008

Survey Results Bryzek and Hooker Lake Dams (Field File # 30.02)

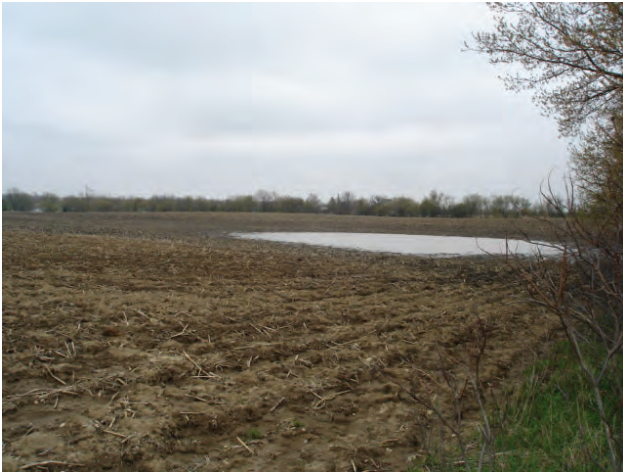
There is an approximately 35.2-acre sub-basin to the west of the north basin that has a depressed area that intercepts runoff. Runoff does not leave this sub-basin in rainfall events of 2-percent probability (50-year average occurrence interval). Some runoff does leave this sub-basin in the 1-percent probability event (100-year average occurrence interval). The runoff flows across the north basin following the same flow path as the north sub-basin,

After several days of rain, the area was ponded as shown in this picture taken on April 28, 2009

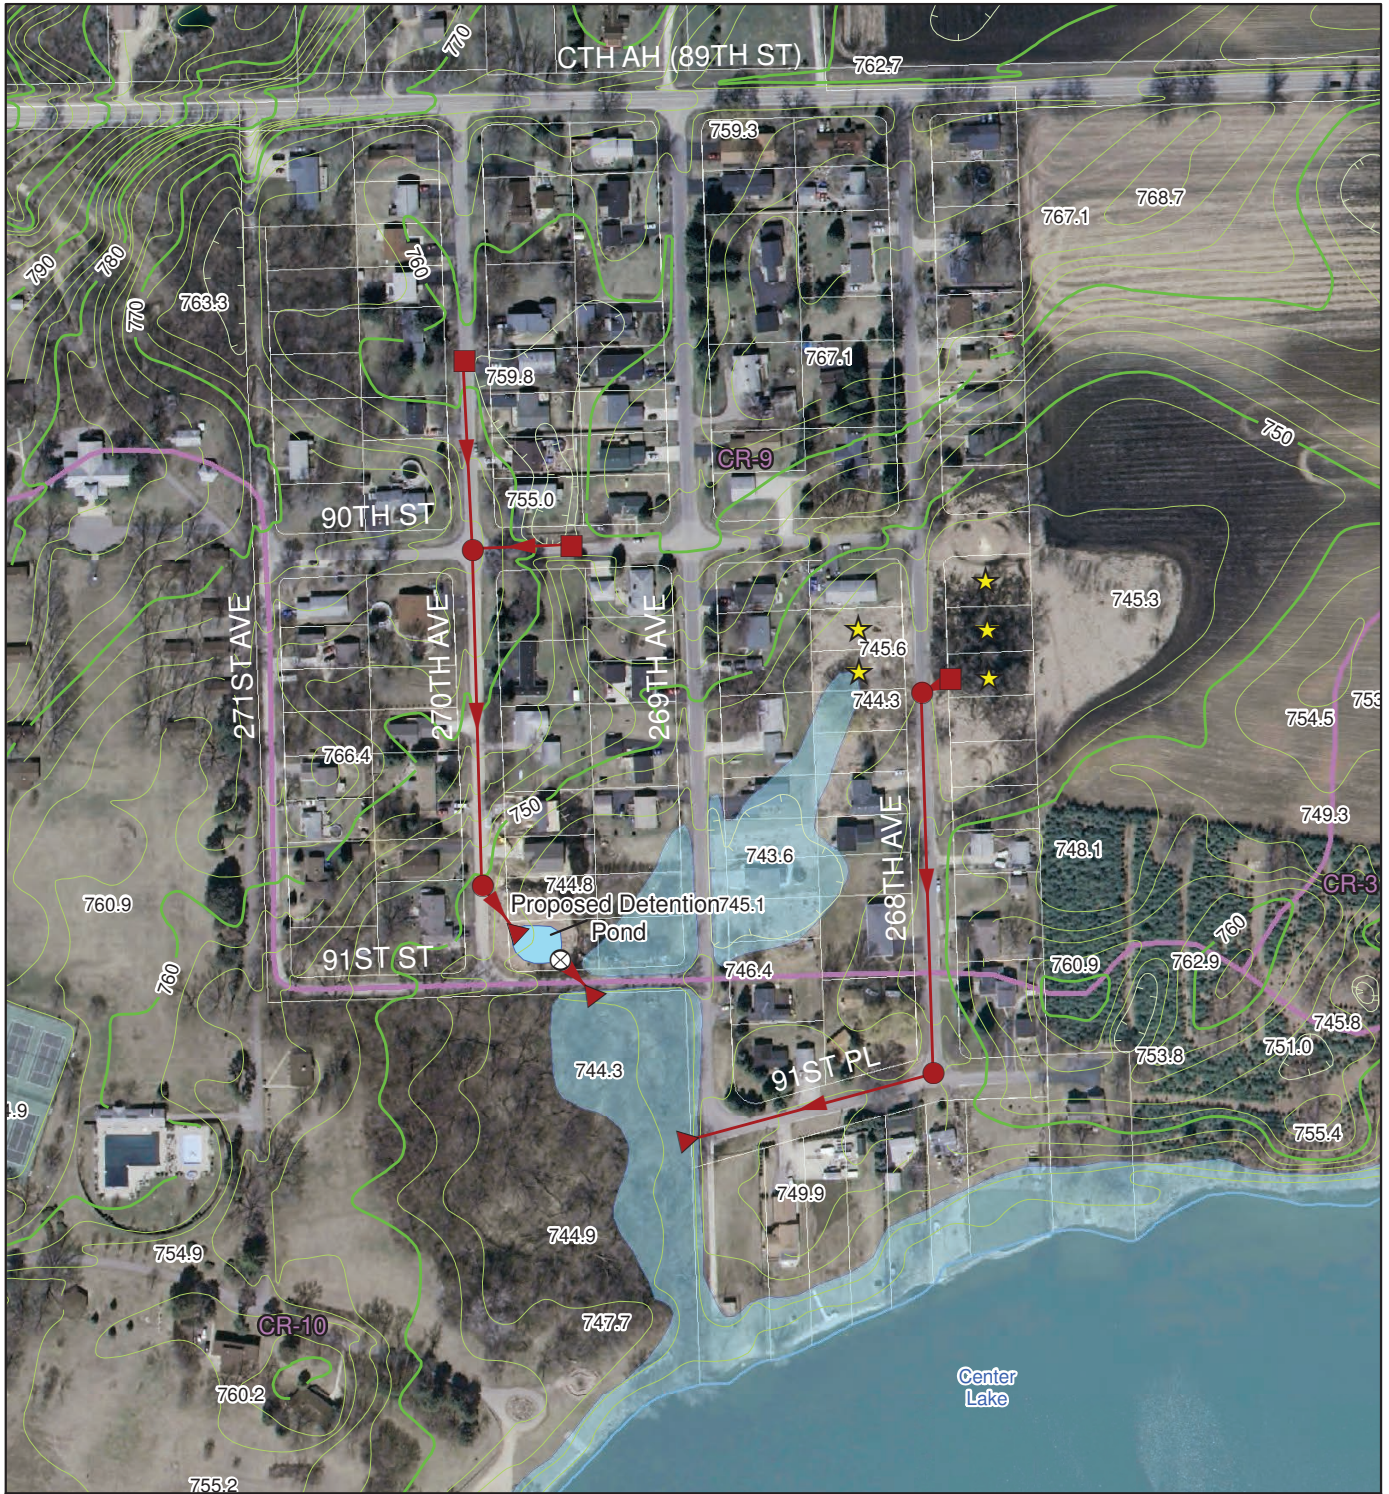
FIGURE 4-7
TOWN OF SALEM
TIMBER LANE SUBDIVISION

The Timber Lane Subdivision is south of 89th Street between 268th and 271st Avenues. This subdivision has a multitude of drainage problems due to the lack of a planned drainage system. The storm water flow is generally through private properties, and there is currently no adequate route conveying the runoff south to Center Lake. Multiple homeowners on the block east of 270th Avenue and north of 90th Street have had damage to their homes during large rain events because it is a natural low area, and the ditches do not have the capacity to handle the amount of storm water draining to this area. The block west of 268th Avenue and north of 91st Place also has many drainage issues because it is also a natural low area that is nearly the same elevation as Center Lake. This area has had a history of drainage problems, possibly stemming from the addition of fill to the natural low lying detention areas with the construction of new homes. The landowner east of 268th Avenue also complains that he has standing water on his agricultural field after storm events due to possible damage or elimination of a previous downstream culvert or drain tile system many years ago.

The tributary drainage area is anticipated to become residential land use in the future. Since the predevelopment runoff is causing considerable flooding, the more restrictive regulations of 0.04 cfs/acre for the 2-year event and 0.30 cfs/acre for the 100-year event required in the Des Plaines Watershed portion of the Town are recommended to be required for this drainage area. As development occurs, the runoff restrictions would reduce the flooding problem at no direct cost to the Town.

The proposed storm sewer will provide a conveyance system that will at a minimum reduce nuisance flooding for smaller events and to a lesser extent for larger events. The wet pond will provide water quality treatment for smaller rain events prior to discharge into Center Lake. Restoring the low lying detention areas would not provide any water quality benefits, but would help relieve flooding in this neighborhood during the smaller more frequent rainfall events. Requiring future development to meet the more restrictive runoff requirements will decrease the future flood flows through the subdivision.

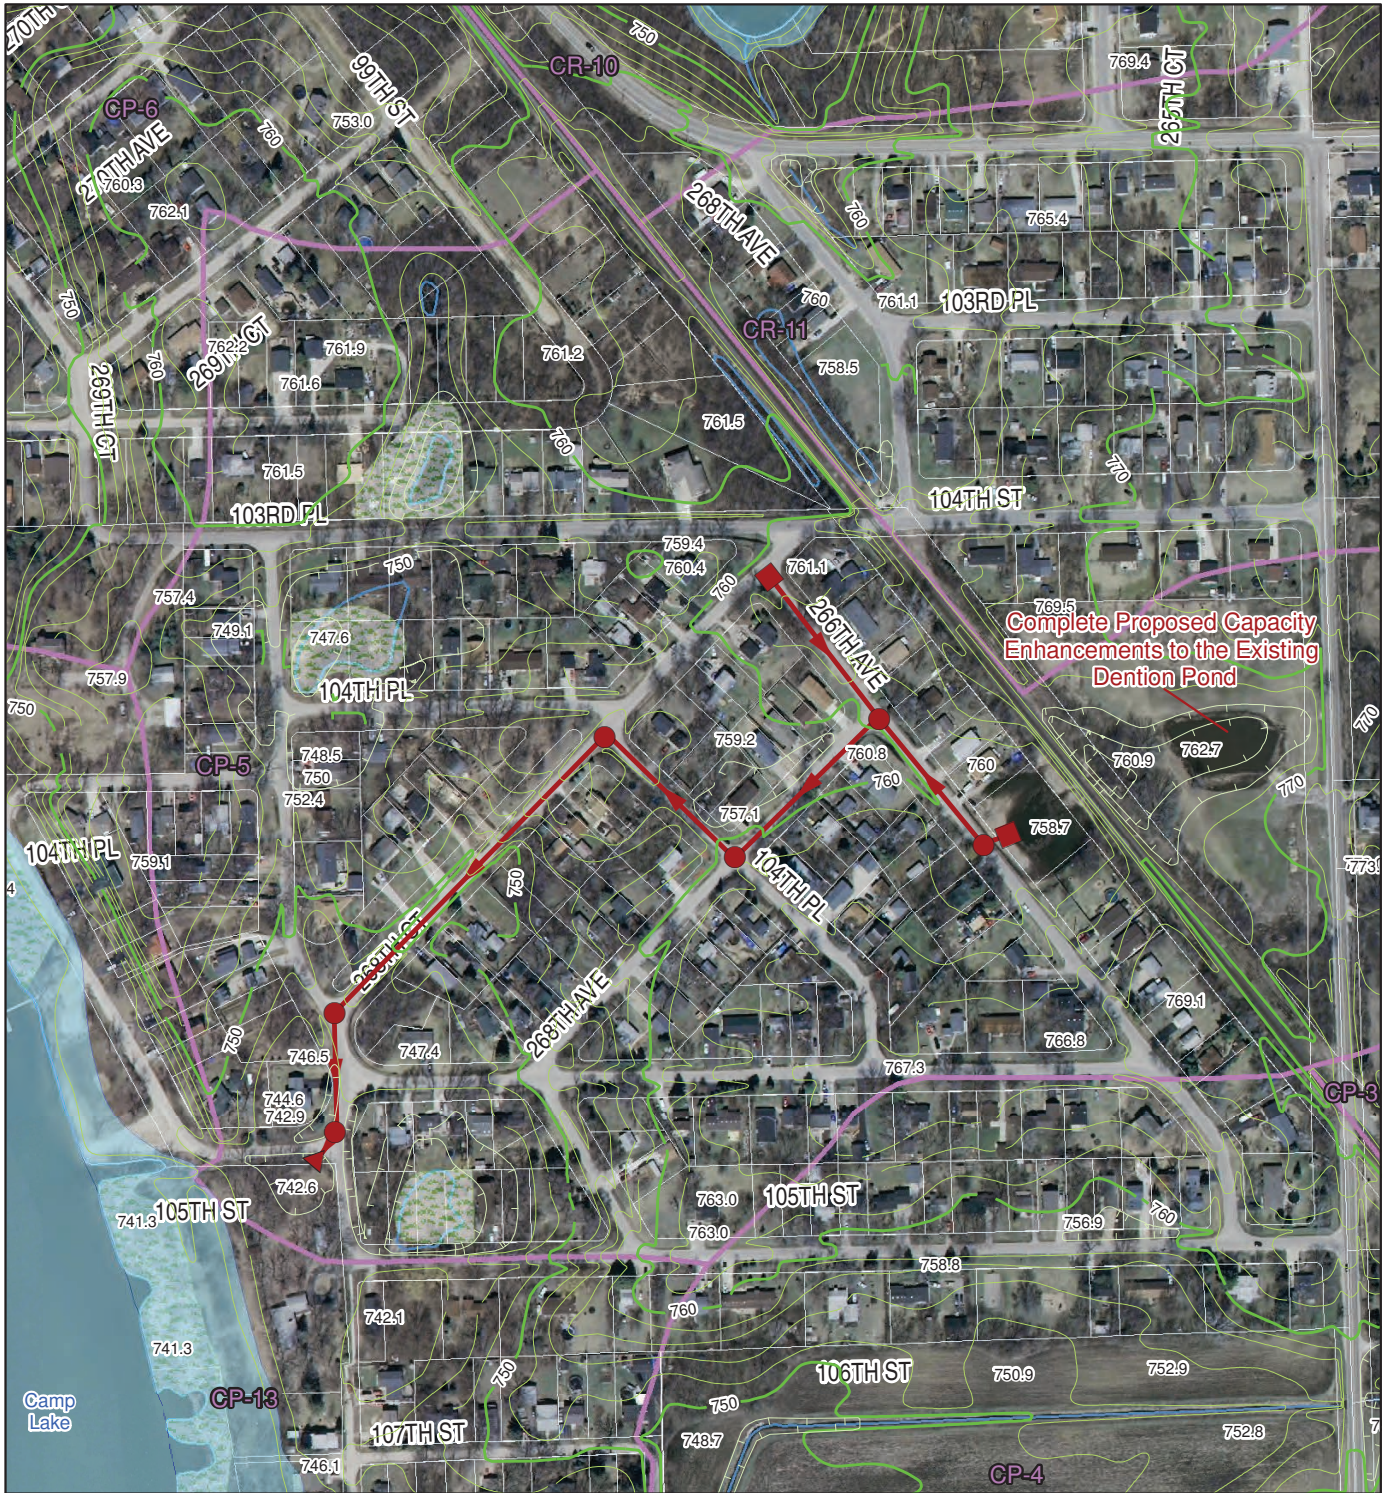
**FIGURE 4-10
TOWN OF SALEM
SUNSET OAKS SUBDIVISION**

The drainage problems are mainly along 122nd Street east of 224th Avenue. The existing storm water drainage patterns in this area can be characterized by a system of french drain inlets that are directed to an old drain tile running down the middle of 122nd Street. At the intersection of 220th Avenue, this drain tile heads north and eventually discharges into Lake Shangri-La. In general, this system is very inefficient and

does not seem to have enough capacity for this drainage area, which causes water to constantly pond on the adjacent properties and on the roadway.

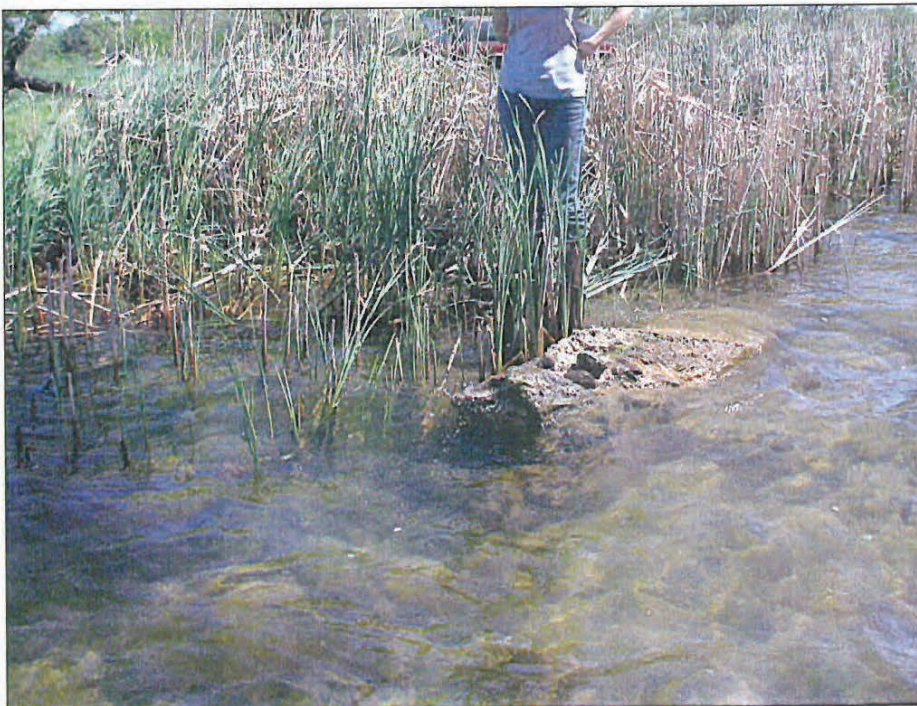
Photo #9 – Hooker Lake Dam (deteriorated left abutment)
(May 20, 2009)

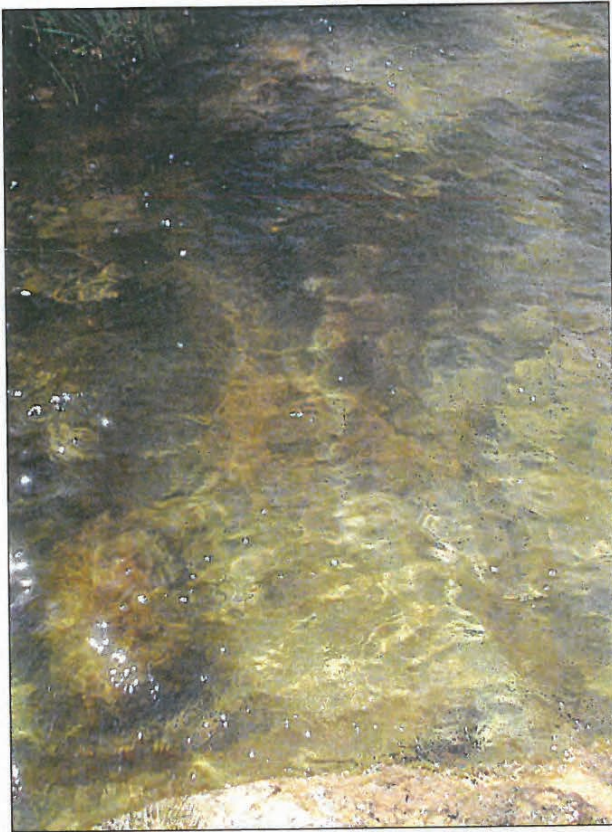
Photo #10 – Hooker Lake Dam (deteriorated spillway)
(May 20, 2009)

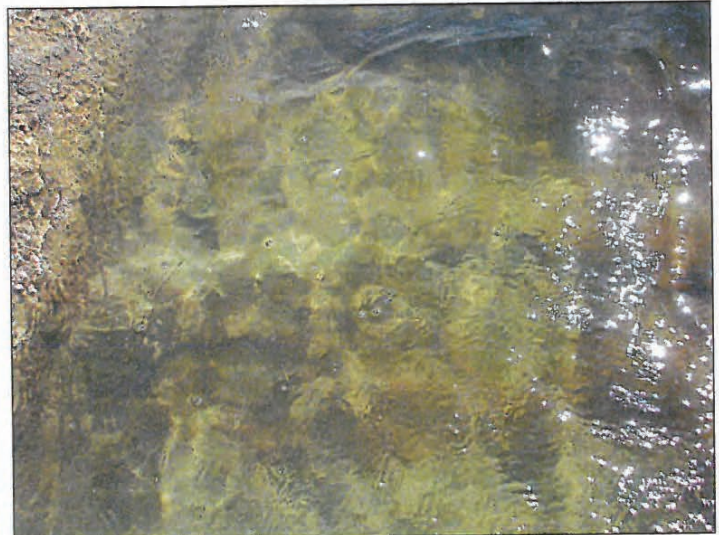
Photo #11 – Hooker Lake Dam (deteriorated spillway)
(May 20, 2009)

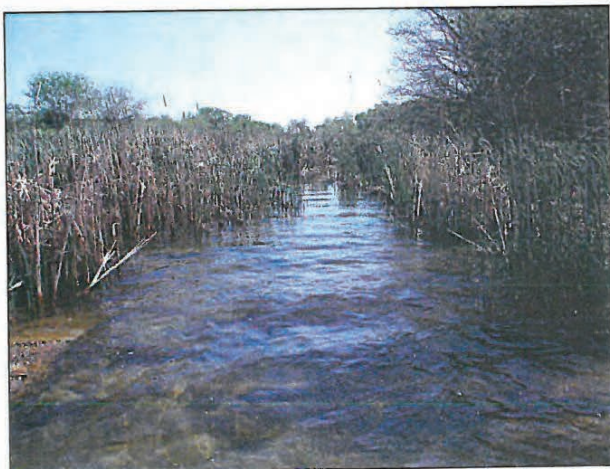
Photo #12 – Cattails (at dam looking downstream)
(May 20, 2009)
