MINERAL POINT BRANCH TWA WQM PLAN 2017

MINERAL POINT AND SUDAN BRANCHES (SP09)

Mineral Point and Sudan Branches (SP09)
HUCs: 070900030101, 070900030102, 070900030103
Monitored in 2015

EGAD # 3200-2017-04
Water Quality Bureau,
Wisconsin DNR

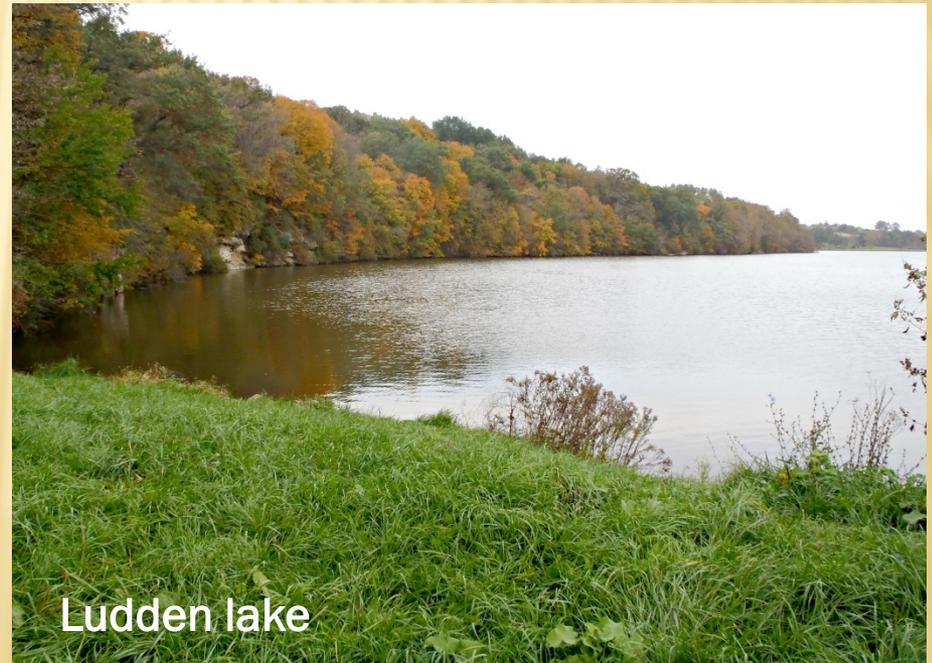
Ludden lake

- ✘ Ludden Lake should be added to the state's 303(d) list of impaired waters because levels of total phosphorus and chlorophyll a exceed criteria and thresholds for shallow lowland lakes (2018 Listing) .

- ✘ Decrease soil and nutrient loss upstream of Ludden Lake to improve water clarity, enhance macrophyte growth, and maintain the depth of the lake system which has been decreased over time due to sediment loads from upstream.
