STREAM CLASSIFICATION

UNNAMED TRIBUTARY

TO BOWER CREEK

OCTOBER 14, 1981

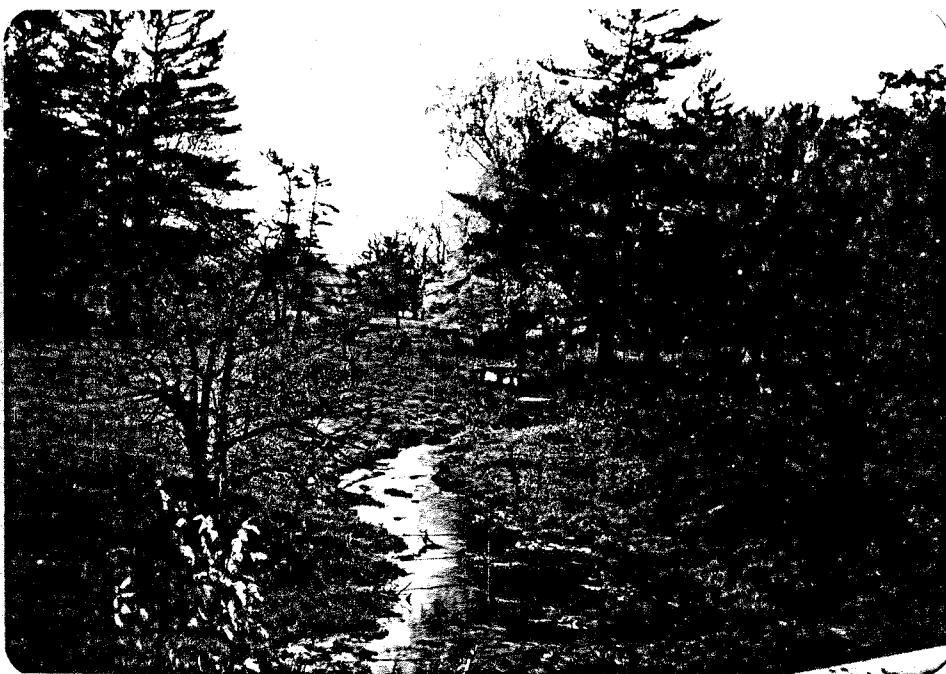
Upstream of the CTH G bridge is pasture land and cattle are allowed unrestricted access to the stream. Approximately 50 feet below the bridge is a waterfall that drops 40 feet into a glen. Numerous macroinvertebrates were observed between the bridge and the waterfall. They include: Gammarids, Ascellus, Hydropsychids, Elmids, Baetidae, Heptagenidae, Simulids and Leeches. No fish were observed.

CTH G
FACING UPSTREAM

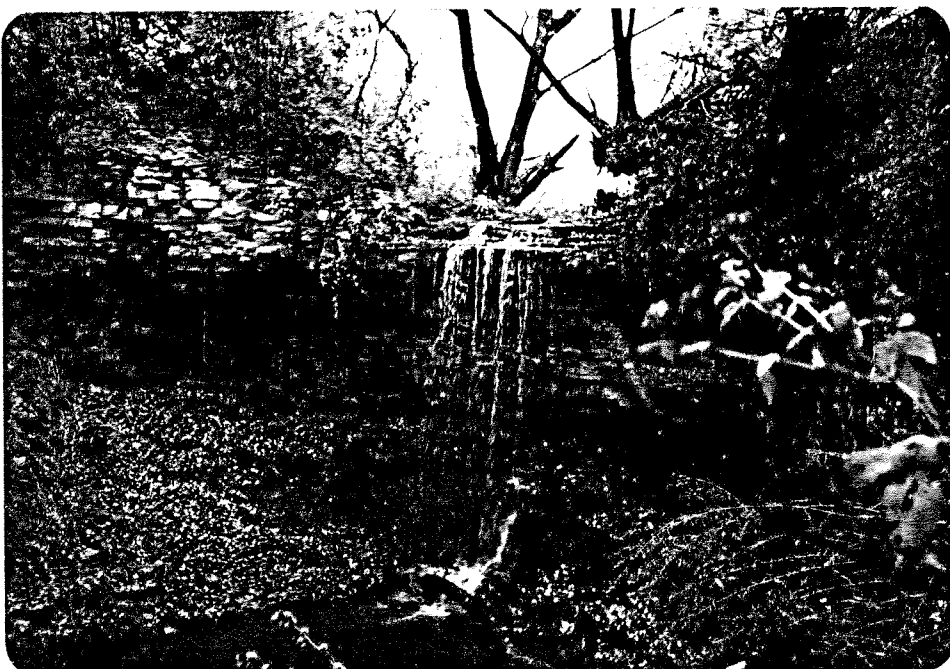
50 FT. BELOW
CTH G

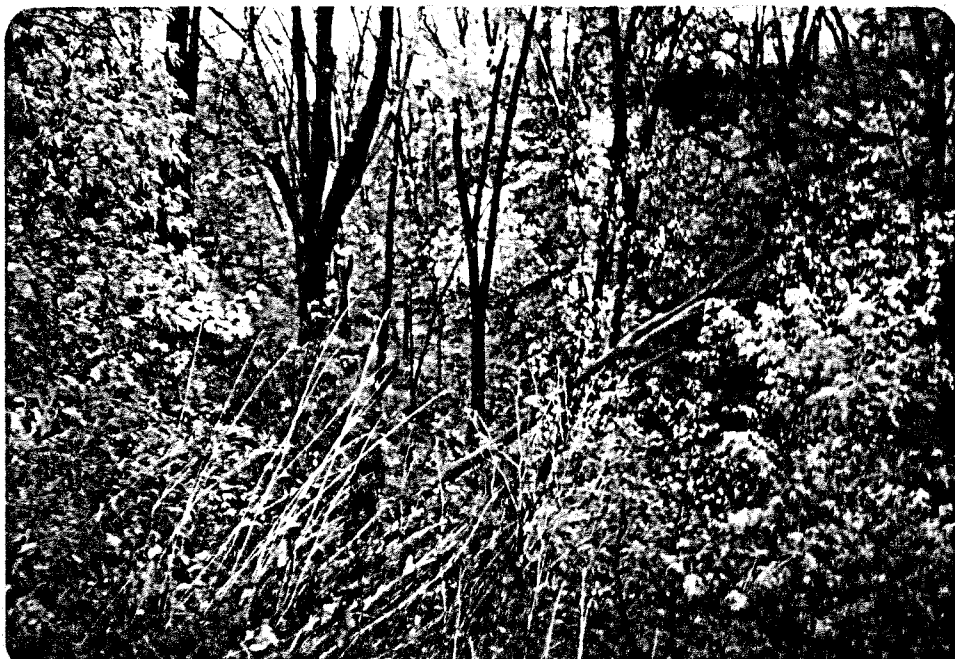
From the waterfall downstream to Dollar Road the stream drops sharply and is very heavily wooded with a healthy variety of ground, brush and canopy cover.

DOWNSTREAM
FROM FALLS

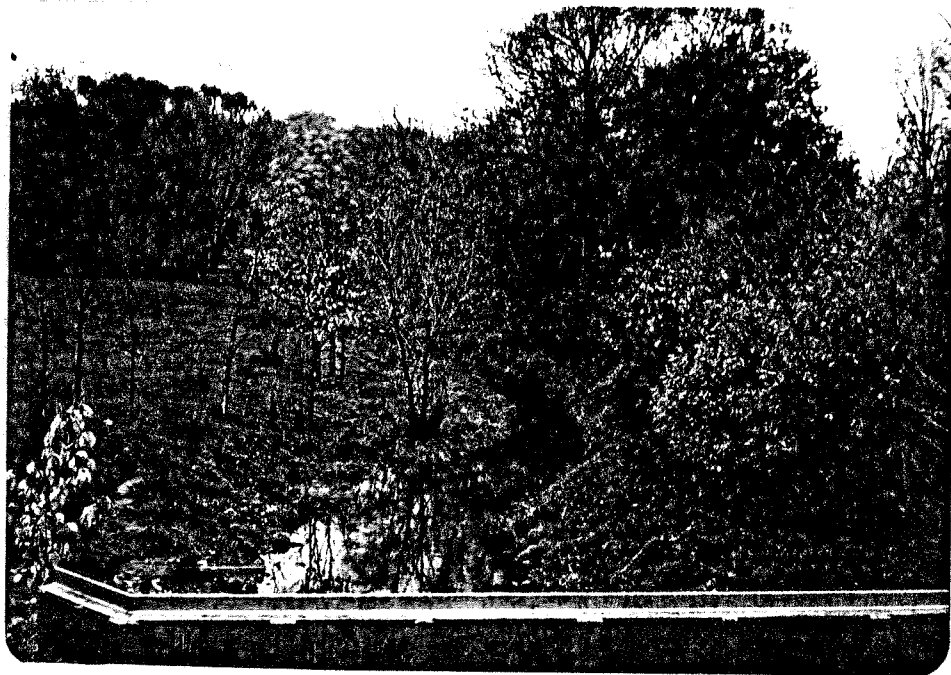
At Dollar Road cattle are allowed limited access and the setting becomes more common although it is still very pleasant. Upstream from Dollar Road there seems to be a good mixture of small pools and rocky riffles. Heptagenidae, Simulids, Hydropsychids, Gammarids, Ascellus and Chimarra were observed in the riffles while Leeches and Snails were present in the pools. Fisheries personnel observed western blacknose dace and brook stickleback.

DOLLAR RD.
FACING UPSTREAM

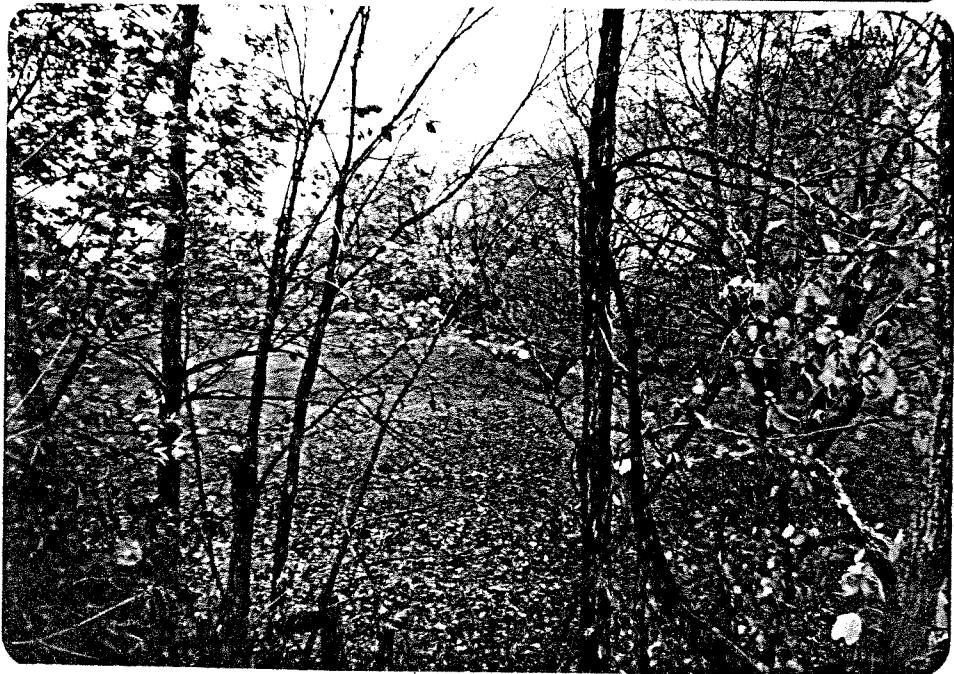
DOLLAR RD.
FACING DOWNSTREAM

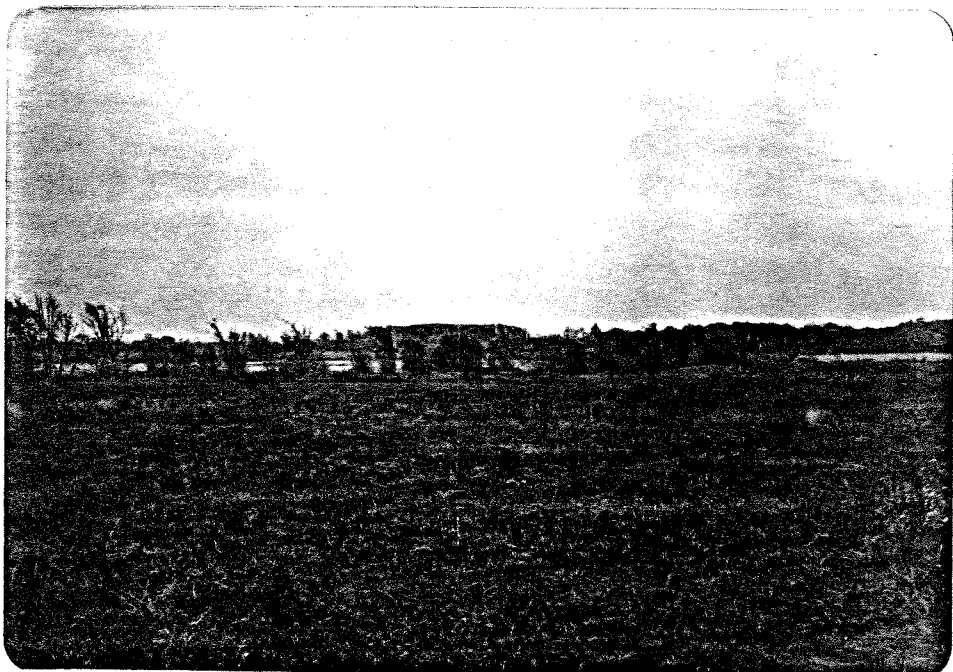
Downstream from Dollar Road to Bower Creek Road is entirely agricultural, but the stream is afforded protection by a wide buffer strip. We did not attempt to collect macroinvertebrates at this location, but Welch and Opgenorth observed northern pike, white sucker, green sunfish and western blacknose dace in this section.

BOWER CR. RD.
FACING UPSTREAM
