**Re: Clam River Hydroelectric Project FERC #9185
Flambeau Hydro, LLC
Article 401 (b) (M) – Final 2014 Purple Loosetrife Inventory Report**

2014 Purple Loosestrife Inventory Report
(Per License Article 401 (b) (M))

Clam River Hydroelectric Project
FERC Project # 9185
Flambeau Hydro, LLC

Clam River Project Purple Loosestrife Inventory
August 18 and August 19, 2014
FERC Project # 9185 Article 401(b)(M)

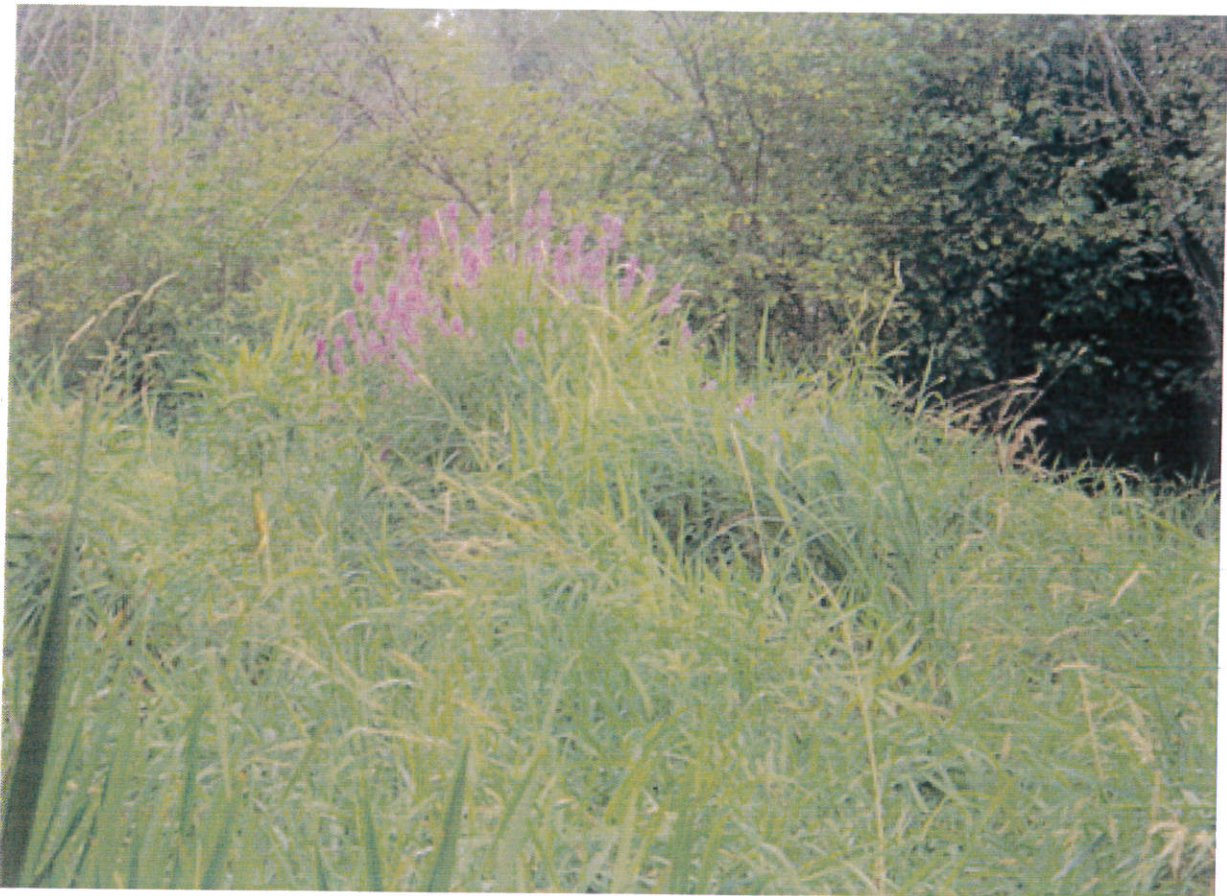
CLRVPL001 AUGUST 18, 2014

CLRVPL001 was first observed in 2007 and pulled. No plants observed in 2008 and 2009. This site was inaccessible in 2010, 2011, and 2012. No plants found in 2013. 2 multi stemmed plants found and pulled out by the root and disposed of properly in 2014. Picture taken 2014.

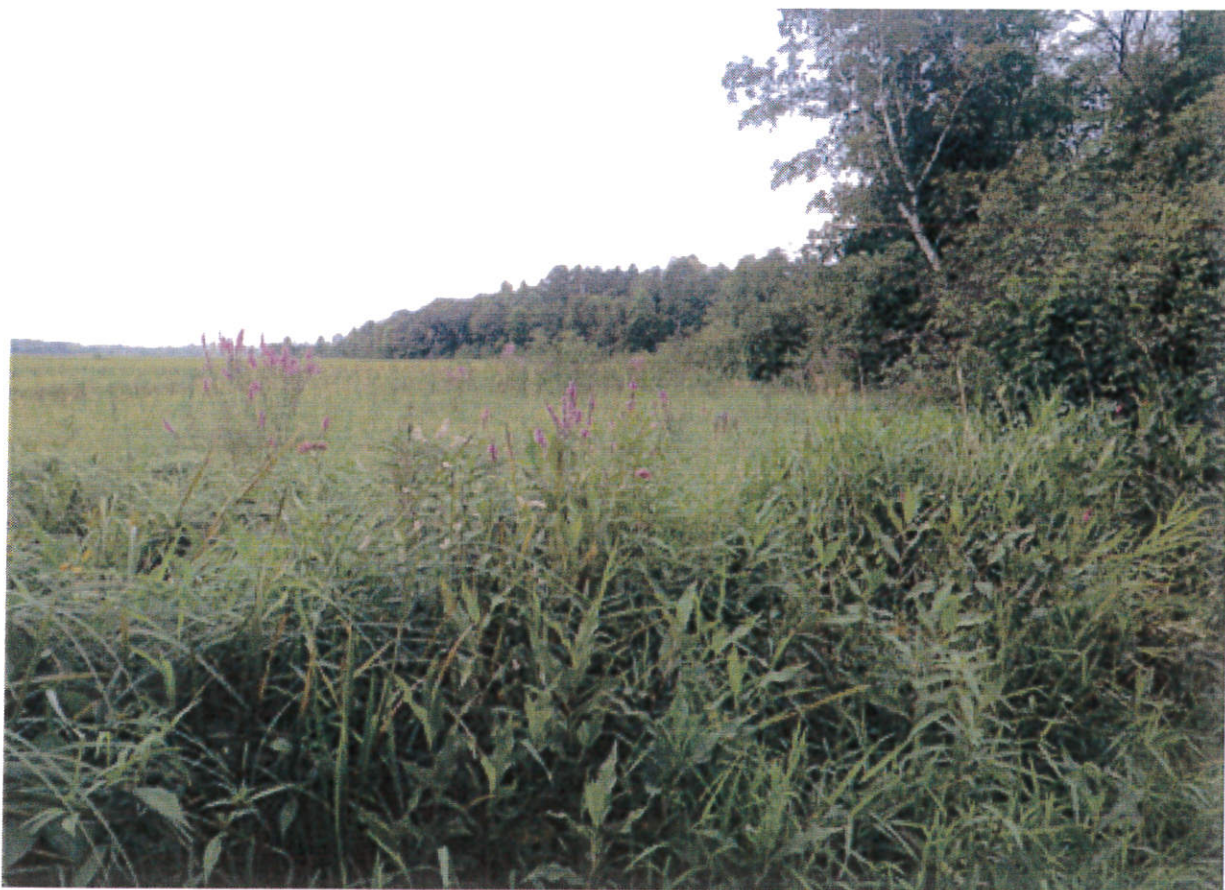
CLRVPL006 AUGUST 18,2014

CLRVPL006 was first observed in 2007. 1 plant located in 2013, no beetle damage. A photo in 2014 shows 22 plants in this area. Beetles will be placed here in the summer of 2015.

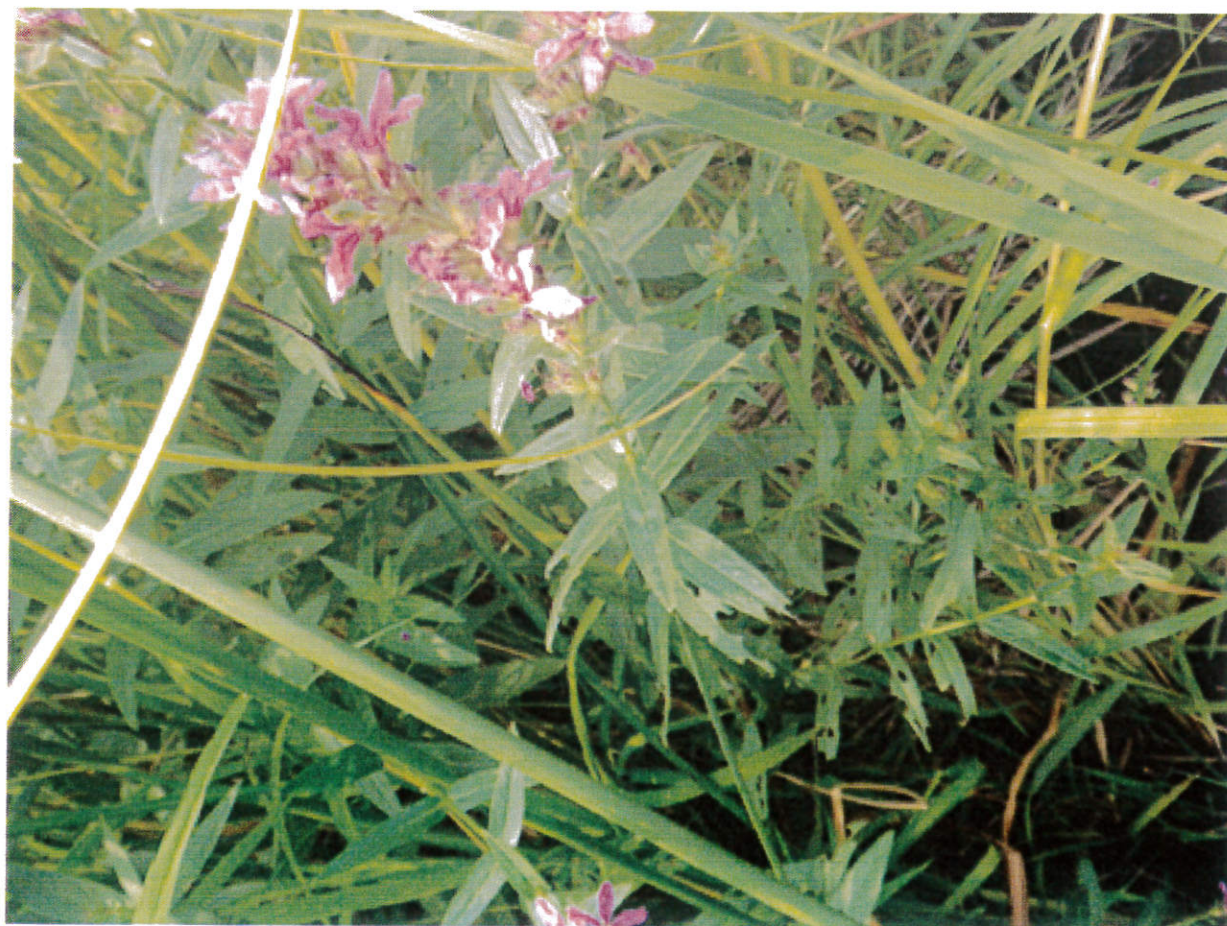
CLRVPL008 was first observed in 2008. We accessed this area by canoe in 2013 and viewed purple loosestrife plants that had shot patterns in the leaves and main stems missing from *Galerucella* beetle damage. Photos included. In 2013 the Grantsburg high school science class raised and released 2000-3000 *Galerucella* beetles in July of 2013 within this patch of purple loosestrife. In 2014 there was a small amount of *Gallerucella* beetle feeding on many of the leaves, but the flower stalks were not eaten on any of the plants viewed. Photo of shot pattern on leaves of plants in 2014.

CLRVPL008 SHOT PATTERNS IN LEAVES AUGUST 18,2014

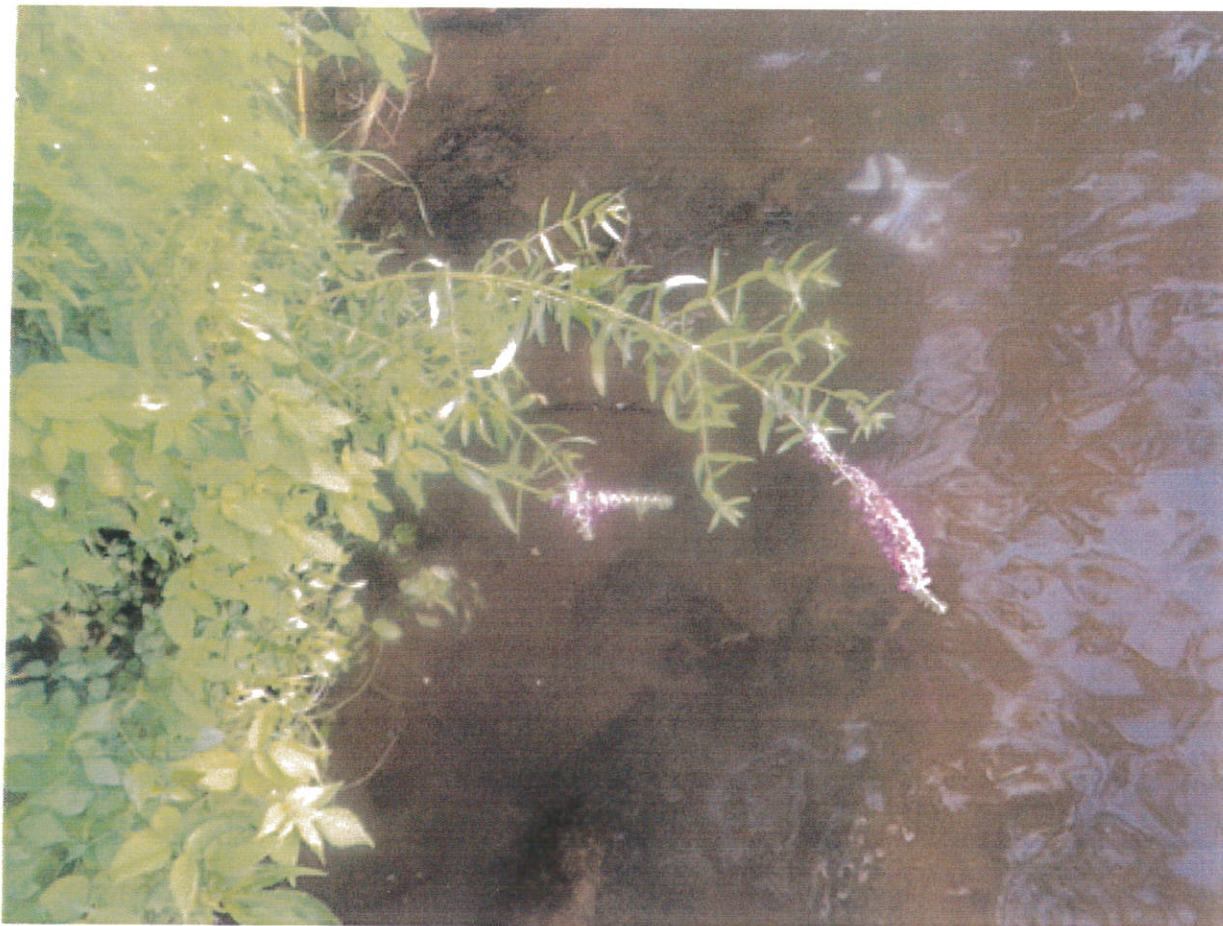
CLRVPL015 AUGUST 19,2014

CLRVPL015 was first observed in 2014 as a single stemmed plant along the shore and was pulled by the root and disposed of properly. Photo in 2014.

1 new plant - pulled - 3' tall - pic. N 45 55.265
W 092 31.566

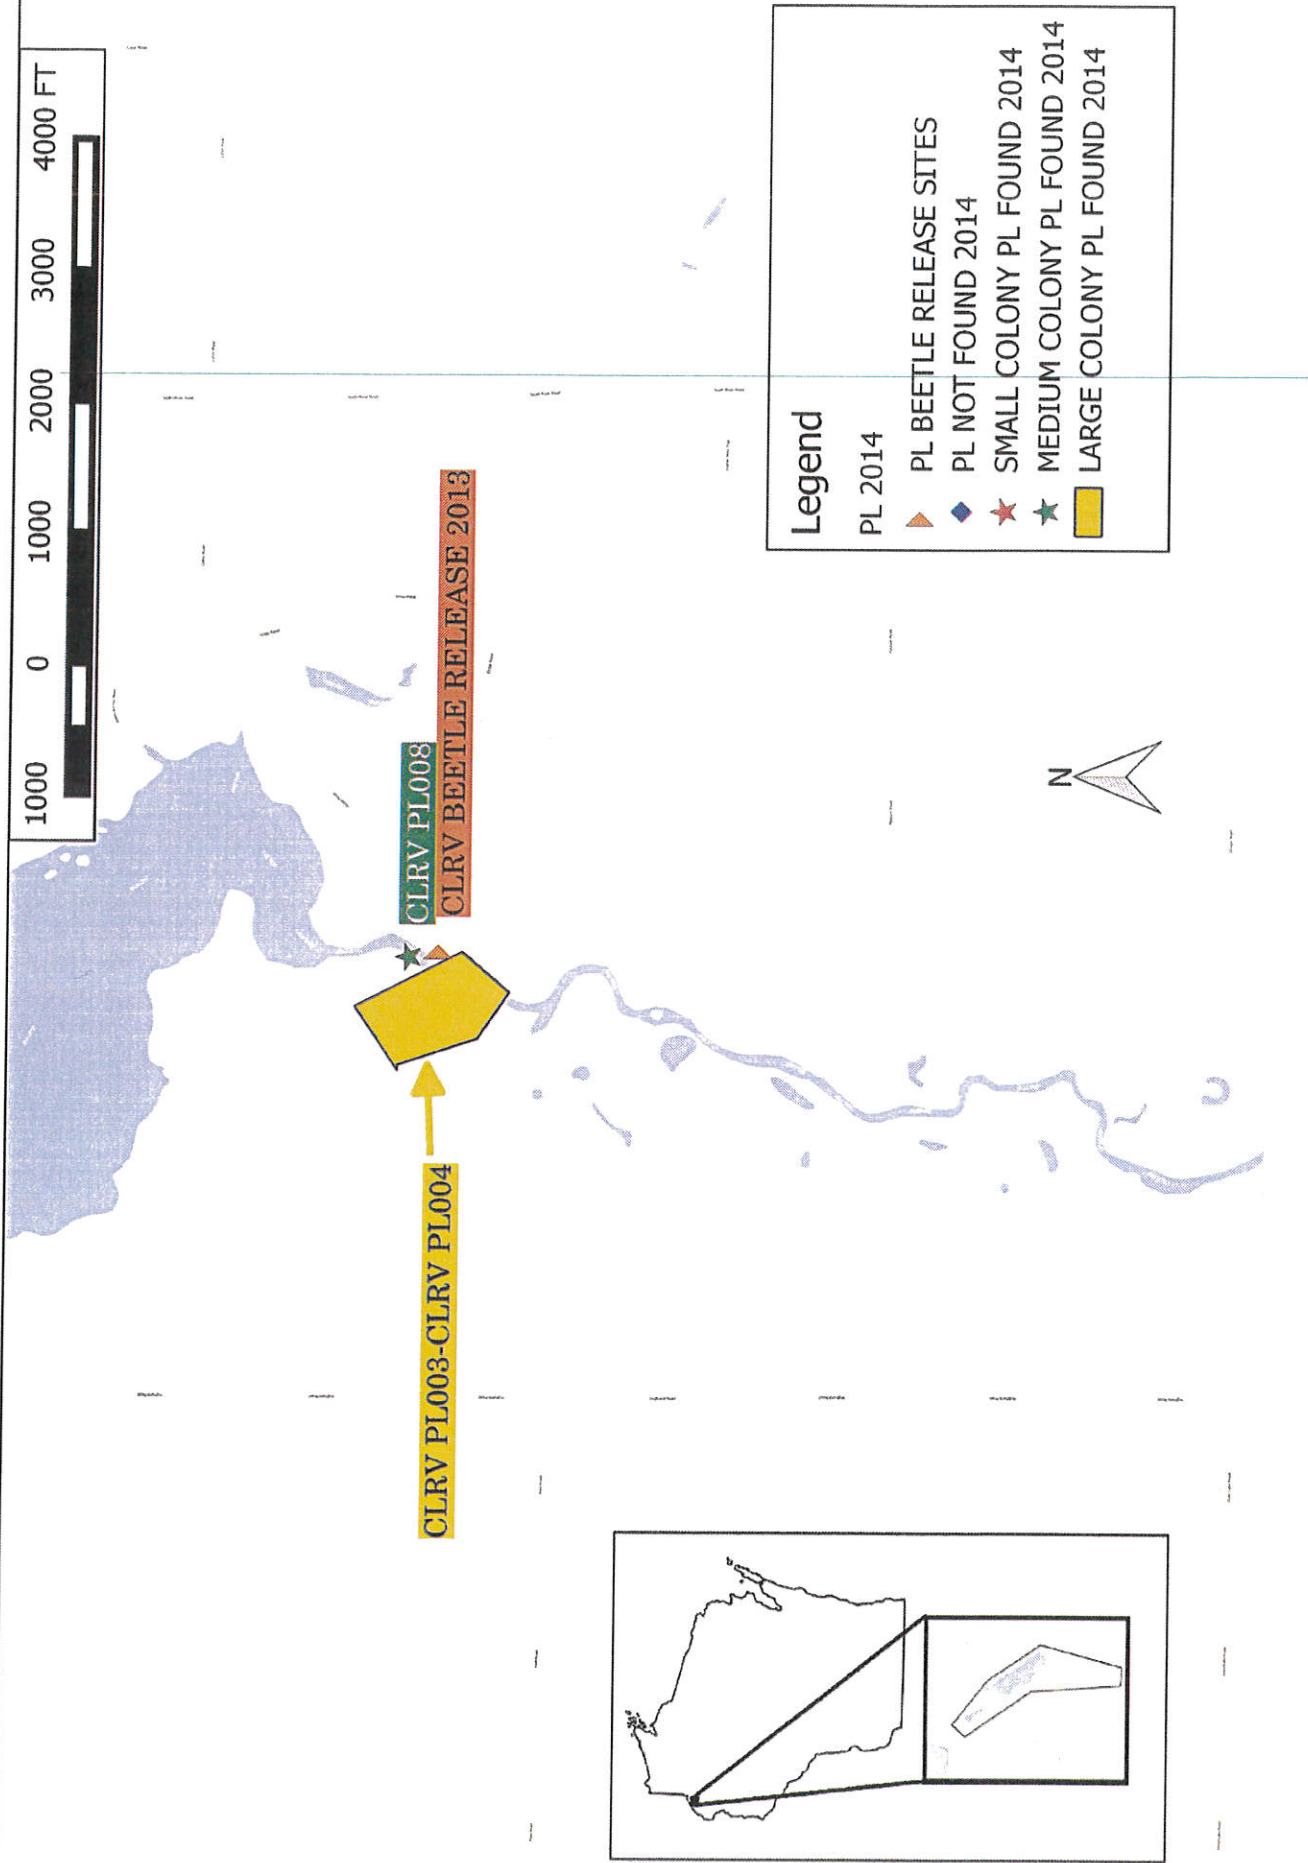
2014 GALERUCELLA BEETLE DAMAGE SITES CLAM RIVER FERC # 9185

CLRVPL003 to CLRVPL004 make up a large 10 acre site in the higher ground of the bogs within wild rice beds of the southern end of the impoundment. This site was first observed in 2007. In 2009 the amount of plants observed at this site had declined with major reductions occurring in the northern half of the 10 acre site. Overall estimates of this site by the survey crew indicated an increase in the amount of plants in 2010, but less than in the 2007 and 2008 surveys. There appeared to be a considerably greater amount of purple loosestrife plants at this location in 2011, specifically near the end of the wild rice beds. Photos taken in 2012 with a digital camera show this area from around 100 feet away. This was as close as the crew could get with the increased silting of the riverbed and low water. In 2013 a canoe was used to access the river and a closer photo of the large area of PL was taken. In 2014 a canoe was used to access this site. There was a small amount of *Gallerucella* beetle feeding on many of the leaves, but the flower stalks were not eaten on any of the plants viewed. This means the beetles have started spreading out from their original placement on site CLRVPL008.

In the summer of 2015 *Galerucella* beetles will again be released at some of the largest sites and the next survey will be completed in 2016.
