Water Quality Monitoring Report Little Chute Hydroelectric Project FERC No. 2588-007

Little Chute, Wisconsin

Submitted to:
Kaukauna Utilities

October 21, 2011

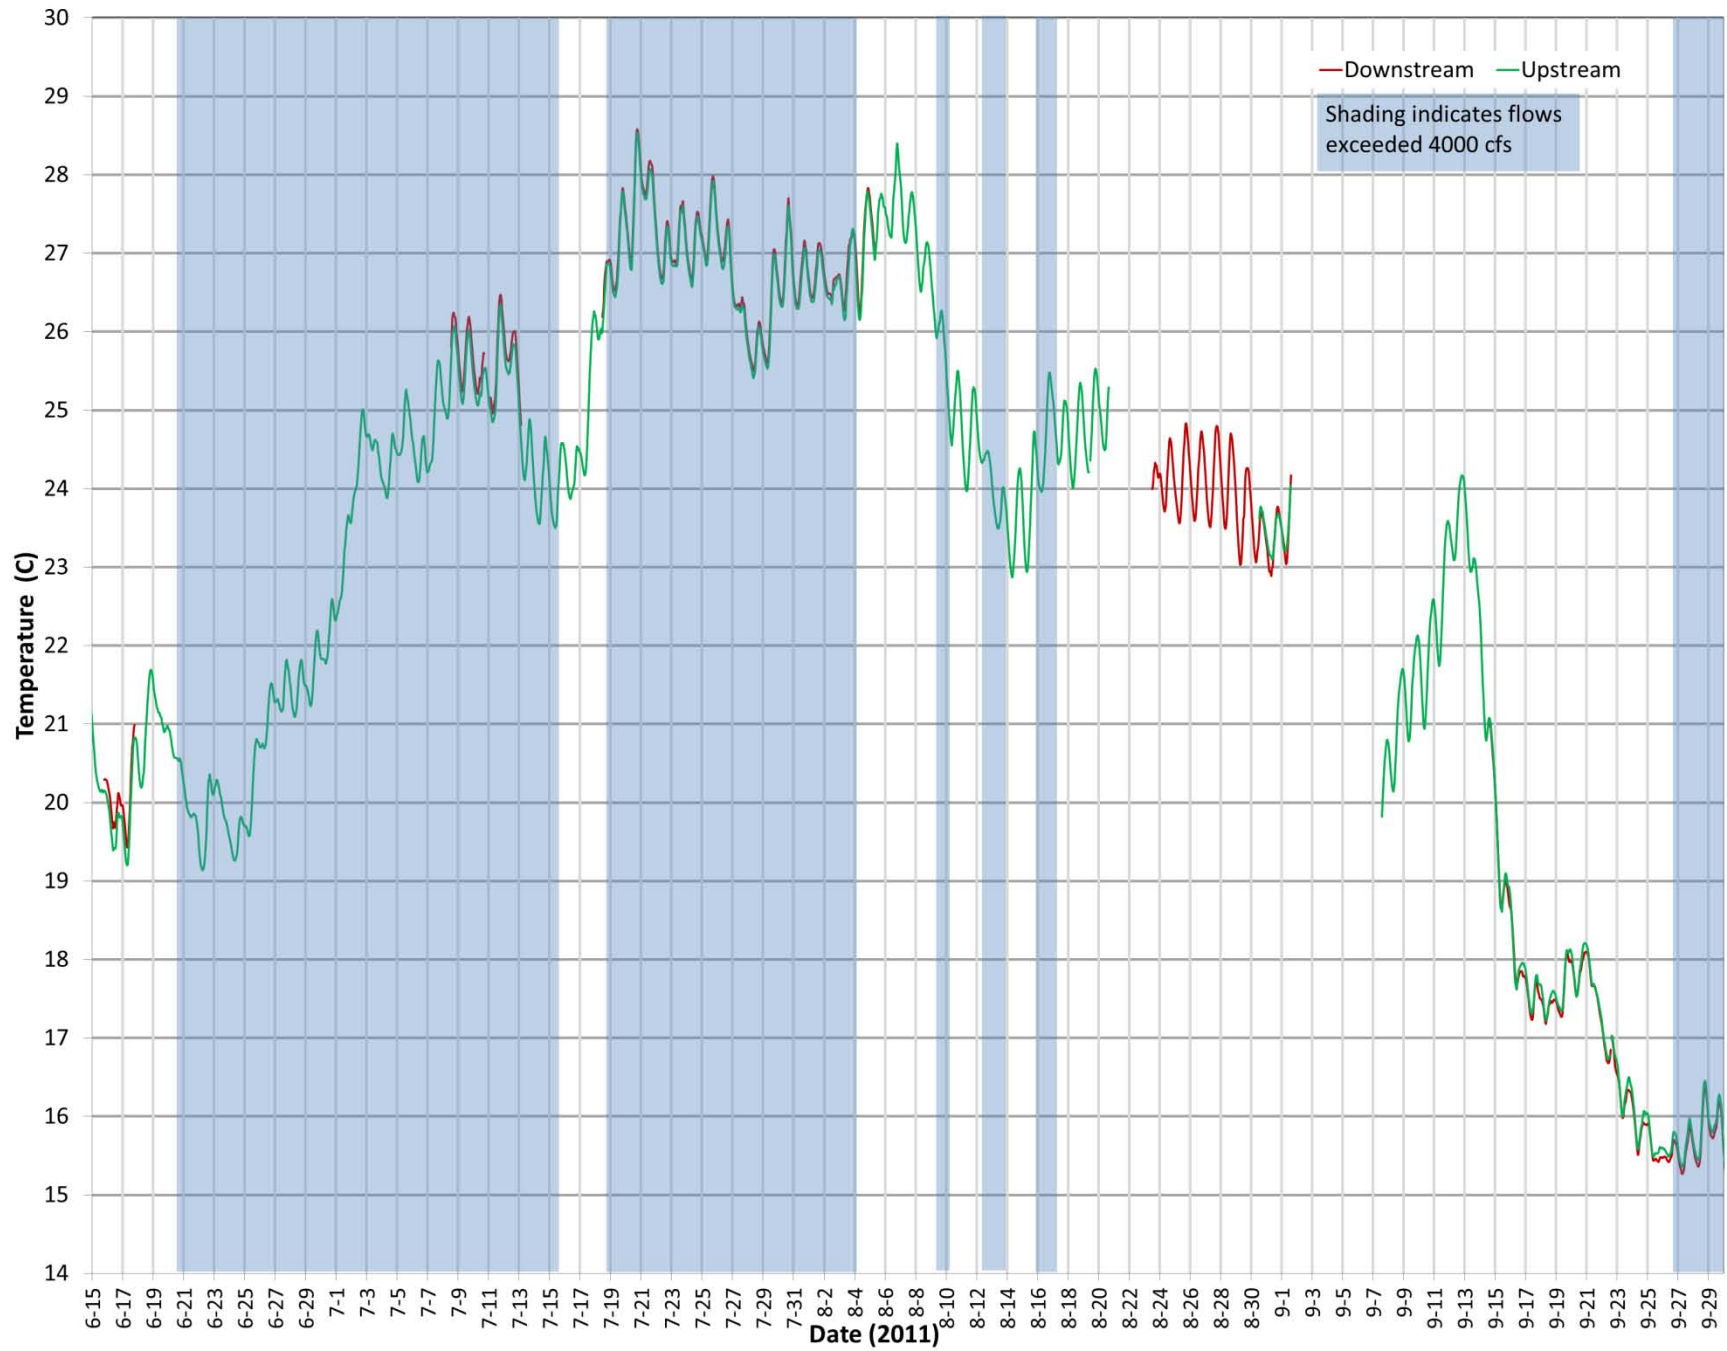
Temperature: For the temperature comparison, the mean of the difference in the daily averages was -0.04°C (upstream minus downstream) with a standard deviation of $\pm 0.16^{\circ}\text{C}$. (The negative sign indicates that the daily averages for upstream temperature were lower than downstream; however, the mean difference in daily averages was less than the error variance of the recording instrument—i.e., zero).

Figure 1. Hourly Temperature Readings Upstream and Downstream of Little Chute Project (High Flow Periods Shaded)

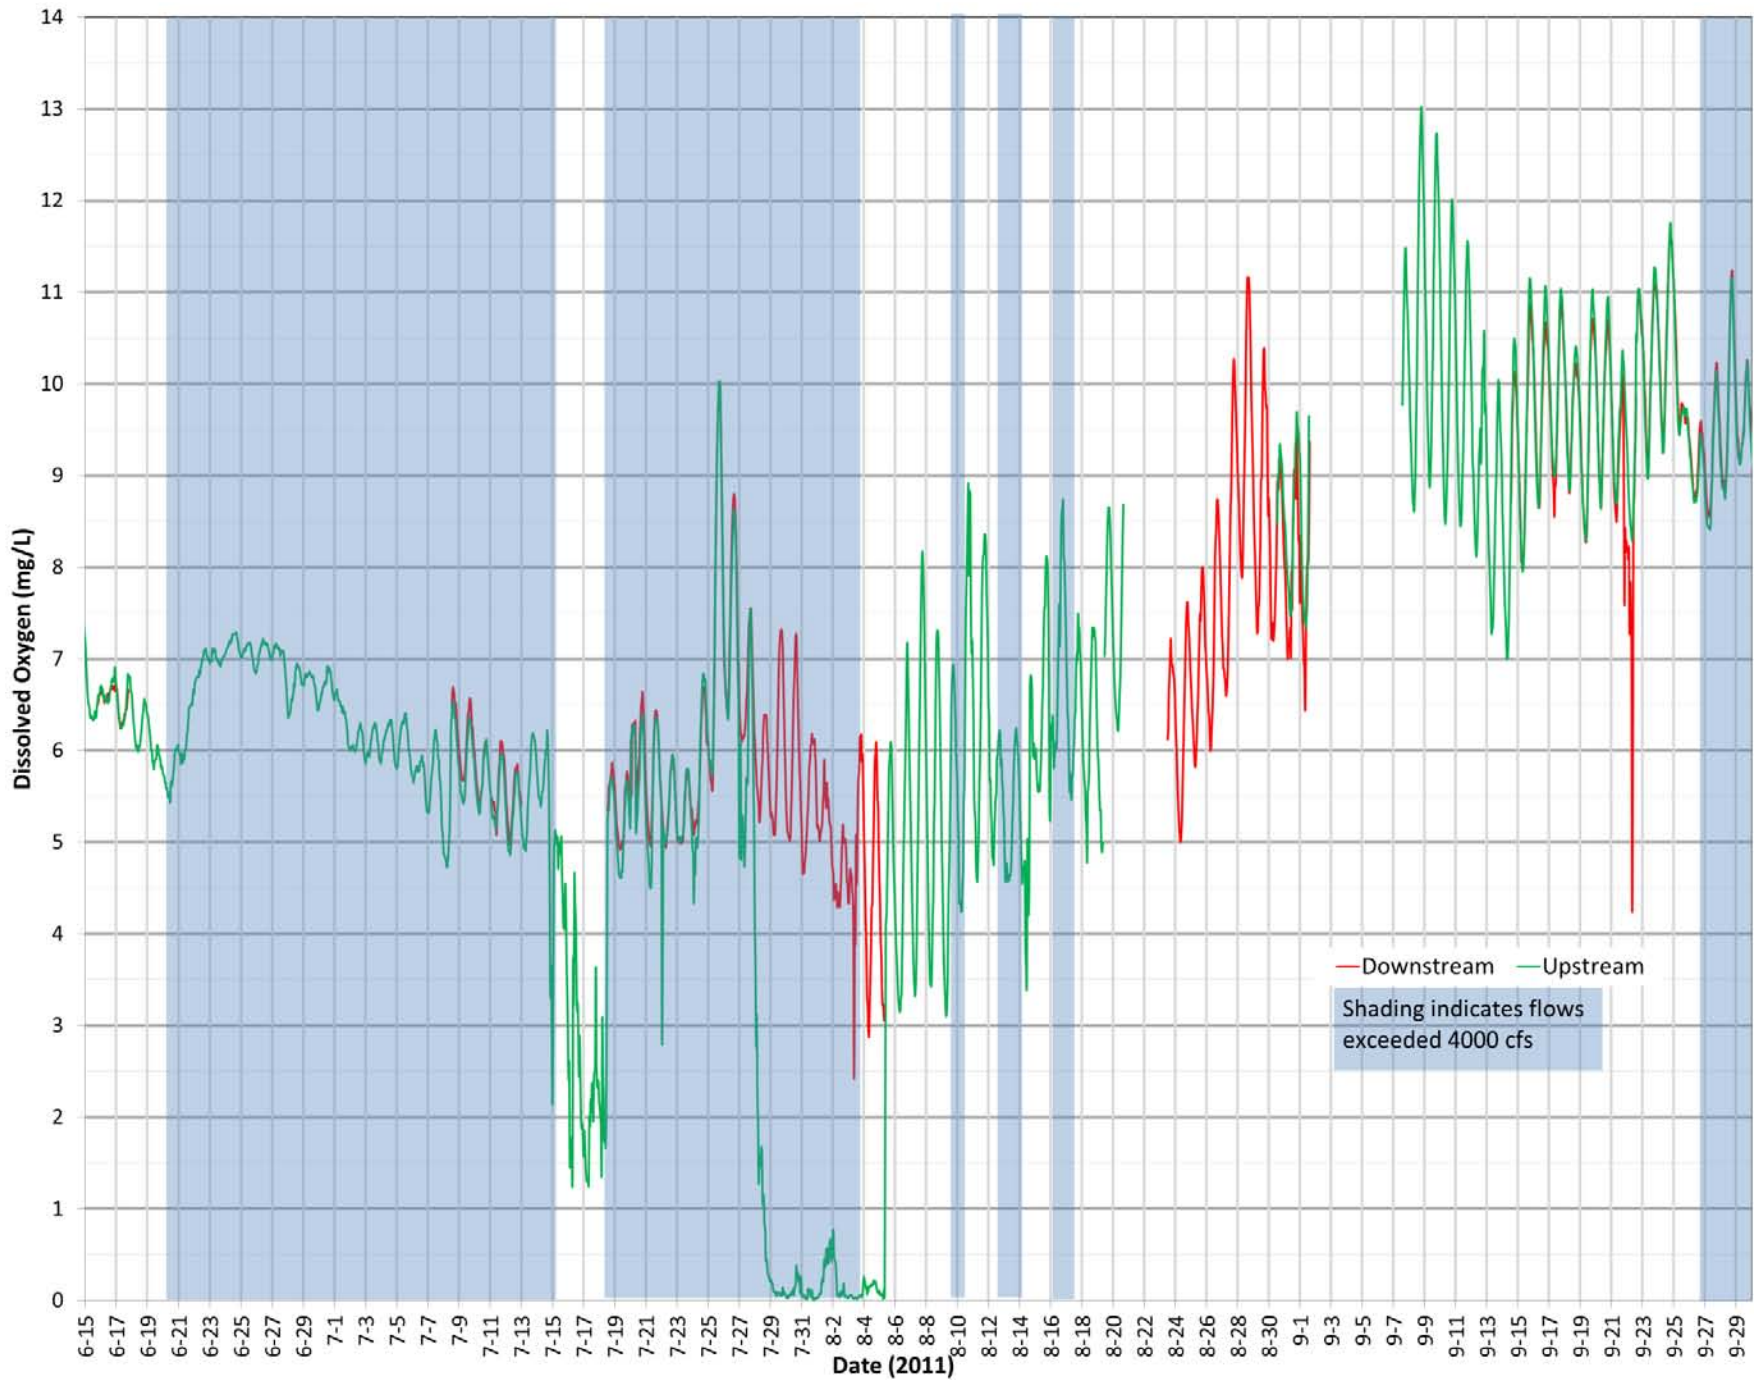
High flow contributed to poor performance of the instruments based on sediment observed embedded in the protective casing around the upstream probe DO probe when it was serviced on August 5. This service date was preceded by a spate of higher flows from approximately July 18 through August 1 (Figures 5 and 6). We also experienced a unit failure which may have been due to bedload movement or debris in the river. Units were cracked, flooded and the batteries had failed on August 5 and 20. During the final month of deployment (September 14), we discovered the downstream unit to have “no data” in the memory even though the unit was calibrated and responded successfully to reset instructions. After consultation with Hach, they replaced this unit with a backup for the final ten days of the sampling season, but were unable to explain this anomalous occurrence. For detailed accounts of outages, refer to Appendix E.

Figure 2. Hourly Dissolved Oxygen Readings Upstream and Downstream of Little Chute Project (High Flow Periods Shaded)

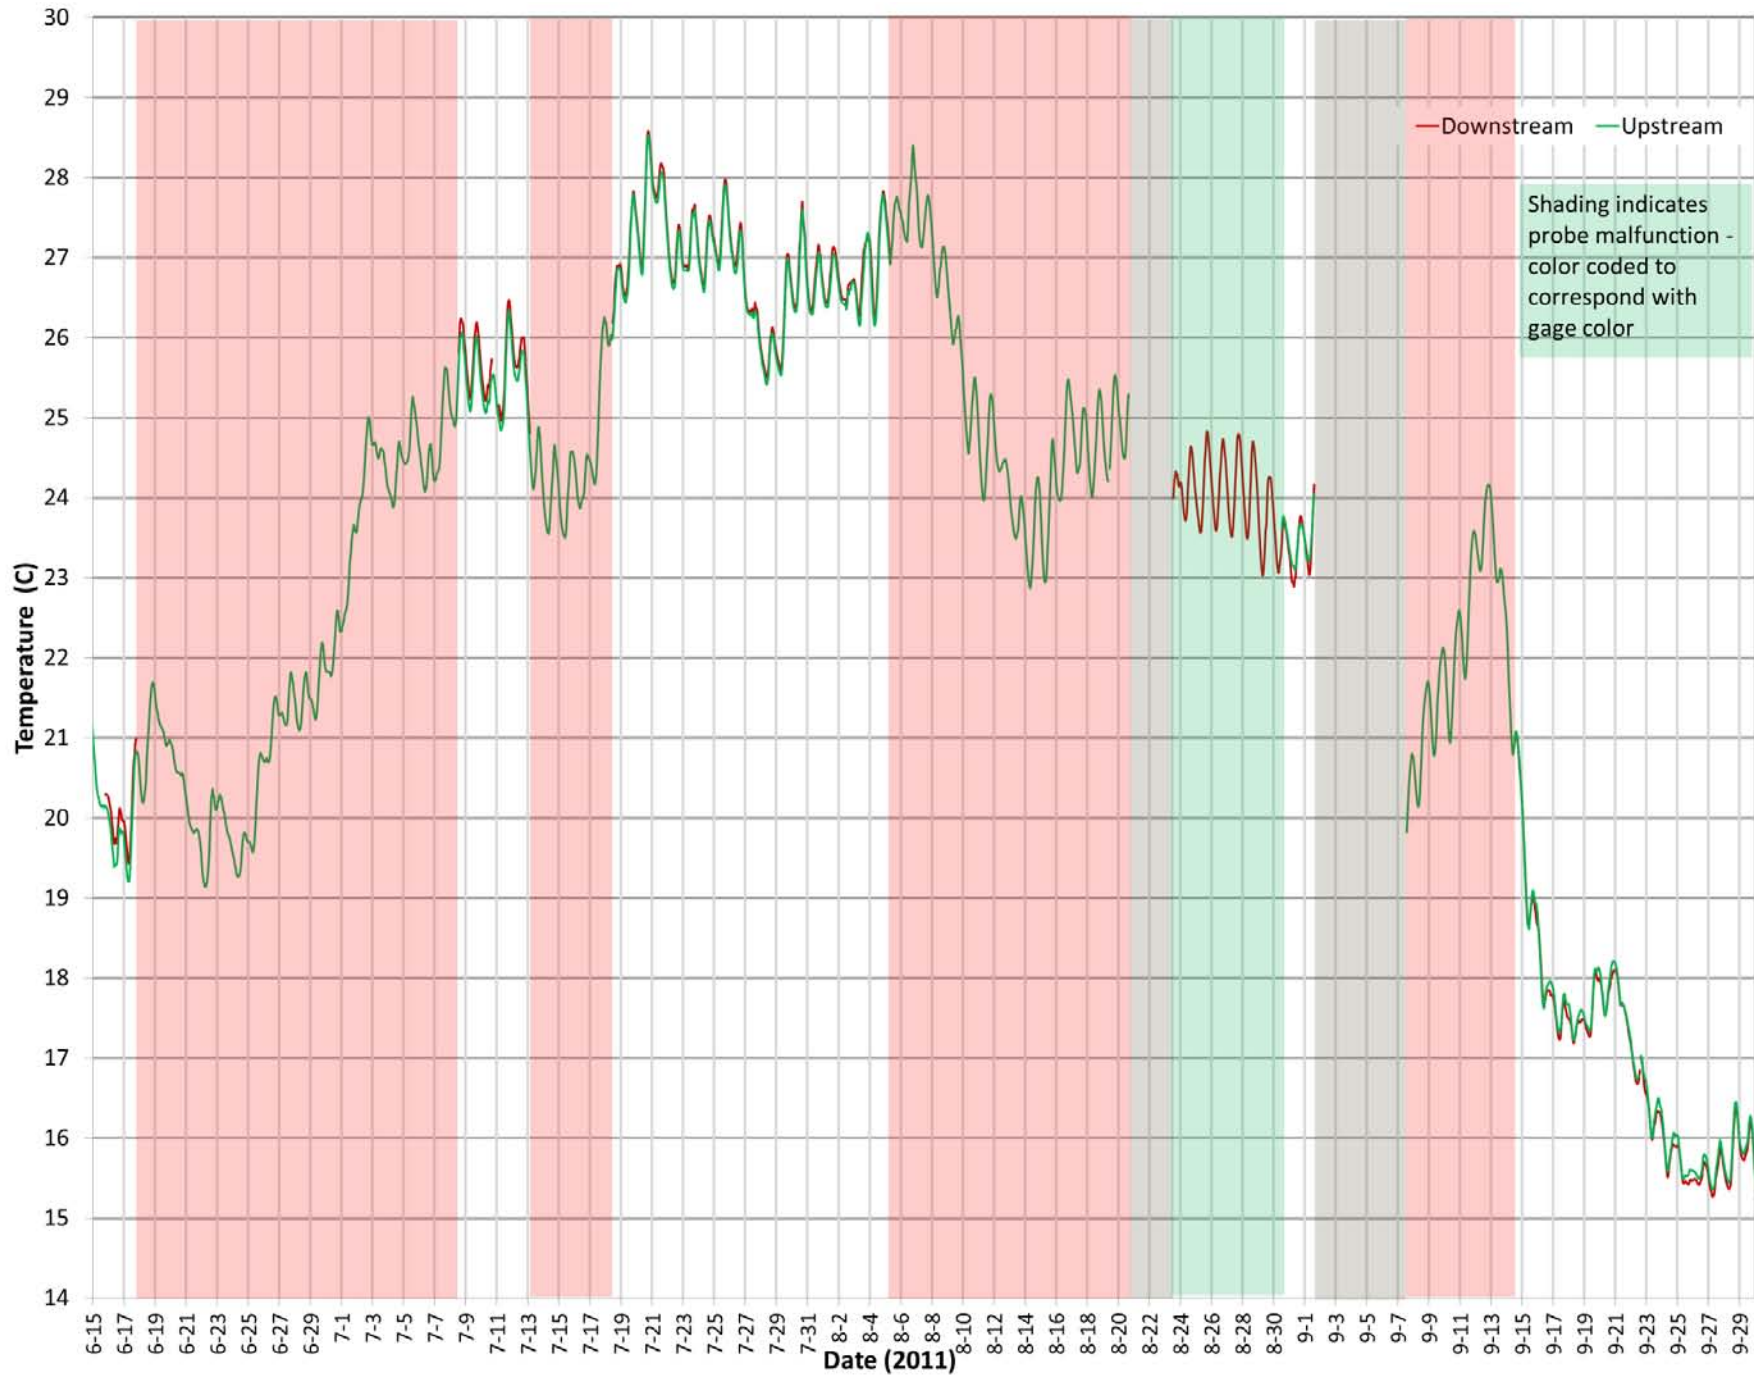
Figure 3. Hourly Temperature Readings Upstream and Downstream of Little Chute Project (Probe Malfunction Periods Shaded)

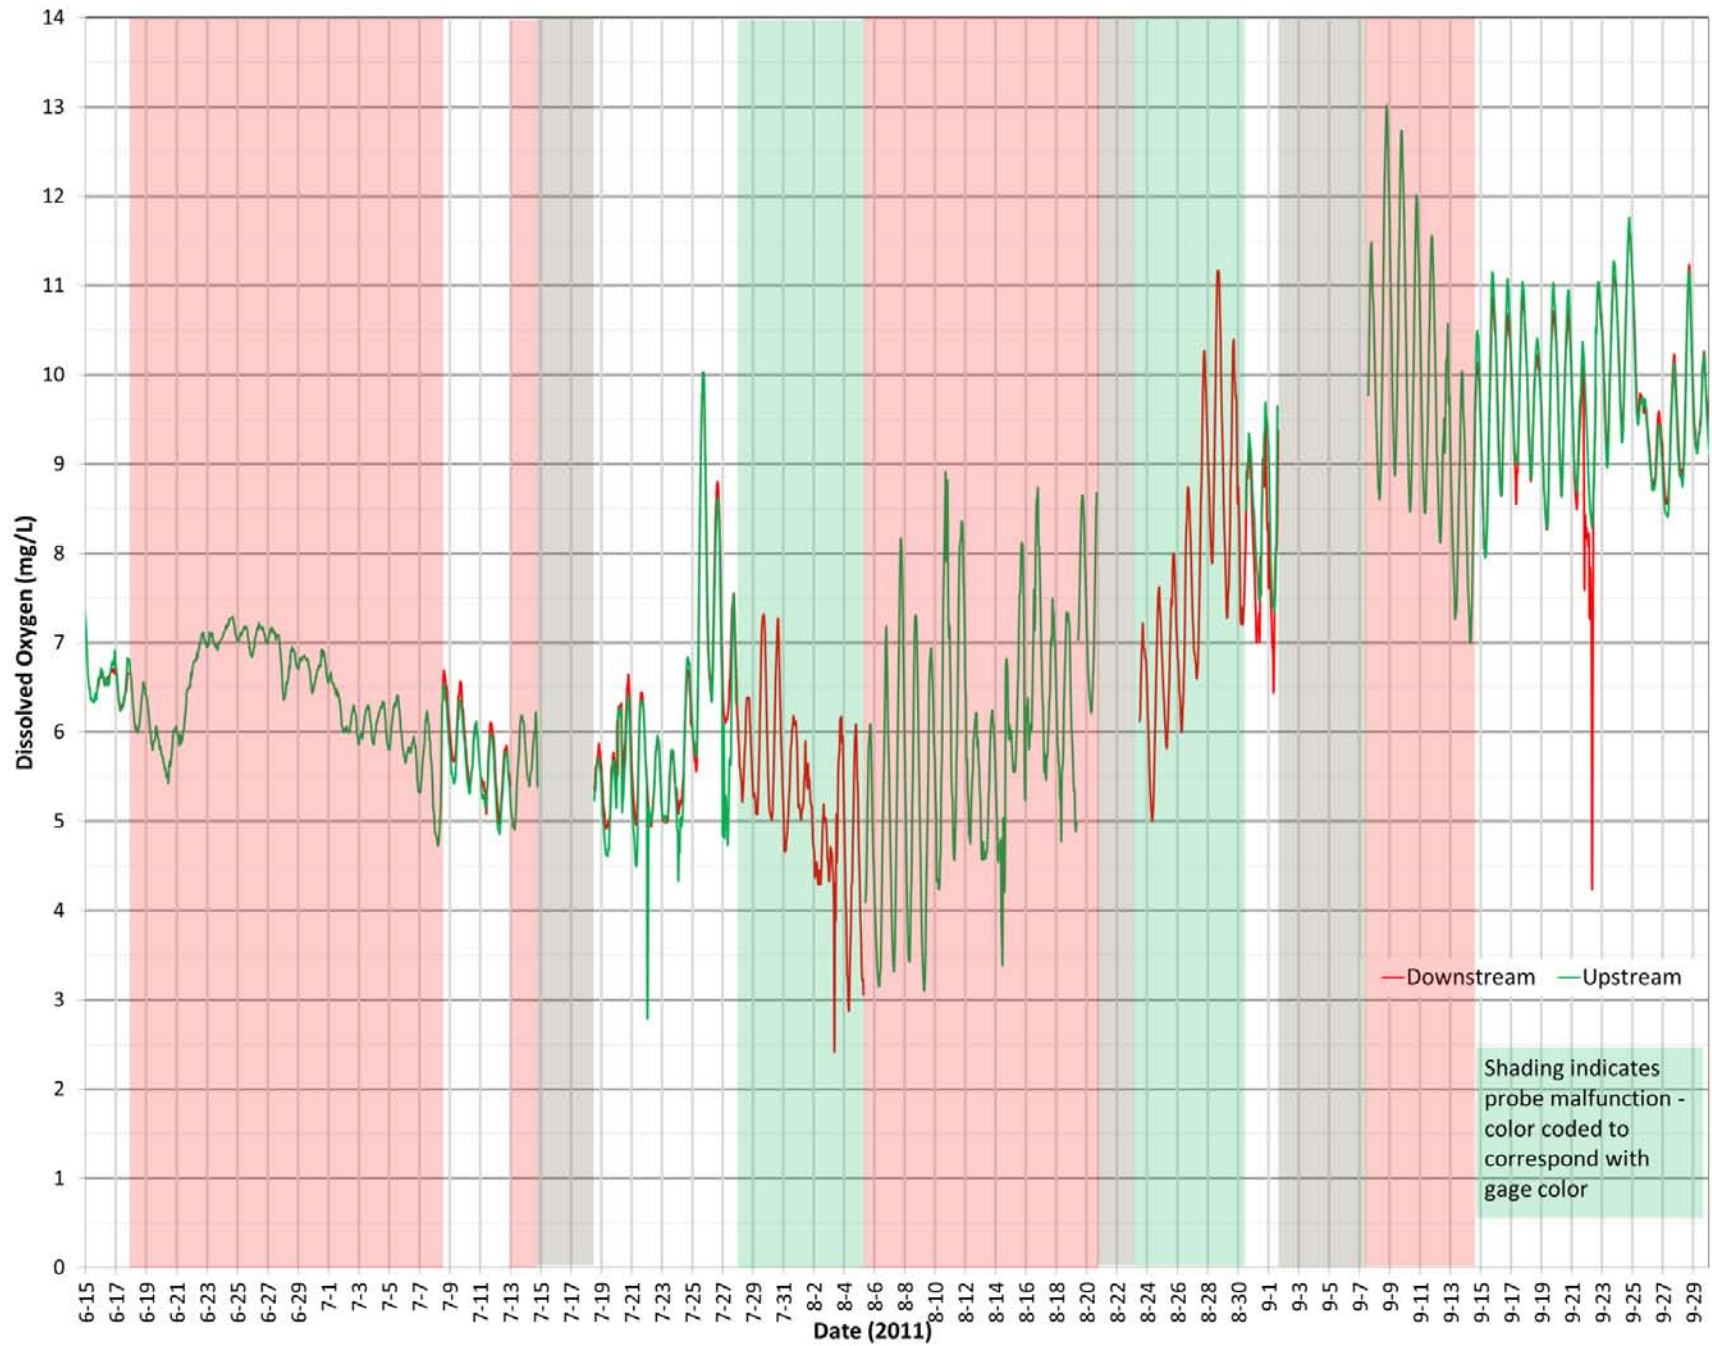
The average daily DO ranged between 5 mg/L and 11 mg/L for the entire study upstream and downstream except during an equipment outage July 31 to August 2 when a probe became fouled. Differences between upstream and downstream DO daily averages were less than 2 mg/L throughout the study, excluding the July 28 to August 4 data when a probe became fouled (Table 1, Appendix C).

Figure 4. Hourly Dissolved Oxygen Readings Upstream and Downstream of Little Chute Project (Probe Malfunction Periods Shaded)

Data were unavailable during two periods from outage problems: August 20 to 30; and September 1 to 7. In addition, on August 5 we observed significant sedimentation/biofouling around the probe which led to near zero DO readings on July 29 to August 5 (Figure 2, Appendix A). Temperature data were generally not sensitive to biofouling, but were lost when the upstream unit failed to collect data from August 20 to 30 due to battery failure (Figures 1 and 3, Appendix A). Observations and corrective actions taken for these two periods are described in the following paragraphs.

During routine maintenance and data downloading on August 5, we removed significant quantities of silt, sand, and fine gravel lodged within the screen surrounding the DO and temperature probes. Following cleaning of the probe, DO readings increased from near zero to greater than 4 mg/L and were consistent with pre-calibration DO levels in the river. On July 27, DO readings dropped off rapidly to near zero through the remainder of the sampling period (August 5). Based on our review of the data including field observations of unusually heavy deposition of sediment around the probe, we concluded that sedimentation around the probe likely caused erroneous DO readings.

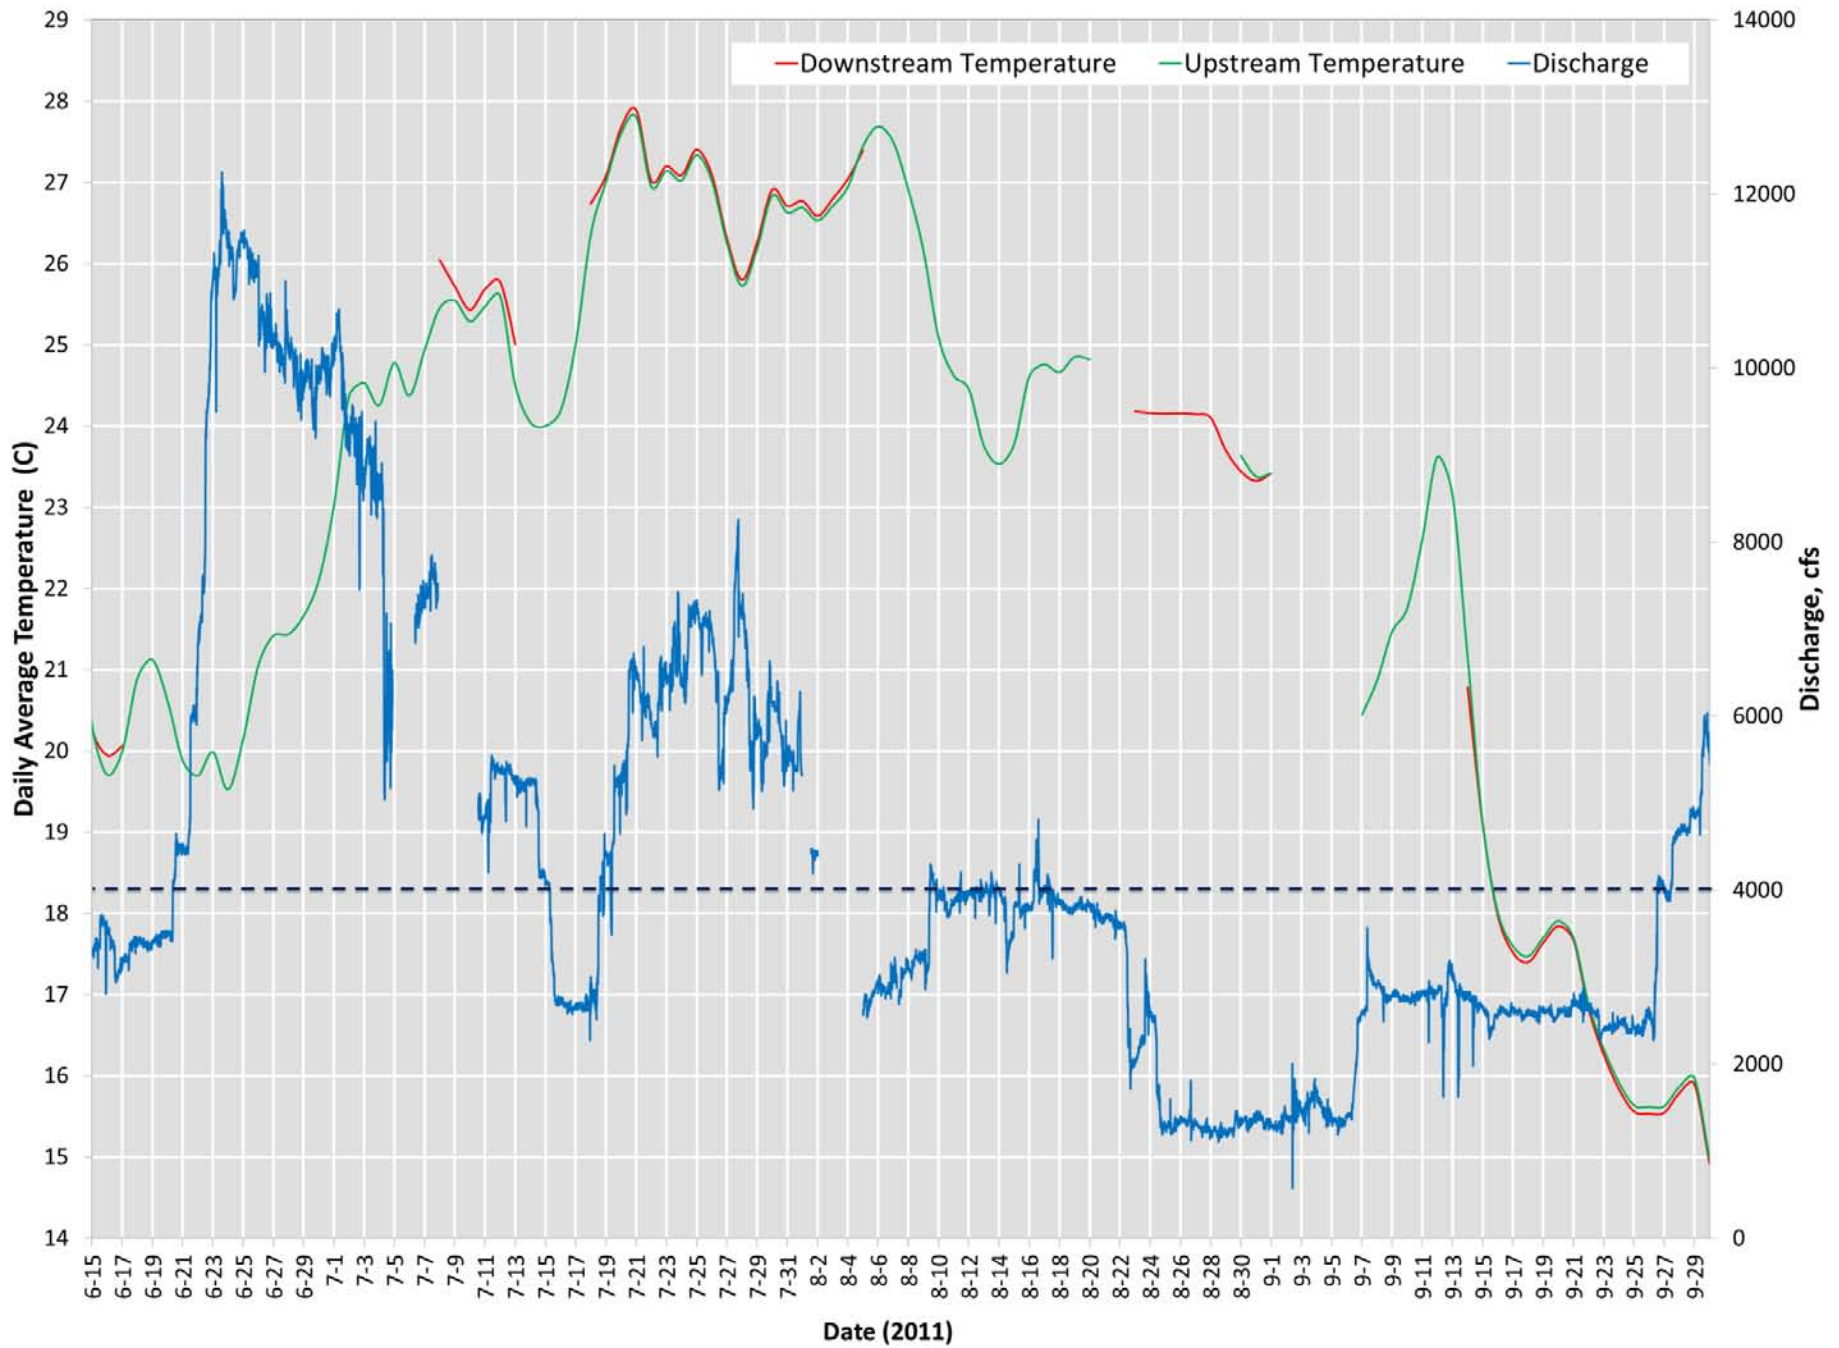
Figure 5. Daily Averages for Temperature Upstream and Downstream of the Little Chute Project and Fox River Discharge

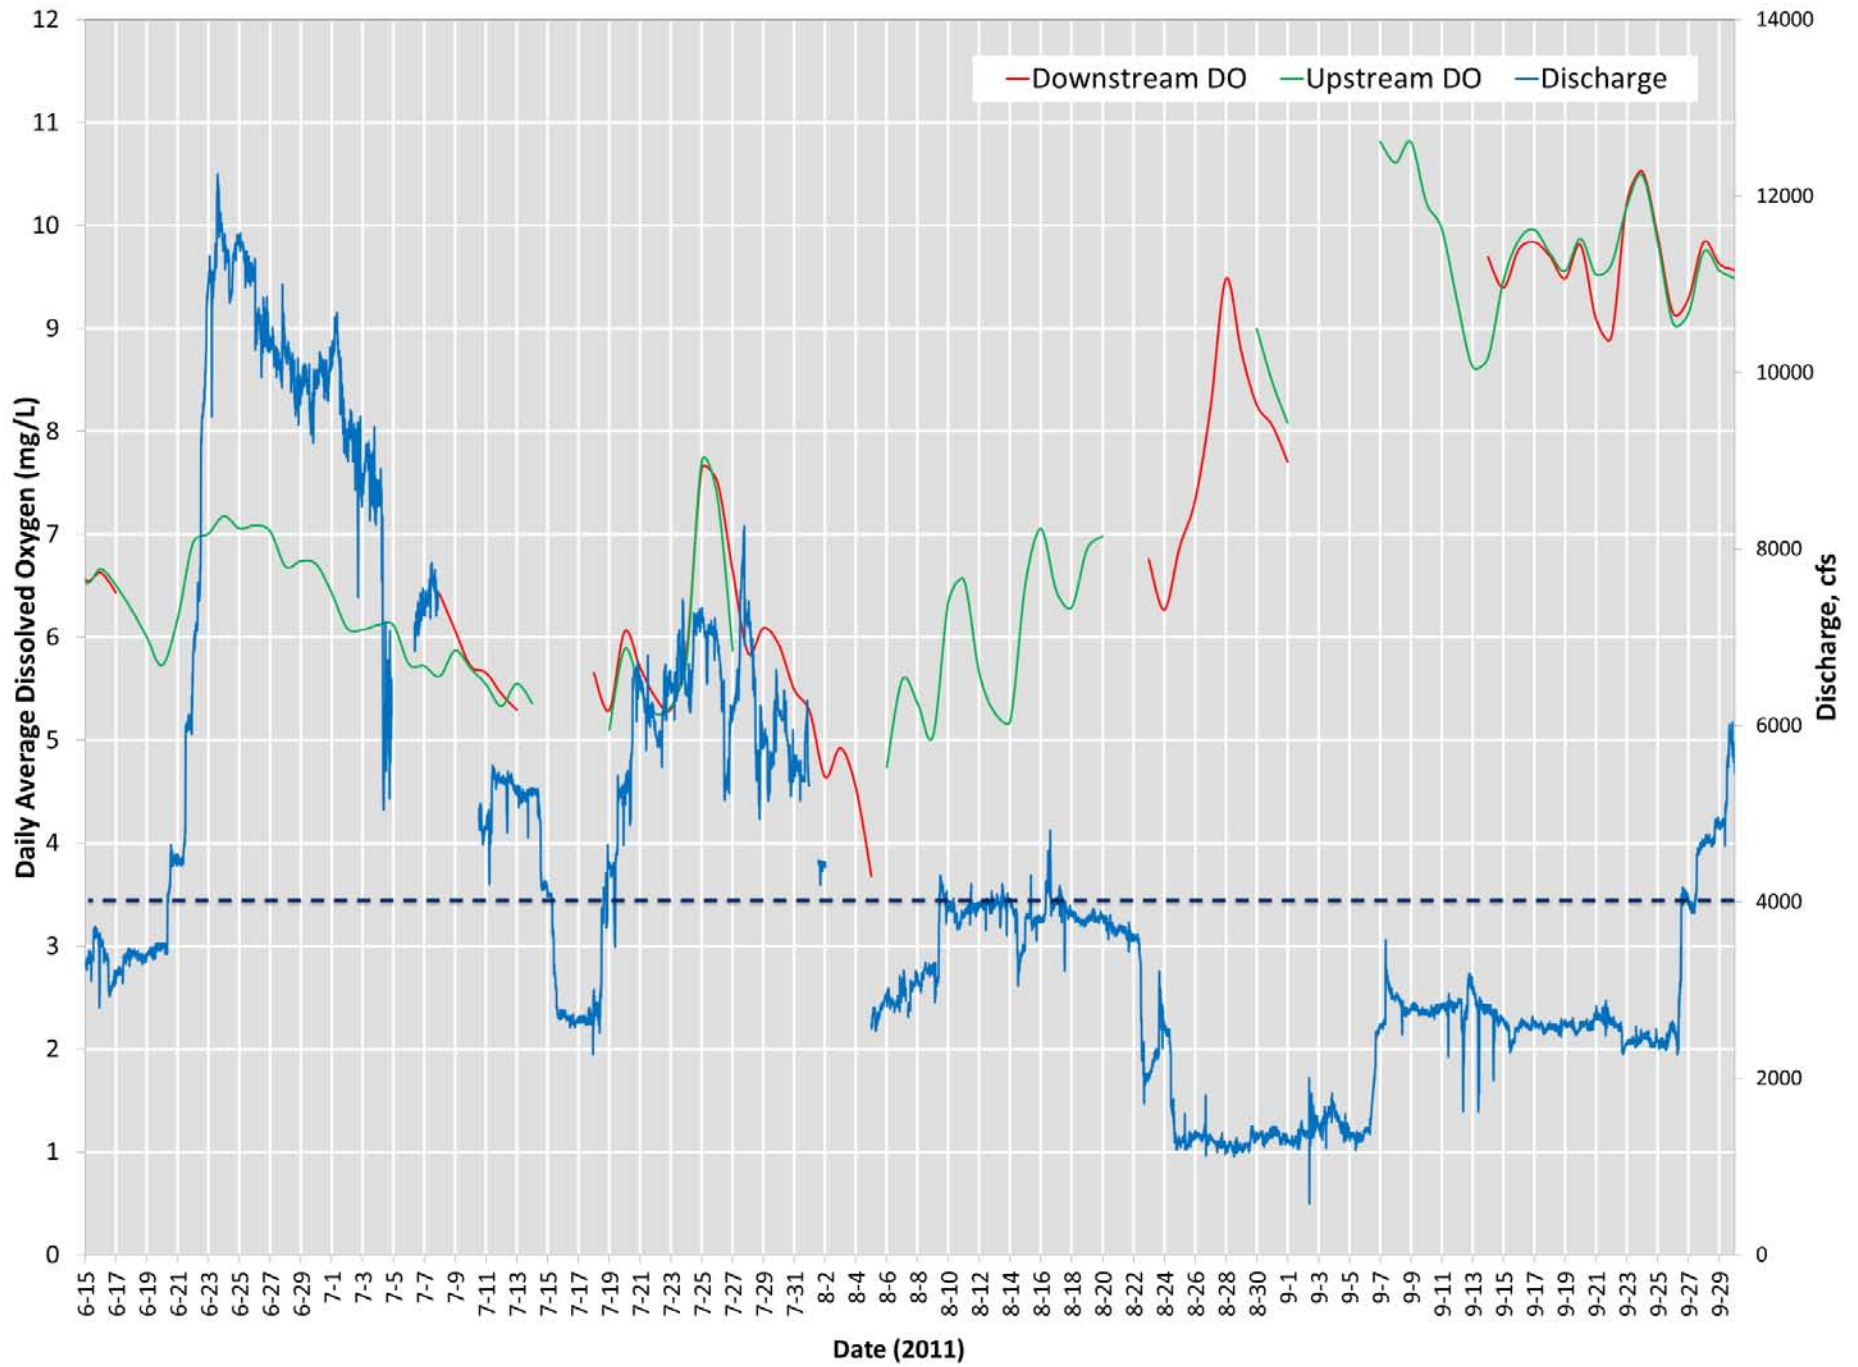
Figure 6. Daily Averages for Dissolved Oxygen Upstream and Downstream of the Little Chute Project and Fox River Discharge
