RE: Flambeau Crowley FERC Project Number 2473

Final Report 2015 Purple Loosestrife Inventory Report

Flambeau Crowley Project Purple Loosestrife Inventory August 27, 2015 FERC Project # 2473 Article 410

CROWLEY HYDROELECTRIC PROJECT FERC #2473 PURPLE LOOSESTRIFE 2015

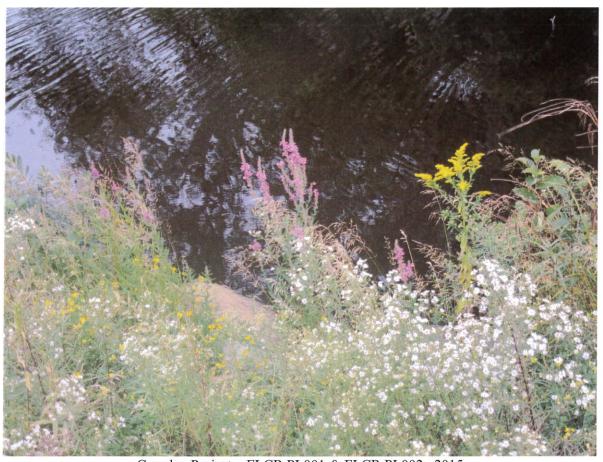
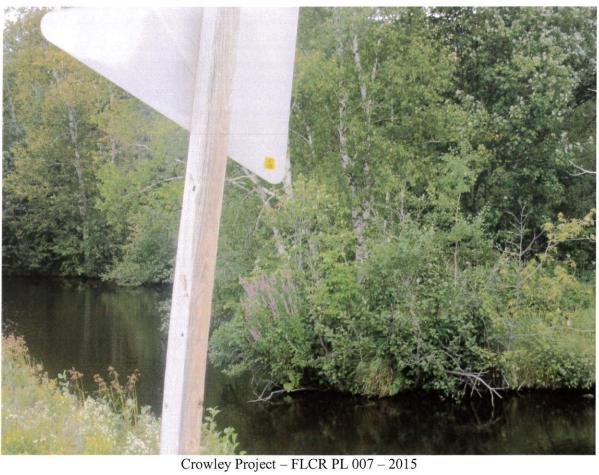
Crowley Project – FLCR PL001 & FLCR PL002 –2015

The first site where purple loosestrife was found was FLCR PL001- FLCR PL002. This is along the south side of the Highway 70 causeway at 6-Mile Creek. From 2003 until 2012, this site had been treated with a Glyphosate solution. In 2010 there were 21 purple loosestrife plants observed in this location. In 2011 that number was down to 3. In 2012 there were 11 multi-stem plants between 1-3 feet tall. In 2013 there were again 10 plants along the causeway. In 2014 there were 15 single and multi-stemmed plants located along this stretch. In 2015 there were 12 plants observed, hand pulled and properly disposed of. The second site observed is directly across from PL001 and PL002 and is labeled FLCR PL007. Technically this could be considered an extension of the sighting noted above. It is located in the same general area as above except: It is at the center of the causeway 45' from the road railing at 110° east of the Hwy sign. This site can't be accessed and for that reason was given a label all its own. There were 1-3 multi stem plants 1-3 feet tall. All plants at both sites showed no signs of Galerucella beetles feeding on the plants and were between 1-3 feet tall with flowering spikes. 12 of 13 were hand pulled with the root ball and properly disposed of.
