**Lake Leota
Watershed Study**

City of
Evansville, WI

January 2006

STRAND ASSOCIATES, INC.®
910 West Wingra Drive
Madison, WI 53715
www.strand.com

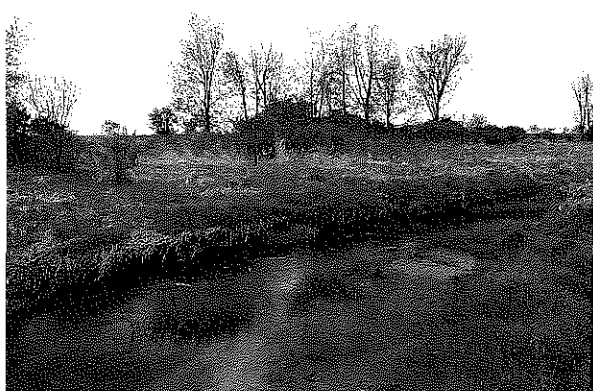
**Figure 3.02-7 Slight (Rating 2)
Streambank Erosion
(pu-20, Photo 74)**

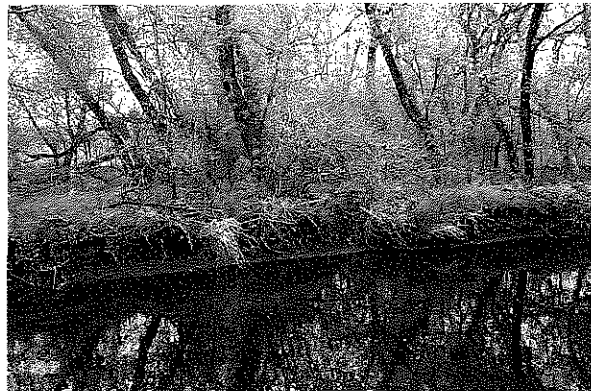
**Figure 3.02-8 Moderate (Rating 3)
Streambank Erosion
(b-6, Photo 14)**

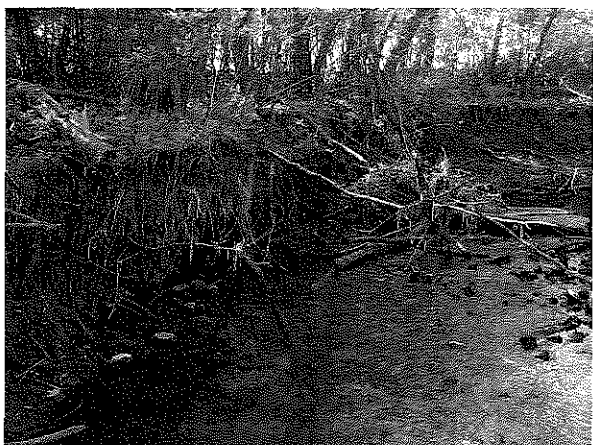
**Figure 3.02-9 Severe (Rating 4)
Streambank Erosion
(or-06, Photo 183)**

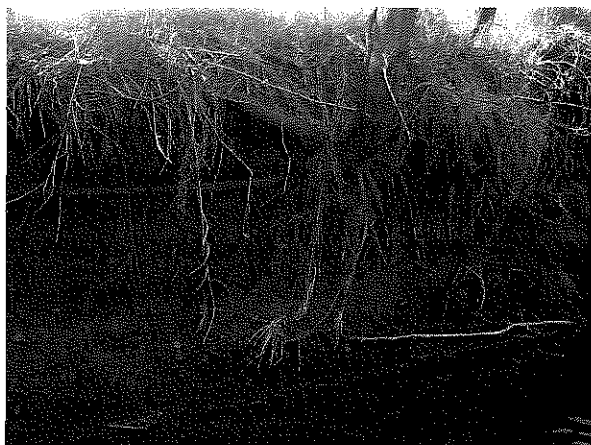
**Figure 3.02-10 Very Severe (Rating 5)
Streambank Erosion
(or-08, Photo 187)**

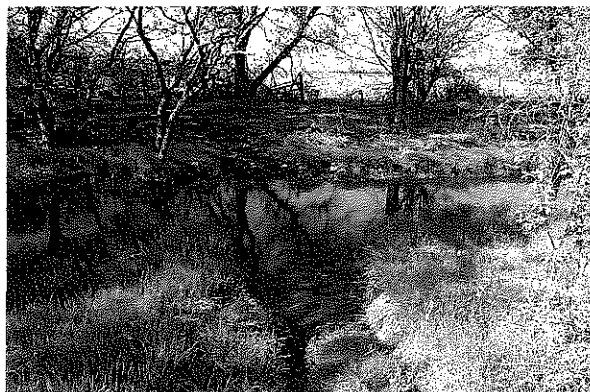
Figure 3.02-11 Vehicle Stream Crossing

We also recommend upgrading all vehicle crossings as Project 3 along the main branches of the creek according to the NRCS Technical Standard (Code 578) to stabilize the crossings and protect the creek from bank and bed erosion. The eight locations identified during the streambank assessment survey

are shown on Figure 4.02-1. Upgrading the vehicle crossings would include adding stone to the creek bed and banks and vegetating side slopes to stabilize crossings in accordance with the NRCS Technical Standard.

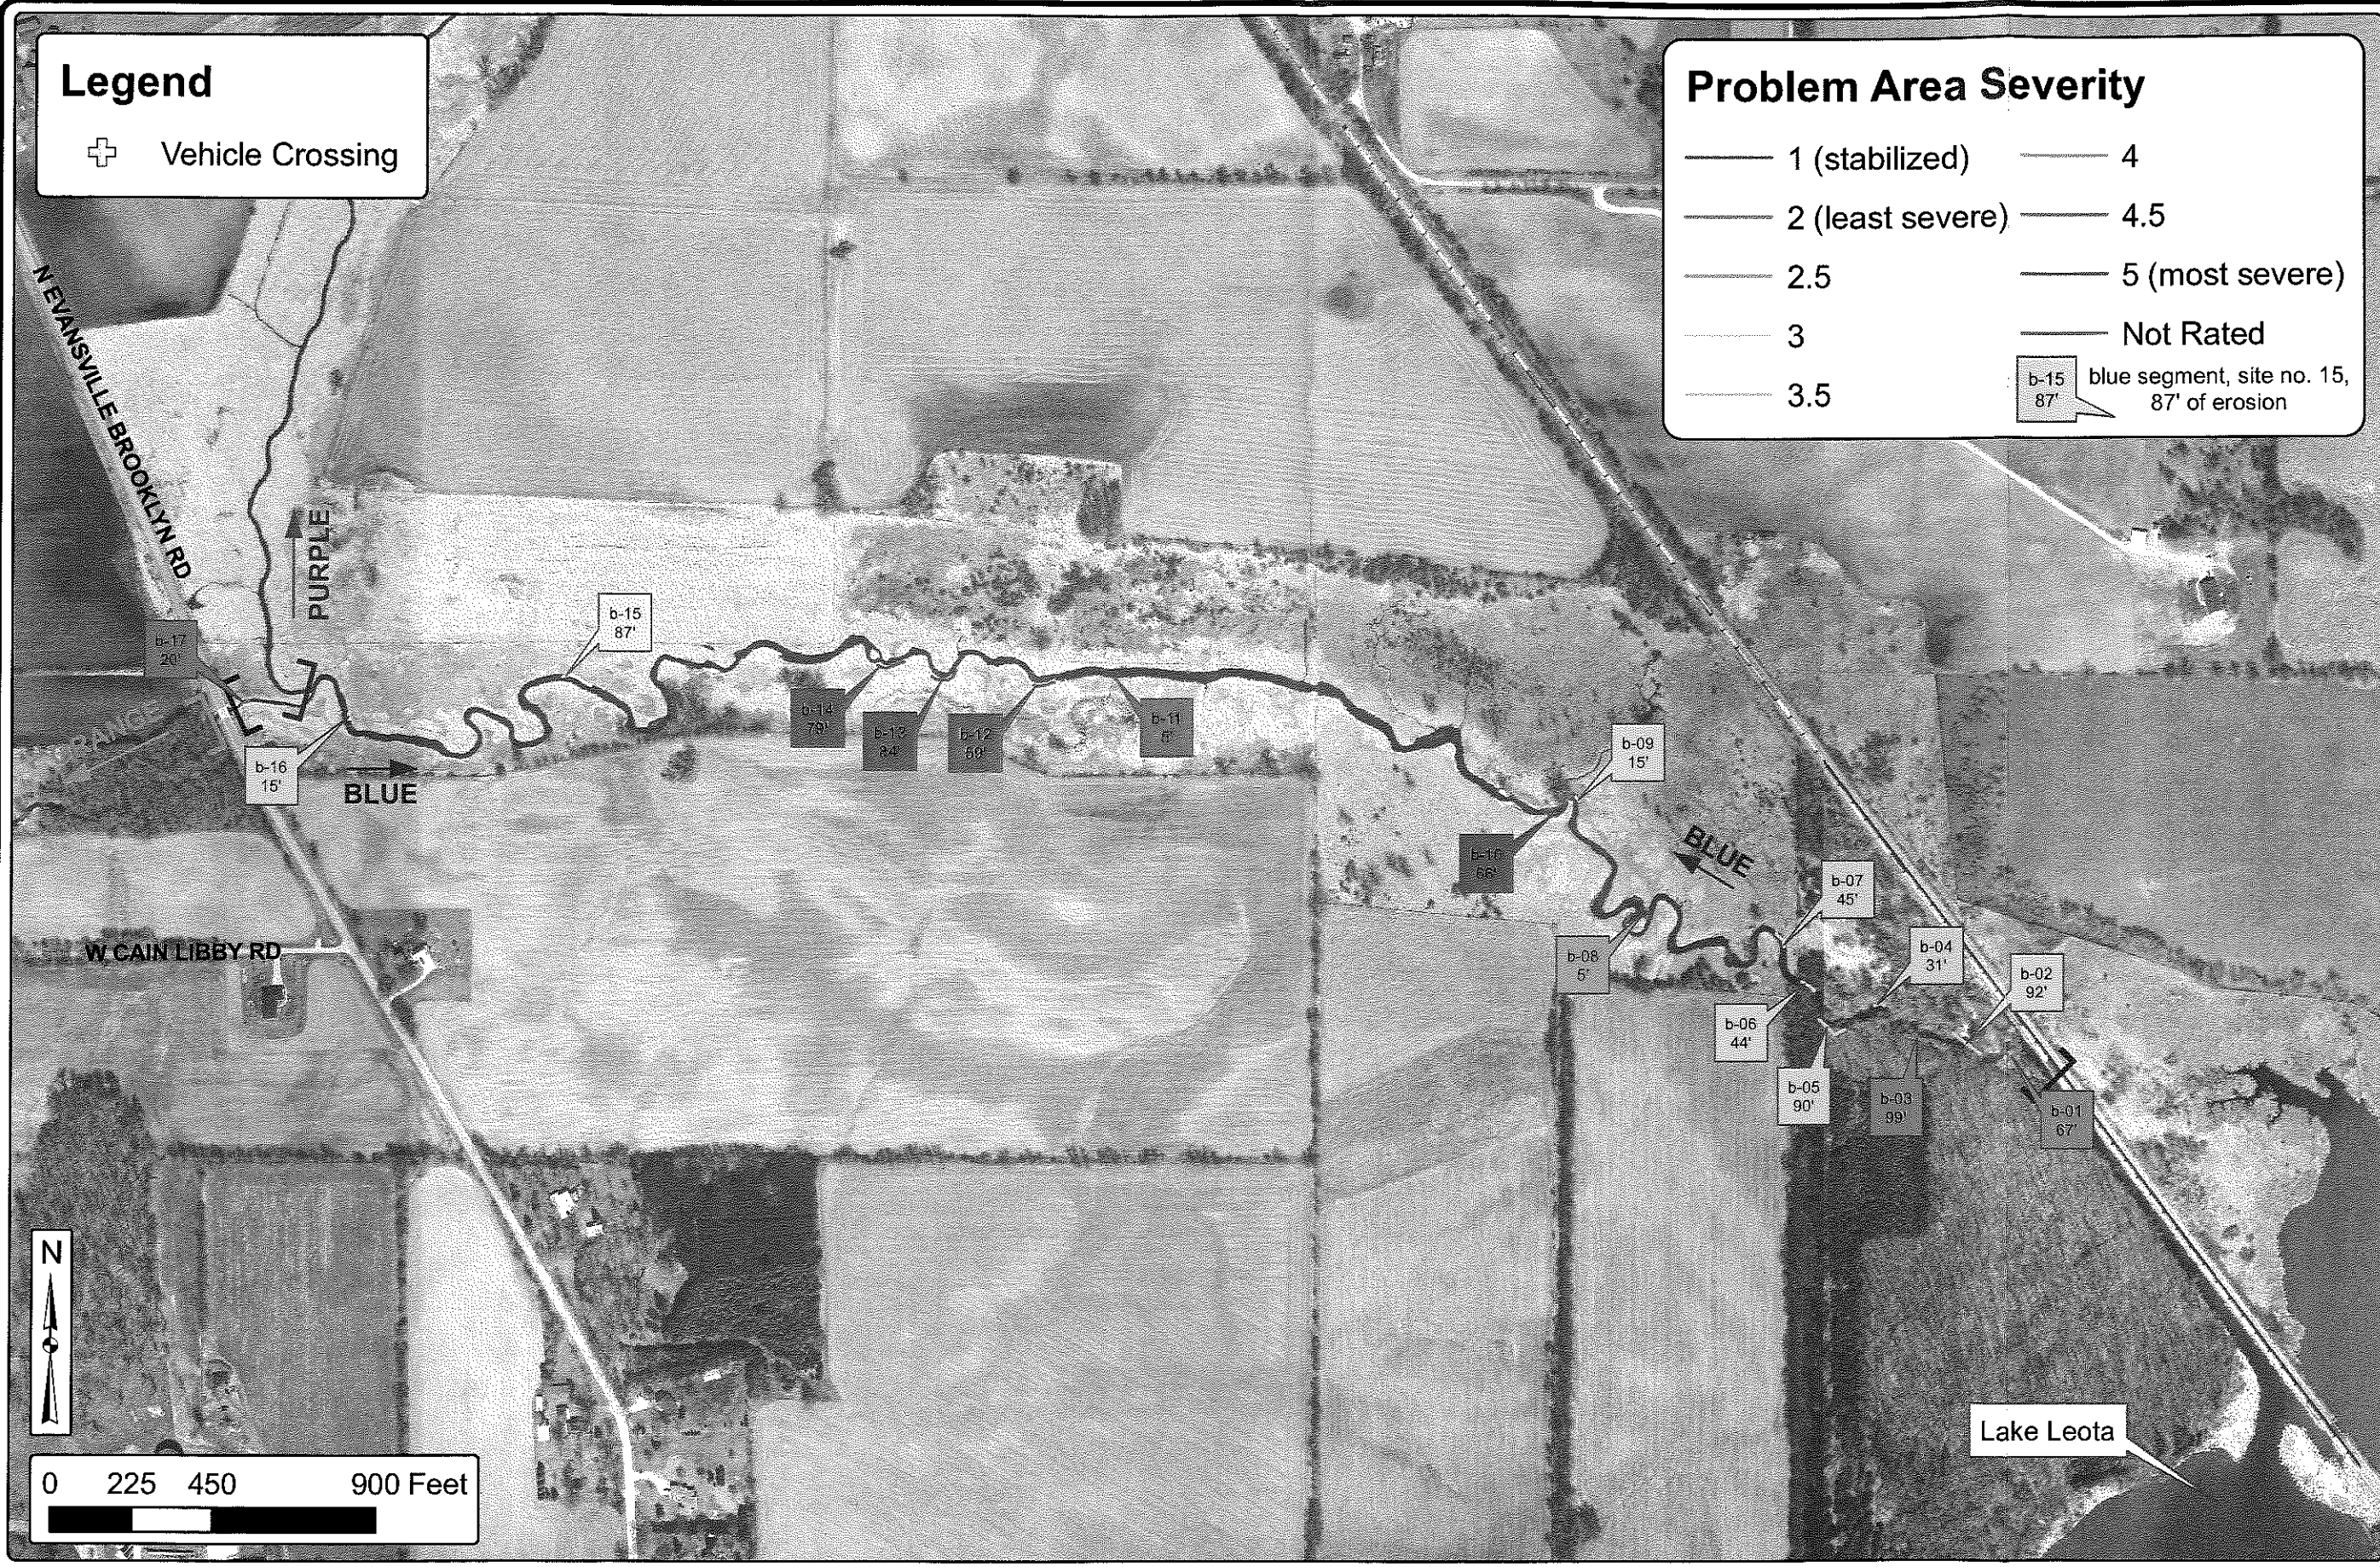
FIGURE 3.02-2
1-354.004

ALLEN CREEK STREAM BANK ASSESSMENT - BLUE SEGMENT

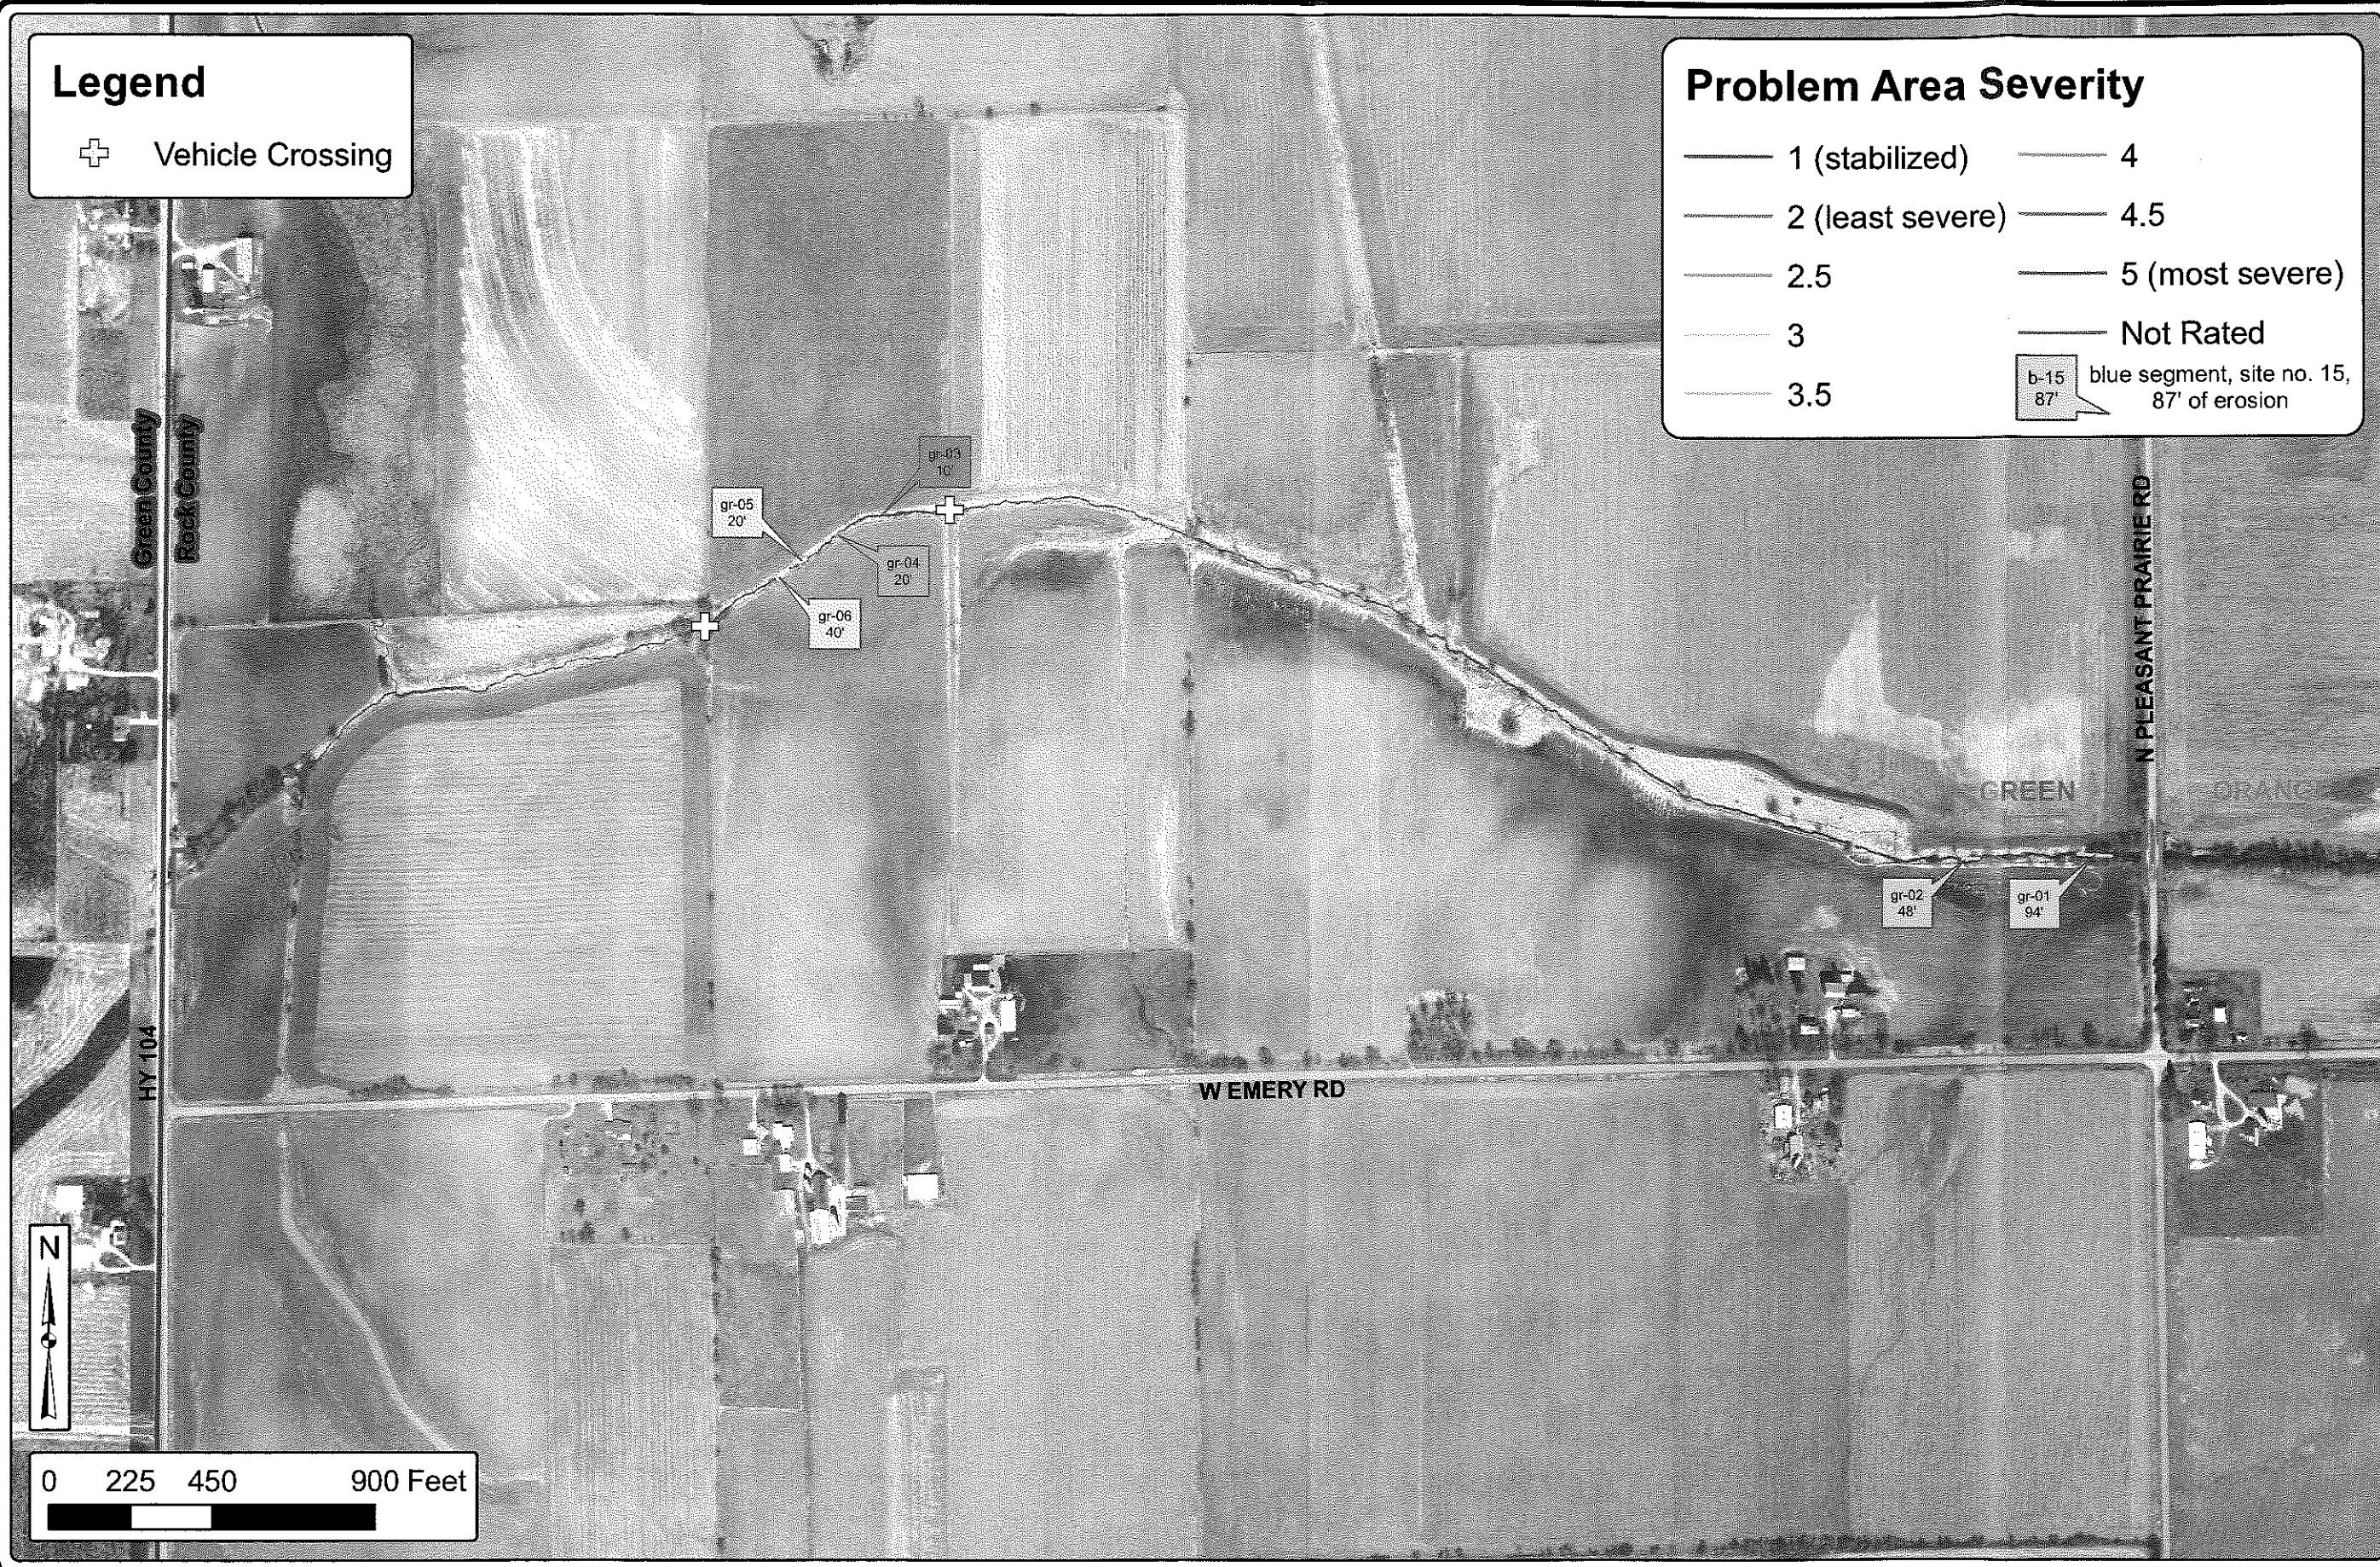
FIGURE 3.02-4
1-354.004

ALLEN CREEK STREAM BANK ASSESSMENT - GREEN SEGMENT

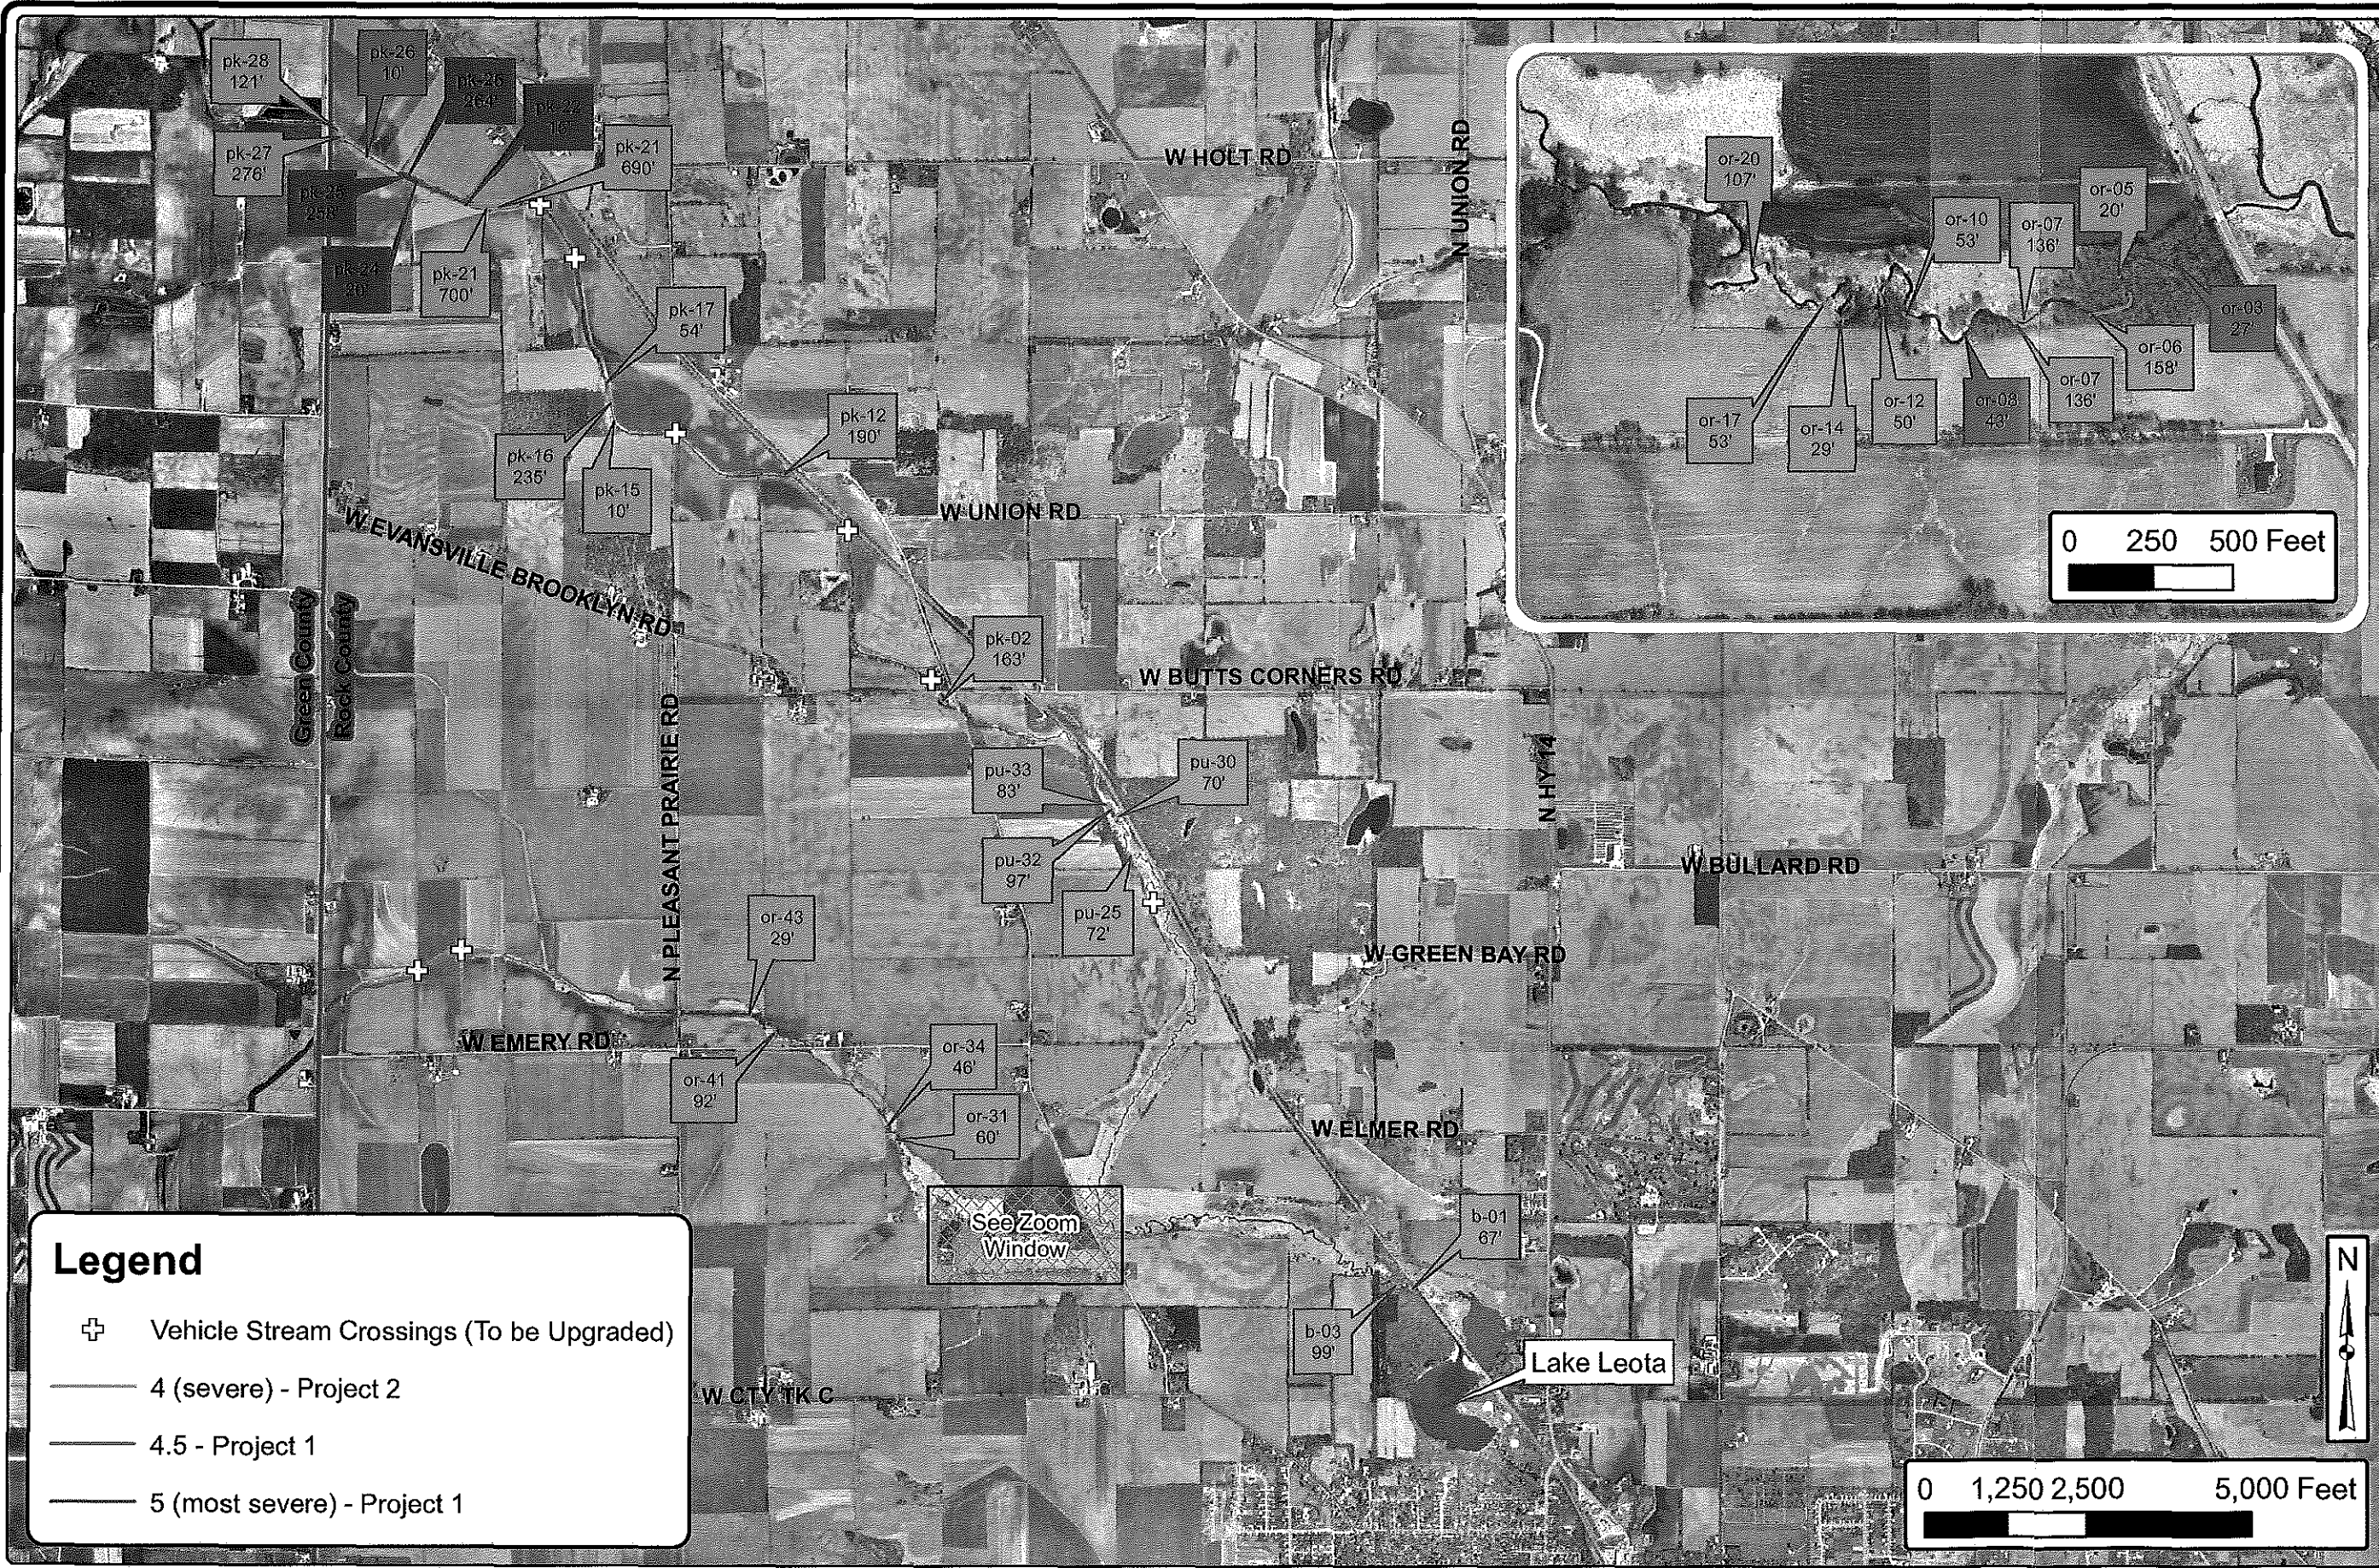
- ⊕ Vehicle Stream Crossings (To be Upgraded)
- 4 (severe) - Project 2
- 4.5 - Project 1
- 5 (most severe) - Project 1
