**Re: *Flambeau Crowley, Project No. 2473, Flambeau Hydro LLC  
Article 410, Purple Loosestrife Inventory***

**Flambeau Crowley Project Purple Loosestrife Inventory**  
**August 8, 2007**  
**FERC Project #2473 Article 410**

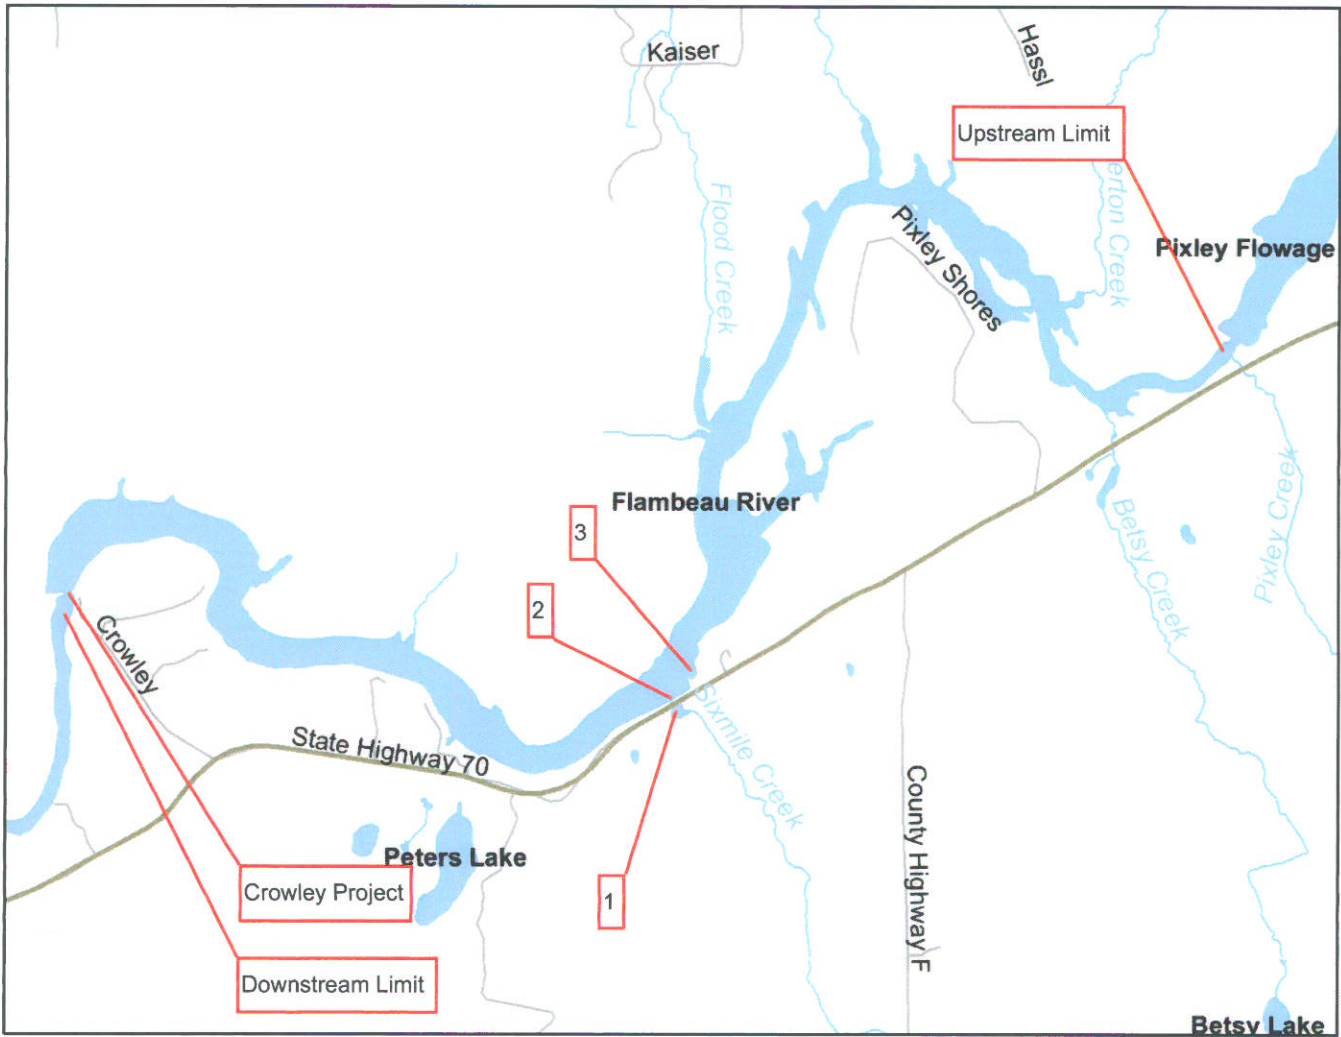
# Crowley #2473 Purple Loosestrife Survey 2007

Sighting #	GPS point	Latitude	Longitude	Plant Height	Stand Area	Comments
1	209 - 215 FLCRPL001 - FLCRPL002	N45°51.816' - N45°51.850'	W90°32.859' - W90°32.786'	1' - 4'	~375' x 25'	Located between GPS points 209 and 215 on the south side of the causeway formed by HWY 70 just east of the 6-mile boat landing. There are 11 plants spread out over a 375 foot long area. The largest concentration is 4 plants and the rest are between 1 and 2 plants. Most plants appear to have 1-2 stems per plant. All seed heads at this occurrence were harvested in August 2002 to prevent propagation. This occurrence recorded on digital photos and video tape in 2002. All plants were treated with herbicide in 2003. This occurrence recorded on videotape in 2003. All plants were treated with herbicide in 2004. This occurrence recorded on digital photos in 2004. One immature single stem plant was pulled and the rest appeared to have been spot treated with an herbicide by other person(s) before the licensee survey crew arrived in 2005. This occurrence recorded on digital photos in 2005. All plants were treated with herbicide in 2006. This occurrence recorded on digital photos in 2006. All plants were treated with herbicide in 2007. This occurrence not recorded on digital photos in 2007.

2	216 - 217 FLCRPL003 - FLCRPL004	N45°51.857' - N45°51.853'	W90°32.806' - W90°32.814'	N/A	N/A	Located between GPS points 216 and 217 on the north side of the causeway formed by HWY 70 just east of the 6-mile boat landing. No plants found in 2007. All seed heads at this occurrence were harvested in August 2002 to prevent propagation. This occurrence recorded on digital photos in 2002. All plants were treated with herbicide in 2003. This occurrence recorded on videotape in 2003. No purple loosestrife plants were observed at this location in 2004. The only plant found in 2005 was pulled. This occurrence recorded on digital photo in 2005. All plants were treated with herbicide in 2006. This occurrence recorded on digital photos in 2006.

Sighting #	GPS point	Latitude	Longitude	Plant Height	Stand Area	Comments
3	208 FLCRPL005	N45°51.926'	W90°32.788'	N/A	N/A	Located on a bog in a stump field in the river east of the 6-mile boat landing. All seed heads were harvested in August 2002 to prevent propagation. This occurrence recorded on digital photos in 2002. This occurrence was not found in 2003, 2004, 2005, 2006, and 2007.
