Re: Clam River Project, No. 9185, Flambeau Hydro, LLC Article 401(b)(M), Purple Loosestrife Inventory 2010

Clam River Project Purple Loosestrife Inventory July 29, 2010 FERC Project #9185 Article 401(b)(M)

Flambeau Hydro, LLC 116 State St. Neshkoro, WI 54960

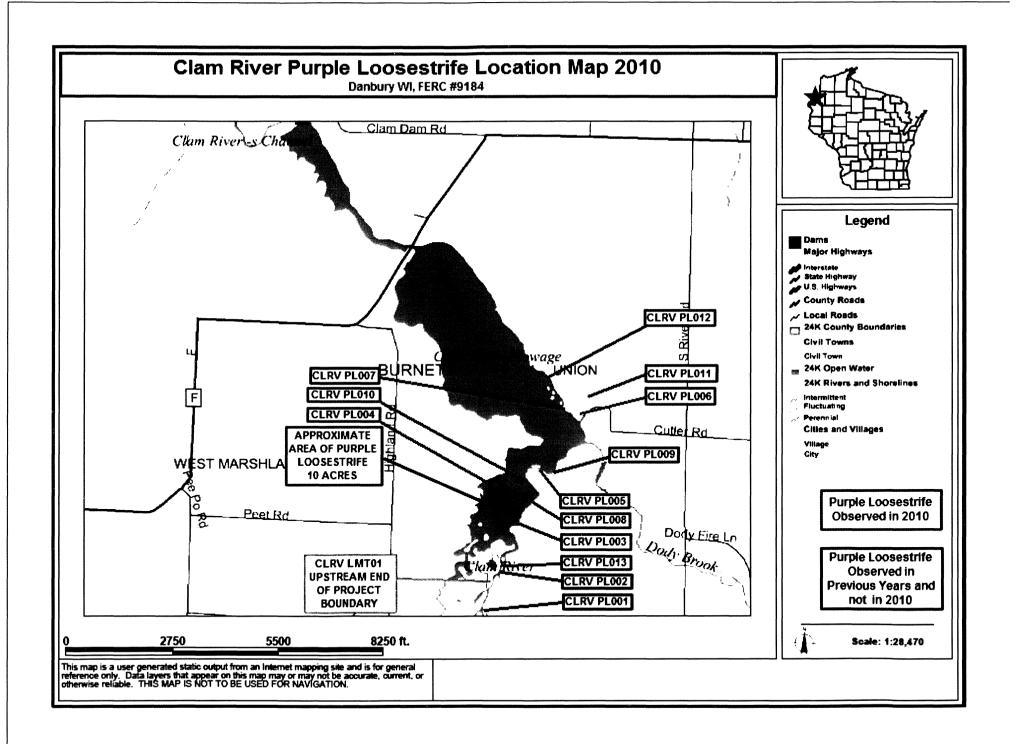
These purple loosestrife plants were inventoried and have been noted on the survey sheet(s) and map(s) at the end of this report. No other occurrences of purple loosestrife were observed.
